#### LOCATION AND CROSSING DESCRIPTION

Site ID:	M-Culv-4	Dates Surveyed:	28-Jun-19; 19-Aug-19	Waterbody Type:	Stream
Project Interaction:	Road Culvert	Centreline UTM Coordinates:	17W 560752 E 7913497 N	Culvert Length (m):	29.95
Number of Barrels:	3	Culvert Diameter/Span (mm):	1500	Slope (%):	0.7

BAFFINLAND IRON MINES MARY RIVER PROJECT

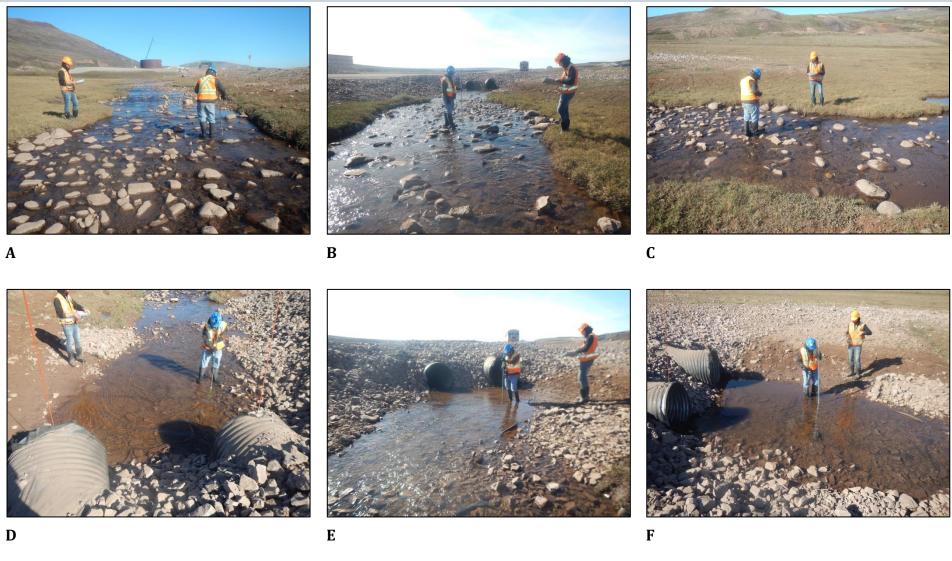
**Photos 1.** Photos taken at the crossing centreline (top) and 20 m downstream (bottom) in spring: (A,D) facing upstream; (B,E) facing downstream; (C,F) across (right bank looking at left bank).

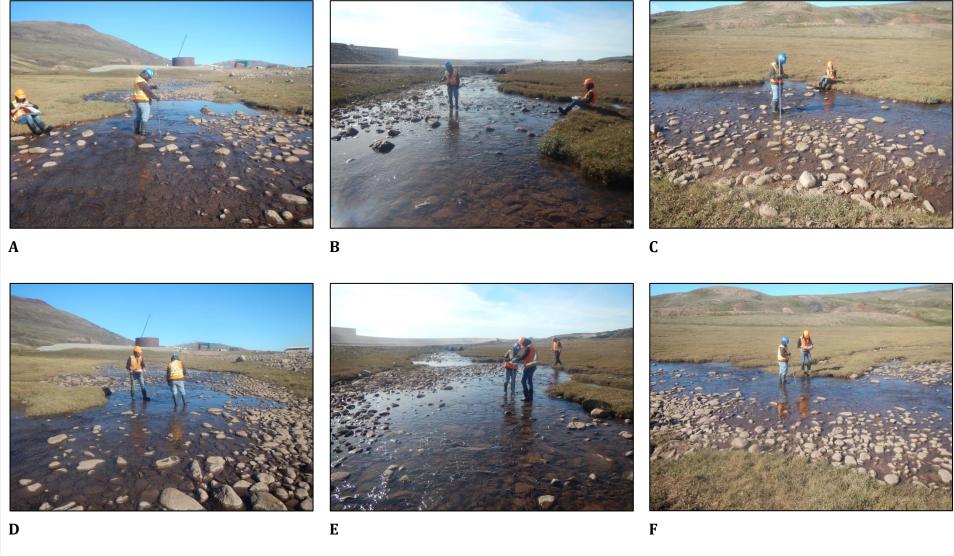
**Photos 2.** Photos taken 20 m upstream (top) and 40 m upstream (bottom) in spring: (A,D) facing upstream; (B,E) facing downstream; (C,F) across (right bank looking at left bank).

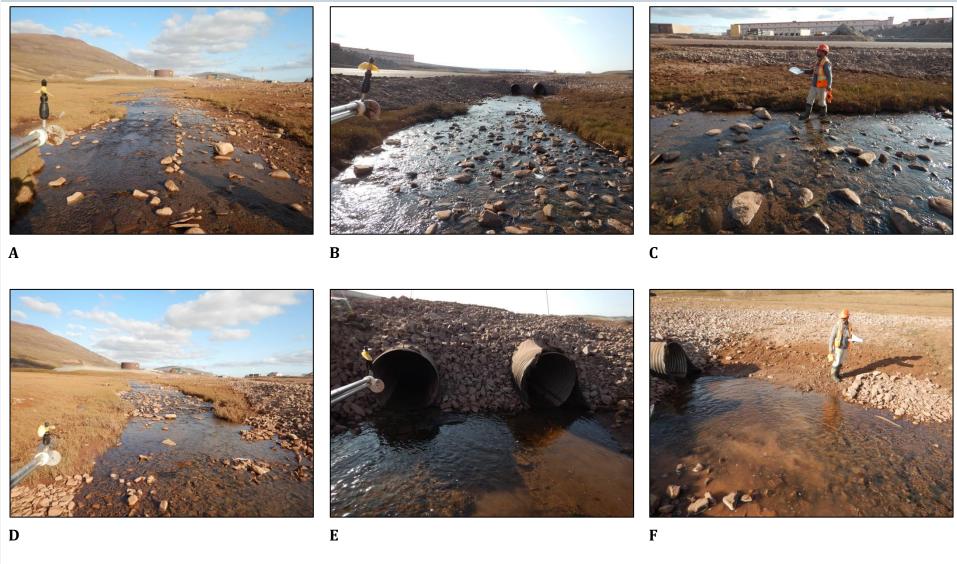
**Photos 5.** Photos taken at the crossing centreline (top) and 20 m downstream (bottom) in summer/fall: (A,D) facing upstream; (B,E) facing downstream; and (C,F) across (left bank looking at right bank).

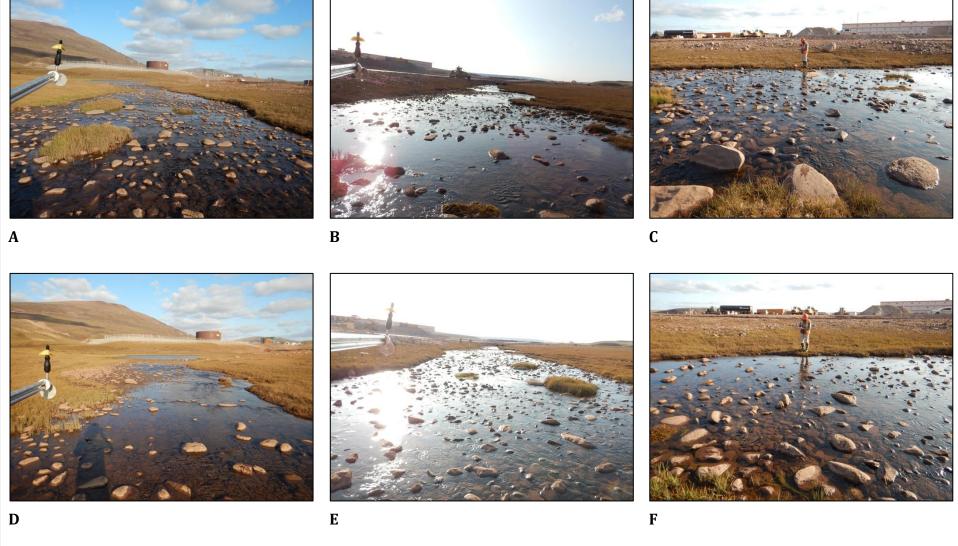
**Photos 7.** Photos taken 60 m upstream (top) and 80 m upstream (bottom) in summer/fall: (A,D) facing upstream; (B,E) facing downstream; (C,F) across (left bank looking at right bank).

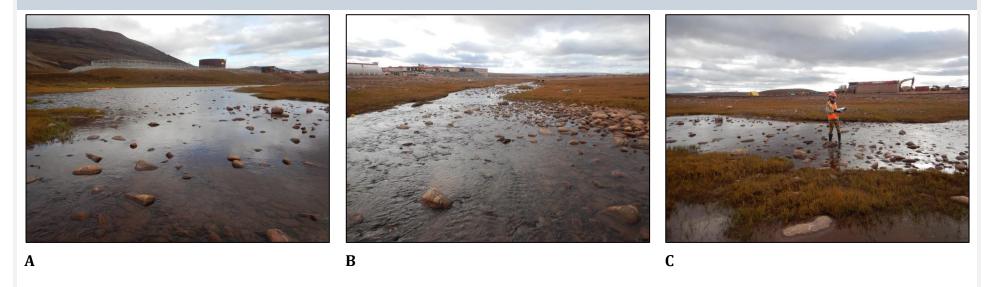
**Photos 8.** Photos taken 100 m upstream in summer/fall: (A) facing upstream; (B) facing downstream; (C) across (left bank looking at right bank).

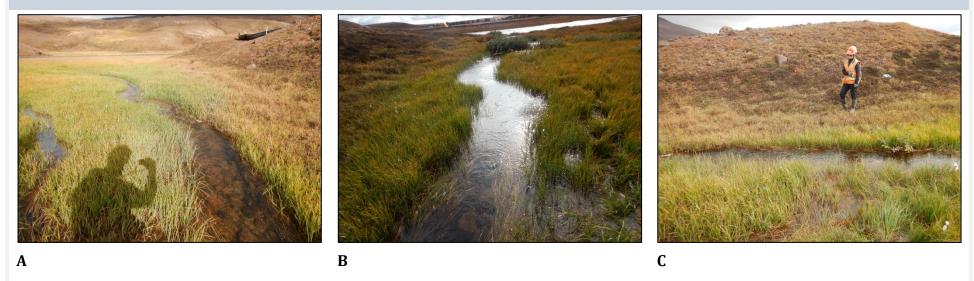
**Photos 11.** Photos taken 200 m upstream in summer/fall: (A) facing upstream; (B) facing downstream; (C) across (right bank looking at left bank). Note: all photos taken while standing at the transect centreline.

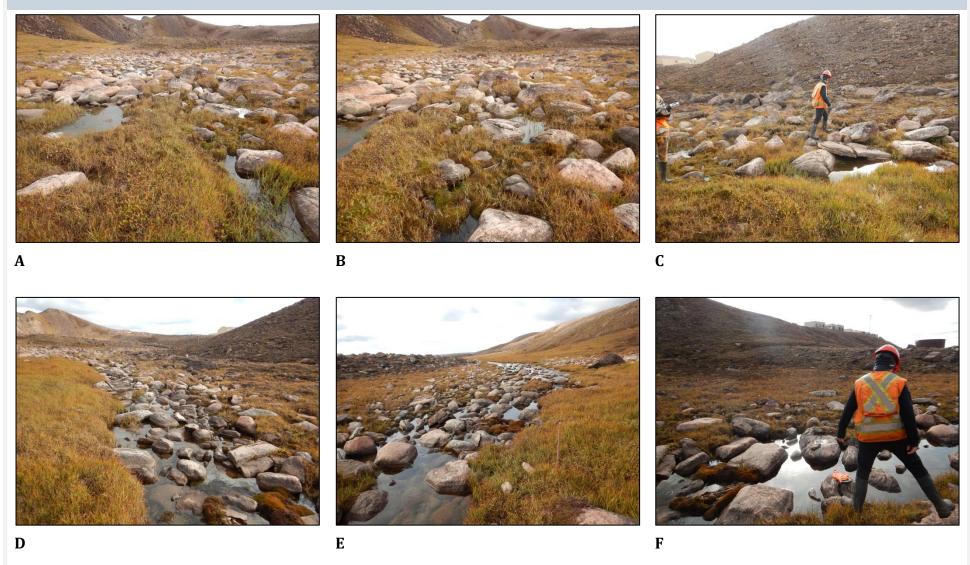
**Photos 12.** Photos taken at the barrier (top) and 20 m downstream (bottom) from the barrier in summer/fall: (A,D) facing upstream; (B,E) facing downstream; (C,F) across (right bank looking at left bank). Note: all photos taken while standing at the transect centreline.

Upstream/	UT	М	Ва	rrier Type	2	Height	Gradient	Description			
Downstream	Easting	Northing	1	2	3	(m)	(°)	Description			
Downstream	NO BARRIERS										
Upstream	561444	7913547	SSF					Permanent Barrier: Subsurface flow under boulders overgrown with vegetation

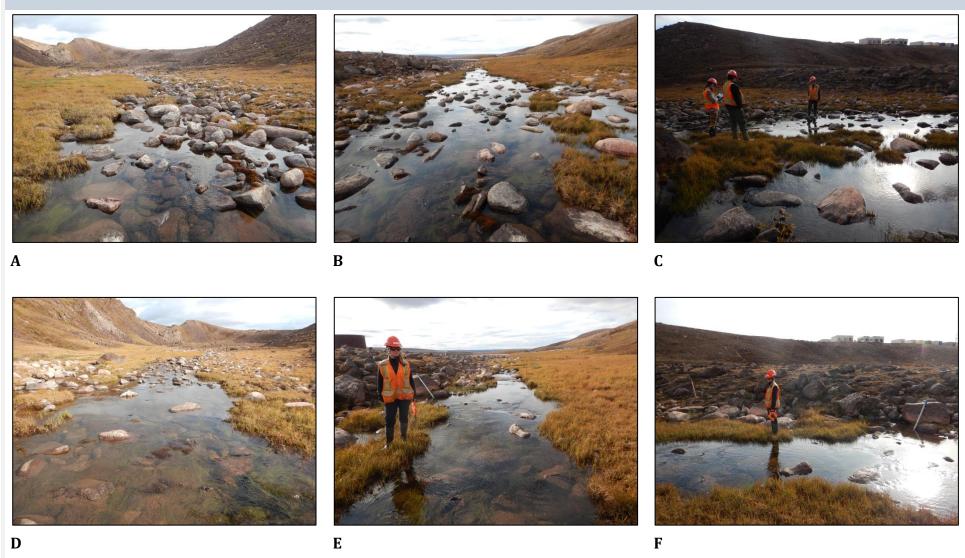
**Photos 13.** Photos taken 40 m downstream (top) and 60 m downstream (bottom) from the barrier in summer/fall: (A,D) facing upstream; (B,E) facing downstream; (C,F) across (right bank looking at left bank). Note: all photos taken while standing at the transect centreline.
