# RAIL CV-17-1

## LOCATION AND CROSSING DESCRIPTION

BAFFINLAND IRON MINES  
MARY RIVER PROJECT

**North/South Consultants Inc.**  
Aquatic Environment Specialists

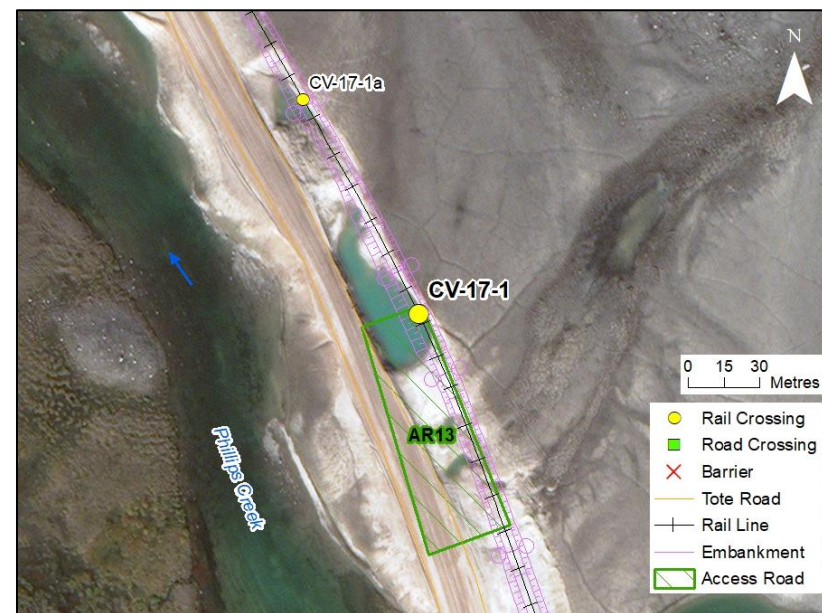
Shallow, isolated pond (approximate maximum depth 1 m) adjacent to the Tote Road. The pond is a former borrow pit used during road construction and maintenance, lacks inflows and outflows and supplied by rain and snowmelt. The pond is not fish habitat.

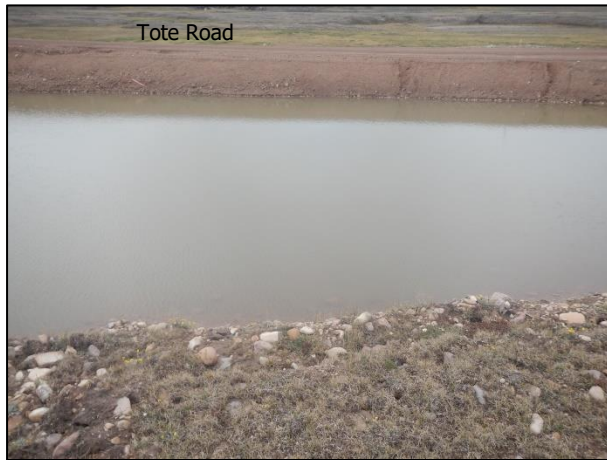
A

**Photos 1.** Photos of the pond at CV-17-1: (A) at the encroachment site looking west toward the Tote Road; (B) looking to the northwest across the pond; (C) looking east towards the encroachment site; (D) looking NW to SE across the pond; and (E) aerial image of pond (from fall 2018).
