**APPENDIX D**  
**AS BUILT REPORTS**

**Re: Baffinland Iron Mines Corporation (BIMC) - Submission of 2013 Annual Geotechnical Inspection, Water Licences Type 'A' No. 2AM-MRY1325 and Type 'B' 2BB-MRY1114**

**ANNUAL GEOTECHNICAL INSPECTION**  
**Baffinland Iron Mines Corporation**  
**Mary River Project**

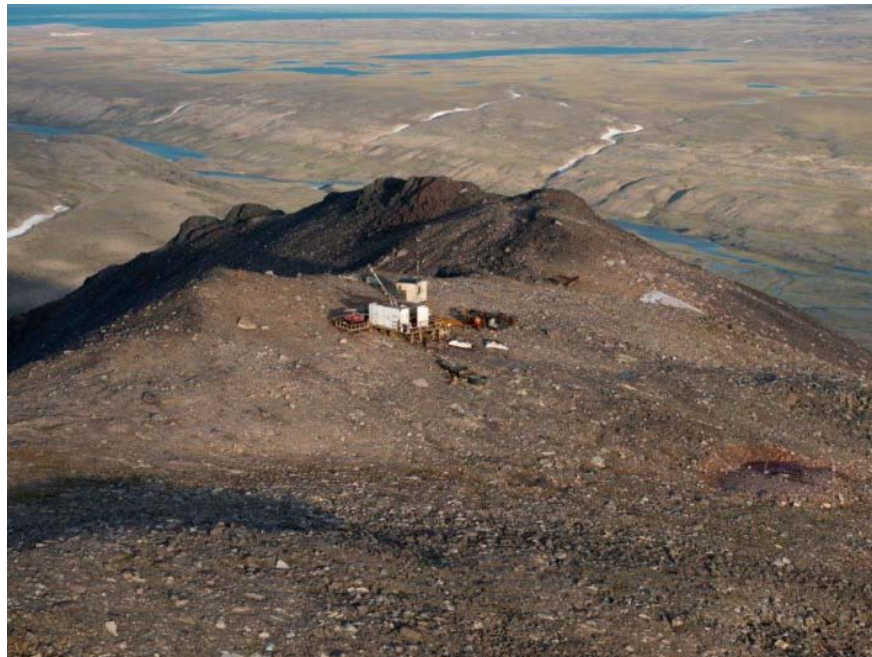
**PHOTO6 5** Geochemical Investigation Drilling Equipment at Deposit #1

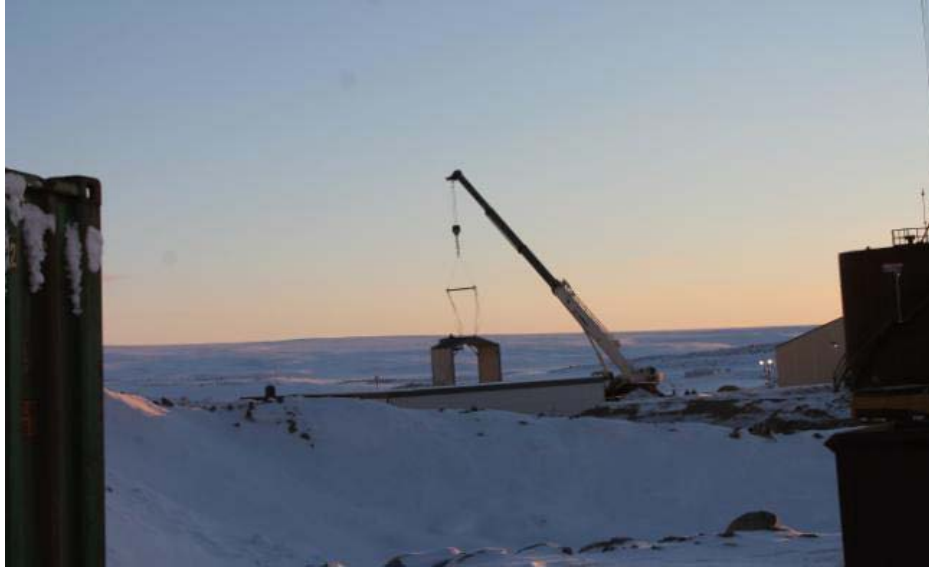
**PHOTO 9** Installation of Sewage Truck Building  
ᐱᓃᐅᐅᐁᐁᐁ ᐃᐱᓃᐅᐁᐁᐁ ᐃᑦᐅᐁᐁᐁᐁᐁ

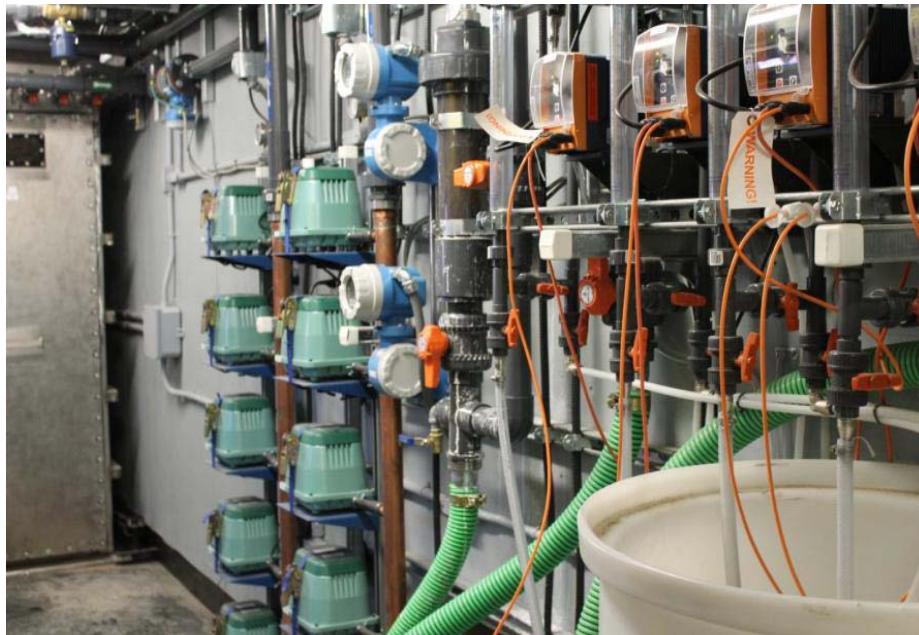
**PHOTO 10** Internal components of the Wastewater Treatment Facility utilizing MBR Technology

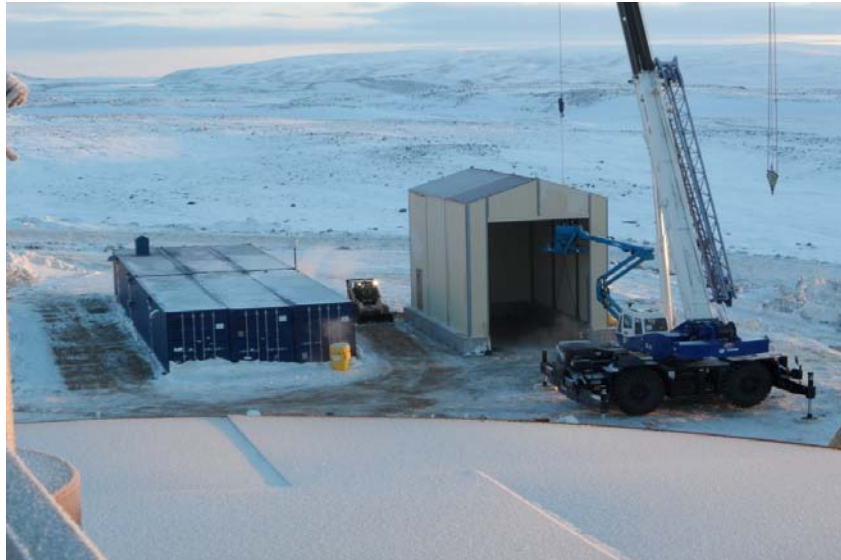
**PHOTO 11** Wastewater Treatment Facility utilizing MBR Technology  
and adjacent Sewage Truck Building

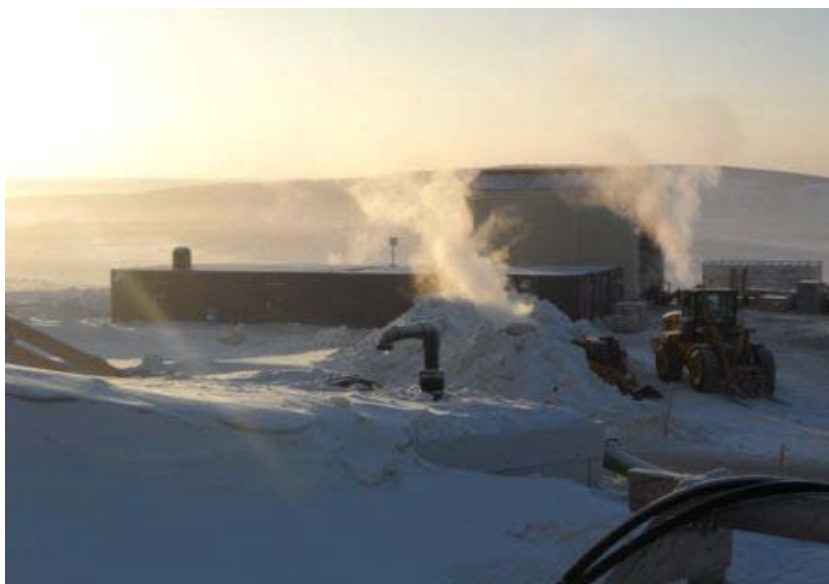
**PHOTO 12** Wastewater Treatment Facility utilizing MBR Technology  
and adjacent Sewage Truck Building (alternate view) November 2013

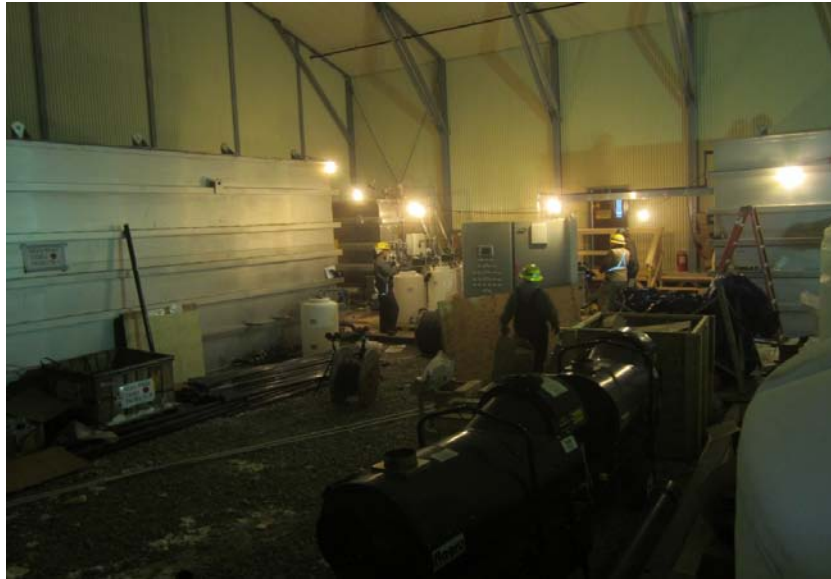
**PHOTO 13** Water (Fresh) Treatment System Installation November 2013

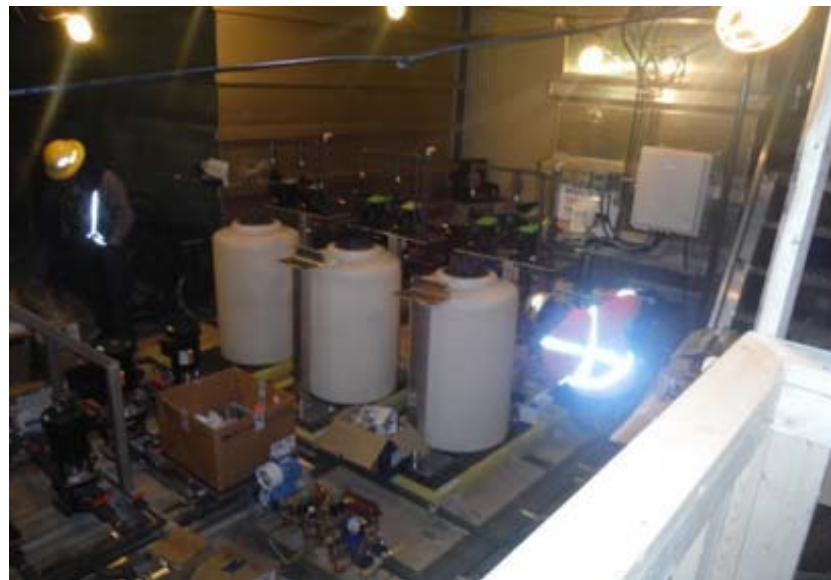
**PHOTO 14** Water Building - Mechanical Installation November 2013

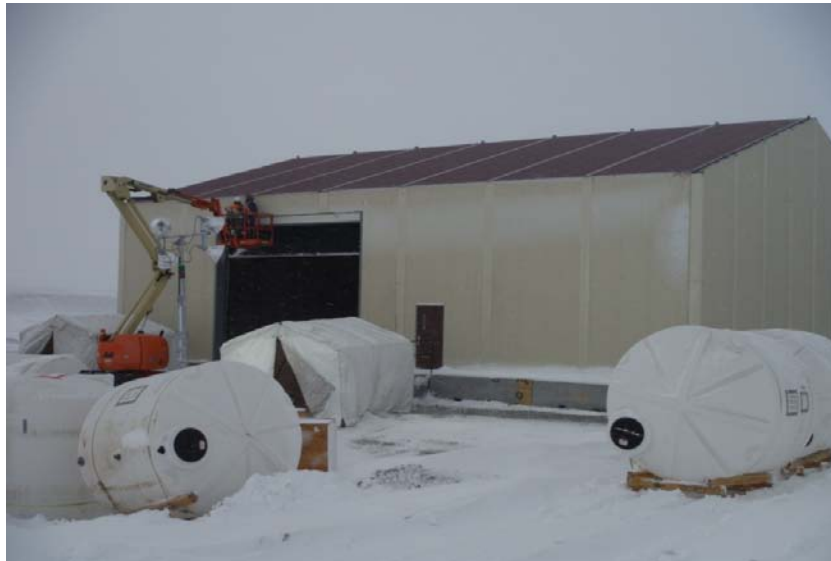
**PHOTO 15** Potable Water Building October 2013  
 ᐱᓕᓕᓐᓂᓐ ᐱᓐᓂᓐᓂᓐ ᐱᓐᓂᓐᓂᓐ ᐱᓐᓂᓐᓂᓐ 2013-ᐱ

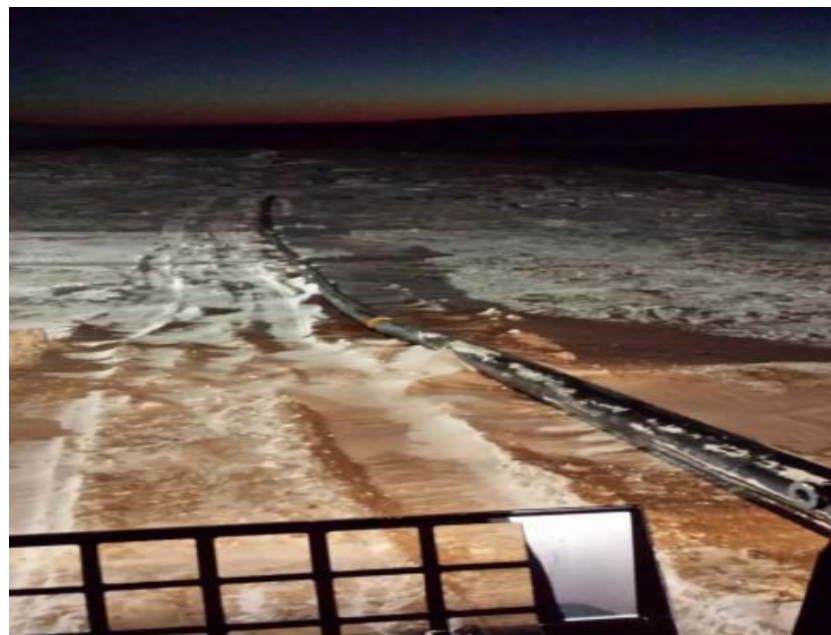
**PHOTO 16** Raw Water Intake Pipeline  
 ነፍሰሃይ ሜሮጋጅ ልገፍፍ ገጋሪባጋልዲስ ሥጋሮህፍ

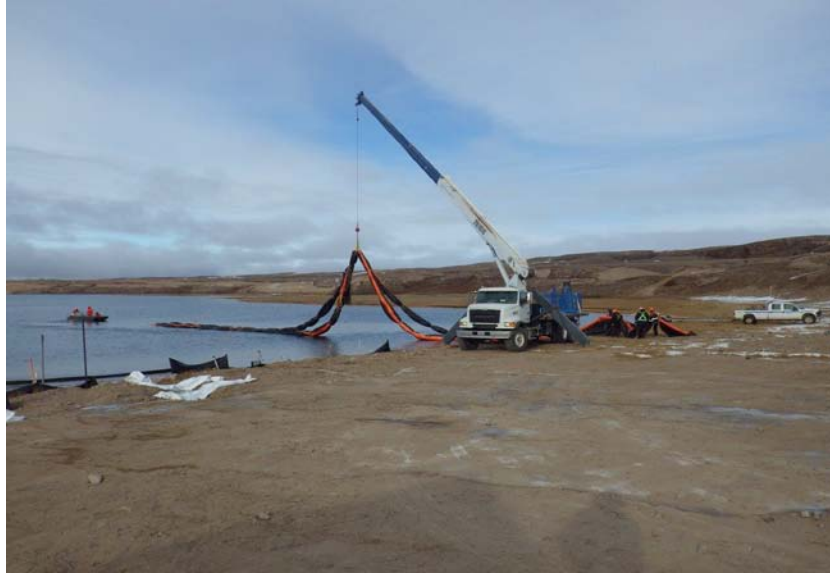
**PHOTO 17** Boom deployment and Silt Curtain installation at Camp Lake for Raw Water Jetty

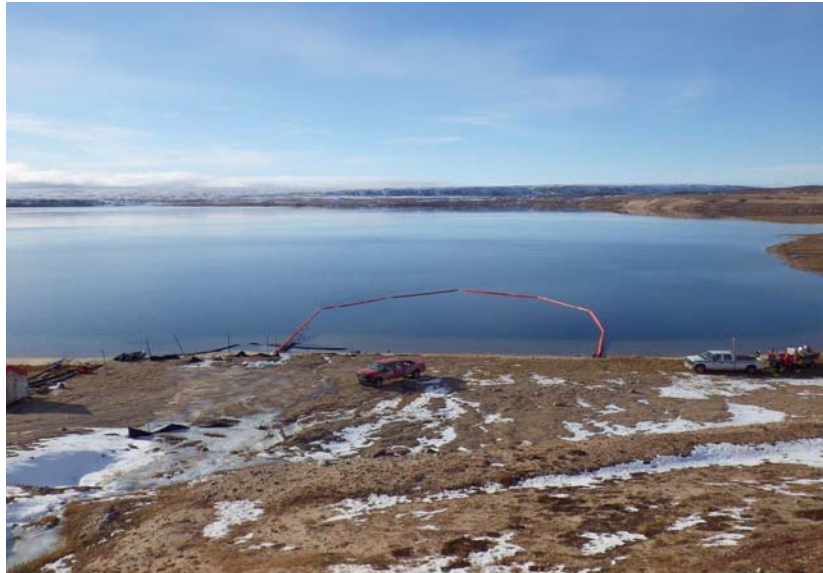
**PHOTO 18** Mine Site Raw Water Jetty Silt Curtain at Camp Lake

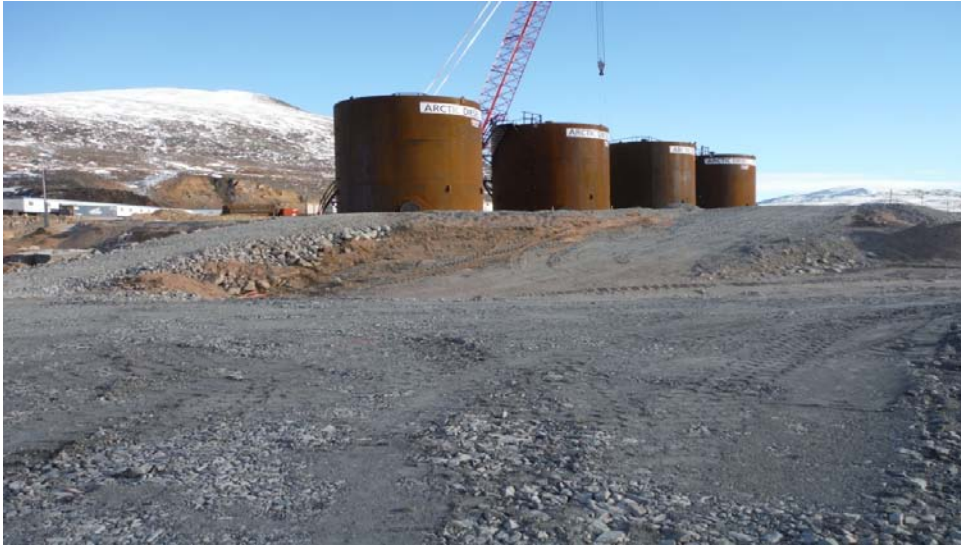
**PHOTO 23** Steel Tank Bulk Fuel Storage Facility September 2013  
 ልናኑል ምርጥናላቸው የሚገኝ የፊደል ተክል ማከማቻ ሰጠ፡፡ ግንባራው ለጥቅምት 2013

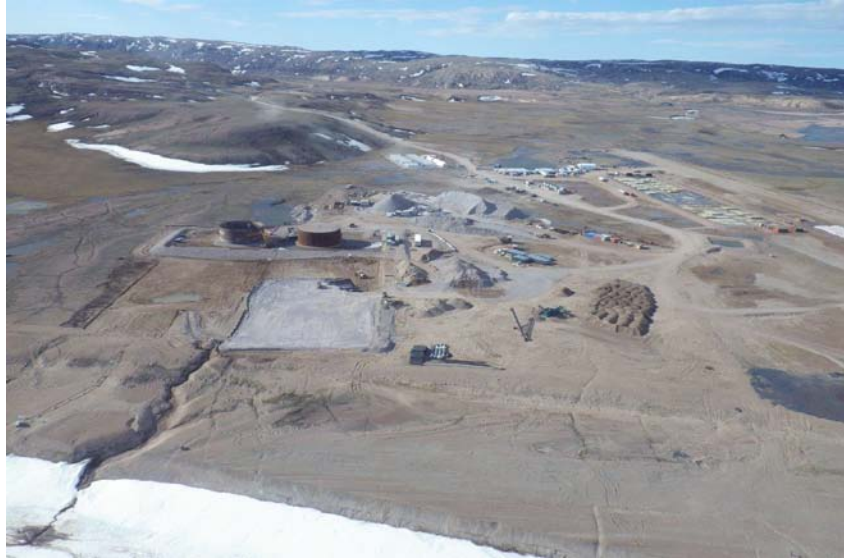
**PHOTO 1** Aerial View - Steel Tank Bulk Fuel Storage Facility and infrastructure laydown June 2013

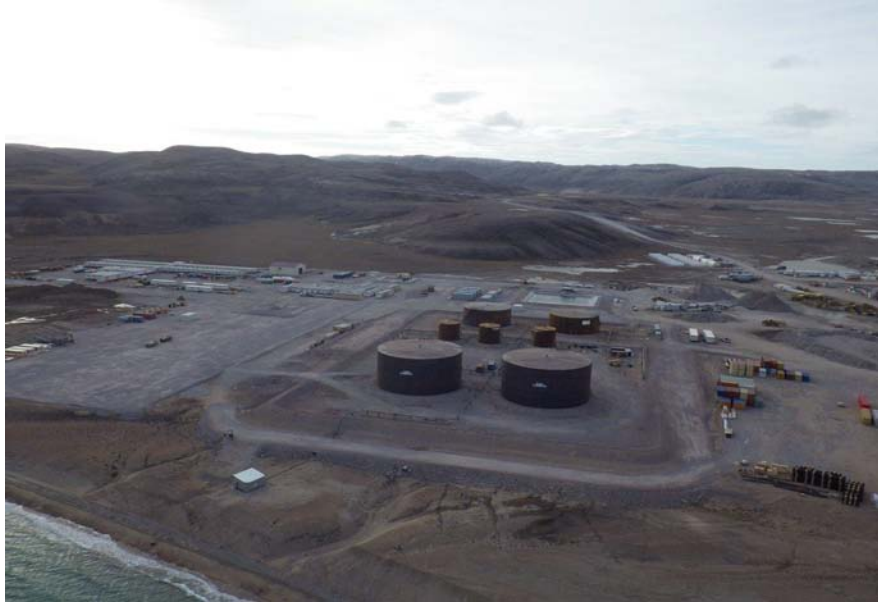
**PHOTO 3** Aerial View - Steel Tank Bulk Fuel Storage Facility and infrastructure laydown September 2013

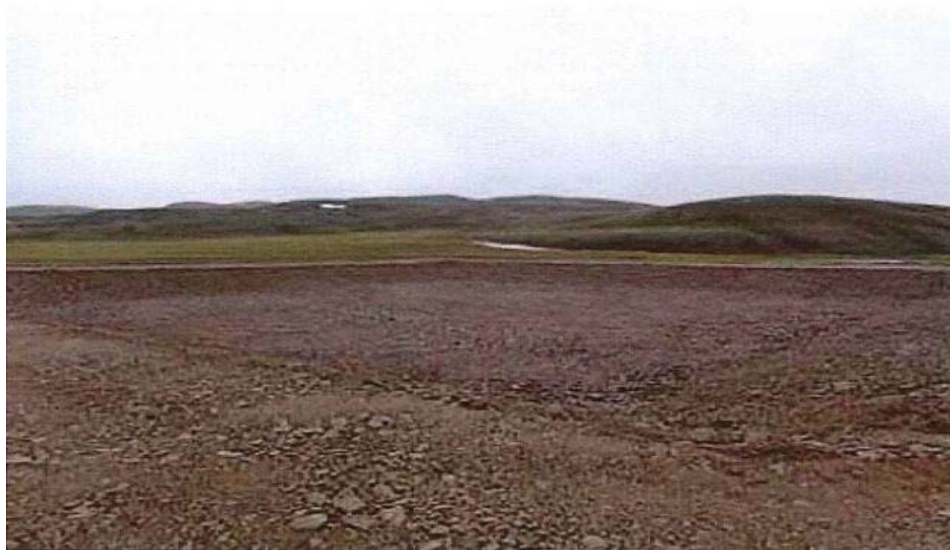
**PHOTO 7** Polishing Waste Stabilization Pond (PWSP) Pad before –sub grade prepared July 2013

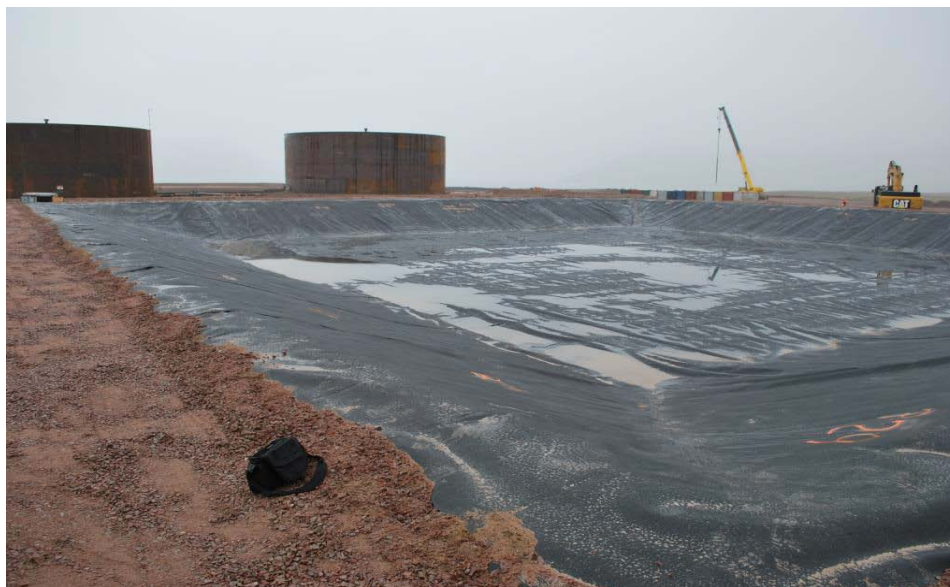
**PHOTO 8** Polishing Waste Stabilization Pond (PWSP) engineered containment structure arctic liner installation July 2013

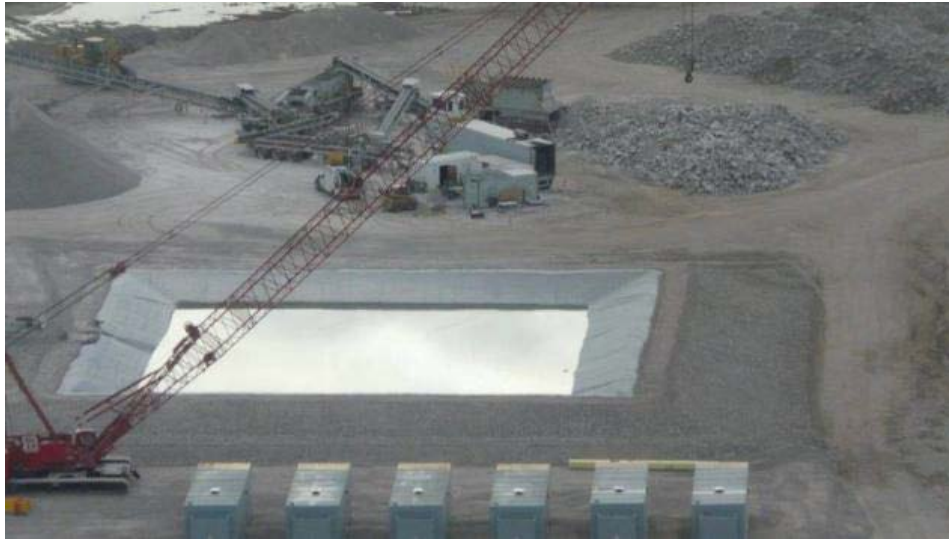
**PHOTO 9** Aerial View – PWSP completed and operational September 2013

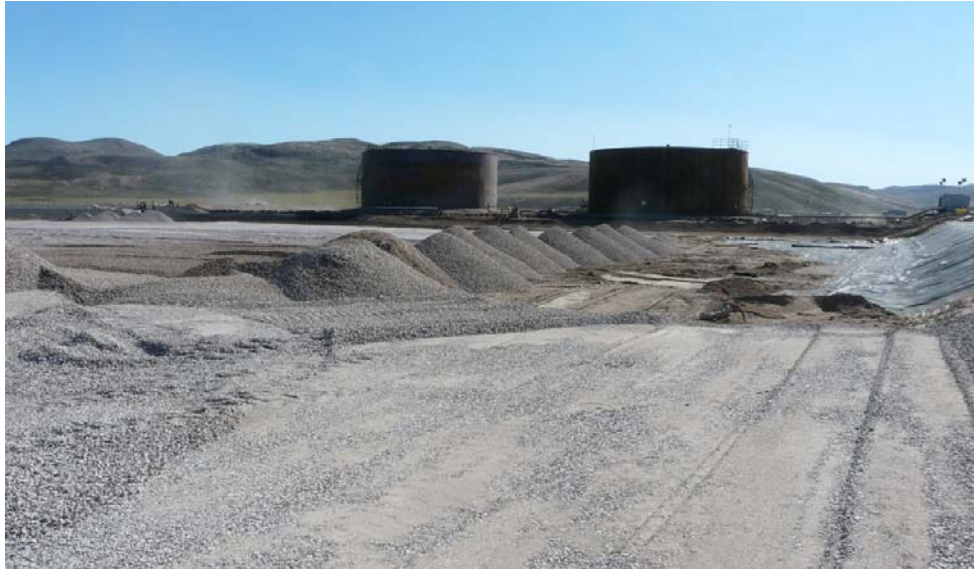
**PHOTO 11** Construction of Steel Tank Bulk Fuel Storage Facility Pad (alternate view) July 2013

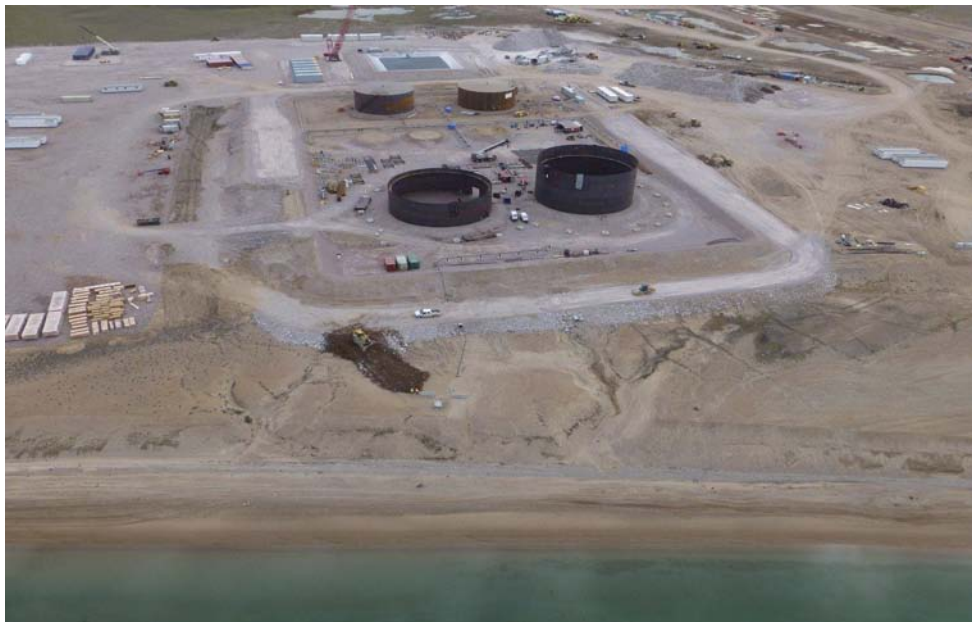
**PHOTO 12** Aerial View - Construction of Steel Tank Bulk Fuel Storage Facility

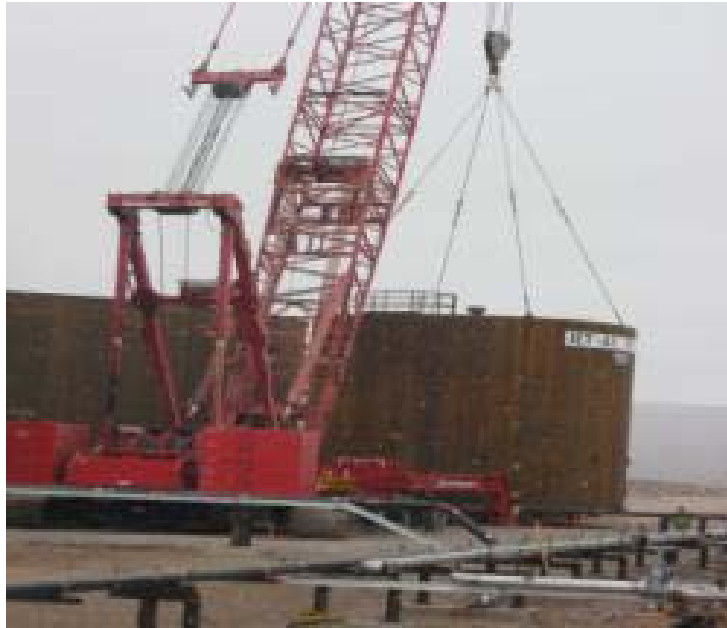
**PHOTO 13** 300 Ton crane placing 1<sup>st</sup> 750,000L Jet A Tank  
August 2013

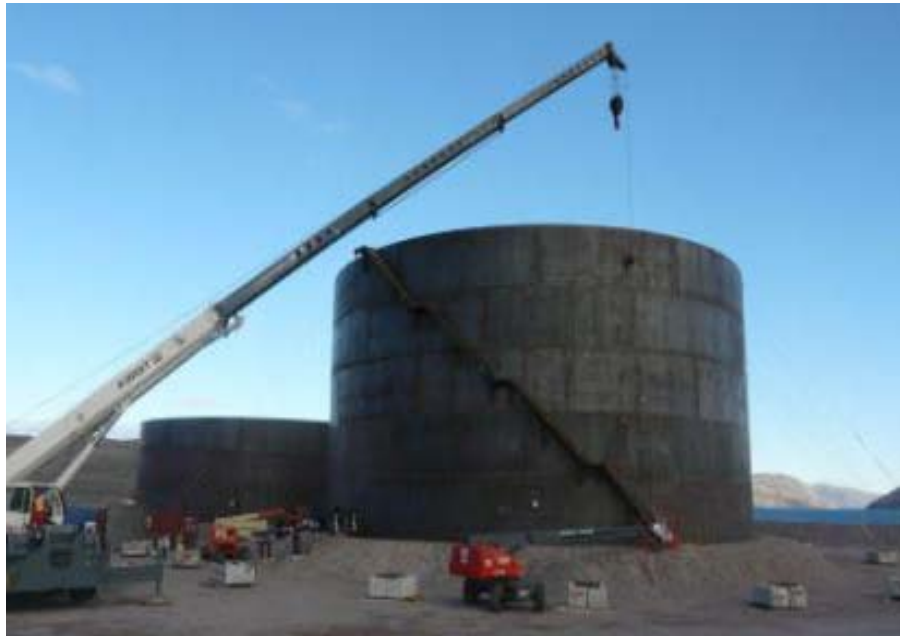
**PHOTO 14** Installing roof on Tank #1 August 2013

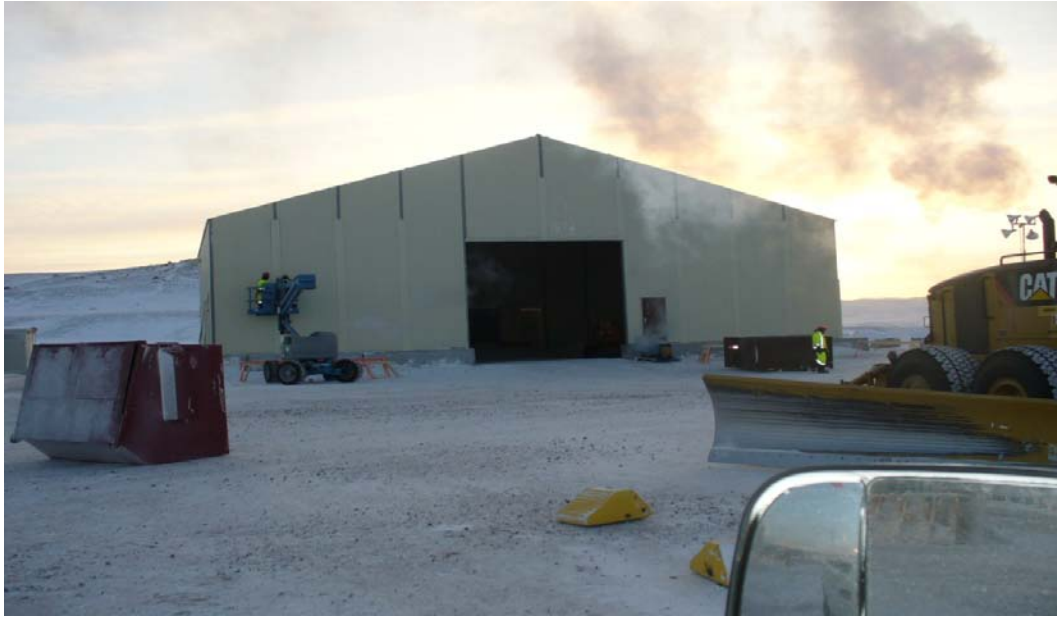
**PHOTO 17** Construction of Waste Management Building  
 ካዲኮቶኒስ ካሚኖር ልገረብልኤር ልኳኤ

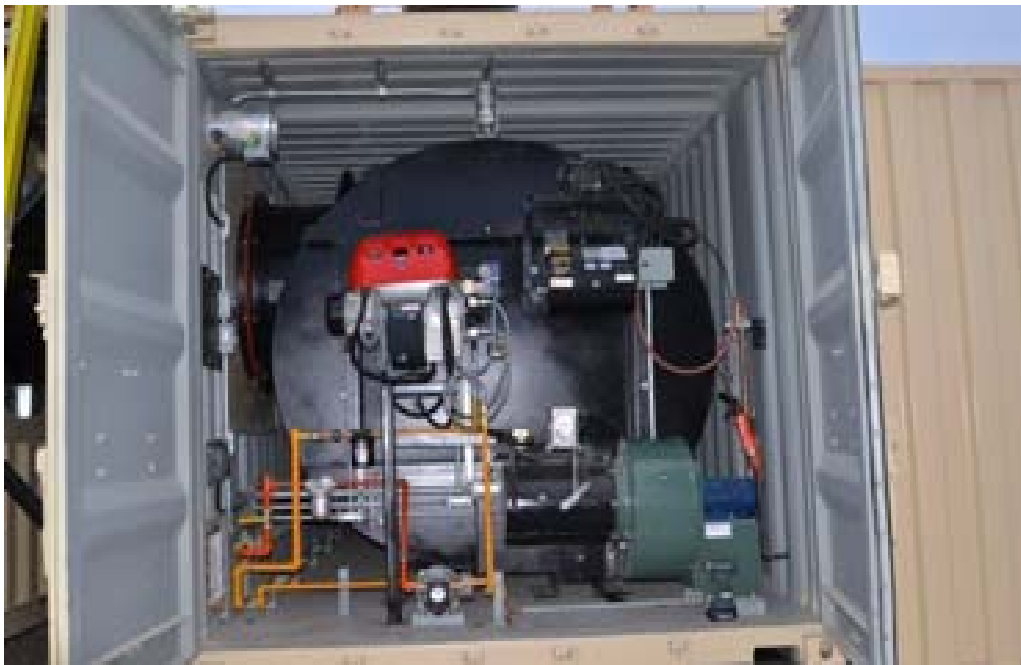
**PHOTO 18** Internal view of secondary chamber of new incinerator  
 ልጋላሙር ርዕሳ ለክር ለረኢልኤር ወር ልገብልኤ

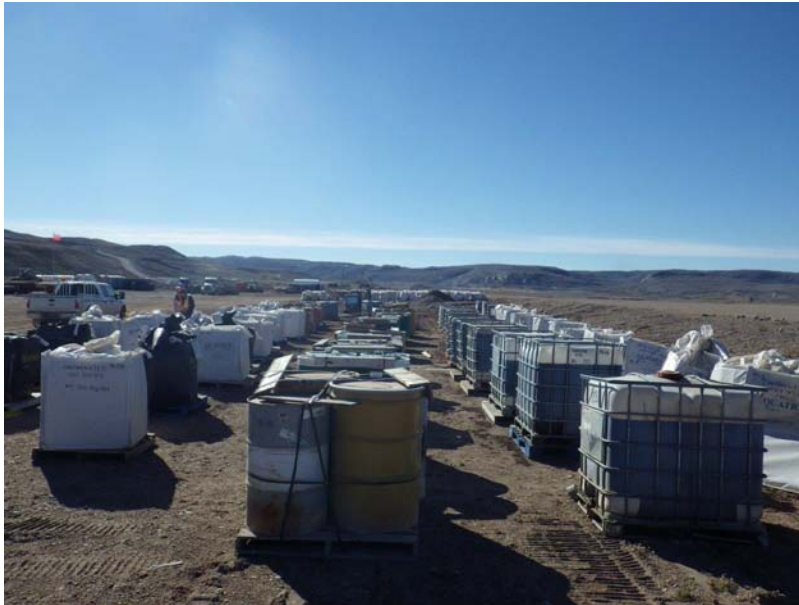
**PHOTO 19** Hazardous Waste waiting sealift backhaul at Milne Port

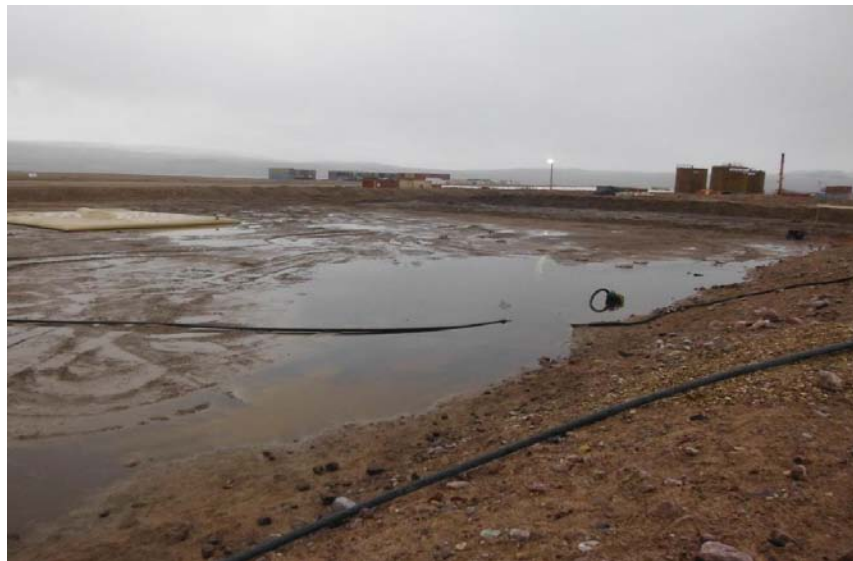
**PHOTO 22** North west view of sump pump in Milne Port Fuel Bladder farm during decommissioning September 2013

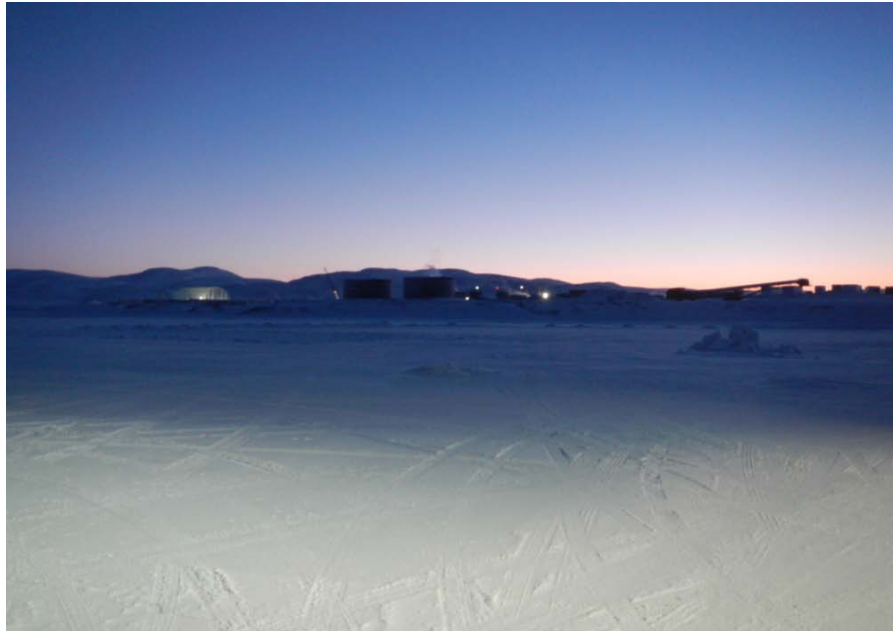
**PHOTO 1** Pre-drilling area at Milne Port (on ice)  
ᐱᑭᓂᐸᓄᓂ-ᓂᑯᑦᑐᑦᕕᑦ ᓄᔪᕈᓴ ᕕᑦᕗᑦᑐᑦᕕᑦᑐᑦᕕᑦ ᑐᓚᑦᕕᑦᓄᑦᓴᓂ (ᐱᑯᐅ)

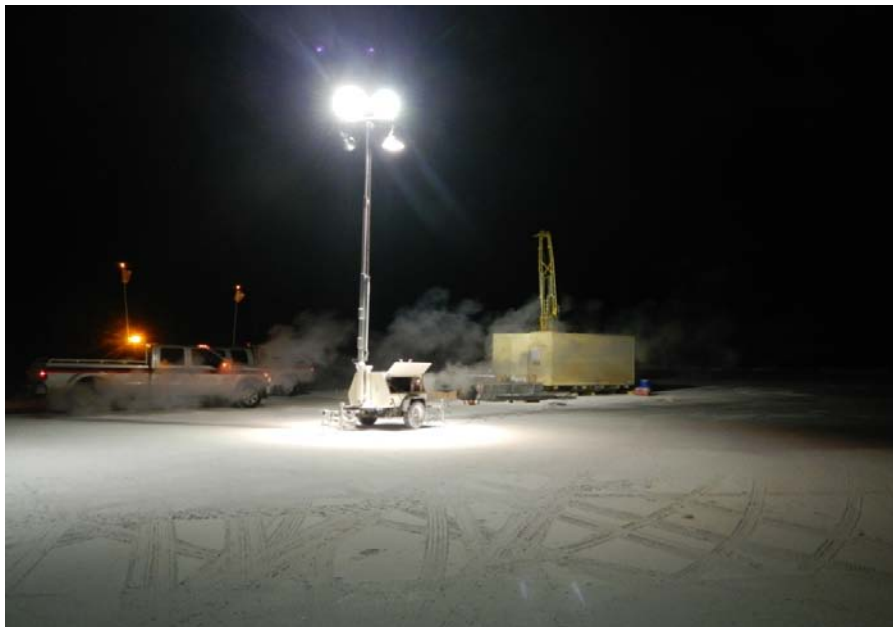
**PHOTO 2** Drilling operations at Milne Port (on ice)  
σᵀᵇᵐᵒ σᵀᵇ ἈϭΛḂᶓᶔᵃᵇ ΔᵇἈΡᵑᶕᶕᶔᶔᶔ ᶗᵑᵑᵑᶕᶔᶔᶔ (ᶓᵑᵑ)

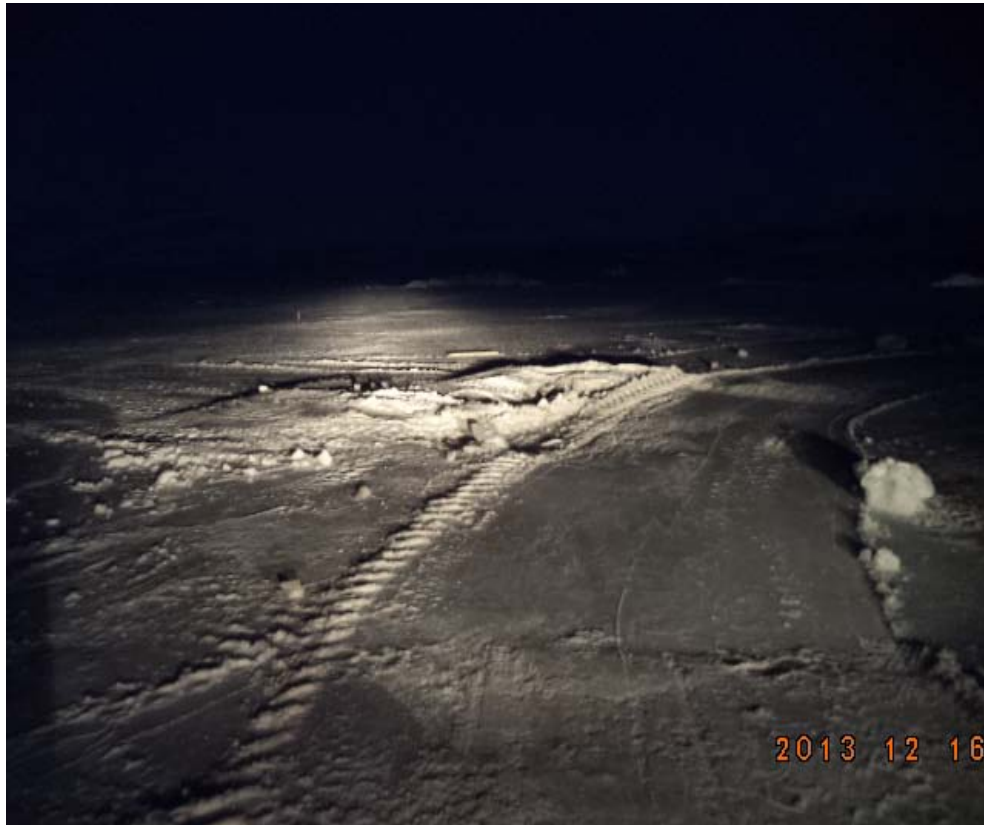
**PHOTO 3** Post-drilling operations at Milne Port (on ice)  
 ሙጥታላዊነት በፖስት ደረሰበት የሚካተት ማለፊያ ነው (የጣም)

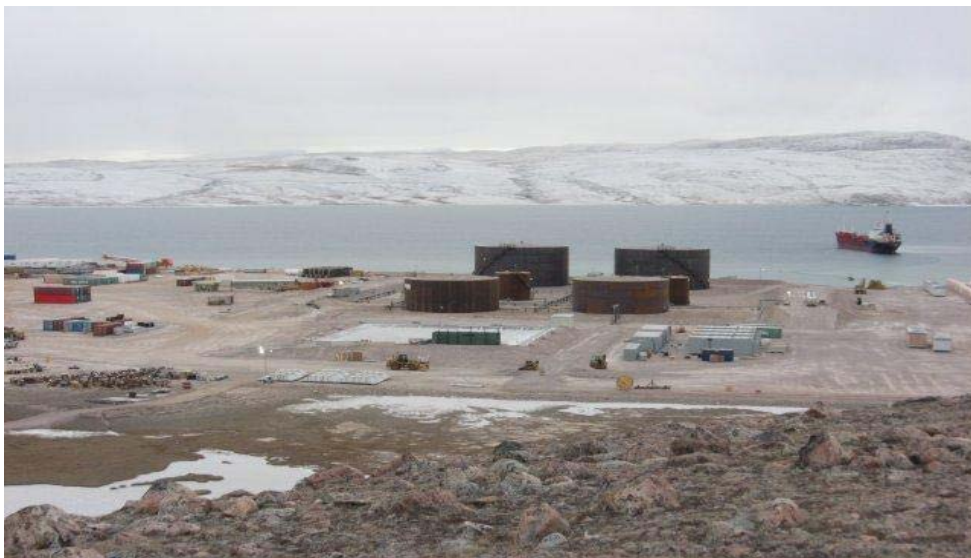
**PHOTO 4** Overview of Milne Port Steel Tank Bulk Fuel Storage Facility and fuel delivery ship during fuel transfer September 2013

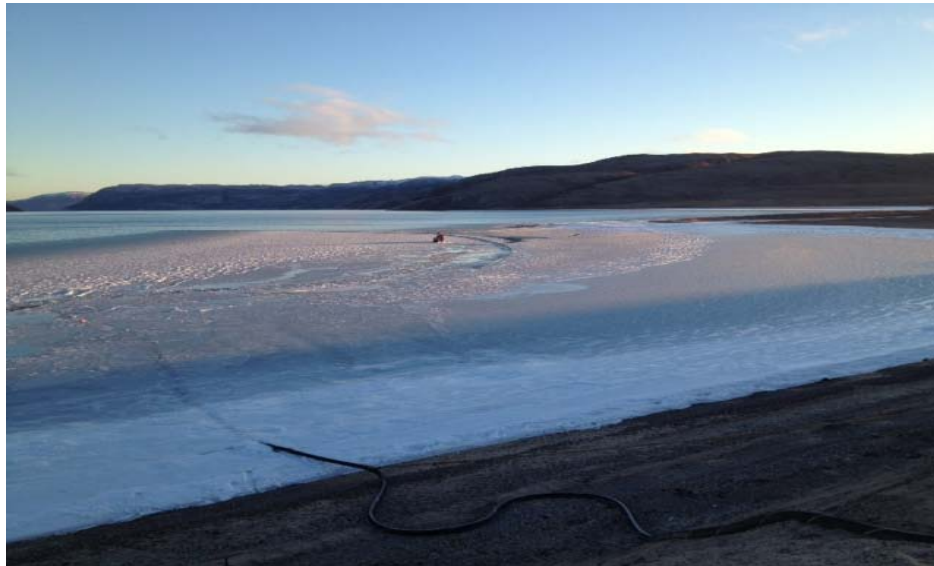
**PHOTO 5** Ship-to-Shore floating hose and Milne Port Marine Emergency Response Team
