## **RE: Submission of 2023 Geotechnical Inspection Report No. 1 (June 2023)**

### **Annual Geotechnical Inspections – 2023 Report 1.**

Mary River Project – Nunavut

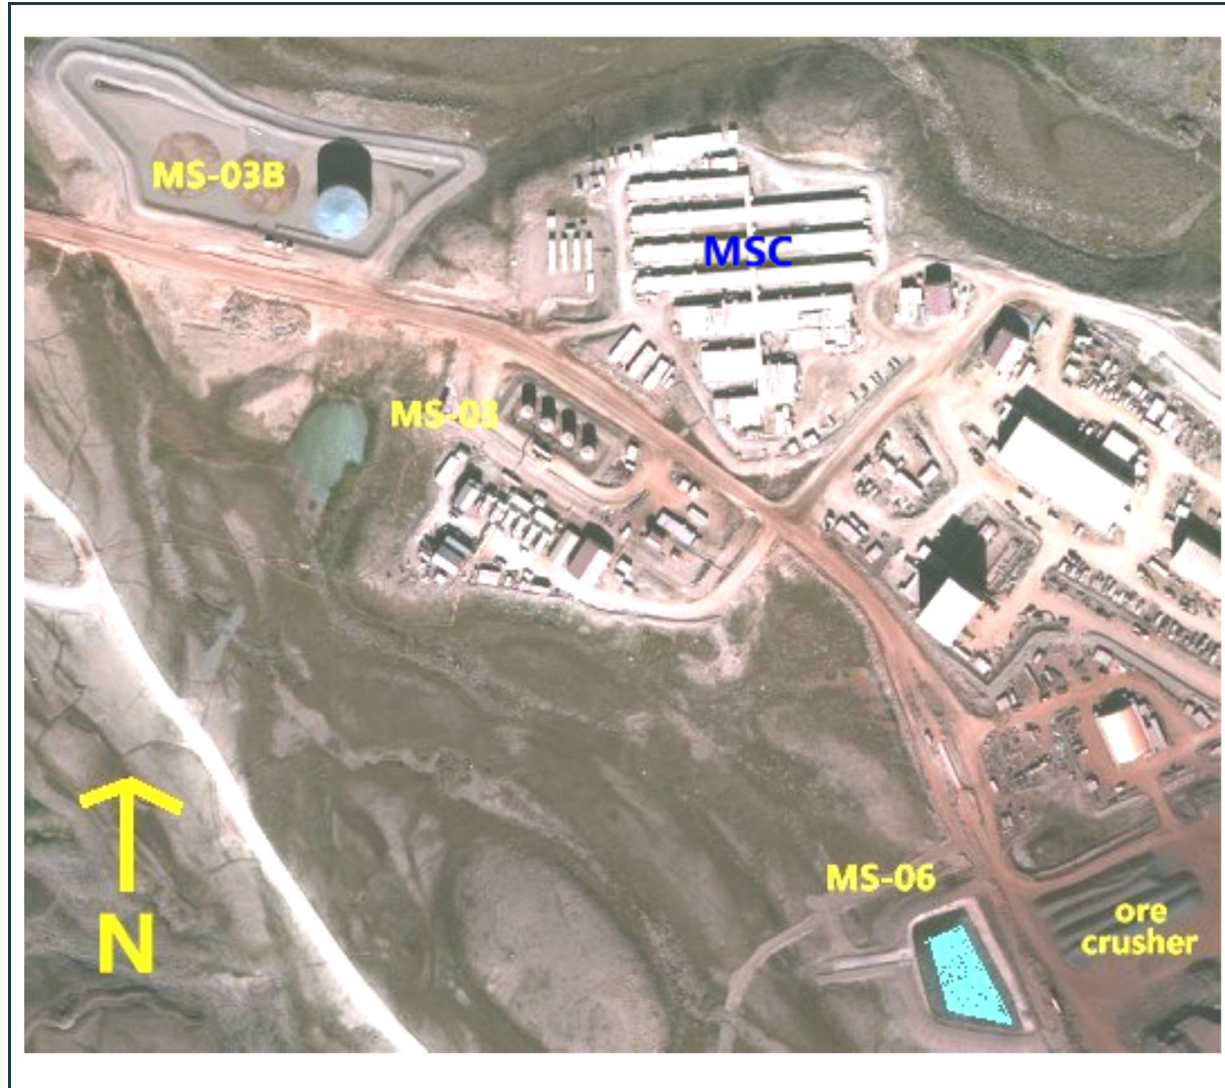
Figure 1: Site layout – Mary River Mine Site - **Central Zone – East**, showing the MS-03 and MS-03B fuel farms and the MS-06 surface water management pond, located near the ore crushing facility.  
© 2023 Digital Globe, Inc.

There are three (3) fuel storage facilities at the Mary River mine site. One (1) is located at the airfield and two (2) adjacent to the main office complex of the mine as shown in Figures 1 and 4. The berms and liners at these facilities are in excellent condition, as shown in the relevant images in Appendix A.

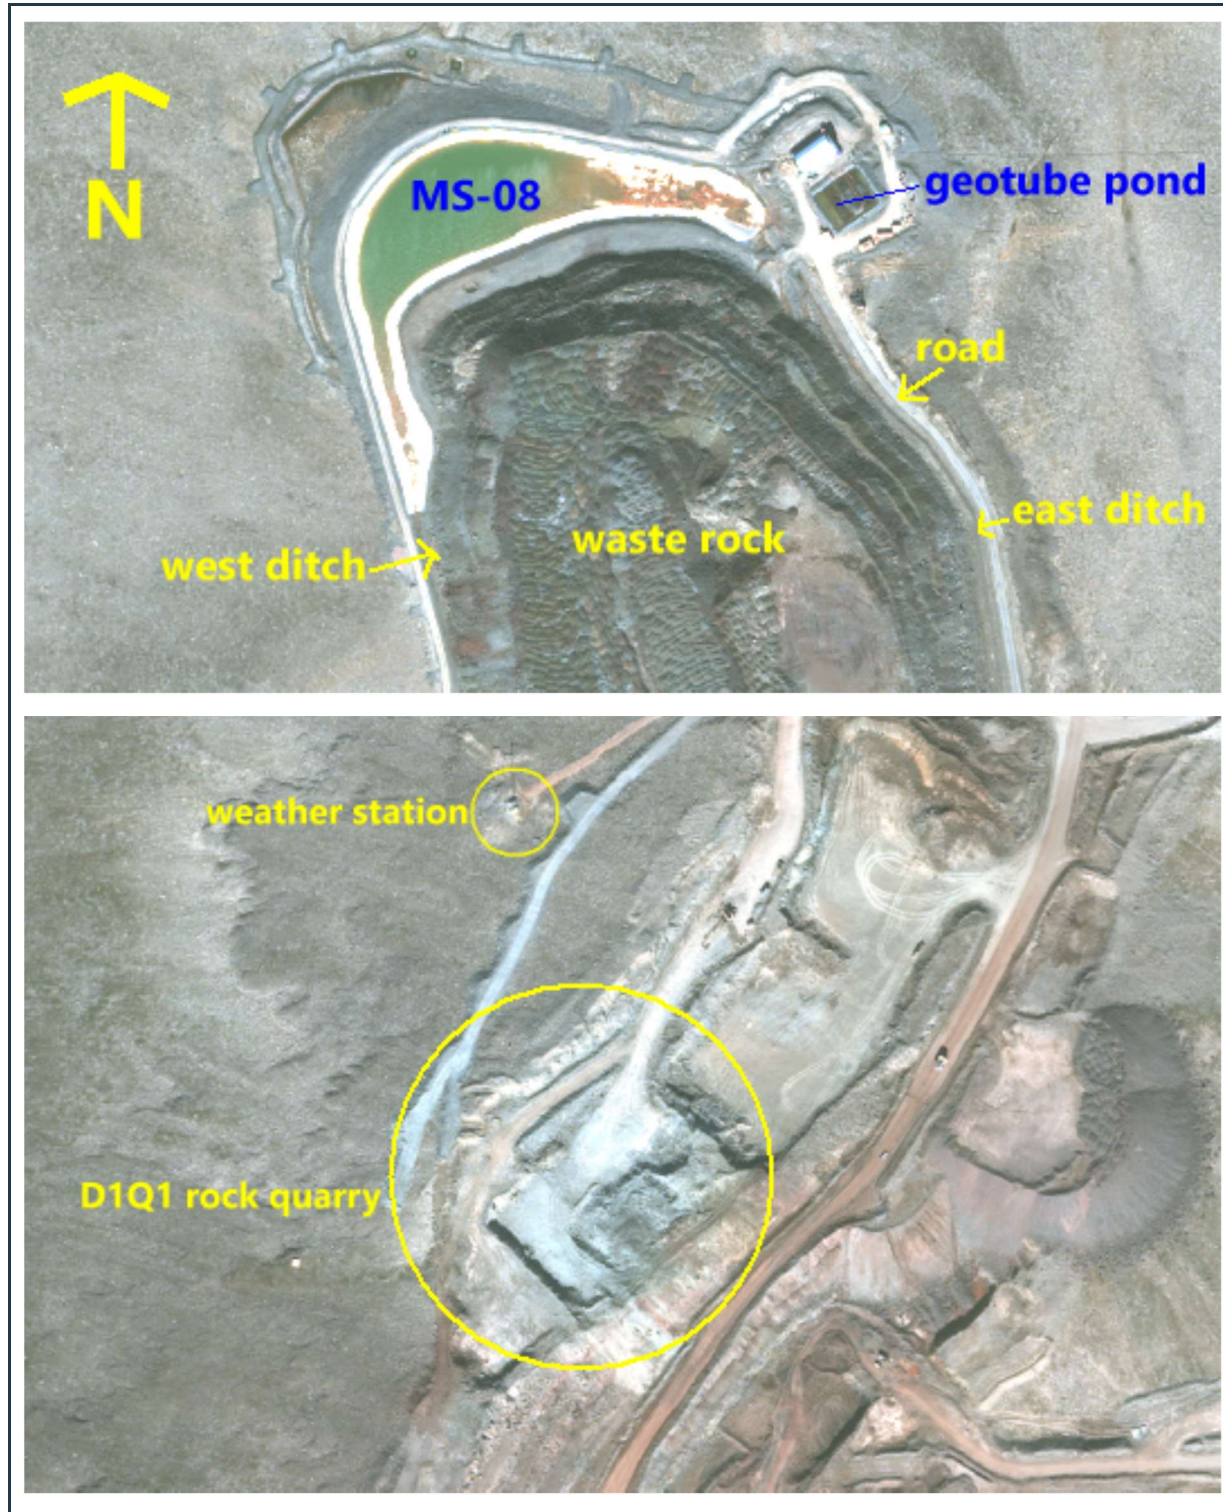
Figure 2: Mary River Site layout – **North-Eastern Zone** – Waste rock facility with the MS-08 and geotube ponds – D1Q1 rock quarry area. © 2023 Digital Globe, Inc.

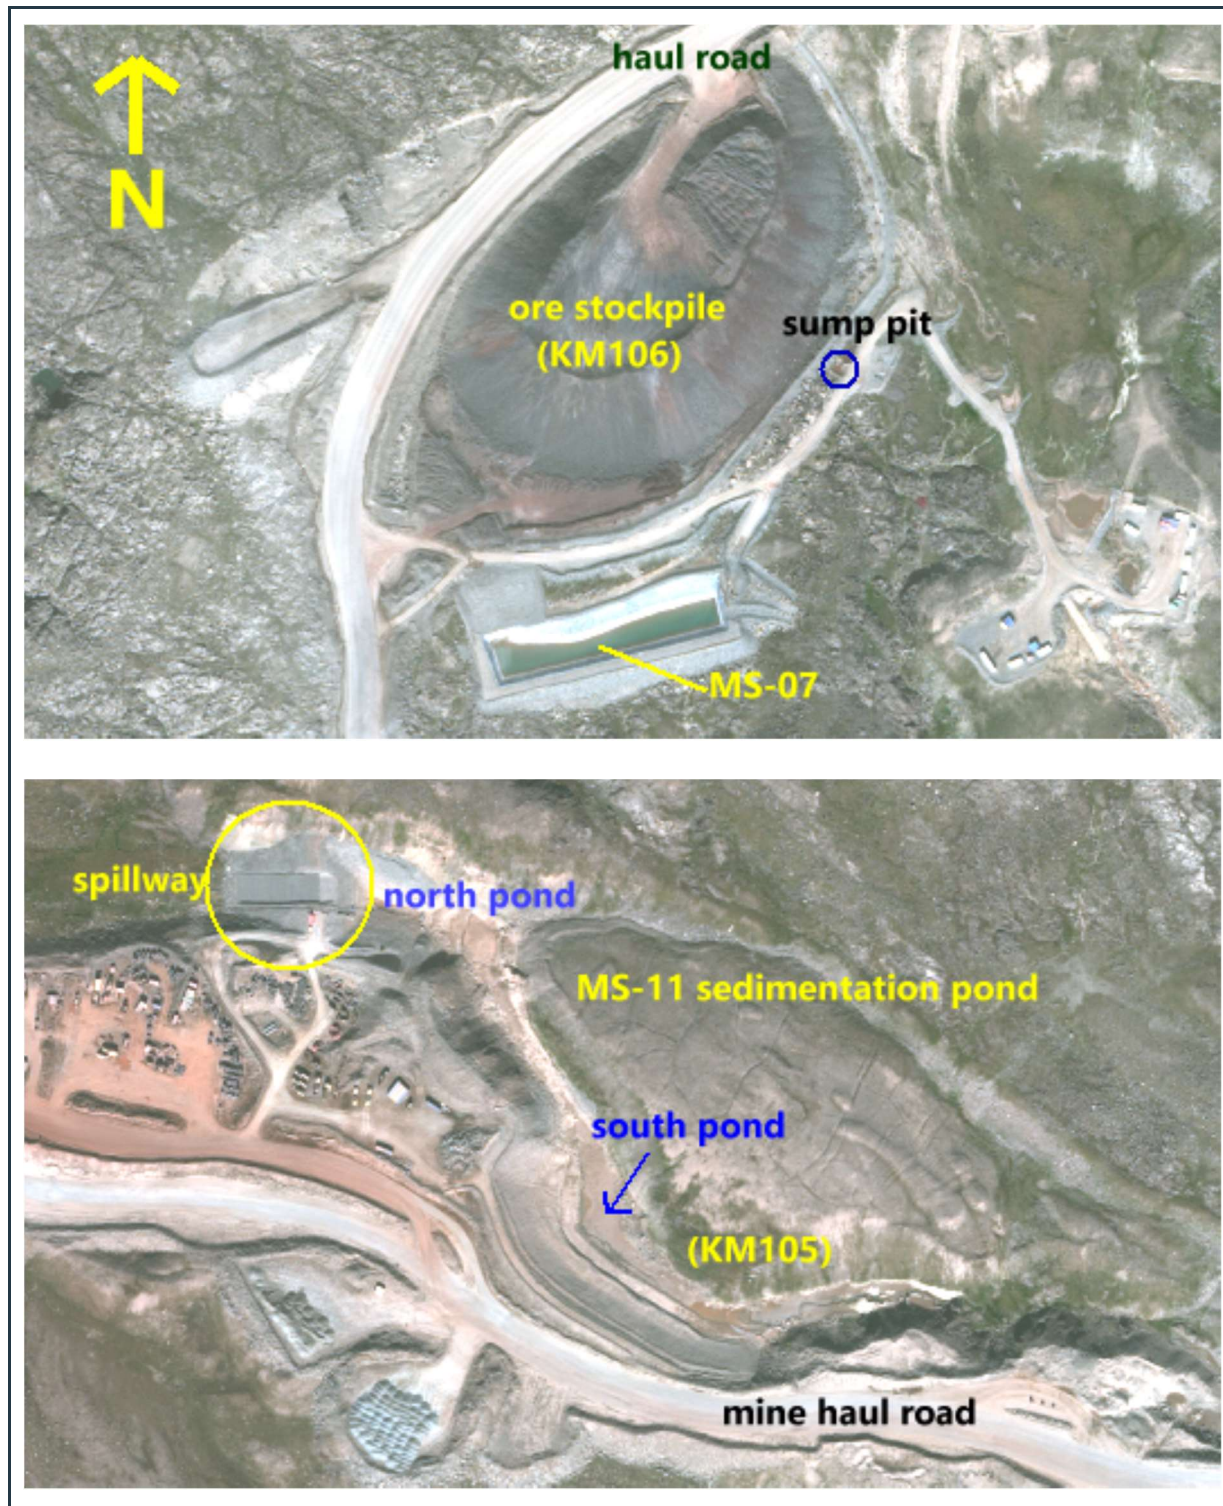
Figure 3: Site layout – Mary River Mine Site – **South-Eastern Zone** – KM106 run-of-mine ore storage area and KM106/MS-07 and KM105/MS-11 surface water management ponds. © 2023 Digital Globe, Inc.

The KM105 surface water management pond (MS-11), shown in Figure 3, was designed, and constructed to provide sediment control for runoff water, originating from the following catchment areas:

The pond includes an emergency spillway with an invert elevation of 220.5 m, which is the design maximum water level in the pond. At normal water level the pond has two separate areas: the “north and south ponds”, as shown in Figure 3. As specified in the design, the upstream slopes of the pond embankments are lined with geomembrane liner, underlain by non-woven geotextile as a cushion layer. The geomembrane liner and non-woven geotextile extend up to the interior (upstream) slope of the embankments and are anchored at the crest. The geomembrane liner is covered with an additional layer of geotextile and a layer of compacted liner bedding, which in turn is covered with a layer of compacted transition material followed by more rockfill (riprap), as shown in Figure 30.

The area previously considered as the future D1Q2 rock quarry is now serving as an ore stockpile site. As shown in Figure 3, the area is located south of the open pit, along the east side of the mine haul road (MHR). Most of the surface water from the stockpile area is diverted to the adjacent MS-07 pond; however, some of the run-off water is collected in a temporary sump, shown in Figure 48, and subsequently pumped into the MS-07 pond. It is recommended to cover the base and slopes of the temporary sump with riprap. It is also suggested to drain the collected water from the sump to the pond by gravity if the topography of the area would allow such alternative.

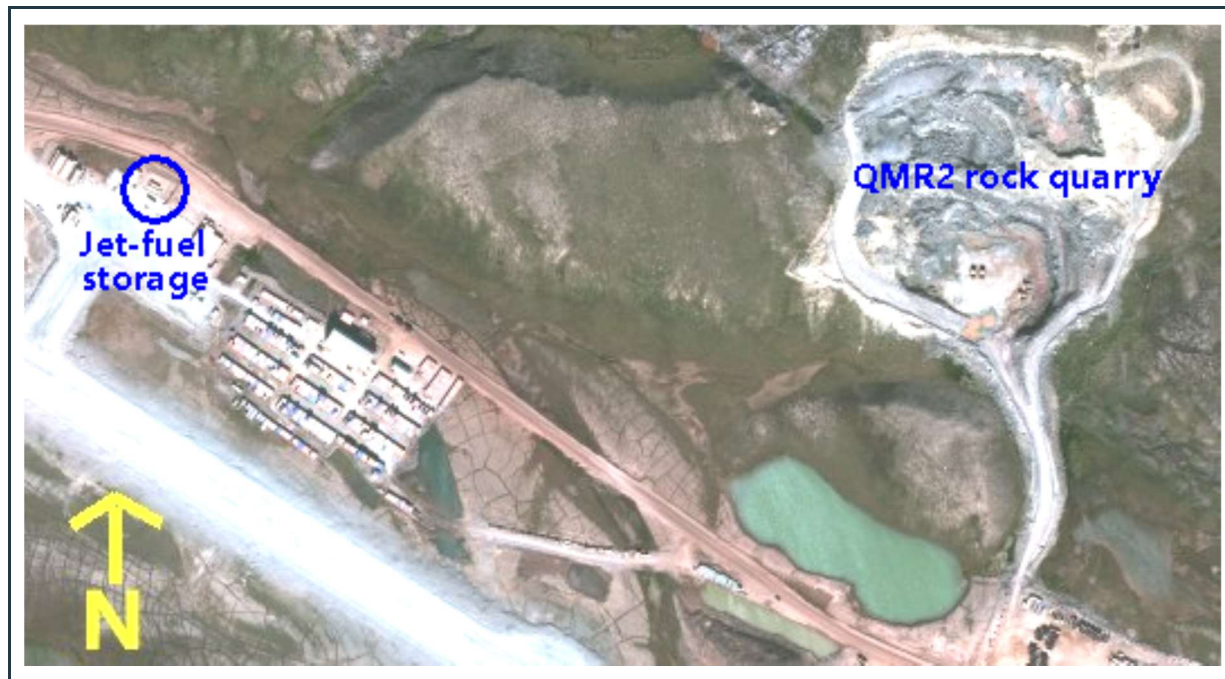
Figure 4: Site layout – Mary River Mine Site – **Central Zone - West** – Jet-fuel storage cell and QMR2 rock quarry. © 2023 Digital Globe, Inc.

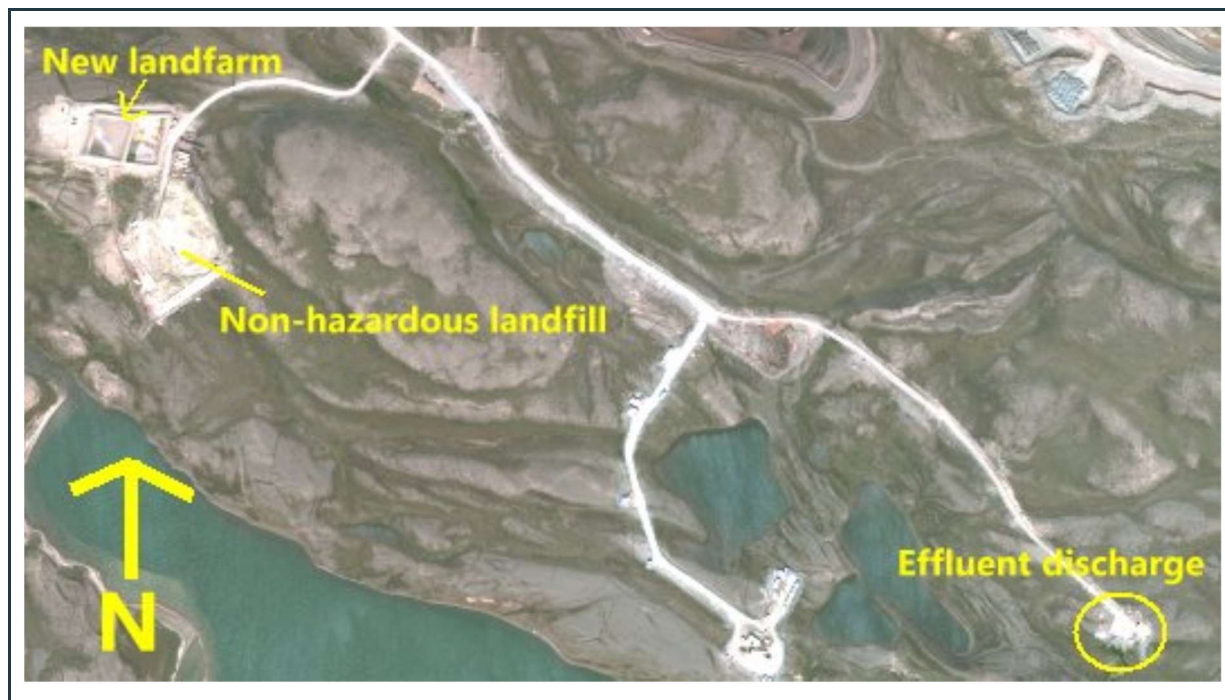
Figure 5: Site layout – Mary River Mine Site – **Southern Zone** – Non-hazardous landfill area with two new land-farm cells, and the effluent discharge location. © 2023 Digital Globe, Inc.

The solid waste disposal area is located in the southern zone of the Mary River Mine site, as shown in Figure 5. Recently, two (2) new landfarm cells were constructed near the gate to the main landfill facility, as shown in Figure 37. It is understood that the number of new landfarm cells will be increased to three (3) as shown in Figure 38.

The effluent discharge point is located south of the Mary River mine complex, as shown in Figure 5. There are two (2) discharge pipes at that location conveying the discharged water down the slope's surface to the adjacent valley. Trucks also bring water for discharge to this location and let the water flow down on the embankment, comprising crushed rock fill, as shown in Figure 44. As shown in the image, new rock fill has been placed on the slope recently and the slope is well-protected against potential erosion.

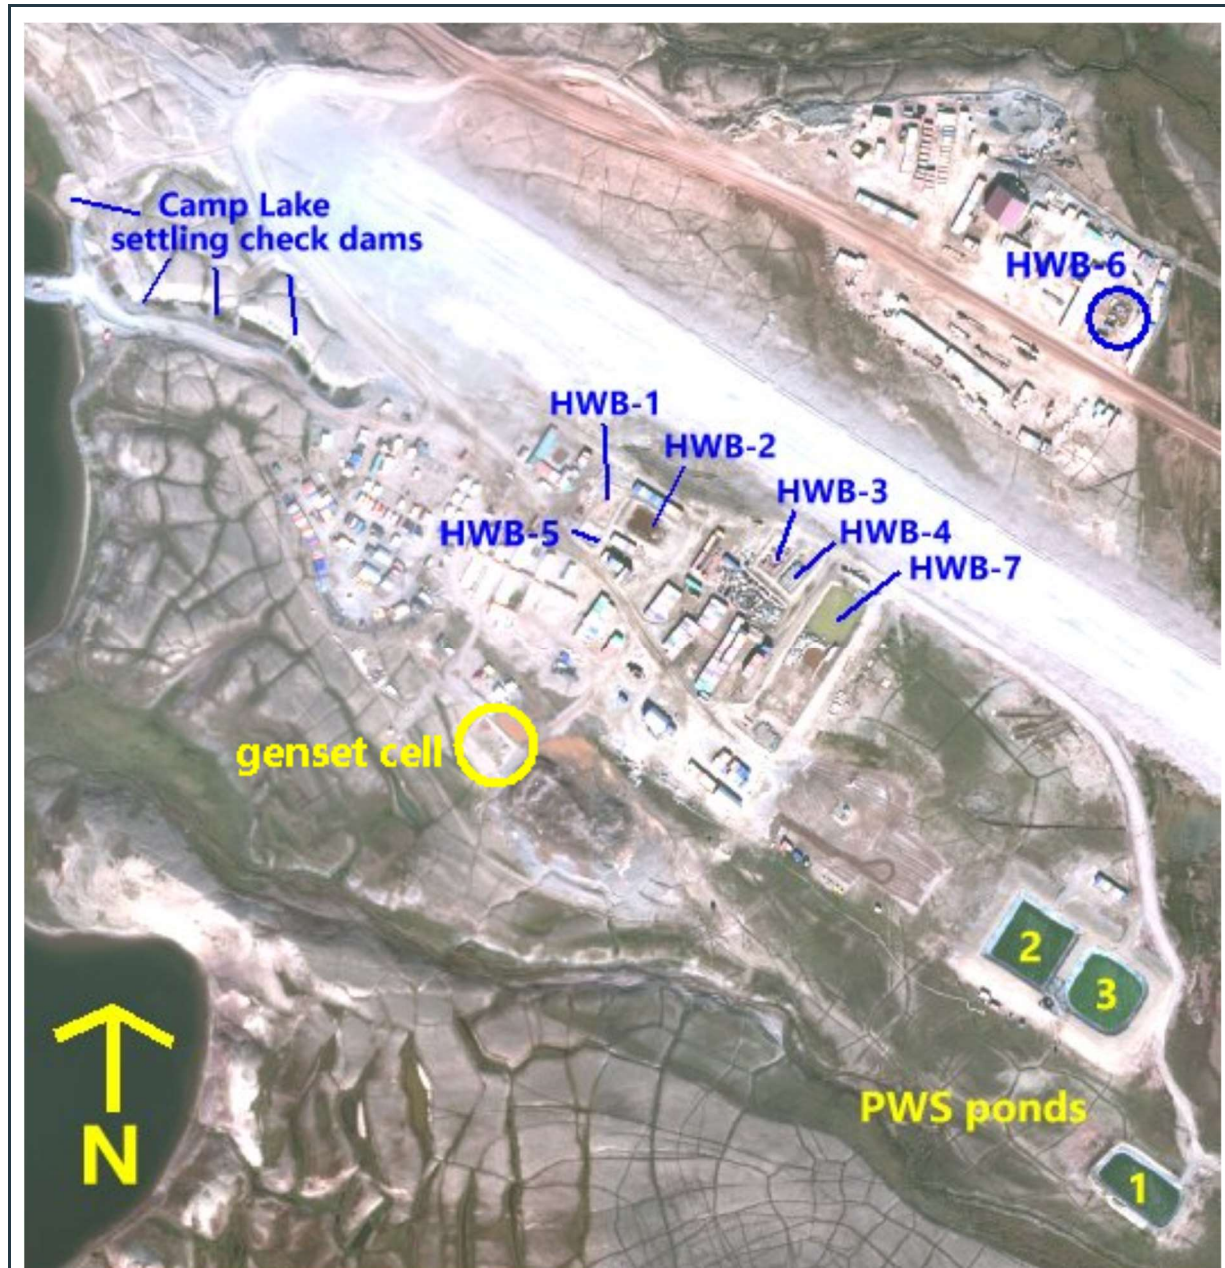
Figure 6: Site layout – Mary River Mine Site - **Western Zone** – PWS ponds (1-3), HWB hazardous waste storage cells (1-7), genset cell, and Camp Lake check dams. © 2023 Digital Globe, Inc.

There are three (3) polishing/waste stabilization ponds, located adjacent to the airstrip, as shown in Figure 6. Pond #1 is a single structure, while Ponds #2 and #3 were constructed as twin-cells, as shown in Figure 12. The photograph in Figure 12 is a historic aerial image showing the robust and stable berms around the three ponds. As mentioned in previous inspection reports, these ponds were associated with the exploration phase of the mine, and currently serve as emergency holding ponds in case problems would arise, which would prevent the discharge of treated effluent directly to the receiving environment. The robust, stable berms around the ponds generally comprise granular materials (rock fill, sand, and gravel), with High Density Polyethylene (HDPE) geomembrane liners. No damage is visible on the membranes in the cells or on the upstream face of the slopes (see Figures 13 to 15). Wrinkles visible on the liners are common features and do not present any potential problems to the resistance of the material against seepage.

This cell has previously contained fuel bladders for the generators; however, it is currently storing a few mobile fuel tanks only. The cell is located immediately adjacent to the power generators, south-west of the hazardous waste cells (Figure 6). As shown in Figure 33, the stable perimeter berm around the cell generally comprises granular materials and the cell is lined. Ponding water within the cell indicates good liner performance.

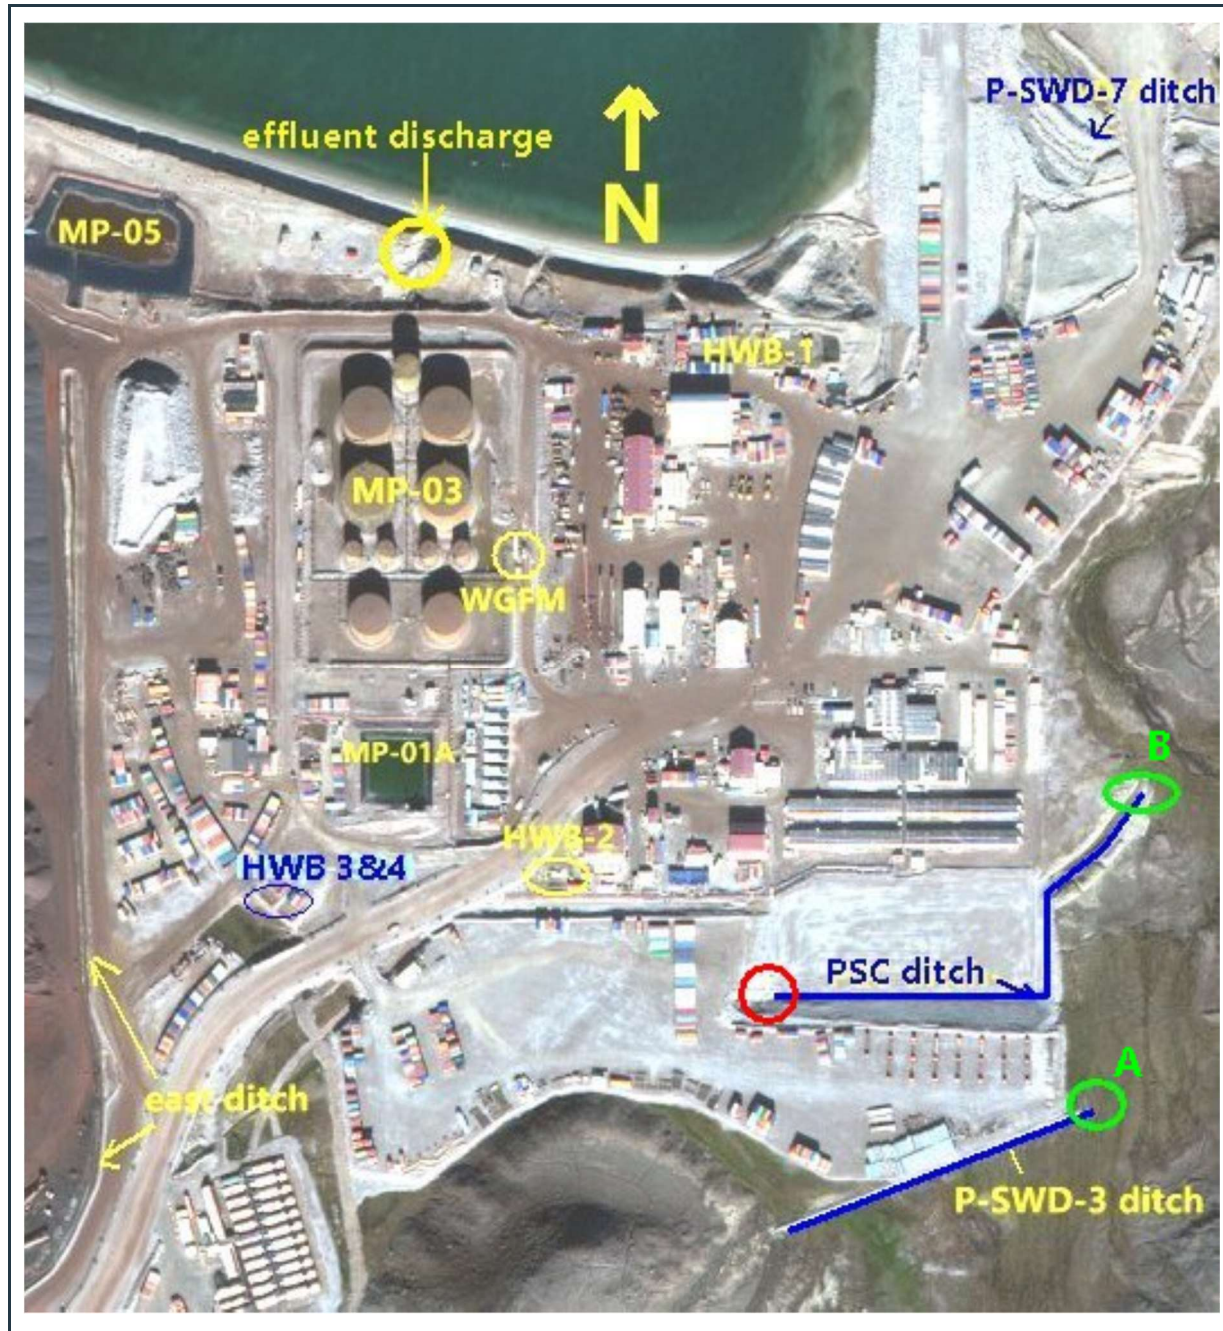
Figure 7: Site layout – Milne Inlet Port Site – **North-Eastern Zone**. © 2023 Digital Globe, Inc.

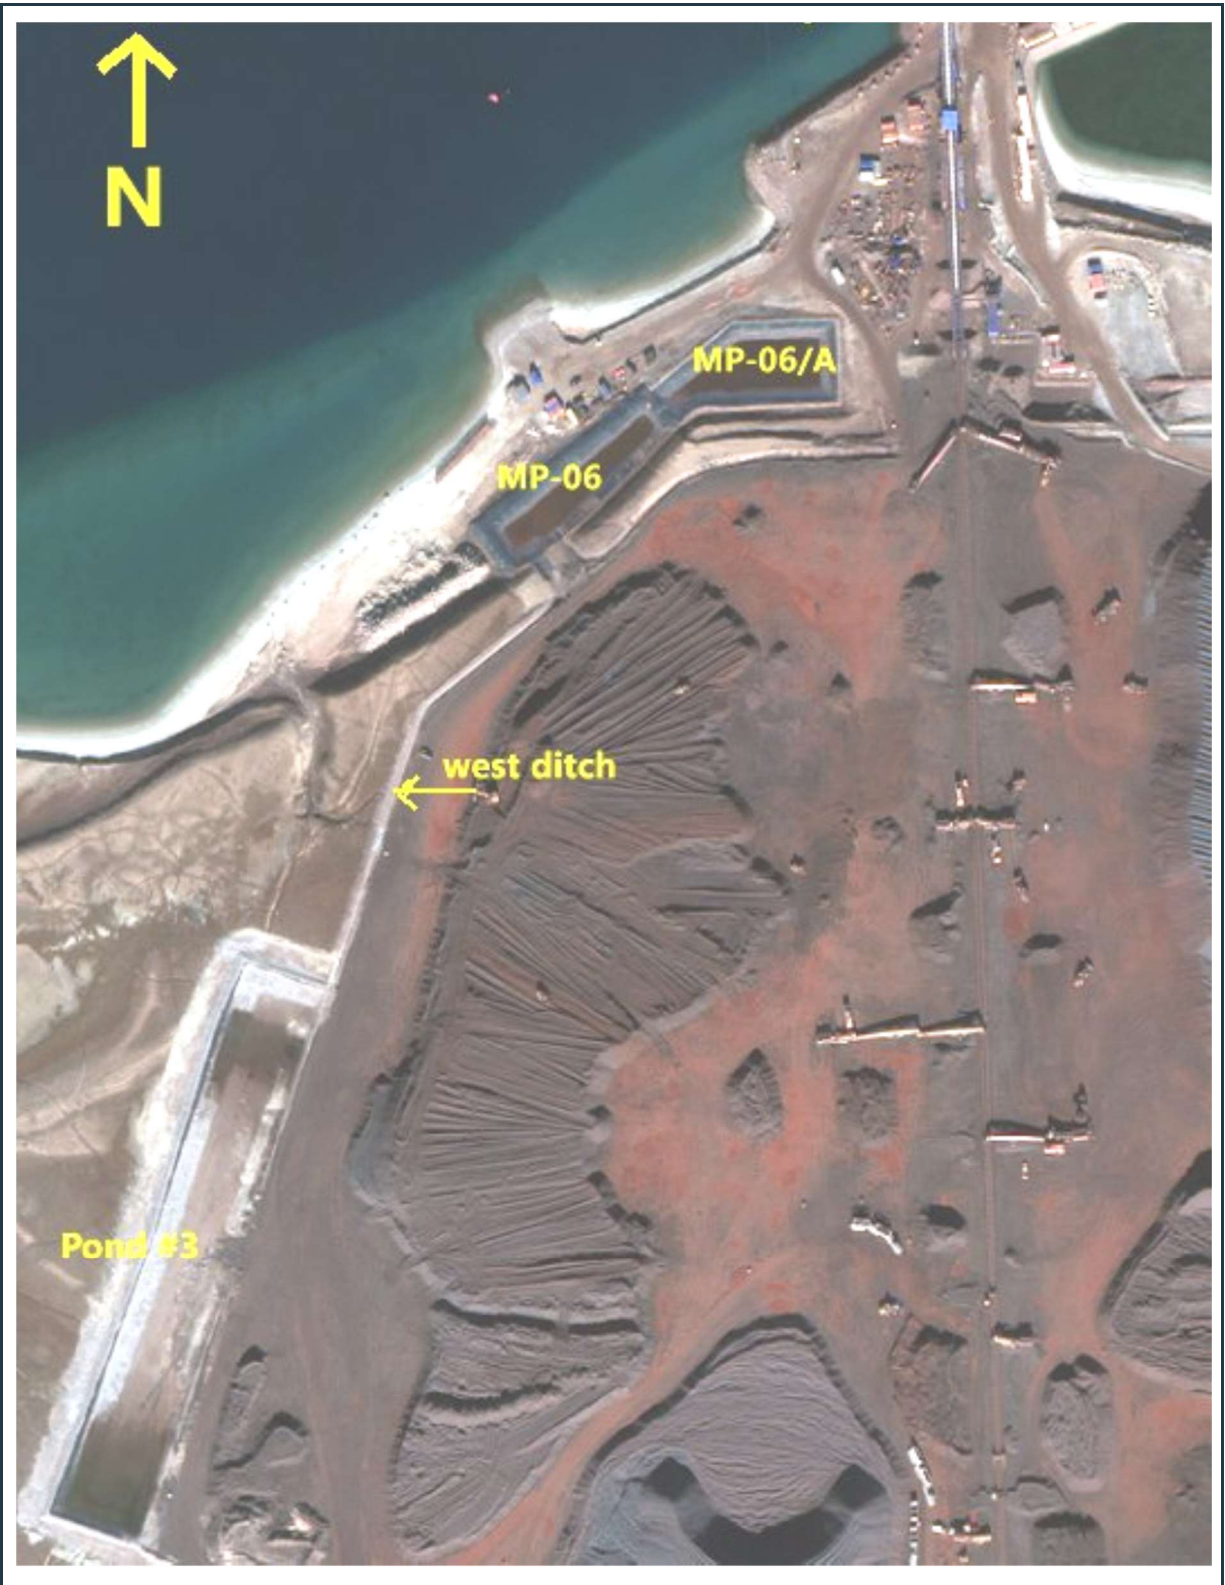
Figure 8: Site layout – Milne Inlet Port Site – **North-Western Zone**. © 2023 Digital Globe, Inc.

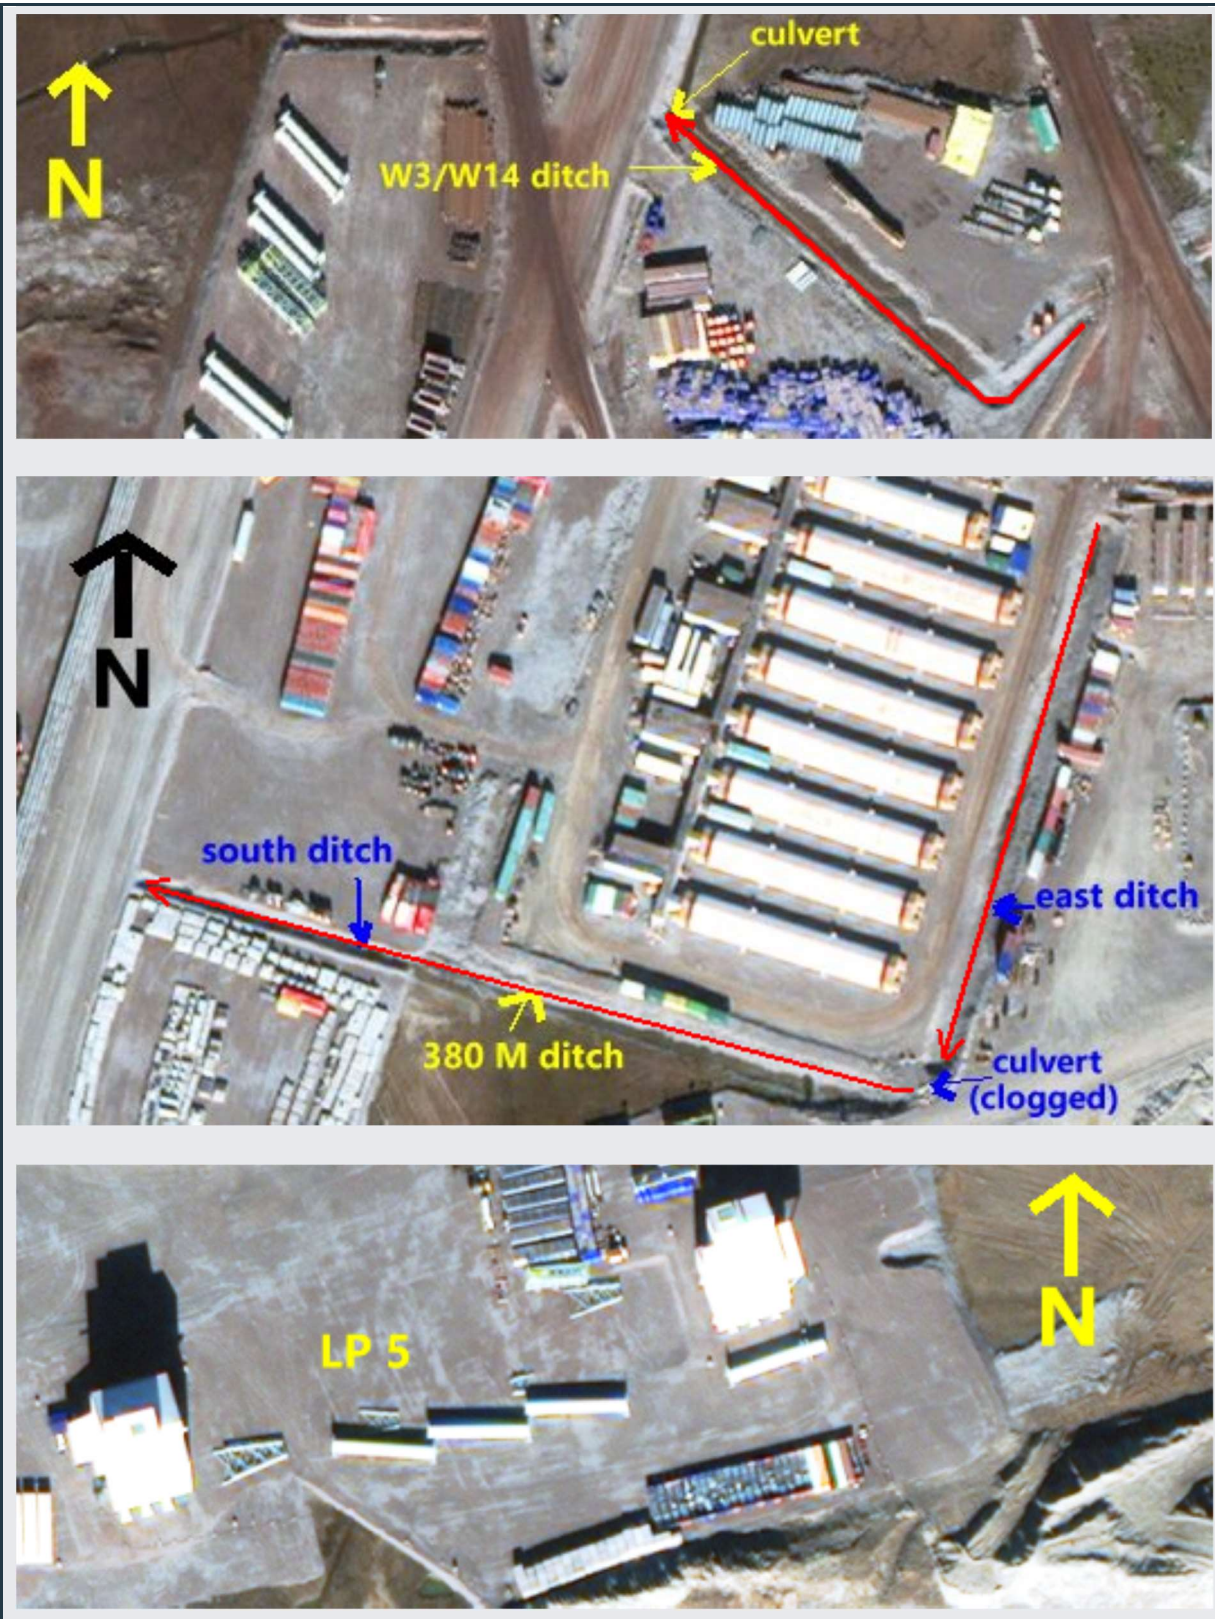
Figure 9: Site layout – Milne Inlet Port Site – **South-Western Zone**. © 2023 Digital Globe, Inc.

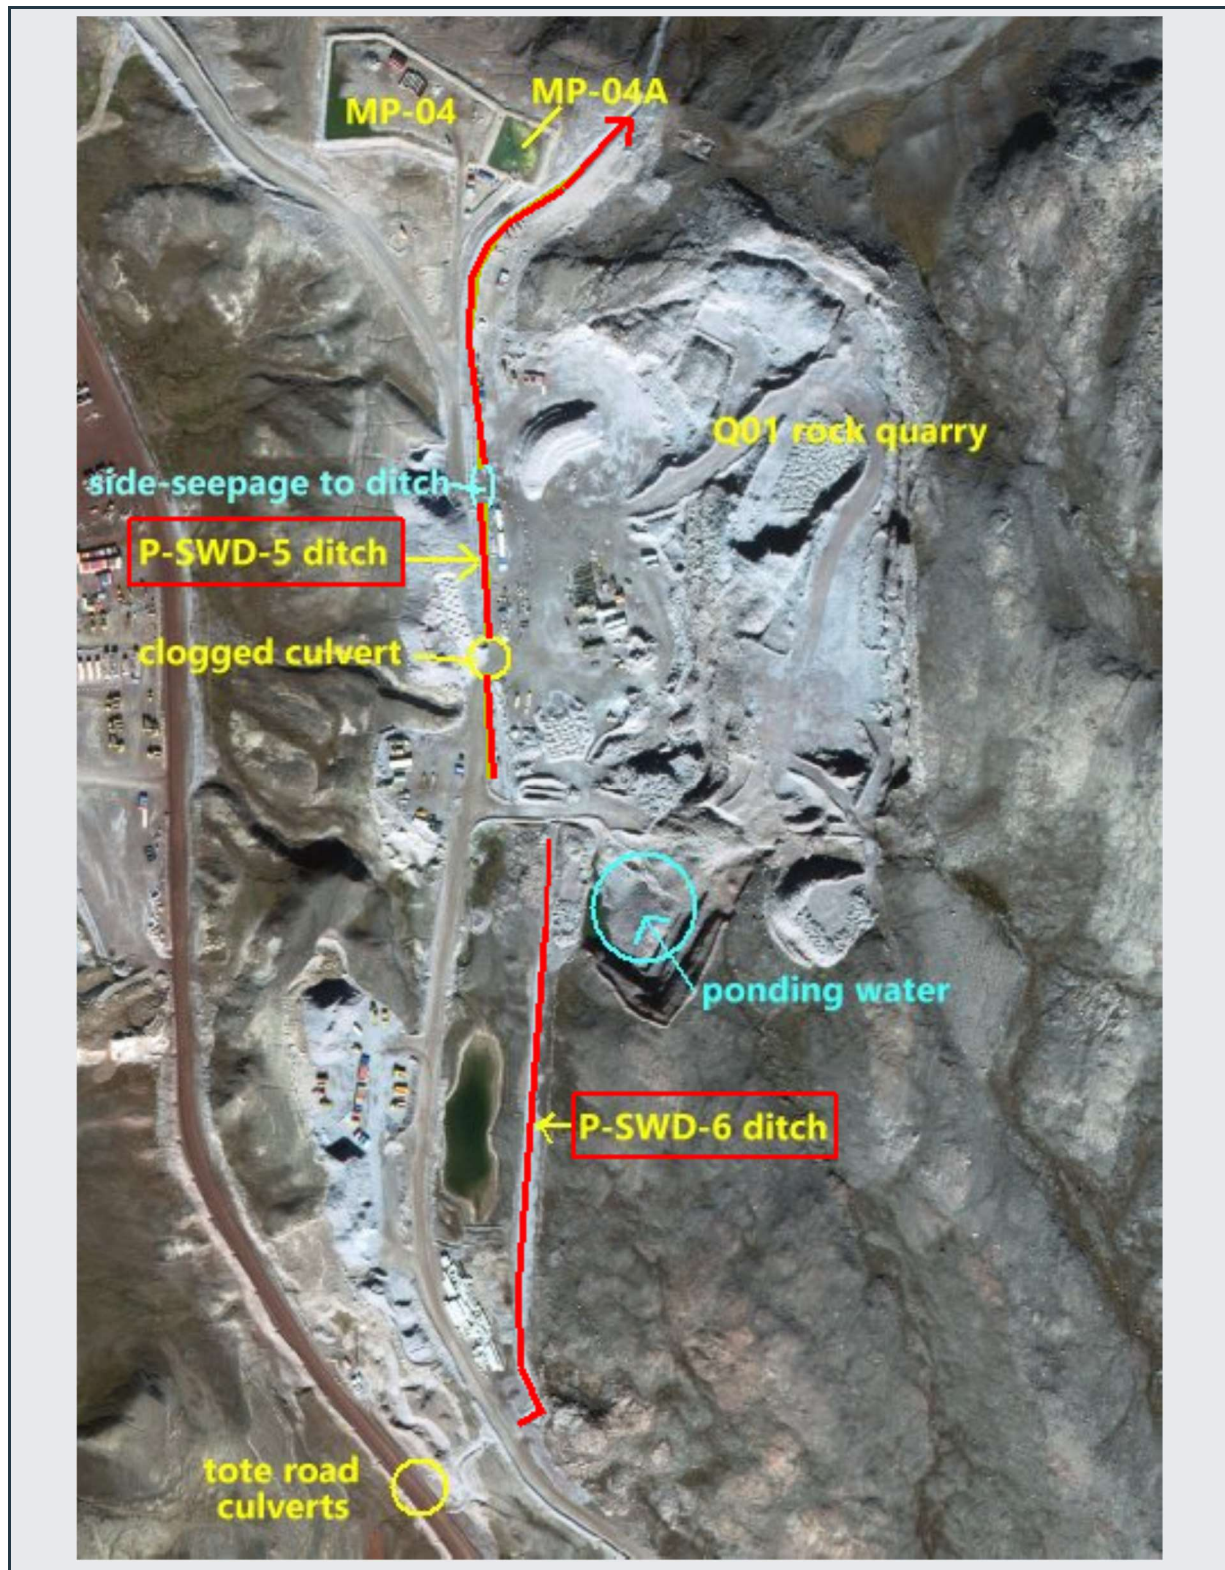
Figure 10: Site layout – Milne Inlet Port Site – **South-Eastern Zone**. © 2023 Digital Globe, Inc.

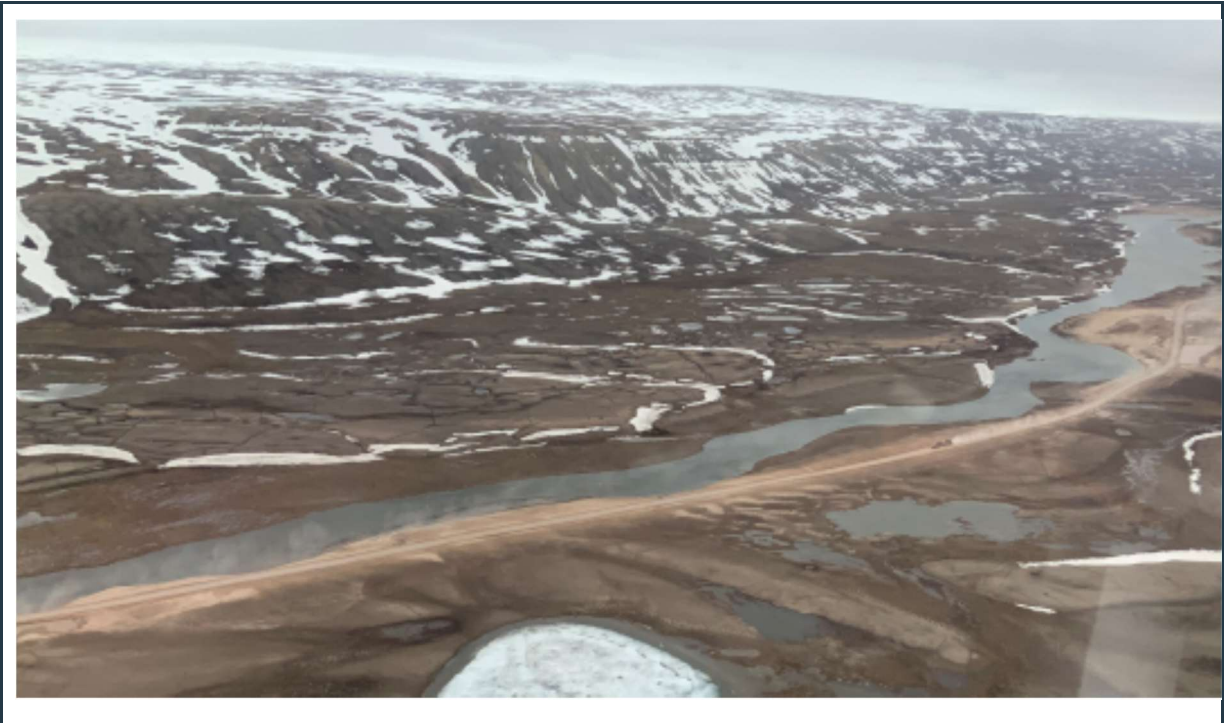
Figure 11: View of a section of the Tote Road between the Mary River Mine and Milne Inlet Port.
