RE: Submission of 2023 Annual Geotechnical Inspection – 2023 Report 2. October 2023

October 31, 2023
Project #: OMGM2212-23

Annual Geotechnical Inspections – 2023 Report 2. Mary River Project – Nunavut

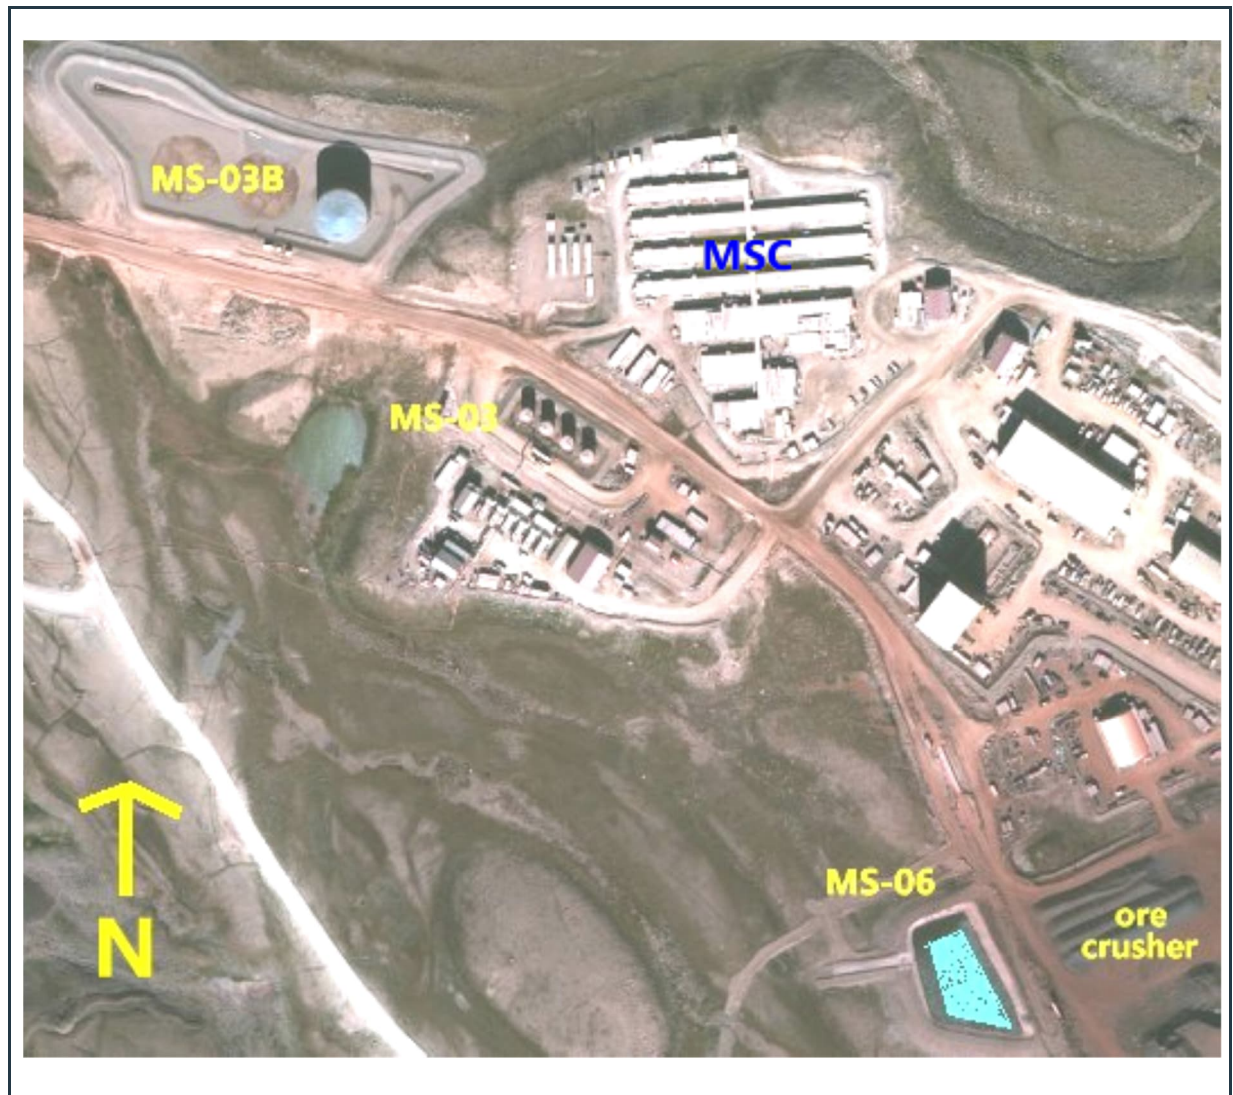
Figure 1: Site layout – Mary River Mine Site - Central Zone – East, showing the MS-03 and MS-03B fuel farms and the MS-06 surface water management pond, located near the ore crushing facility.
© 2023 Digital Globe, Inc.

There are three (3) fuel storage facilities at the Mary River mine site. One (1) is located at the airfield and two (2) adjacent to the main office complex of the mine, as shown in Figures 1 and 4. The berms and liners at these facilities are in excellent condition, as shown in the relevant images in Appendix A.

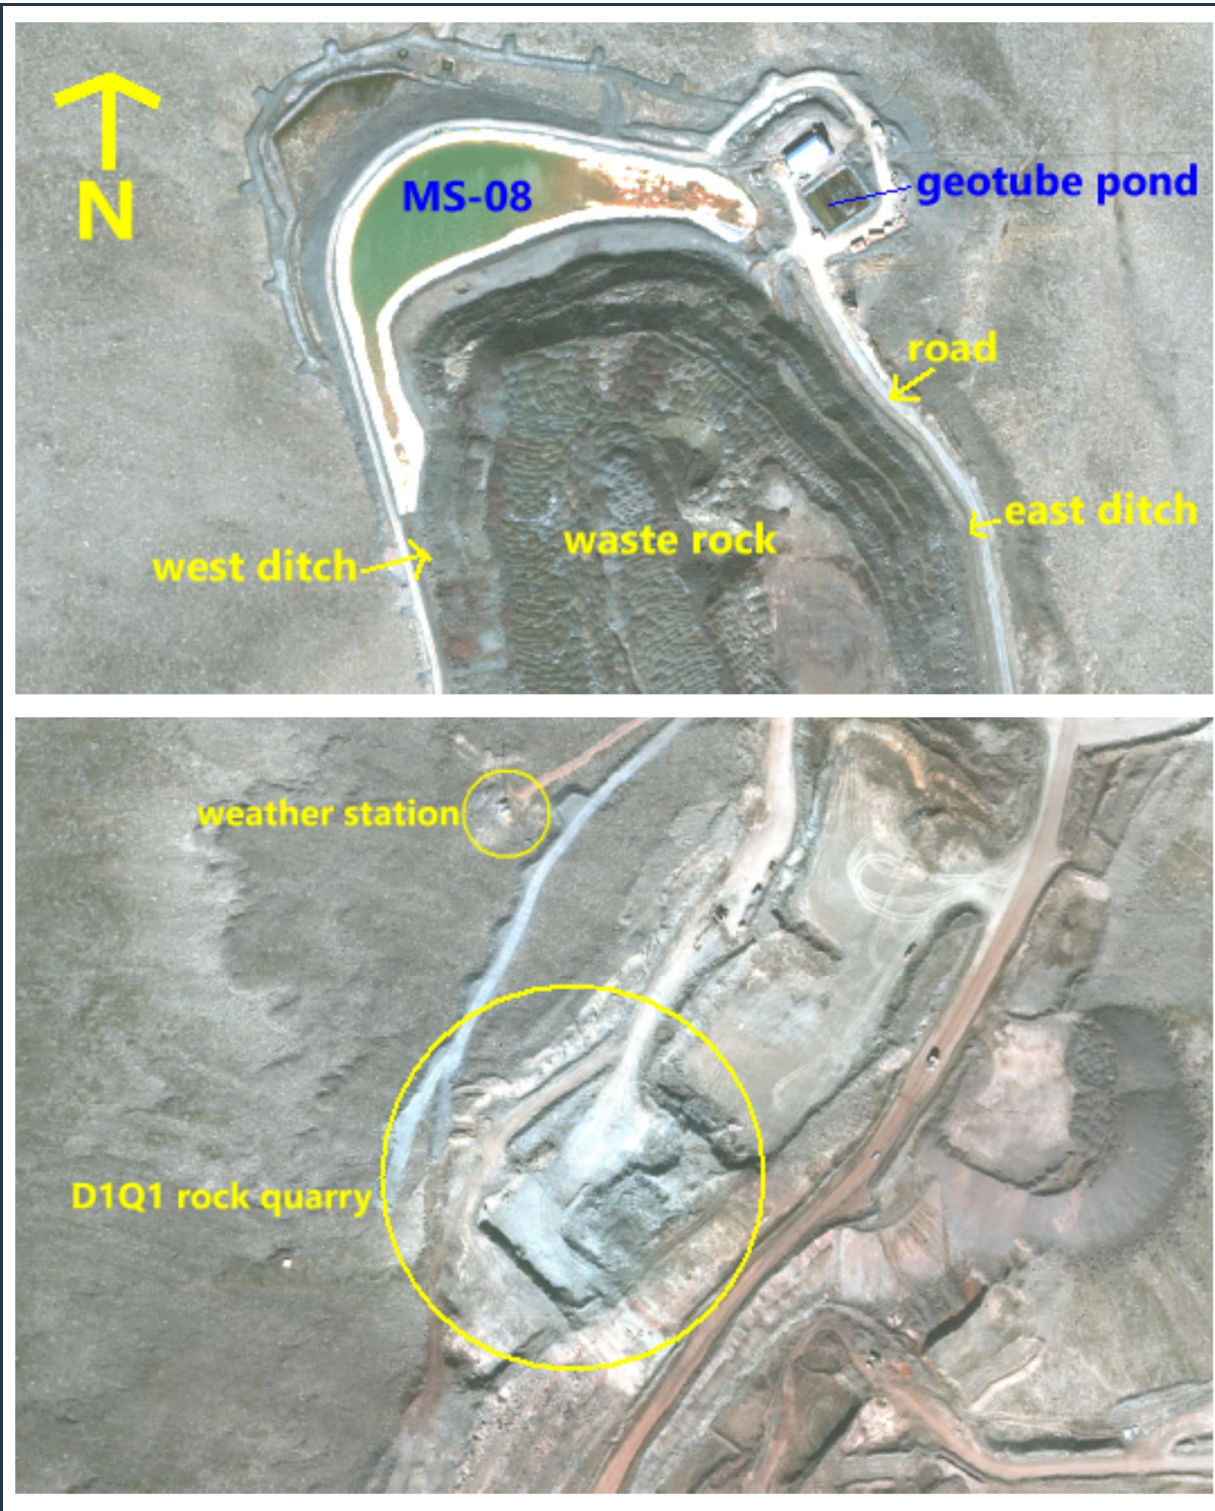
Figure 2: Mary River Site layout – North-Eastern Zone – Waste rock facility with the MS-08 and geotube ponds – D1Q1 rock quarry area. © 2023 Digital Globe, Inc.

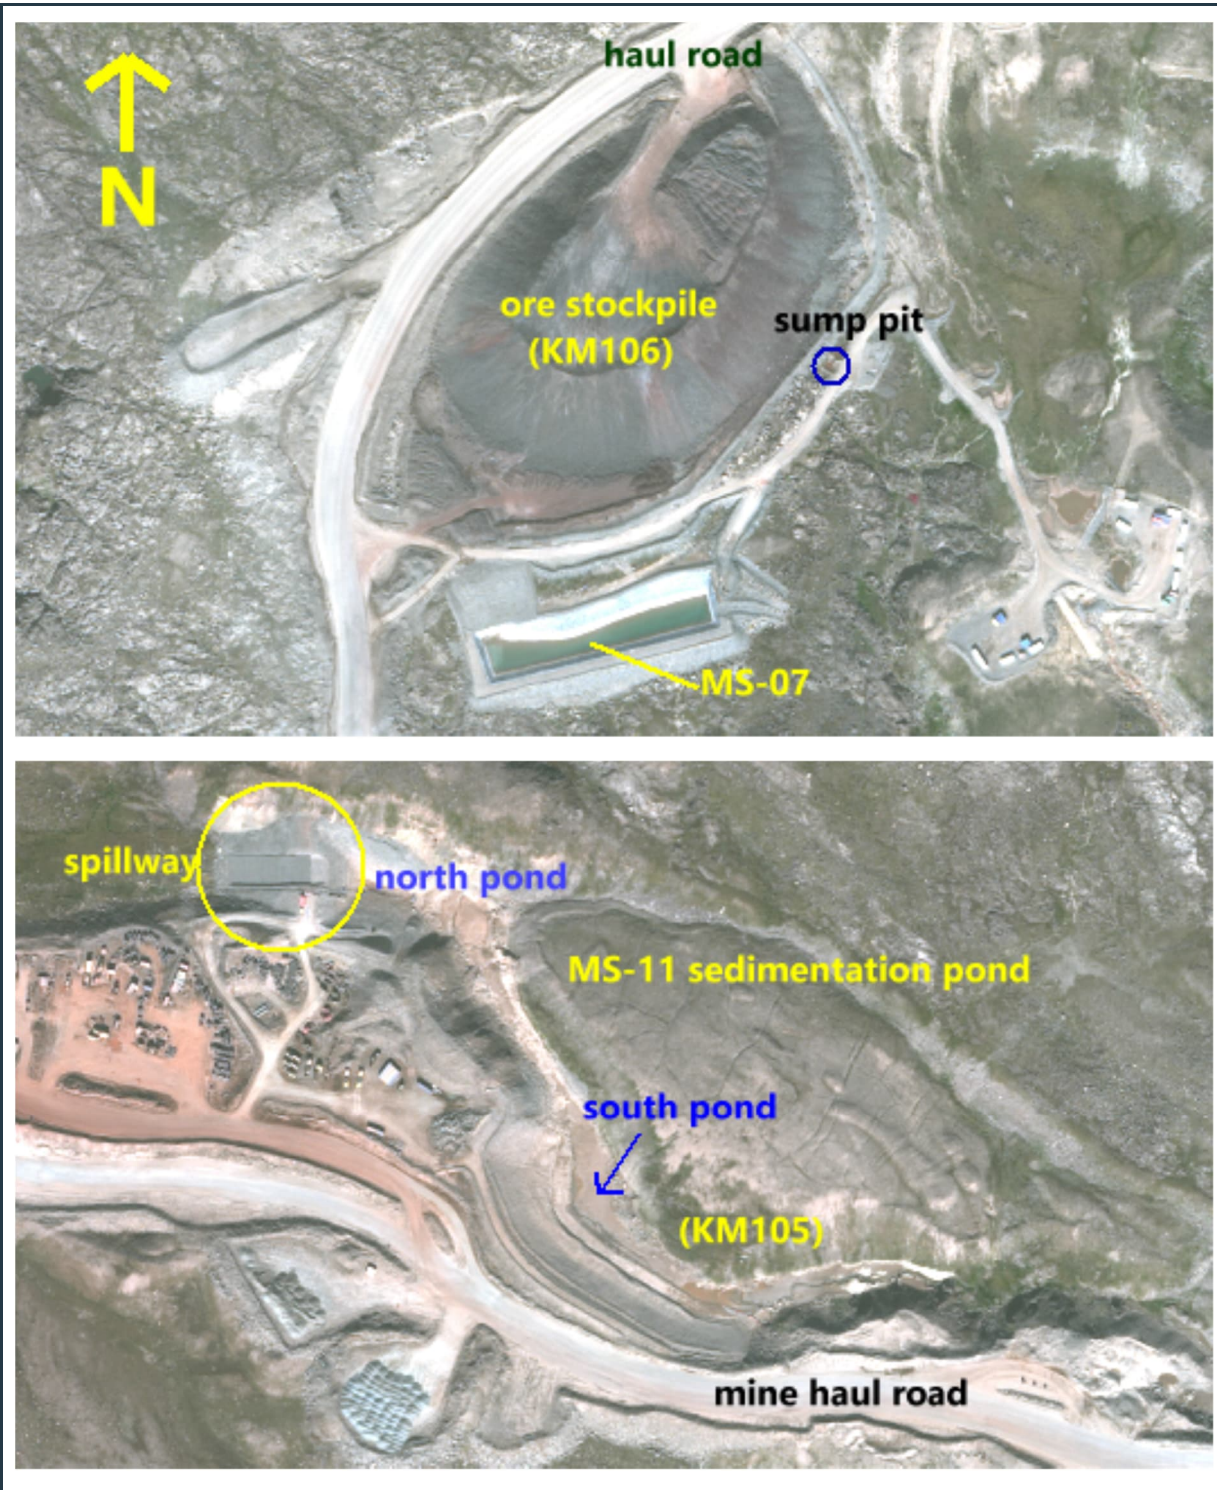
Figure 3: Site layout – Mary River Mine Site – South-Eastern Zone – KM106 run-of-mine ore storage area and KM106/MS-07 and KM105/MS-11 surface water management ponds. © 2023 Digital Globe, Inc.

The KM105 surface water management pond (MS-11), shown in Figure 3, was designed, and constructed to provide sediment control for runoff water originating from the following catchment areas:

The pond includes an emergency spillway with an invert elevation of 220.5 m, which is the design maximum water level in the pond. At normal water level the pond has two separate areas: the “north and south ponds”, as shown in Figure 3. As specified in the design, the upstream slopes of the pond embankments are lined with geomembrane liner, underlain by non-woven geotextile as a cushion layer. The geomembrane liner and non-woven geotextile extend up to the interior (upstream) slope of the embankments and are anchored at the crest. The geomembrane liner is covered with an additional layer of geotextile and a layer of compacted liner bedding, which in turn is covered with a layer of compacted transition material followed by more rockfill (riprap), as shown in Figure 32. As shown in the image (drill rig operating at the background), there is an ongoing geotechnical investigation at the base of the pond as part of the rehabilitation work at this pond.

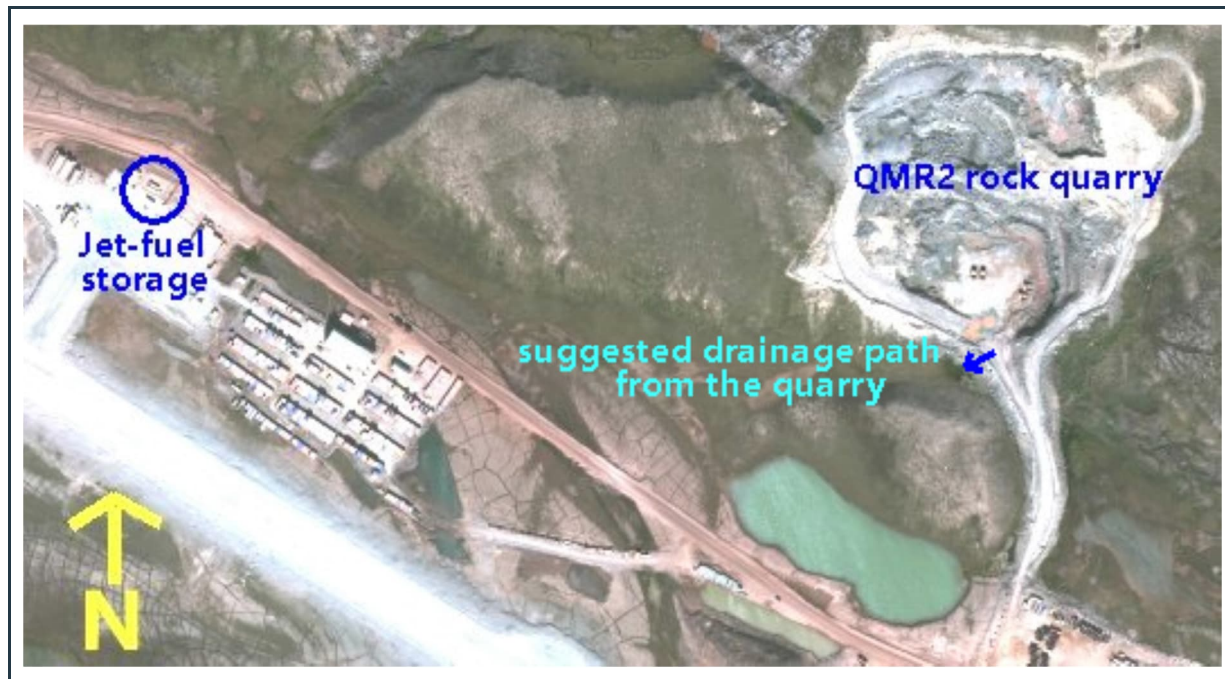
Figure 4: Site layout – Mary River Mine Site – Central Zone - West – Jet-fuel storage cell and QMR2 rock quarry. © 2023 Digital Globe, Inc.

The ponding water is then flowing uninterrupted along the side of the access road, as shown in Figure 48, still eroding the edge of the road, and initiating erosion and some settlement of the road embankment. As pointed out in earlier reports, the uncontrolled surface water presents not only potential slope stability issues in the area, but also traffic safety issues as well, particularly during freezing periods. To maintain traffic safety and stable side slopes when the operation in this facility will resume, the surface water at the quarry's main level should be collected in drainage ditches and a sump, and then properly drained from the sump down on the side-slope of the plateau. The location of the suggested drainage path is marked in Figure 4 by a blue arrow. It is recommended that consideration be given to the

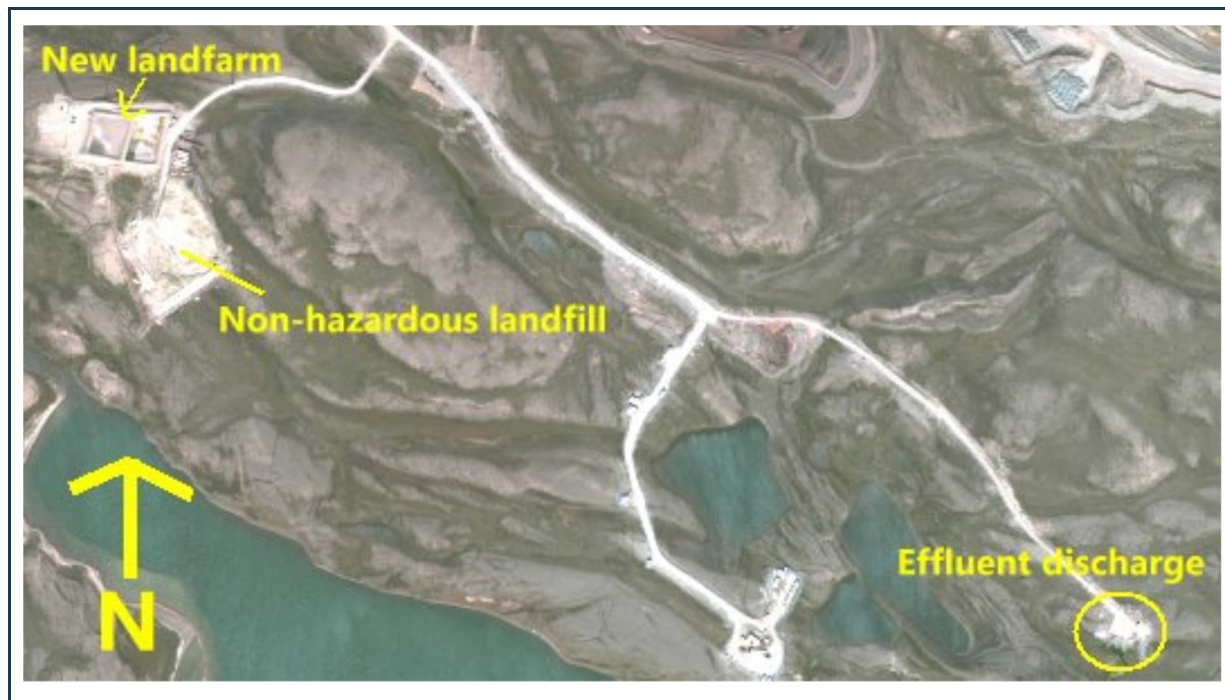
Figure 5: Site layout – Mary River Mine Site – Southern Zone – Non-hazardous landfill area with two new land-farm cells, and the effluent discharge location. © 2023 Digital Globe, Inc.

The non-hazardous solid waste disposal area is in the southern zone of the Mary River Mine site, as shown in Figure 5. Recently, two (2) new landfarm cells were constructed near the gate of the main landfill facility, as shown in Figure 39. It is understood that the number of new landfarm cells will be increased to three (3) as shown in the image. Cells #1 and #2 have been recently completed covering an approximate area of 10,180 m², while cell 3 will be completed later.

The effluent discharge point is located south of the Mary River mine complex, as shown in Figure 5. There are two (2) discharge pipes at that location conveying the clean, discharged water down the slope's surface to the adjacent valley. Trucks also bring water for discharge to this location and let the water flow down on the embankment, comprising crushed rock fill, as shown in Figure 45. As shown in the image, the slope is well-protected against potential erosion by the rockfill.

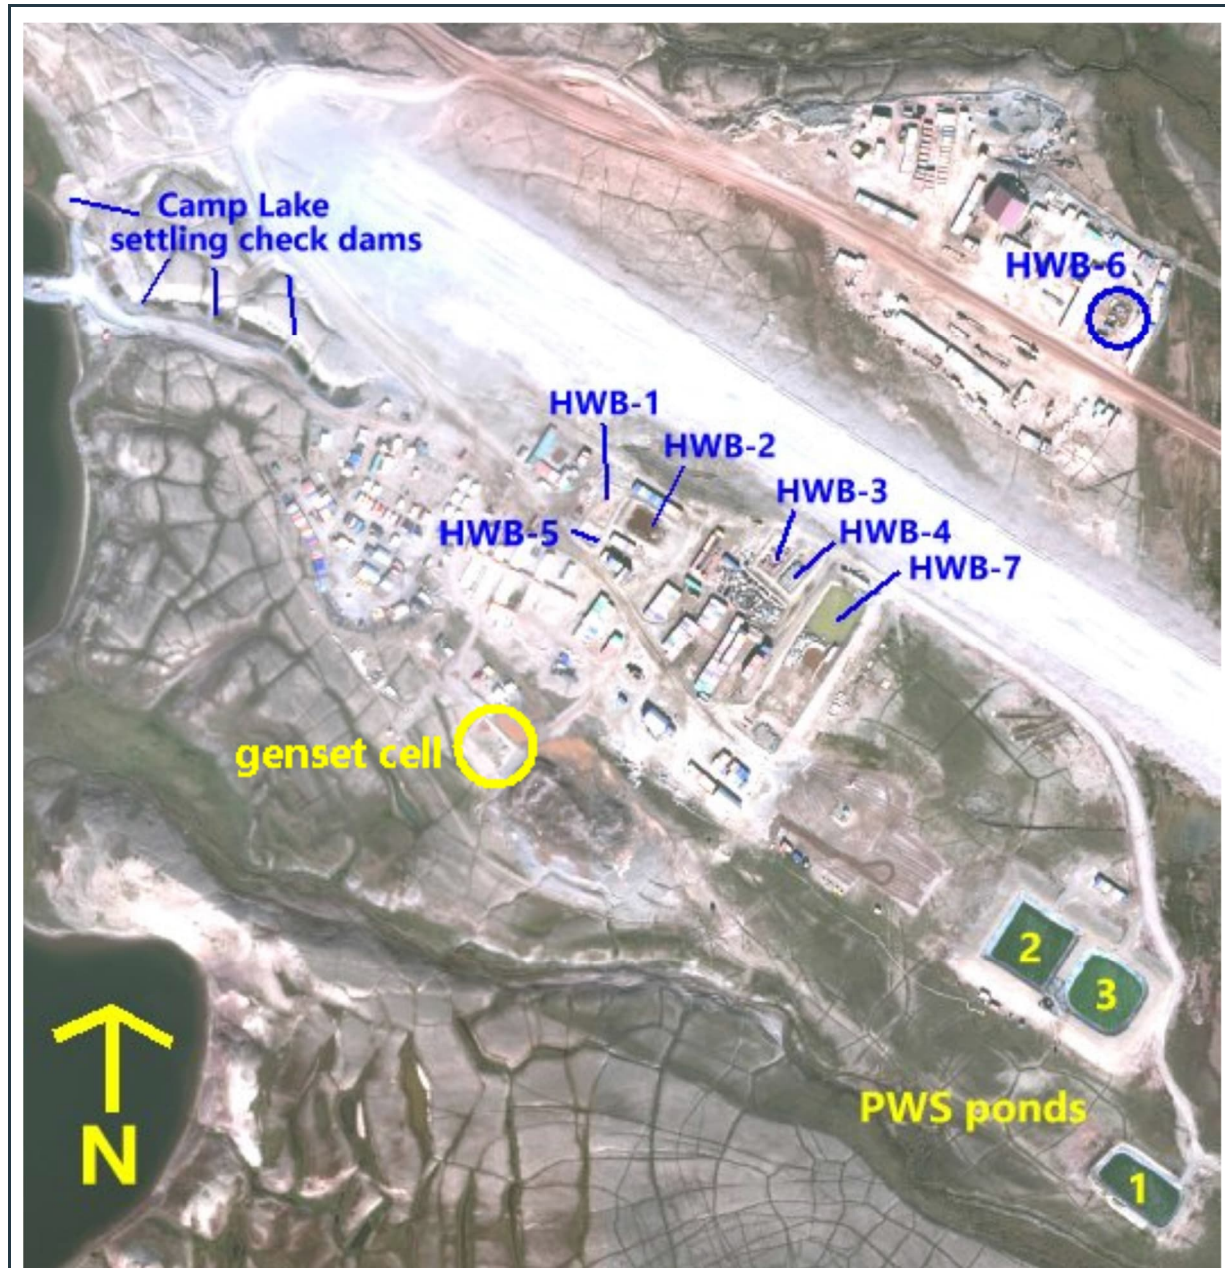
Figure 6: Site layout – Mary River Mine Site - Western Zone – PWS ponds (1-3), HWB hazardous waste storage cells (1-7), genset cell, and Camp Lake check dams. © 2023 Digital Globe, Inc.

There are three (3) polishing/waste stabilization ponds, located adjacent to the airstrip, as shown in Figure 6. Pond #1 is a single structure, while Ponds #2 and #3 were constructed as twin-cells, as shown in Figure 12. The photograph in Figure 12 is a historic aerial image (taken by the author of this report) showing the robust and stable berms around the three stabilization ponds. As mentioned in previous inspection reports, these ponds were associated with the exploration phase of the mine, and currently serve as emergency holding ponds in case problems would arise, which would prevent the discharge of treated effluent directly to the receiving environment. The robust, stable berms around the ponds generally comprise granular materials (rock fill, sand, and gravel), with High Density Polyethylene (HDPE) geomembrane liners. No damage is visible on the membranes in the cells or on the upstream face of the slopes (see Figures 13 to 15).

This cell has previously contained fuel bladders for the generators; however, it is currently storing mobile fuel tanks only. The cell is located south-west of hazardous waste cells, HWB-1 to HWB-5 (Figure 6). As shown in Figure 35, the stable perimeter berm around the cell generally comprises granular materials and the cell is lined. Ponding water within the cell indicates good liner performance.

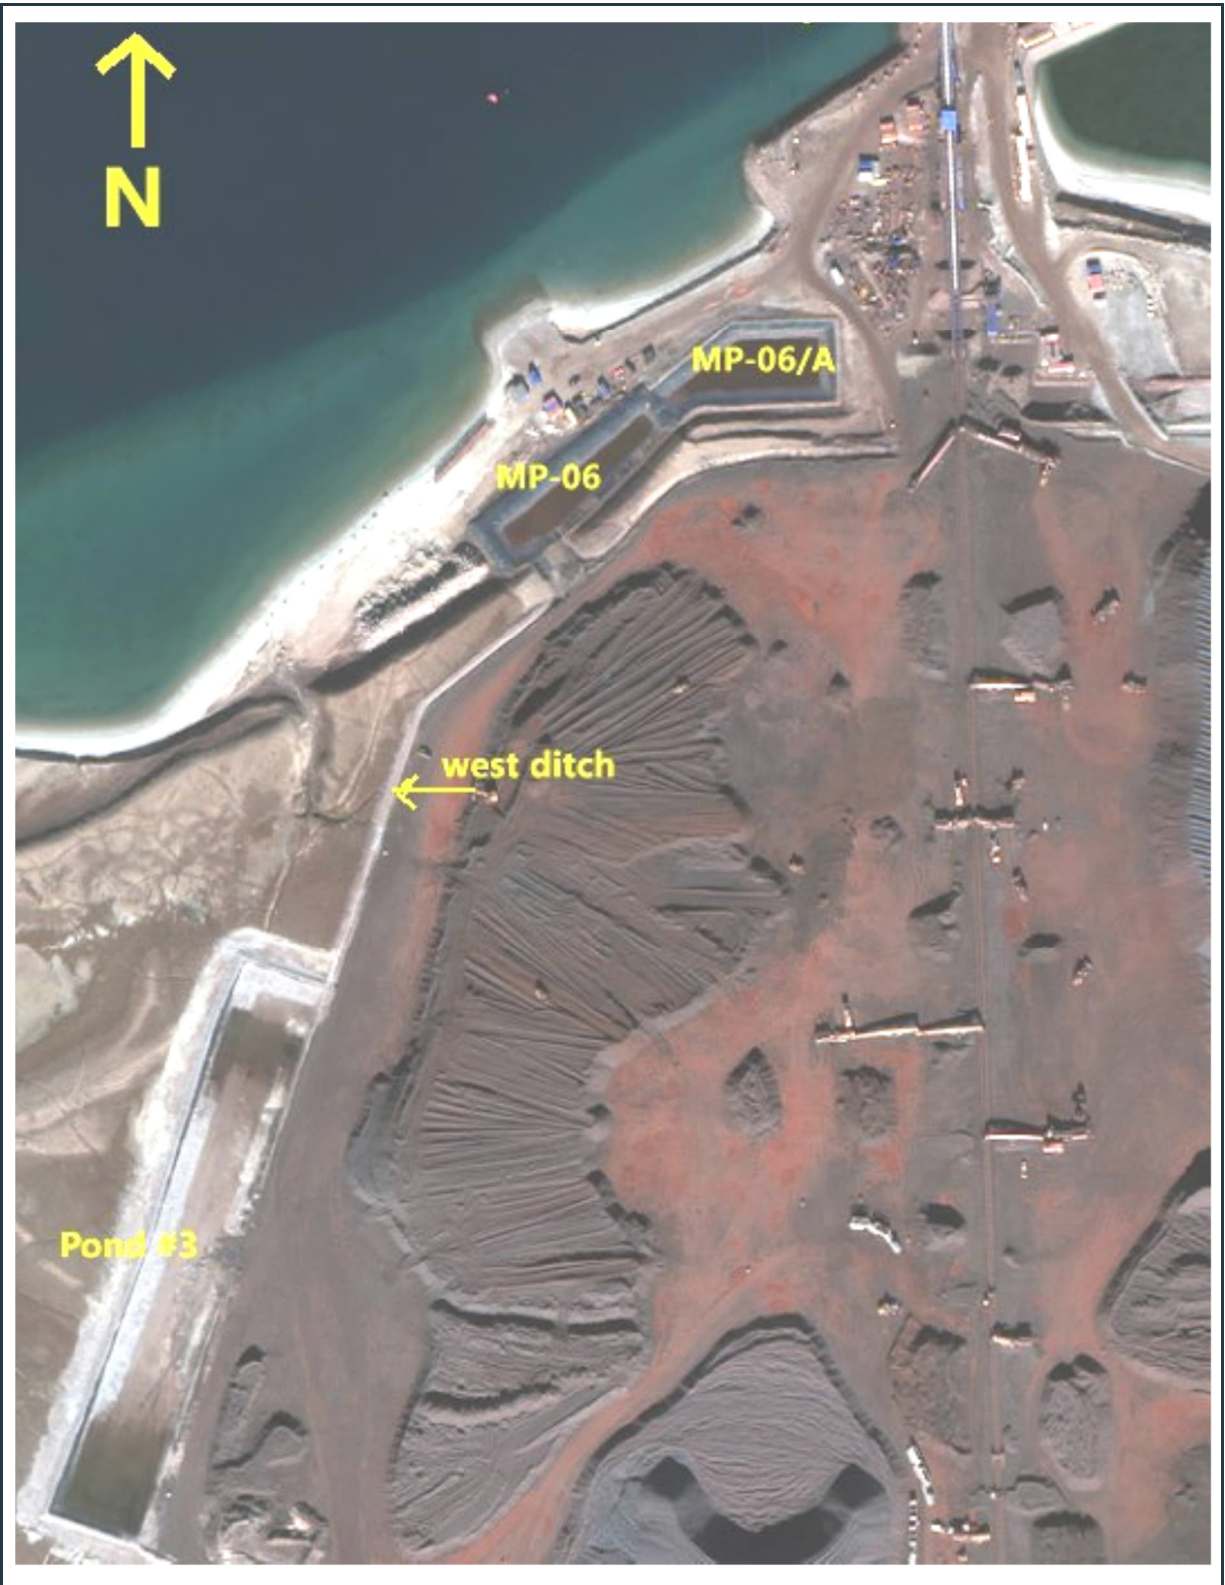
Figure 8: Site layout – Milne Inlet Port Site – North-Western Zone. © 2023 Digital Globe, Inc.

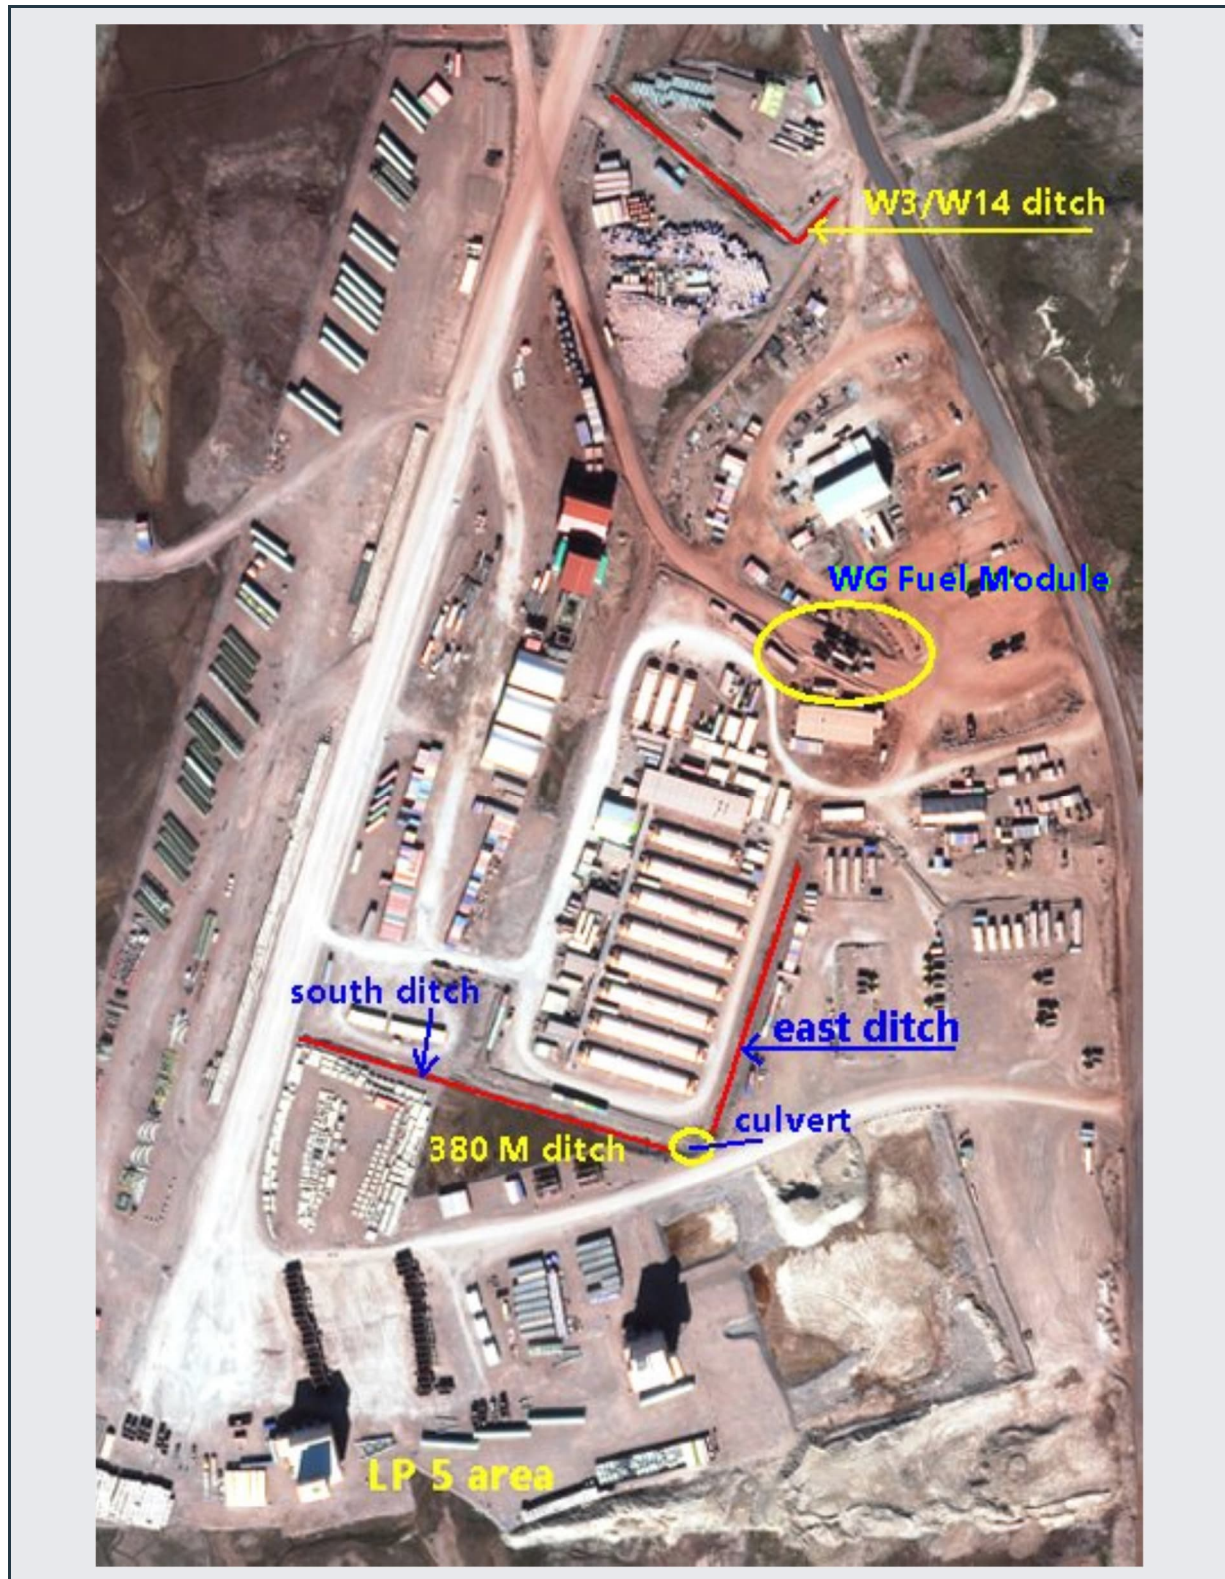
Figure 9: Site layout – Milne Inlet Port Site – South-Western Zone. © 2023 Digital Globe, Inc.

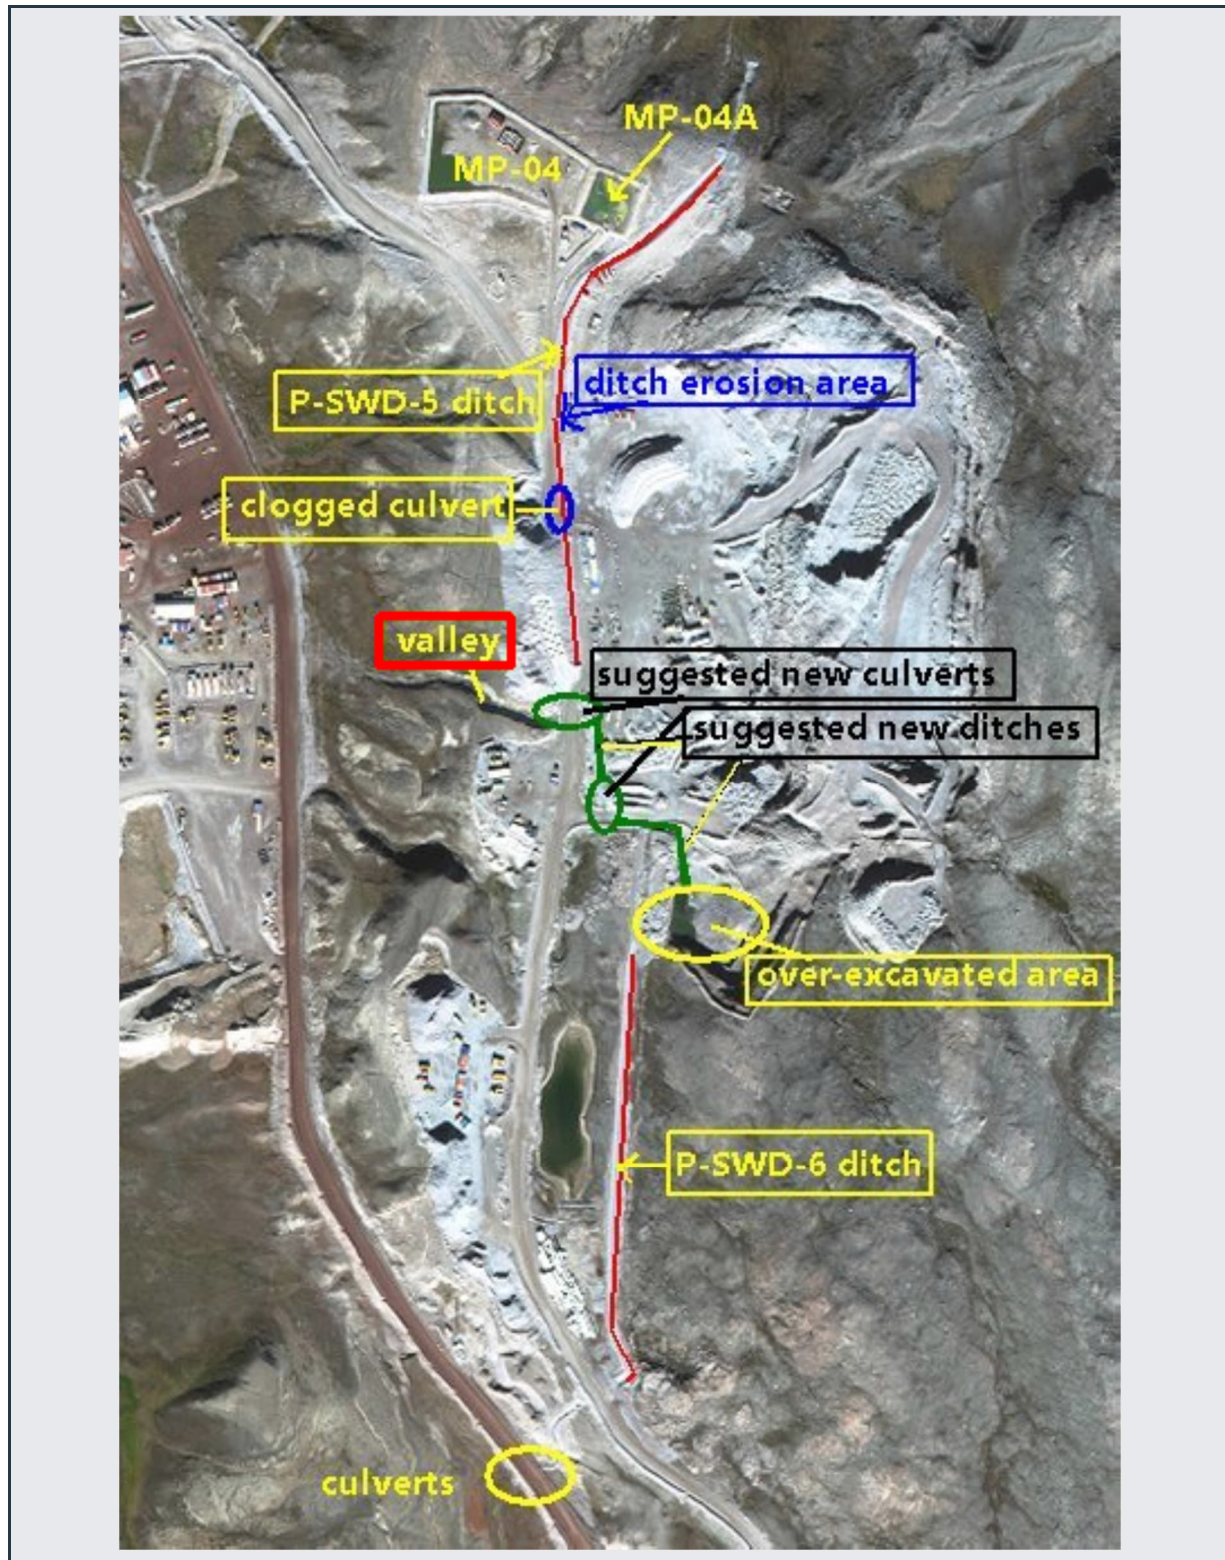
Figure 10: Site layout – Milne Inlet Port Site – South-Eastern Zone. © 2023 Digital Globe, Inc.

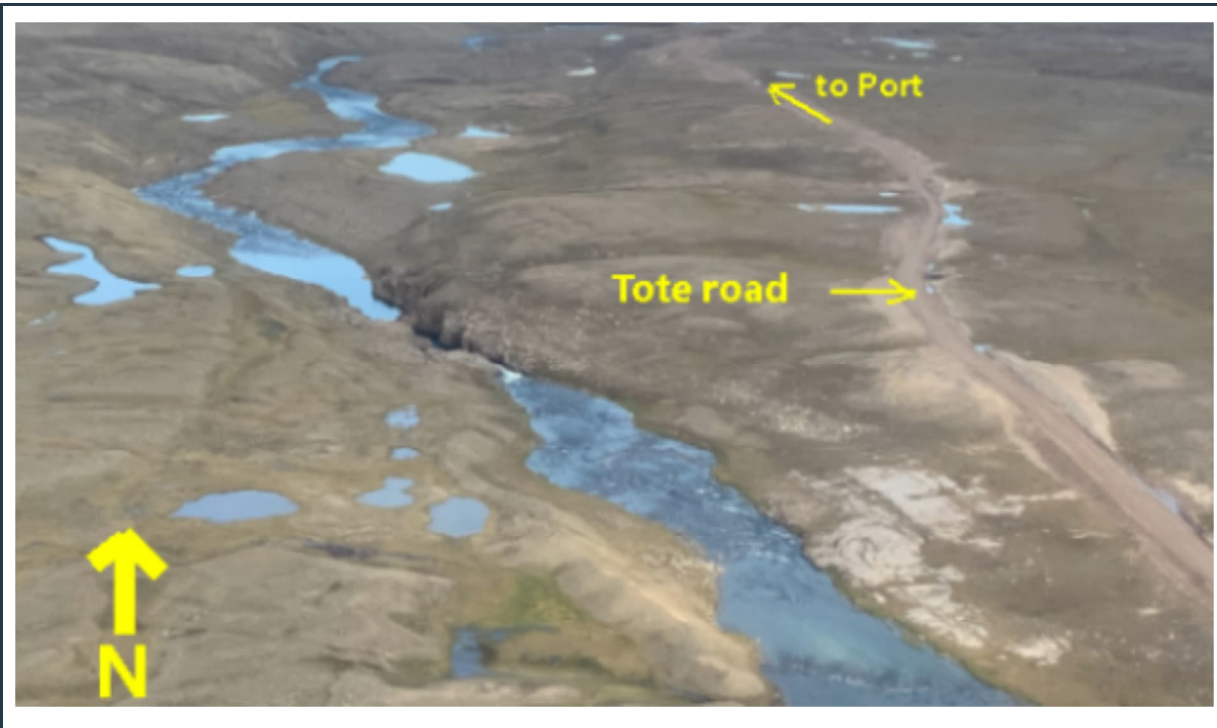
Figure 11: View of a section of the Tote Road between the Mary River Mine and Milne Inlet Port.
