# APPENDIX 6-D

# **AMARUQ EXPLORATION ACCESS ROAD AQUATICS BASELINE REPORT 2015 AGNICO EAGLE MINES LTD. - MEADOWBANK DIVISION**

Submitted to:

November 25, 2015.

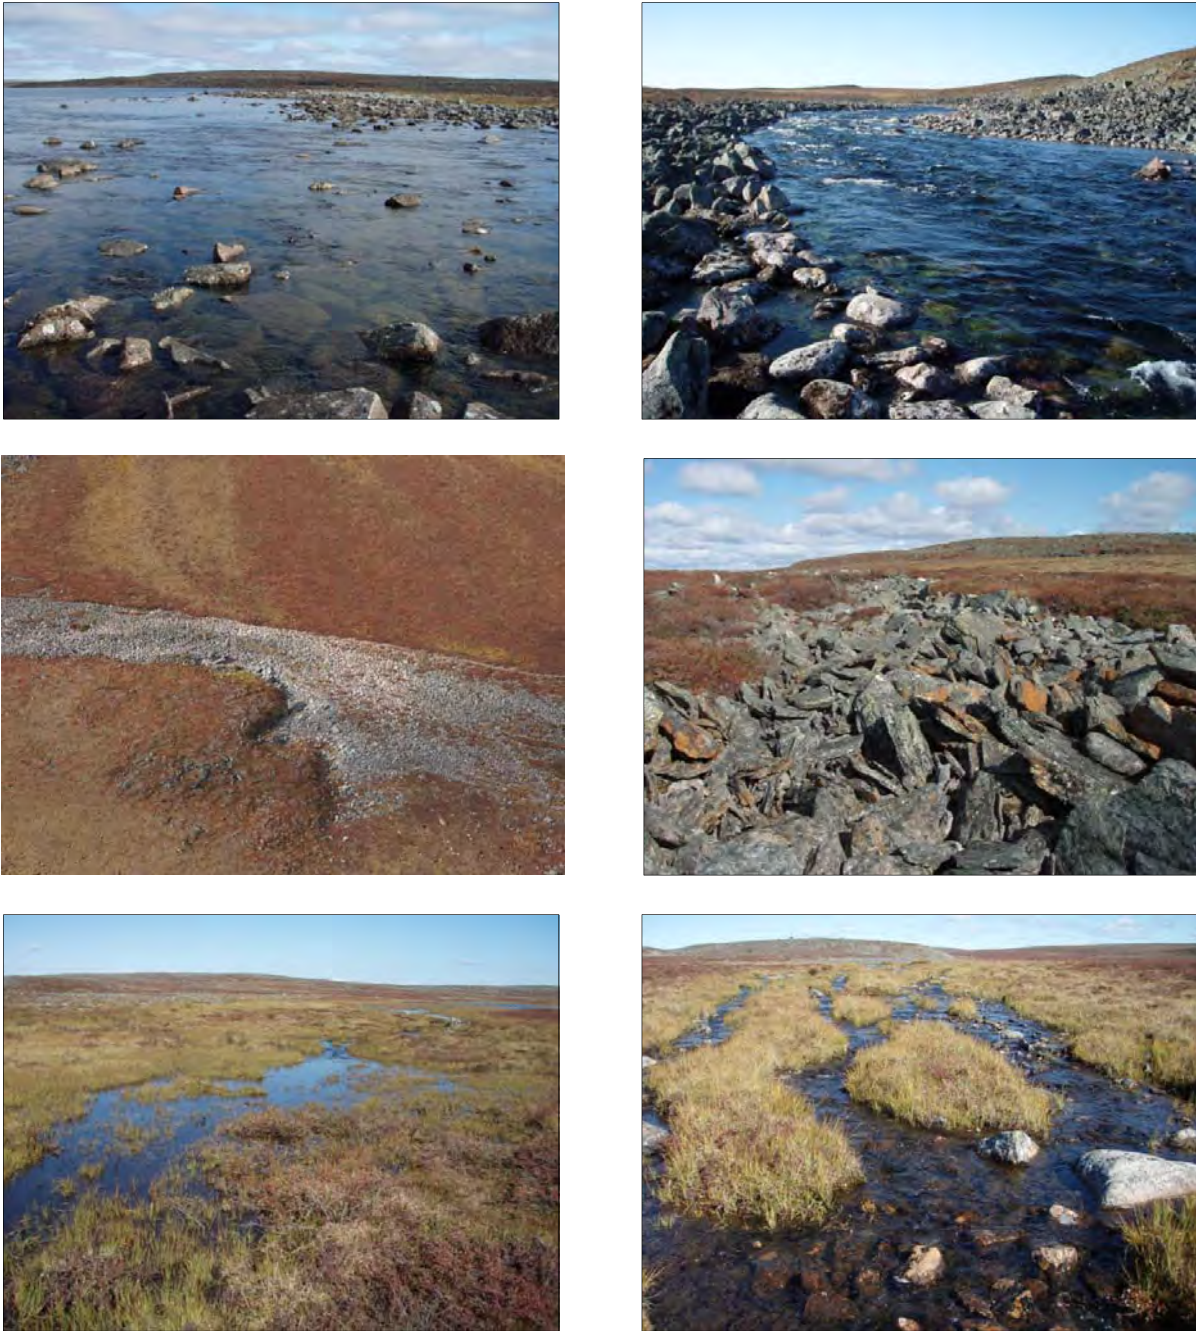
Figure 2-2. Examples of habitat types encountered. The top row are rivers. The middle row are boulder watercourses. The bottom row are graminoid watercourses, with the right photograph showing graminoid with coarse substrate, and the left photograph showing graminoid with organic substrate.

The watercourse habitats were divided into three categories, river, boulder, and graminoid. Examples of each are shown in Figure 2-2. River habitats were large, flowing, open channels, which occurred at only three locations. Boulder habitats typically appear in the aerial photographs as well-defined, linear, boulder fields associated with depressions on the landscape. Graminoid habitats are reaches of small watercourses whose banks are vegetated primarily by graminoids growing on peat. Often there are multiple smaller channels that branch and coalesce. Some of these habitats have a significant sand/gravel fraction in the substrate while others flow almost entirely over an organic peaty layer.

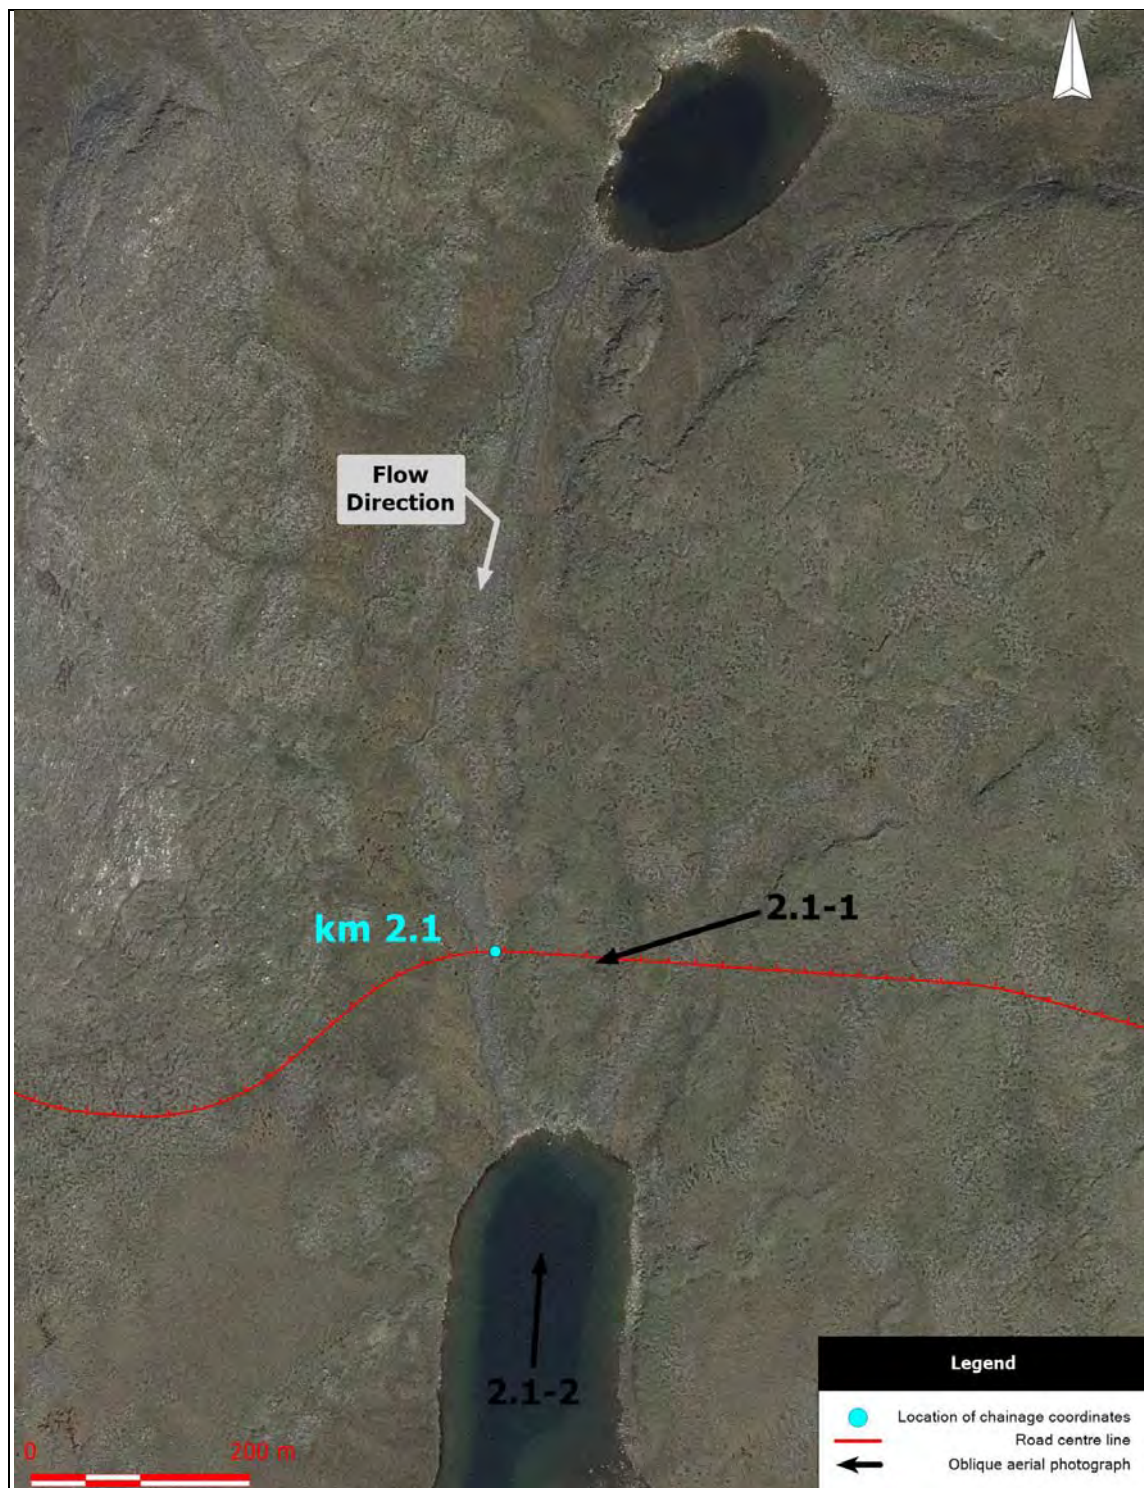
Kilometre 2.1. Aerial photograph showing the road centre line, the location of chainage coordinates provided in Table 3-2, the flow direction, and the location of oblique aerial photographs.

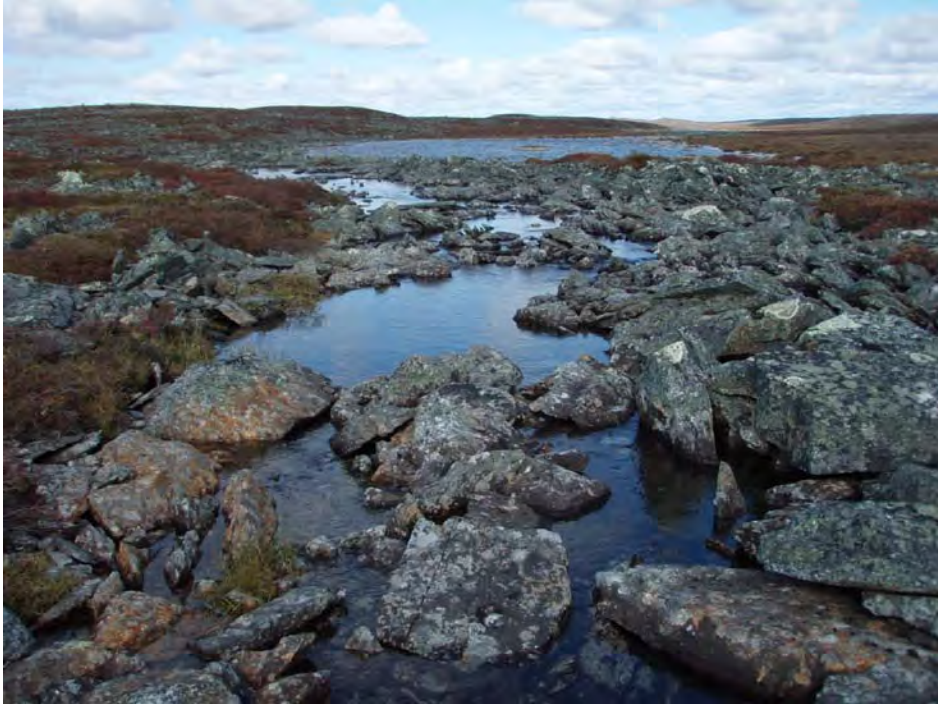
Kilometre 3.4. Photograph from the ground. Upstream view from the proposed road crossing. August 30, 2014.

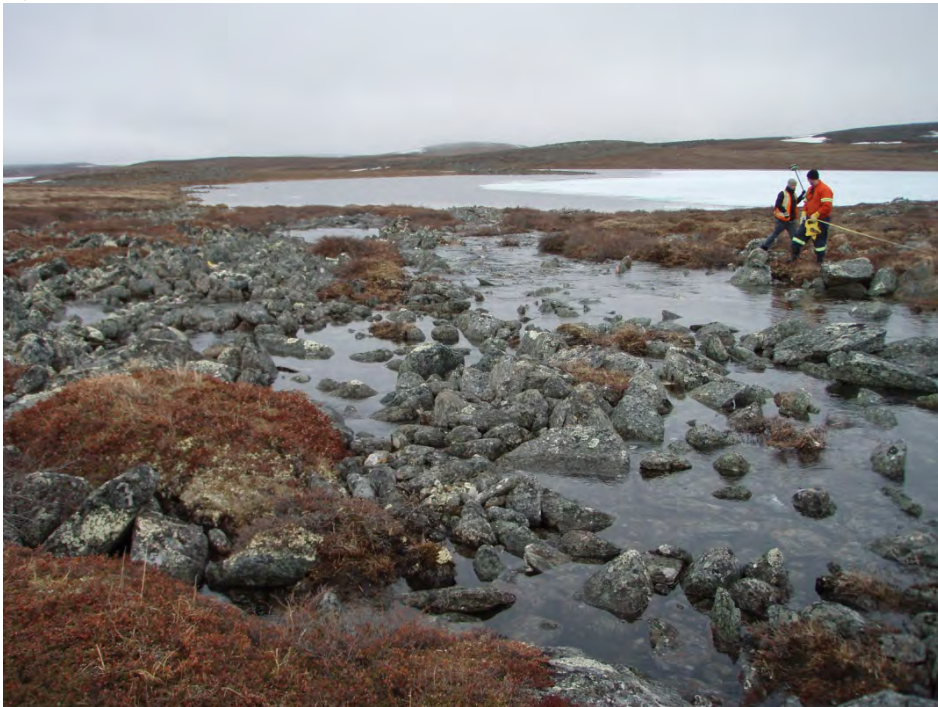
Kilometre 3.4. Photograph from the ground. Downstream view from approximately 30 m downstream from the proposed road crossing. June 23, 2015.

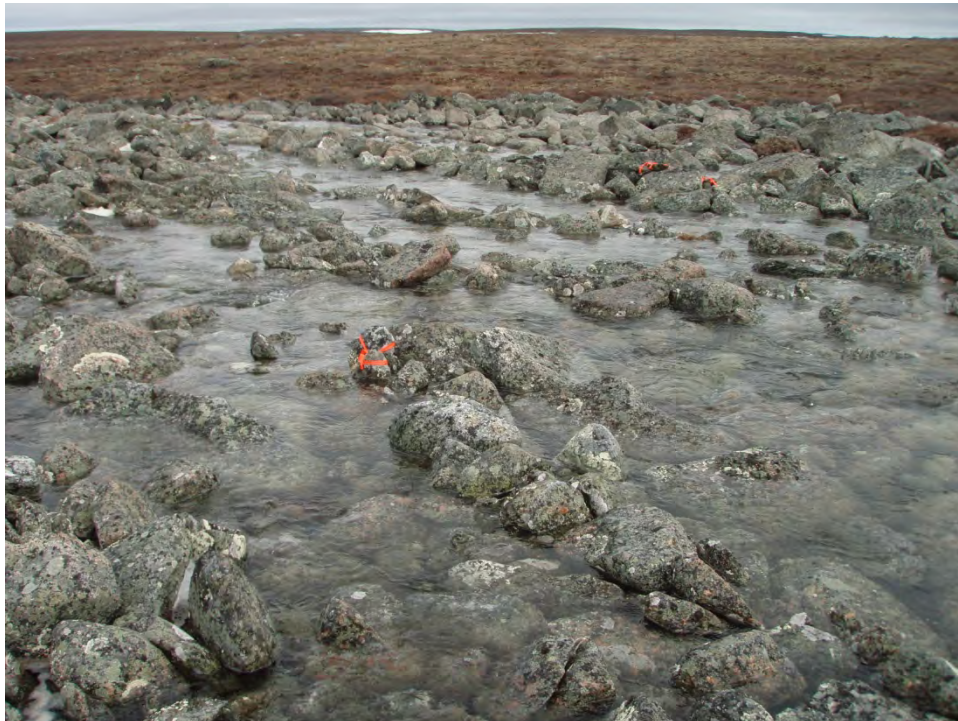
Kilometre 10.7. Photograph from the ground. View of the proposed road crossing. June 23, 2015.

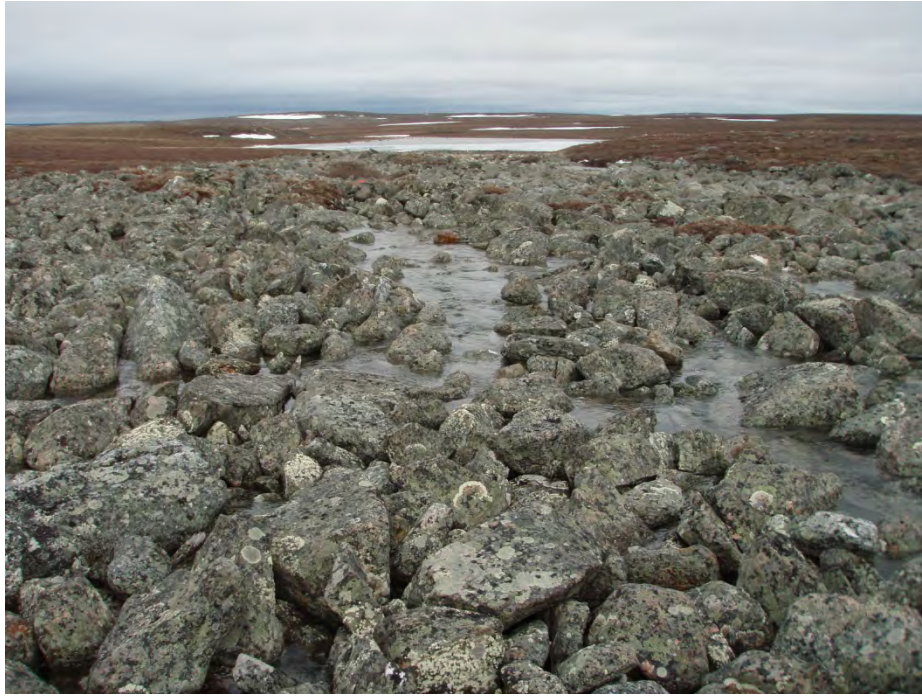
Kilometre 10.7. Photograph from the ground. View downstream from the proposed road crossing. June 23, 2015.

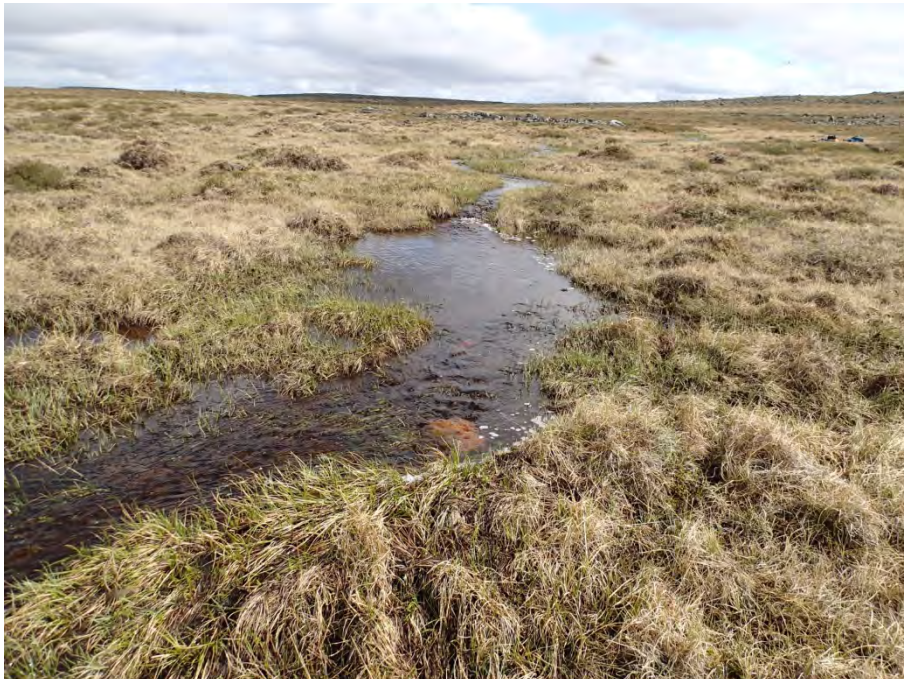
Kilometre 11.1. Photograph from the ground. View upstream from near the downstream lake.  
July 11, 2015.

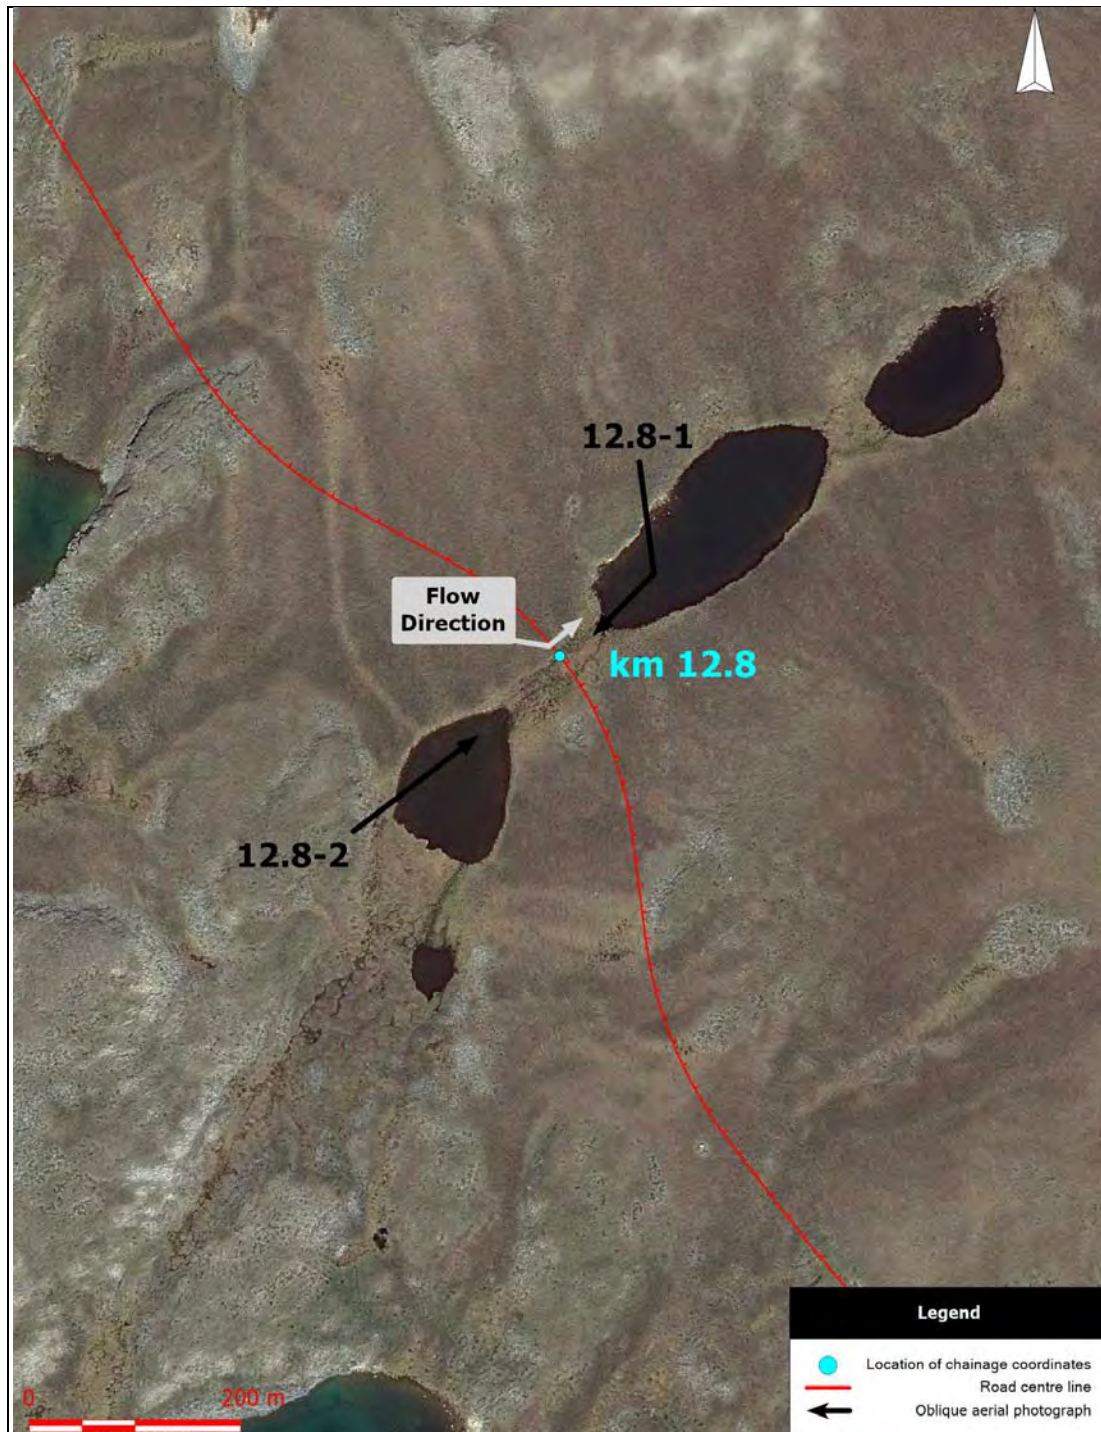
Kilometre 12.8. Aerial photograph showing the road centre line, the location of chainage coordinates provided in Table 3-2, the flow direction, and the location of oblique aerial photographs.

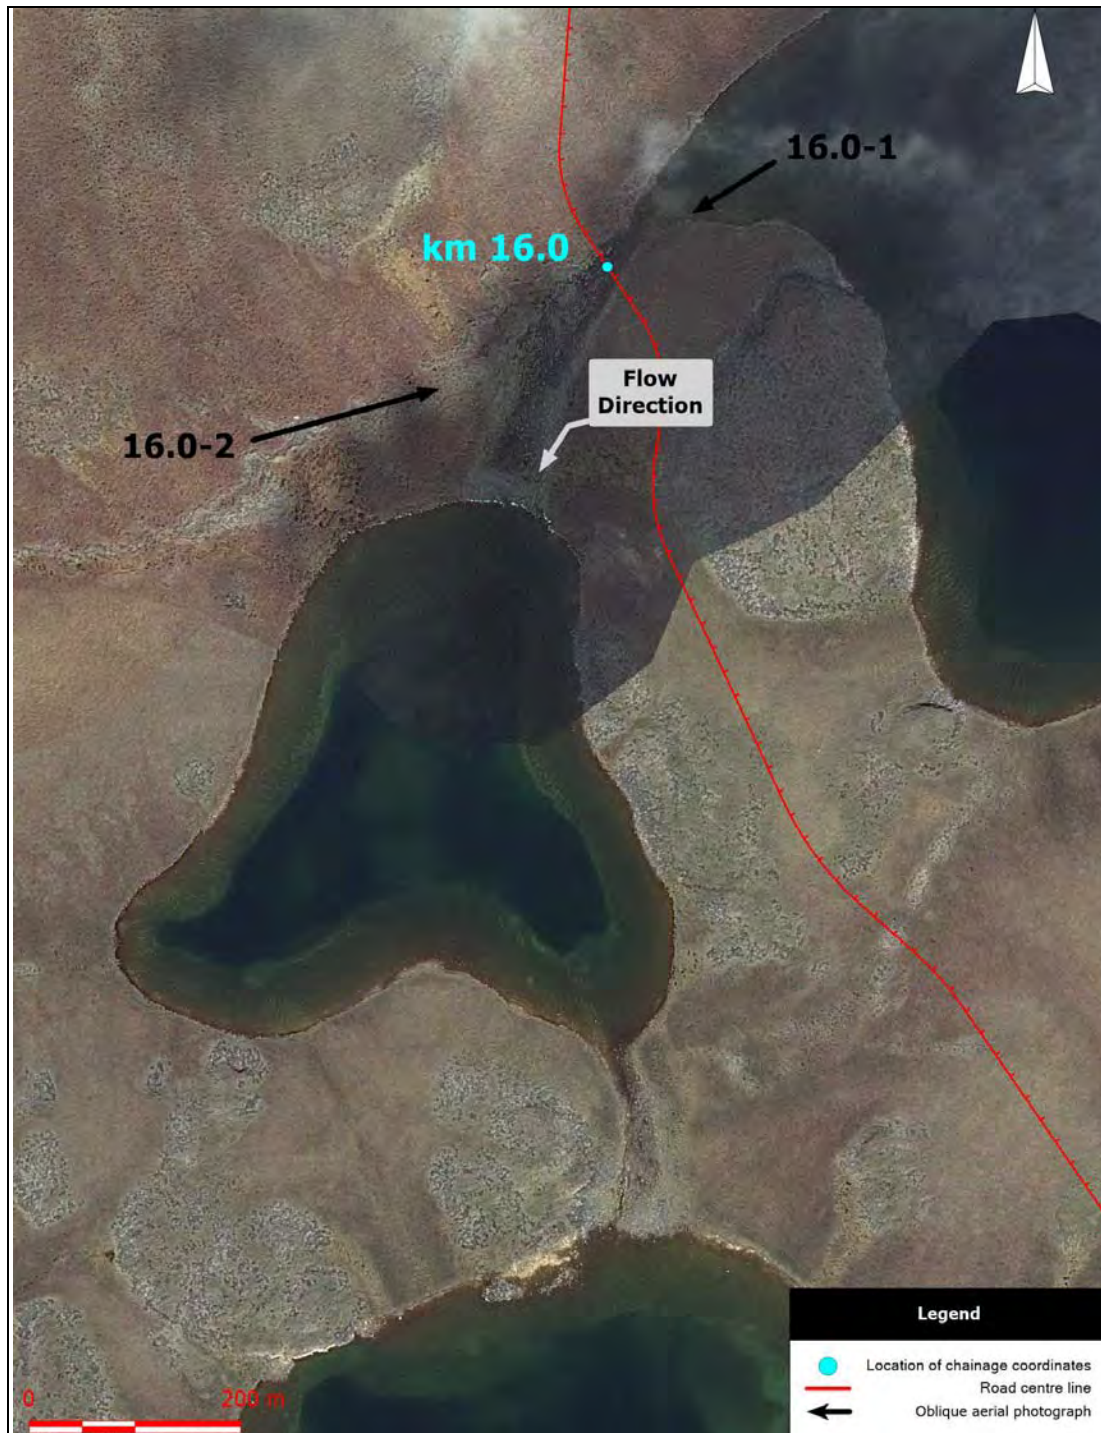
Kilometre 16.0. Aerial photograph showing the road centre line, the location of chainage coordinates provided in Table 3-2, the flow direction, and the location of oblique aerial photographs.

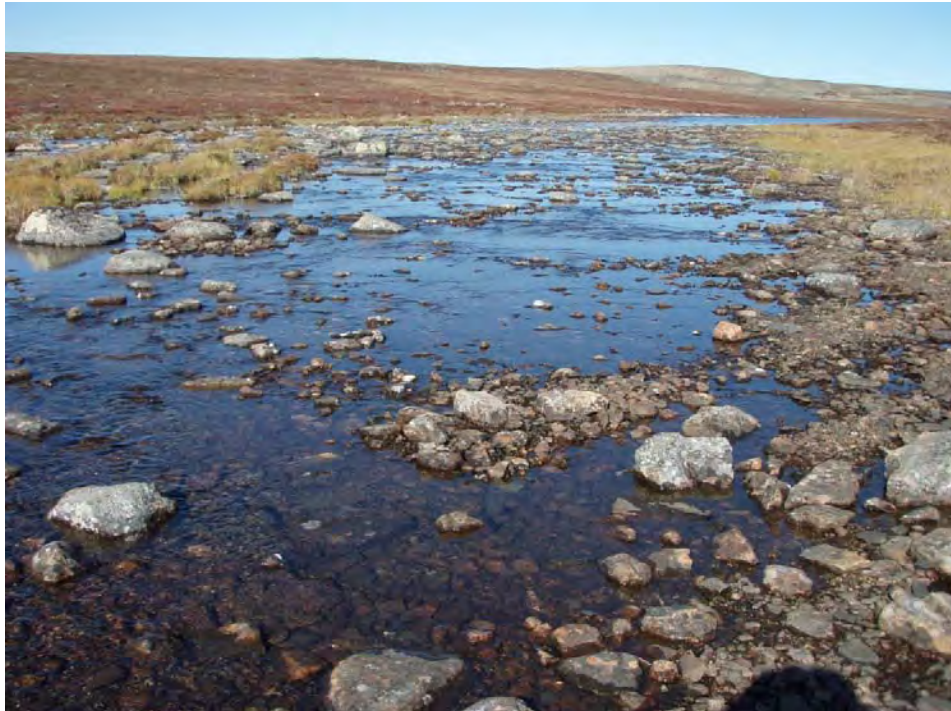
Kilometre 16.0. Photograph from the ground. Upstream view from 37 m downstream of the proposed road crossing location. September 1, 2014.

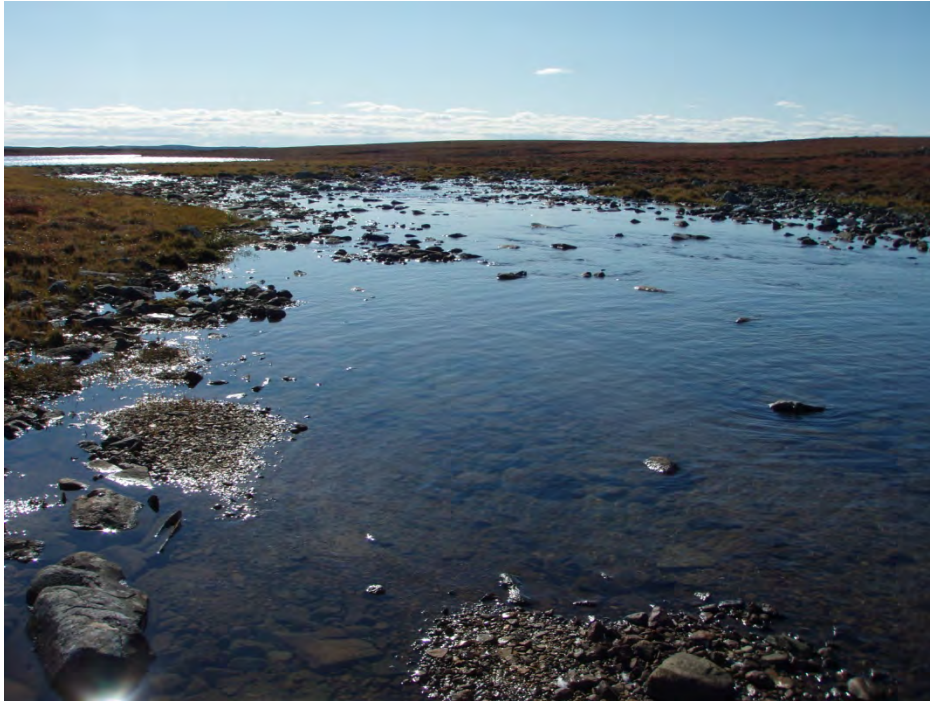
Kilometre 16.0. Photograph from the ground. Downstream view from 56 m upstream of the proposed road crossing location. September 1, 2014.

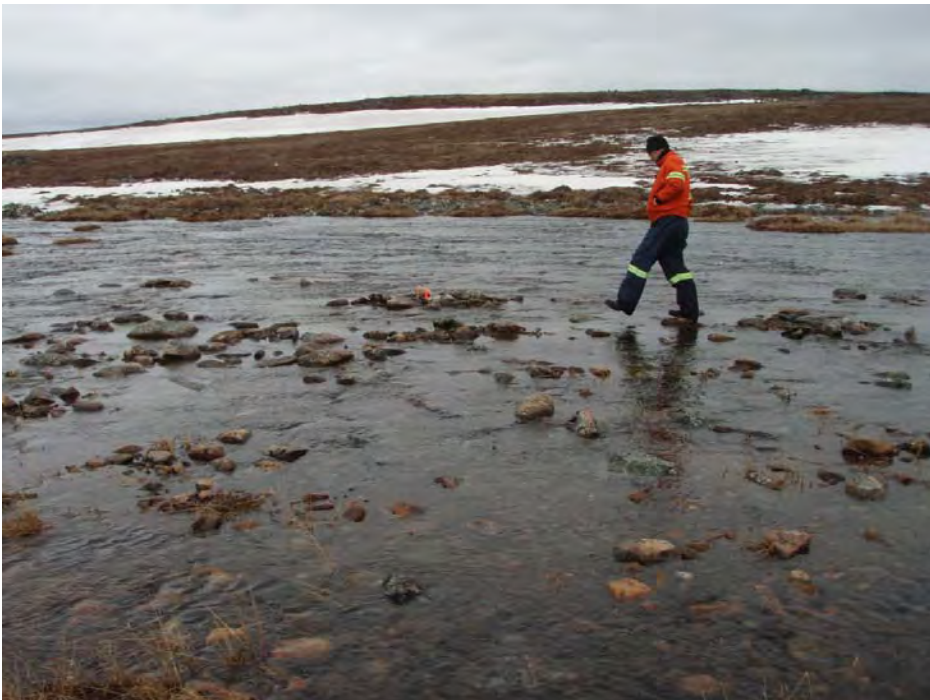
Kilometre 16.0. Photograph from the ground. Approximately 250 m upstream from lake at the proposed bridge location. June 23, 2015.

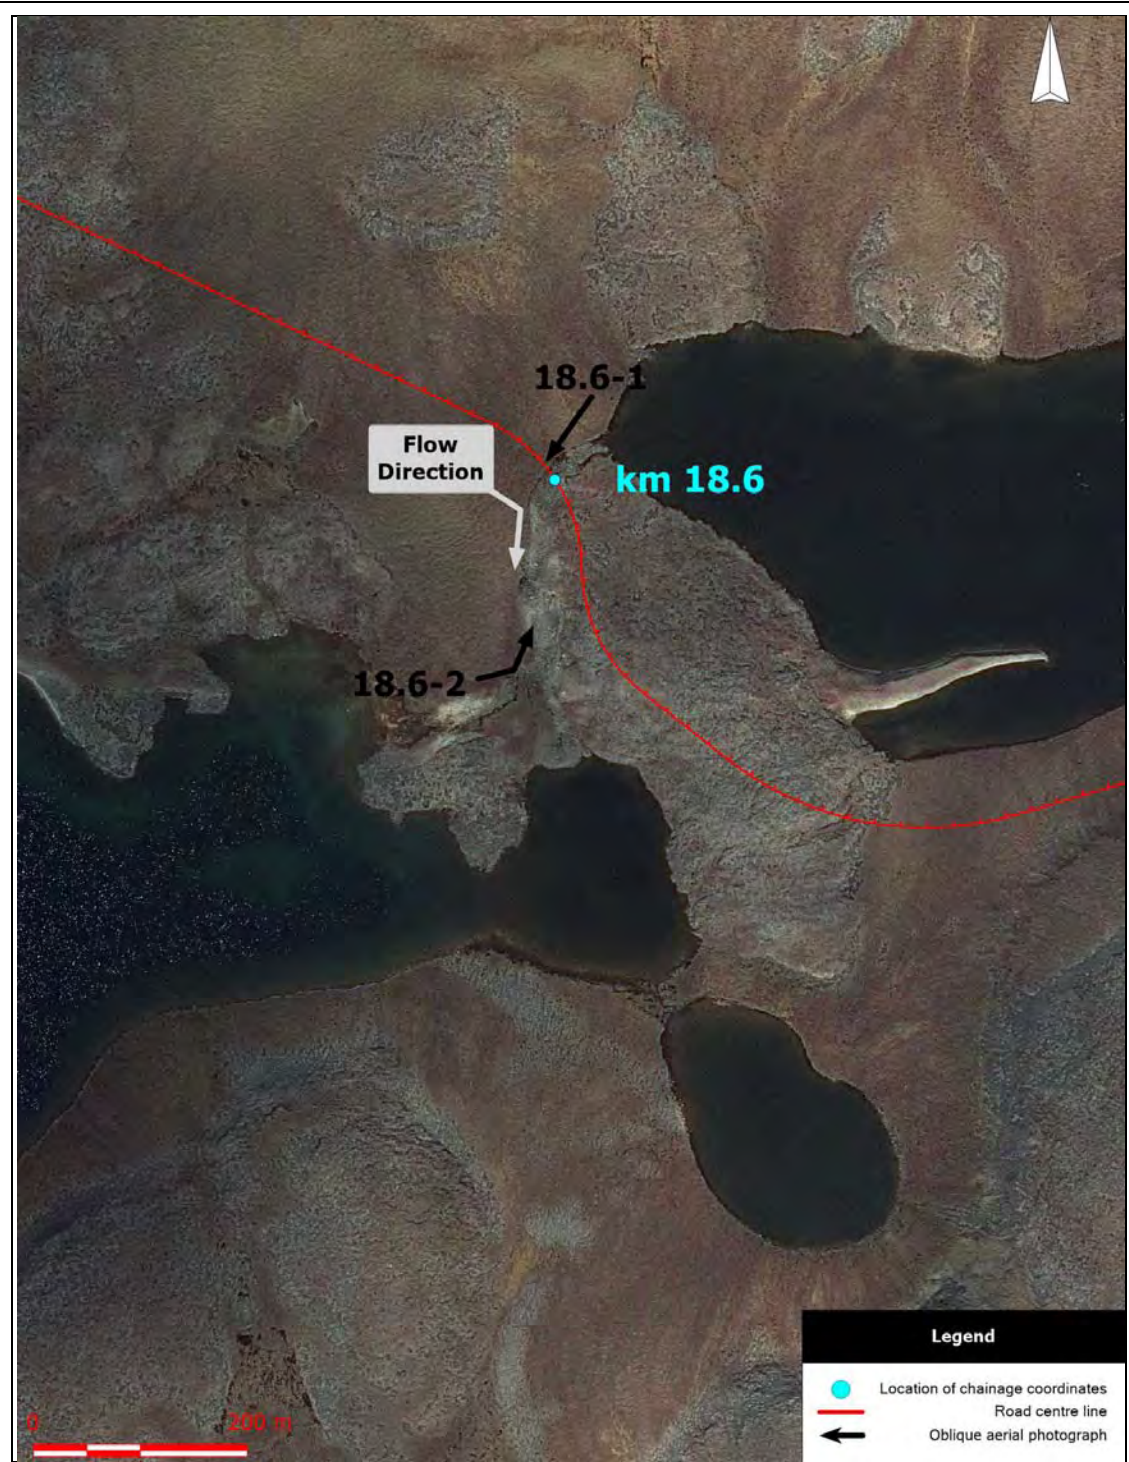
Kilometre 18.6. Aerial photograph showing the road centre line, the location of chainage coordinates provided in Table 3-2, the flow direction, and the location of oblique aerial photographs.

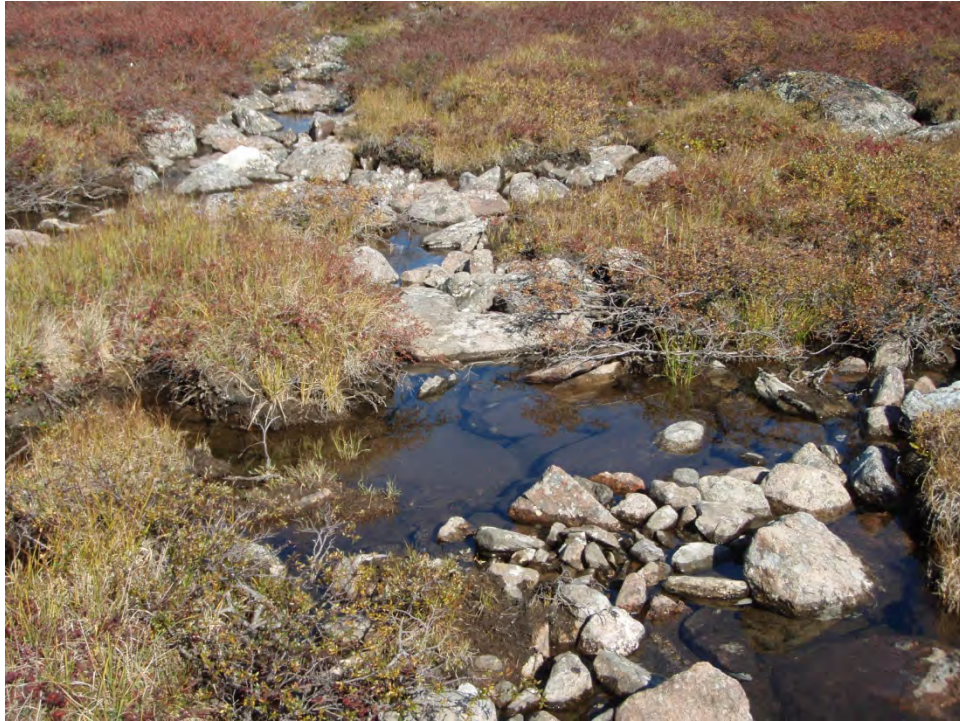
Kilometre 20.0. Photograph from the ground. Near watercourse mouth. September 2, 2014.

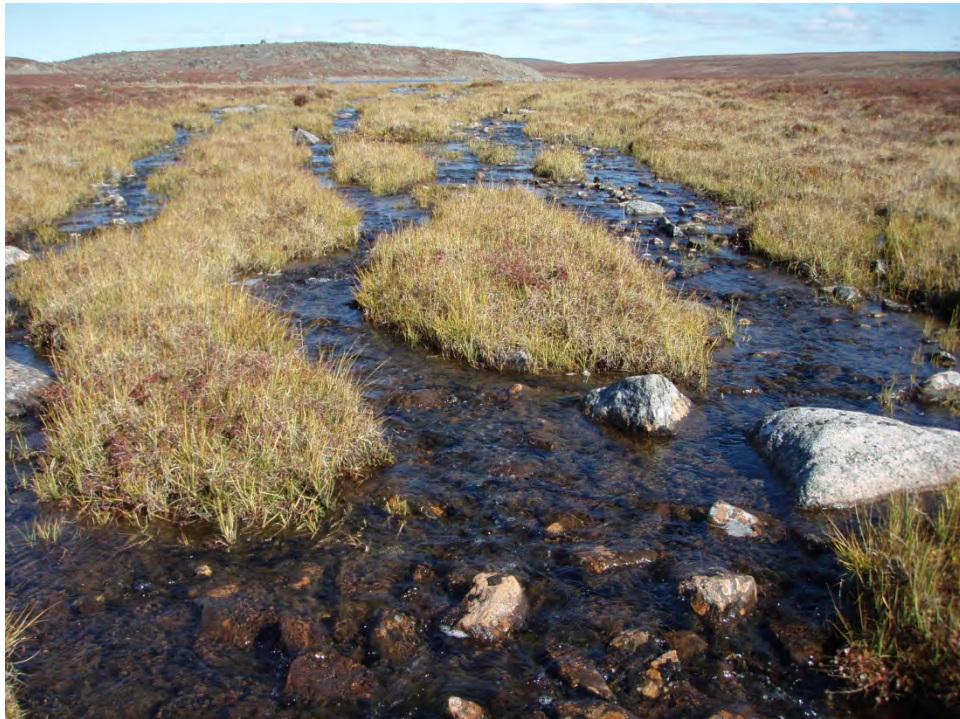
Kilometre 20.0. Photograph from the ground. Upstream view approximately 200 m upstream of watercourse mouth. September 2, 2014.

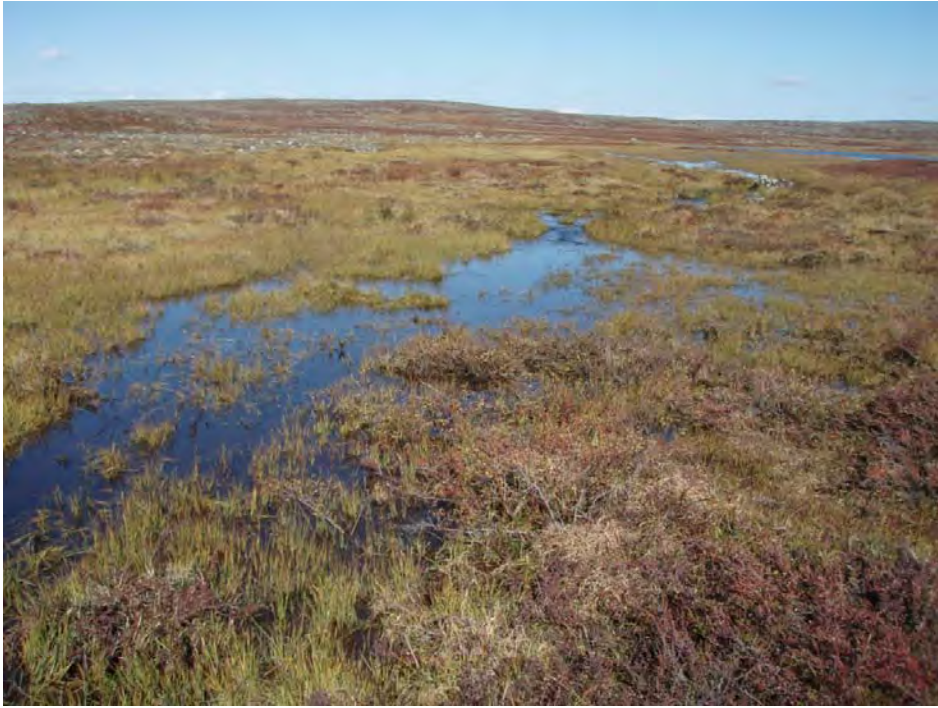
Kilometre 22.1. Photograph from the ground. Upstream view approximately 100 m upstream of watercourse mouth. August 31, 2014.

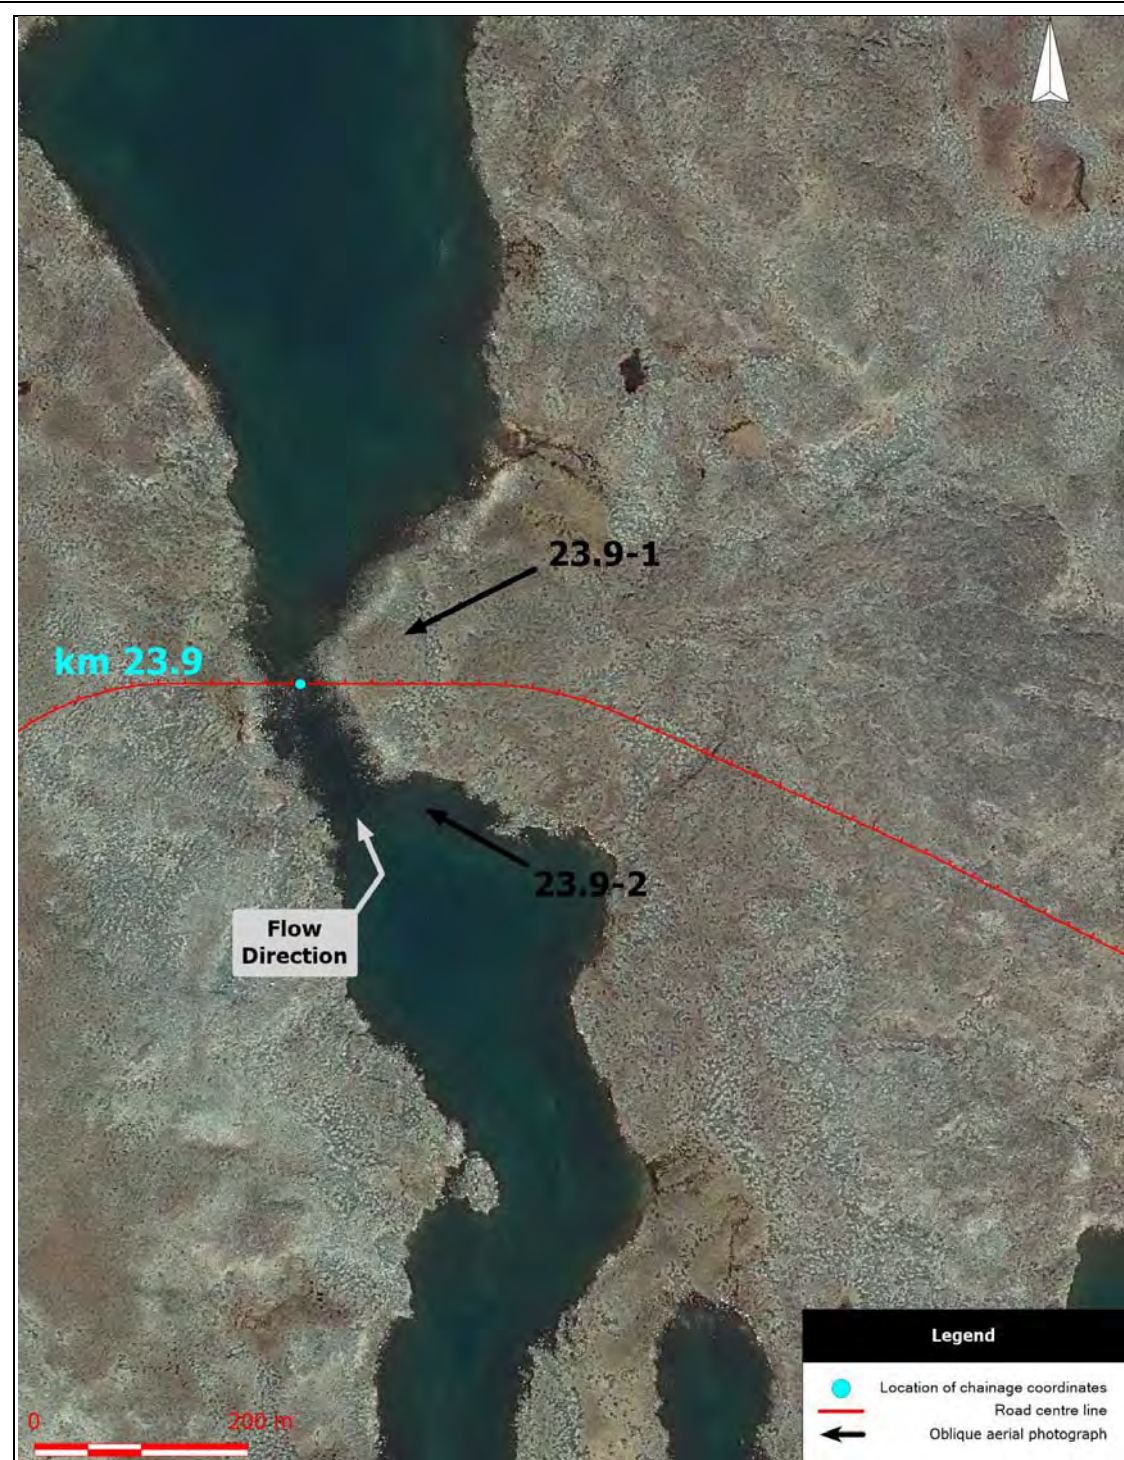
Kilometre 23.9. Aerial photograph showing the road centre line, the location of chainage coordinates provided in Table 3-2, the flow direction, and the location of oblique aerial photographs.

The total number of locations where fish habitat exists or may exist, based on the observed habitat conditions along the road alignment, is 28. The watercourses at three of the locations (km 16.0, km 23.9 and km 32.3) were characterized as rivers. These provide habitat for small-bodied fish, and potentially also for large-bodied fish, throughout the open-water period. Due to their depth and flow, these watercourses are also potential migration routes for large-bodied fish throughout the open water period. Clear-span bridges are recommended for these locations.

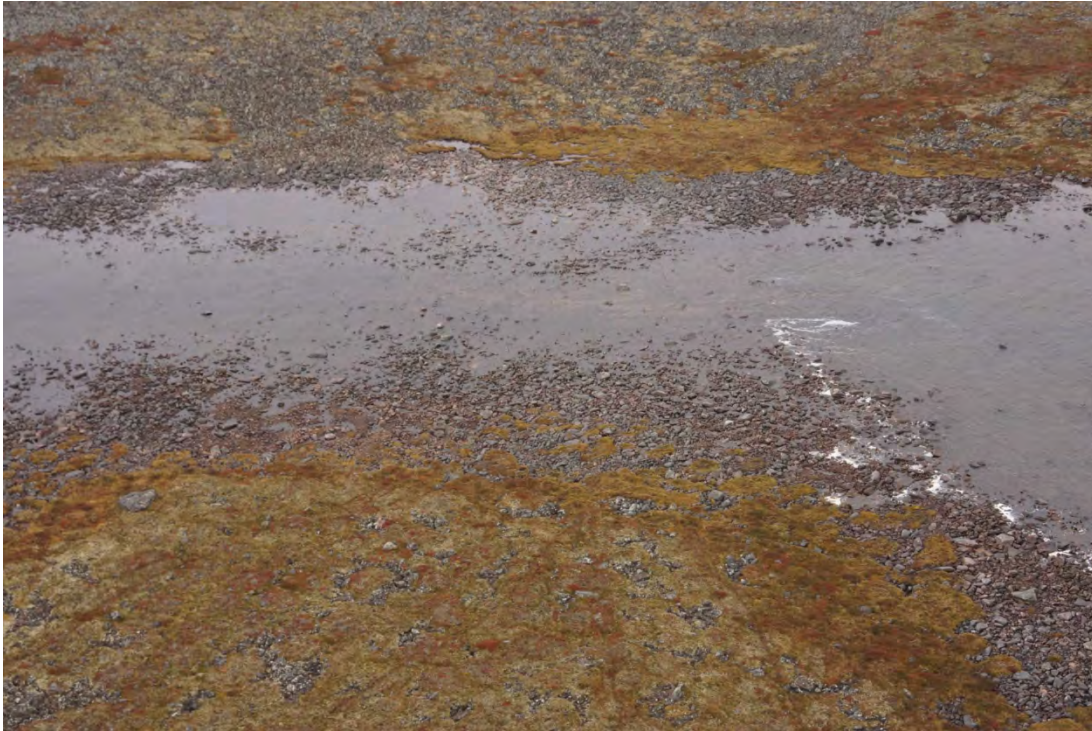
Kilometre 23.9. Oblique aerial photograph 23.9-1. August 29, 2014.

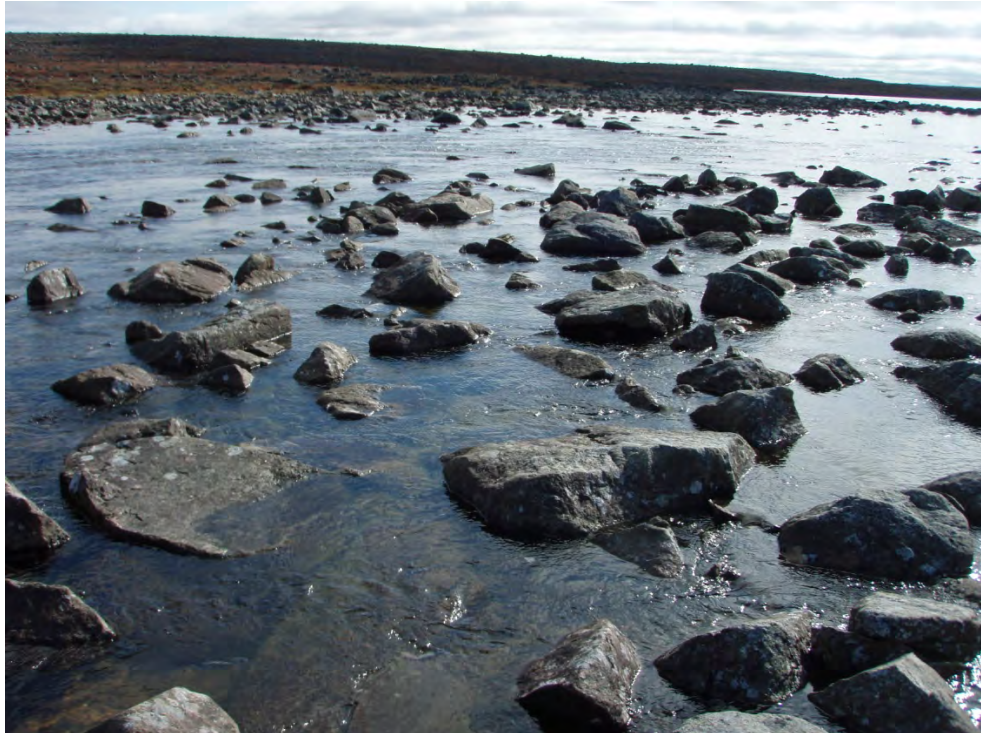
Kilometre 23.9. Photograph from the ground. Note flow through narrows. August 31, 2014.

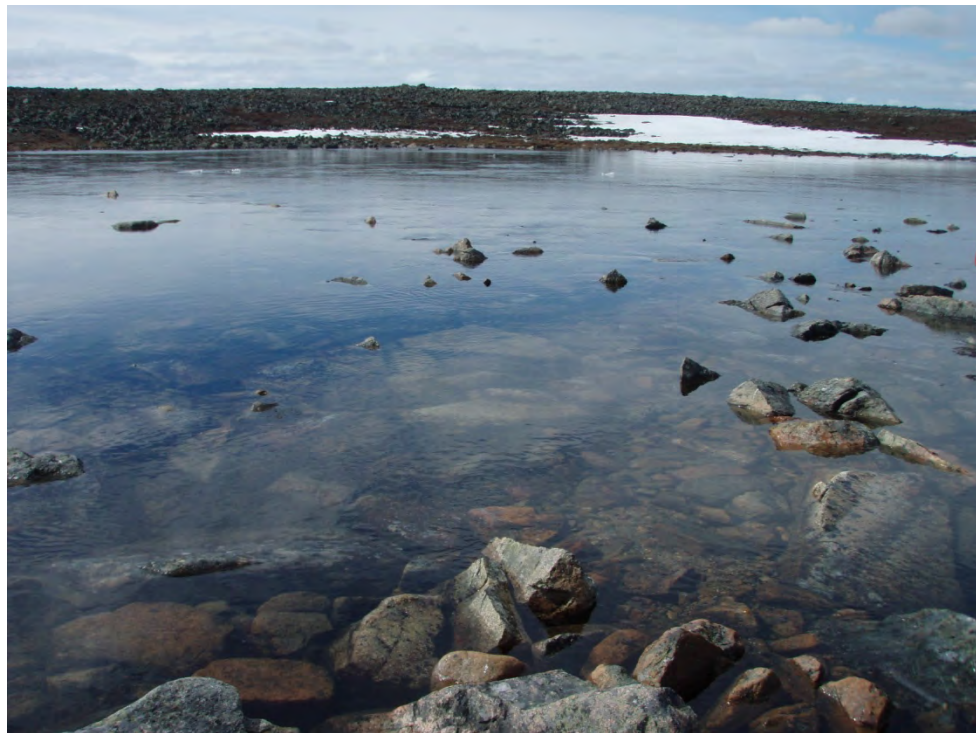
Kilometre 23.9. Photograph from the ground. June 23, 2015.

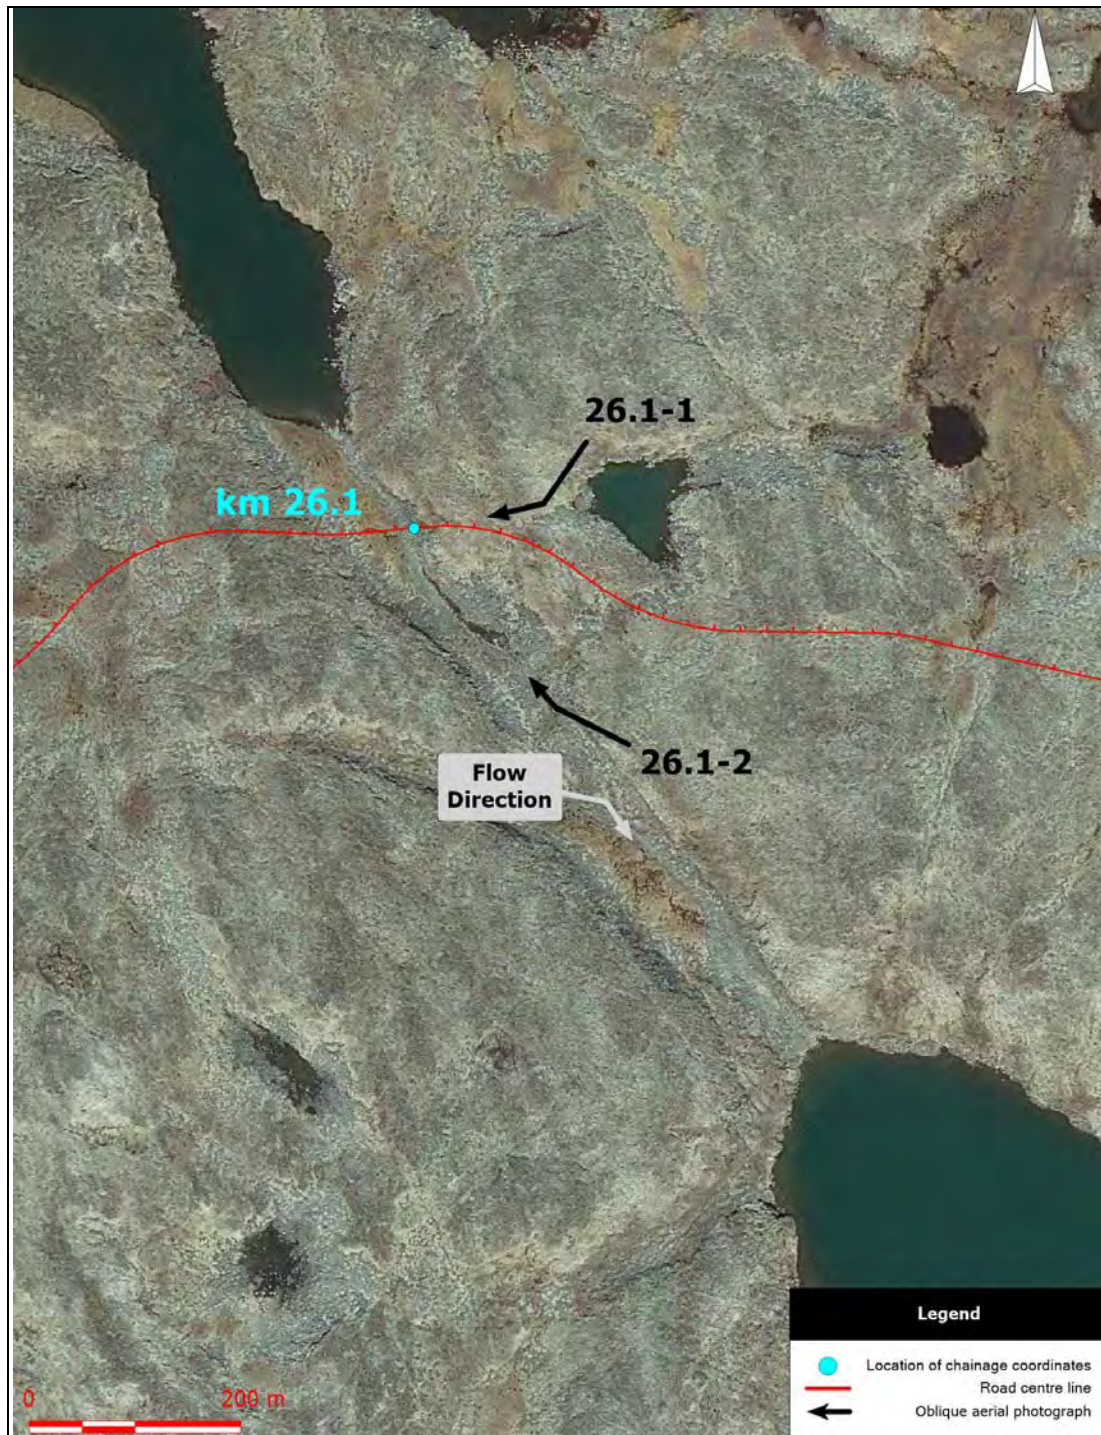
Kilometre 26.1. Aerial photograph showing the road centre line, the location of chainage coordinates provided in Table 3-2, the flow direction, and the location of oblique aerial photographs.

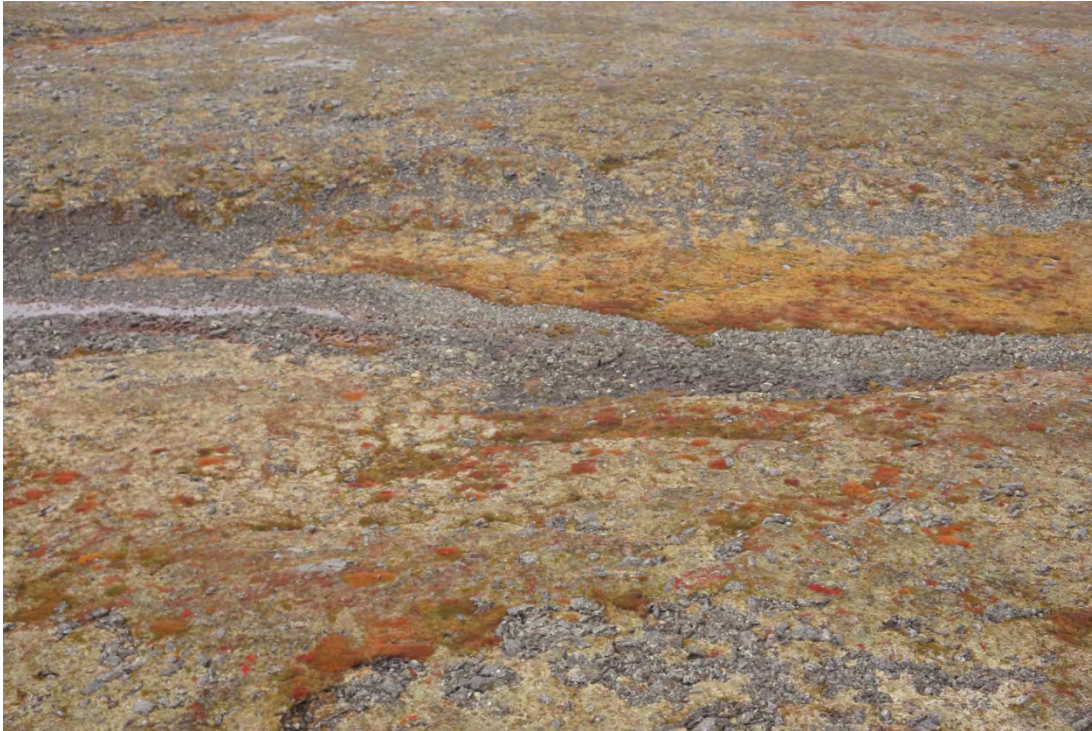
Kilometre 26.1. Oblique aerial photograph 26.1-1. August 29, 2014. Crossing at centre.
