# APPENDIX 6-D

# **AMARUQ EXPLORATION ACCESS ROAD AQUATICS BASELINE REPORT 2015 AGNICO EAGLE MINES LTD. - MEADOWBANK DIVISION**

Submitted to:

November 25, 2015.

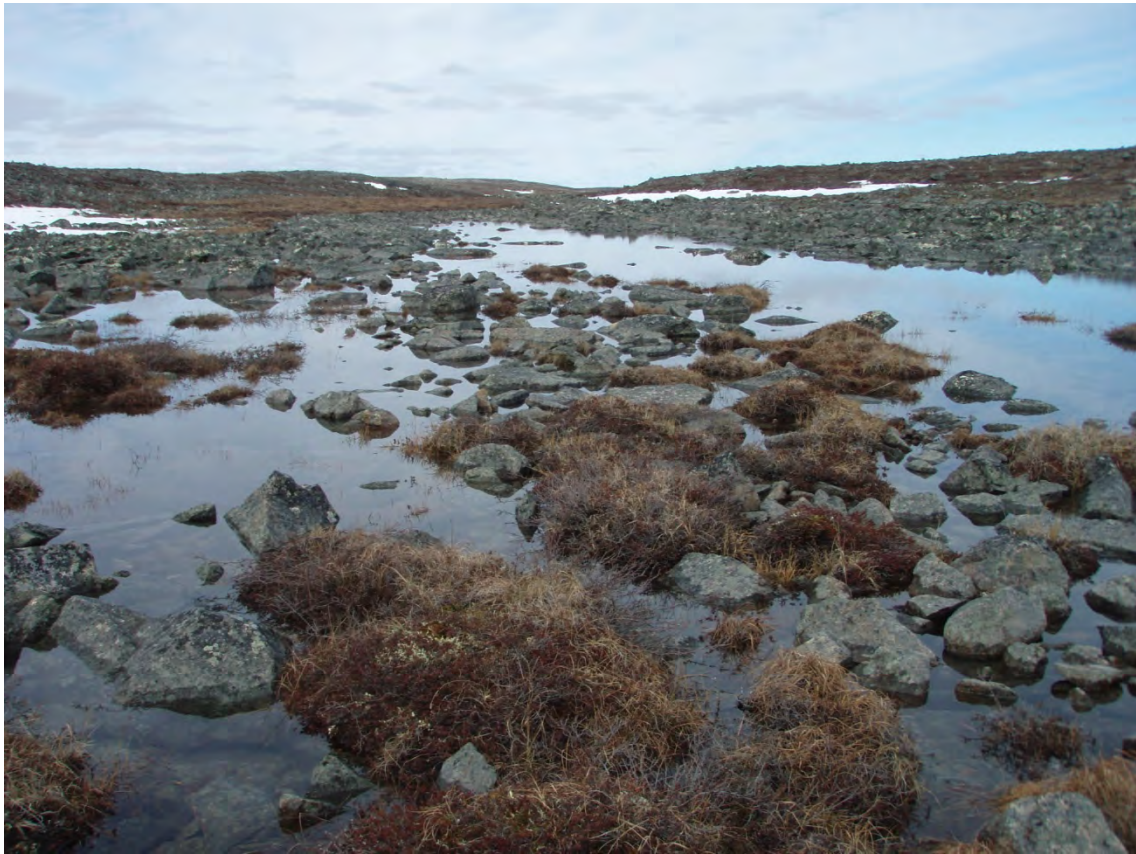
Kilometre 26.1. Photograph from the ground. Upstream view approximately 130 m downstream from road crossing location. June 23, 2015.

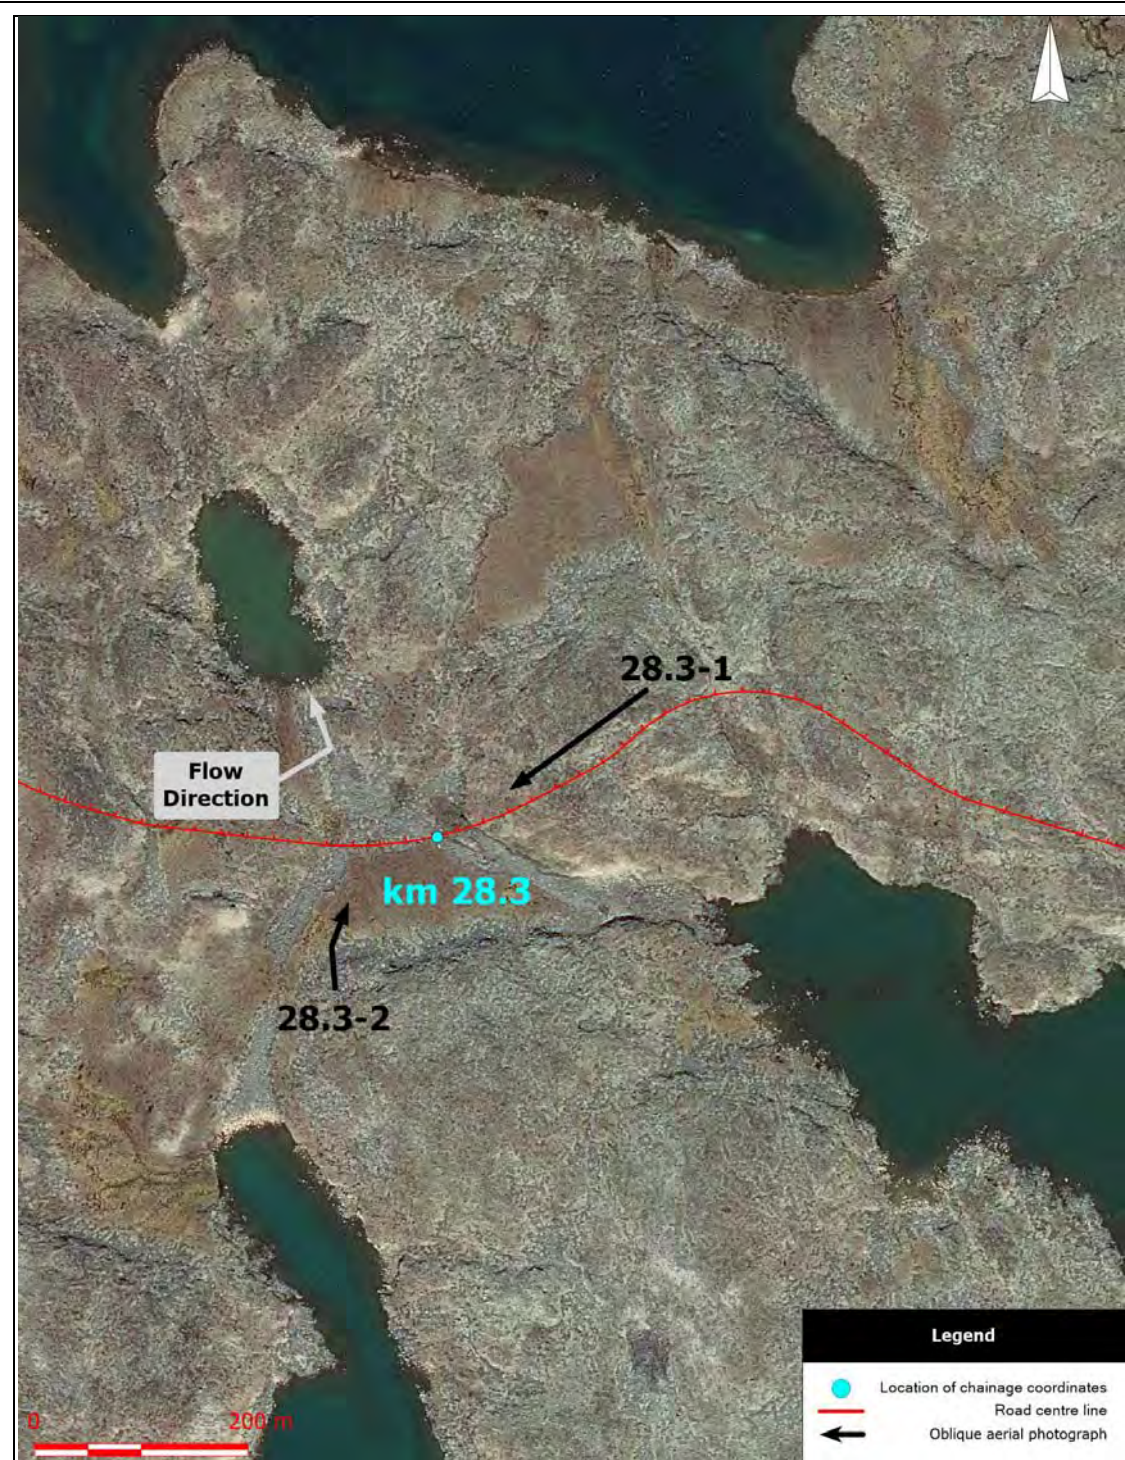
Kilometre 28.3. Aerial photograph showing the road centre line, the location of chainage coordinates provided in Table 3-2, the flow direction, and the location of oblique aerial photographs.

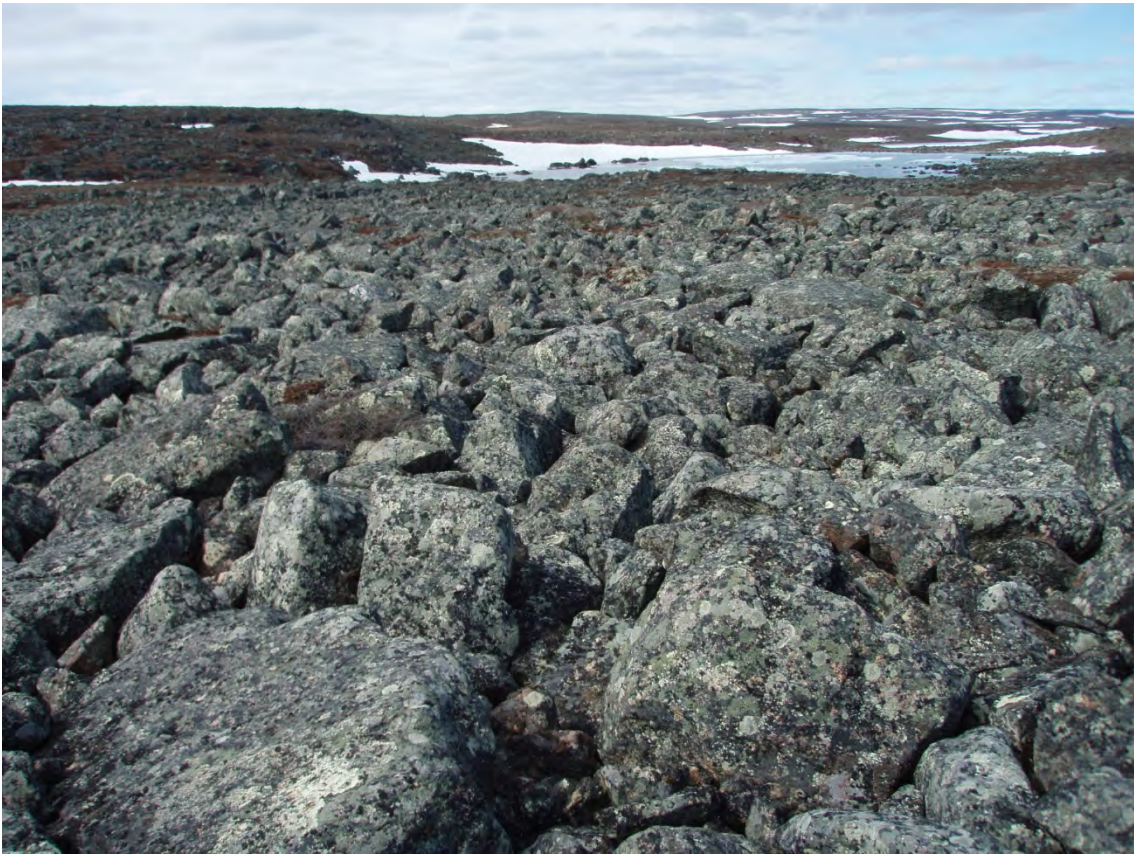
Kilometre 28.3. Photograph from the ground. Road crossing location. June 23, 2015.

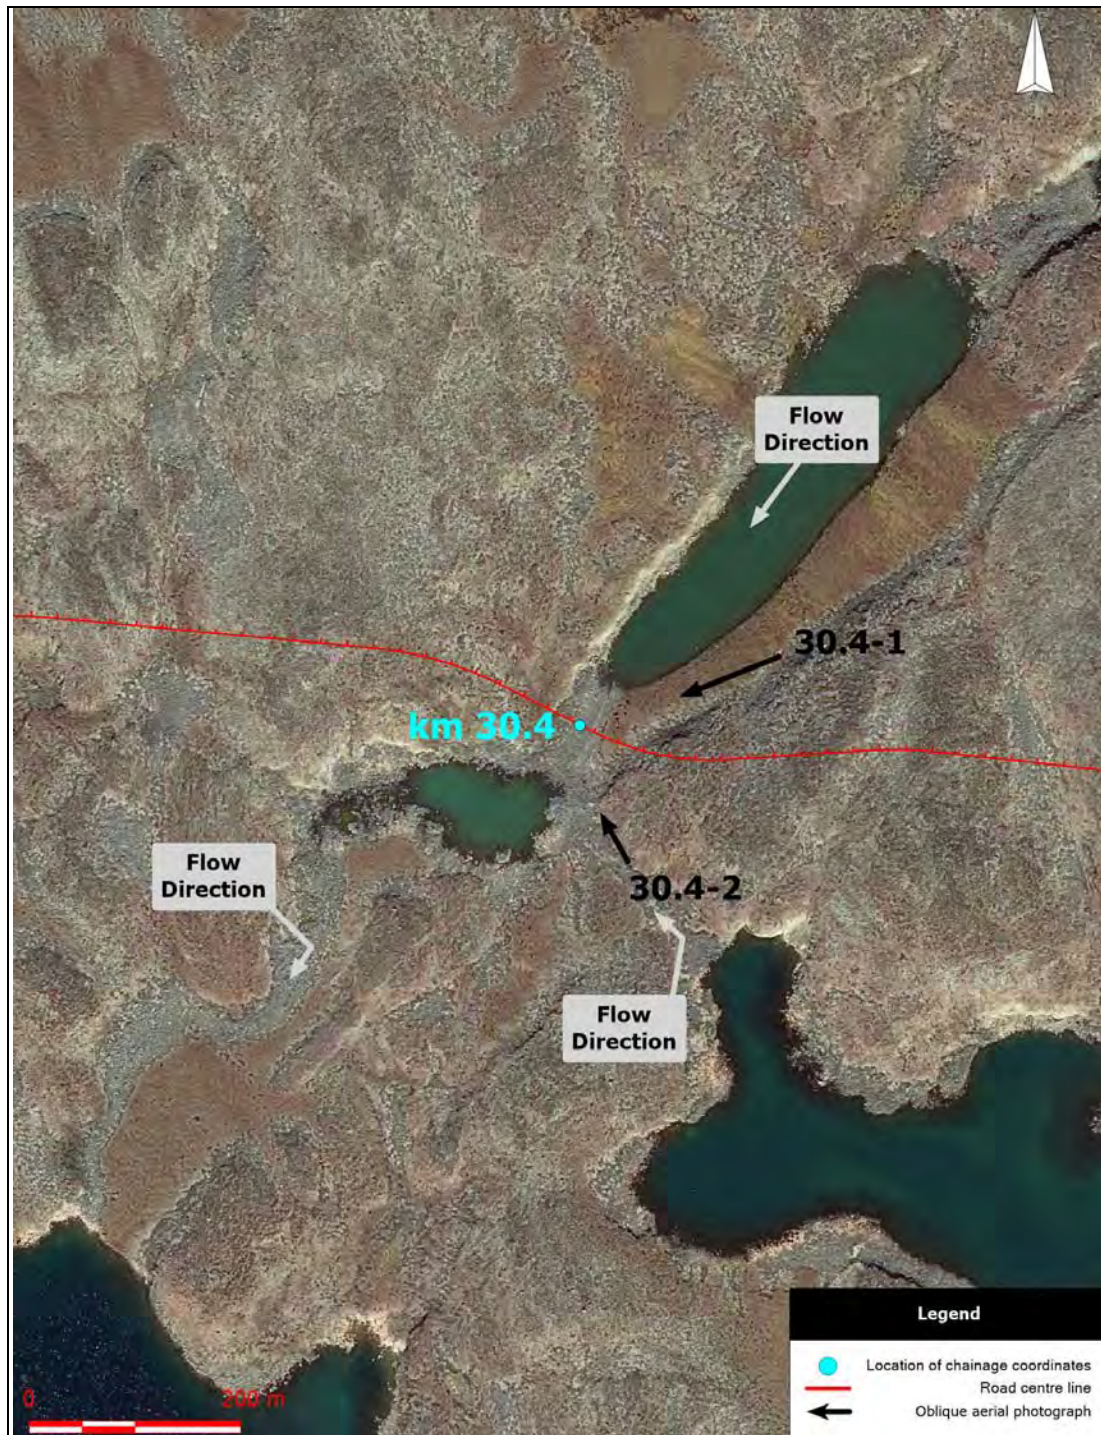
Kilometre 30.4. Aerial photograph showing the road centre line, the location of chainage coordinates provided in Table 3-2, the flow direction, and the location of oblique aerial photographs.

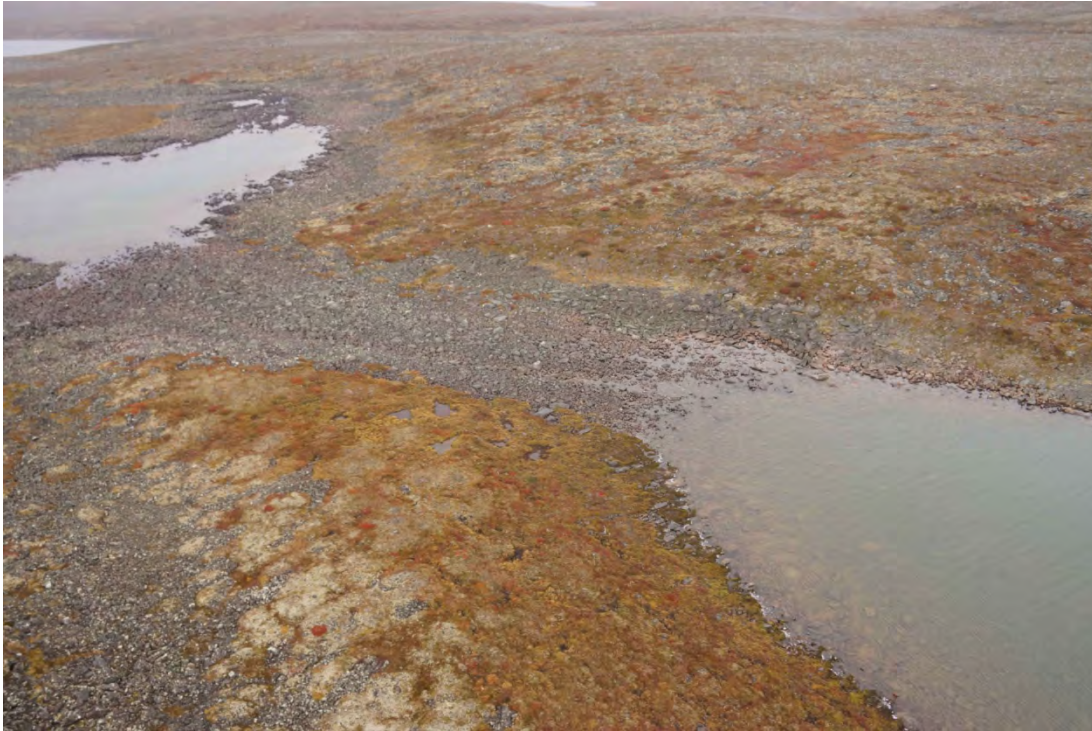
Kilometre 30.4. Oblique aerial photograph 30.4-1. August 29, 2014.

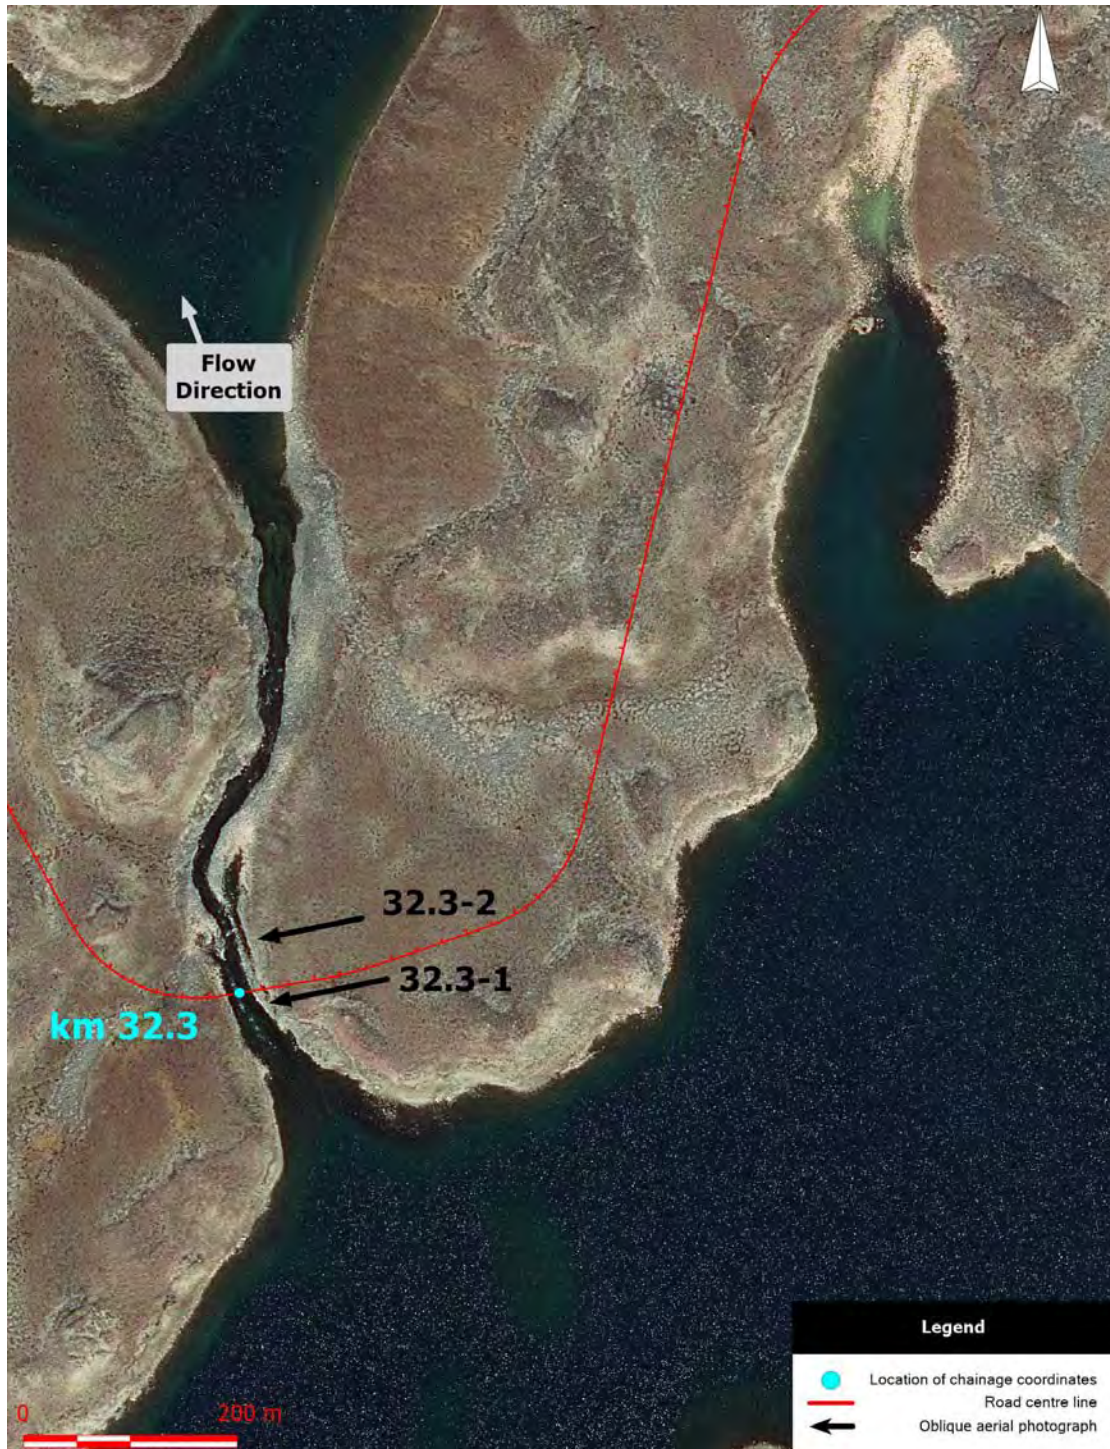
Kilometre 32.3. Aerial photograph showing the road centre line, the location of chainage coordinates provided in Table 3-2, the flow direction, and the location of oblique aerial photographs.

The total number of locations where fish habitat exists or may exist, based on the observed habitat conditions along the road alignment, is 28. The watercourses at three of the locations (km 16.0, km 23.9 and km 32.3) were characterized as rivers. These provide habitat for small-bodied fish, and potentially also for large-bodied fish, throughout the open-water period. Due to their depth and flow, these watercourses are also potential migration routes for large-bodied fish throughout the open water period. Clear-span bridges are recommended for these locations.

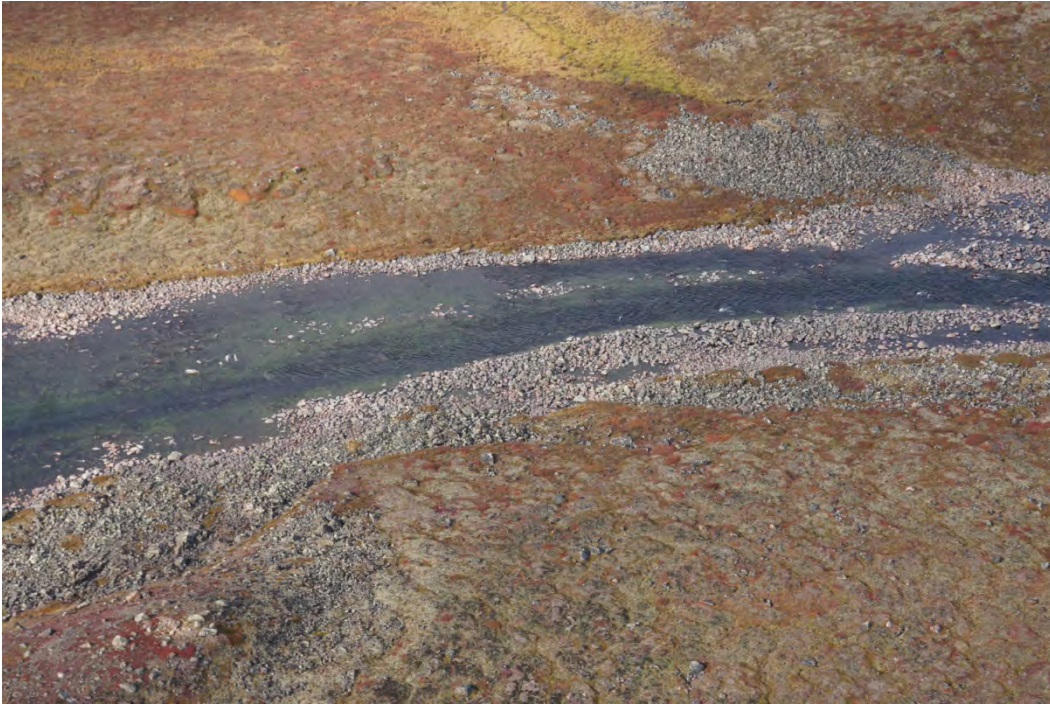
Kilometre 32.3. Oblique aerial photograph 32.3-1. August 30, 2014. Crossing a photograph centre.

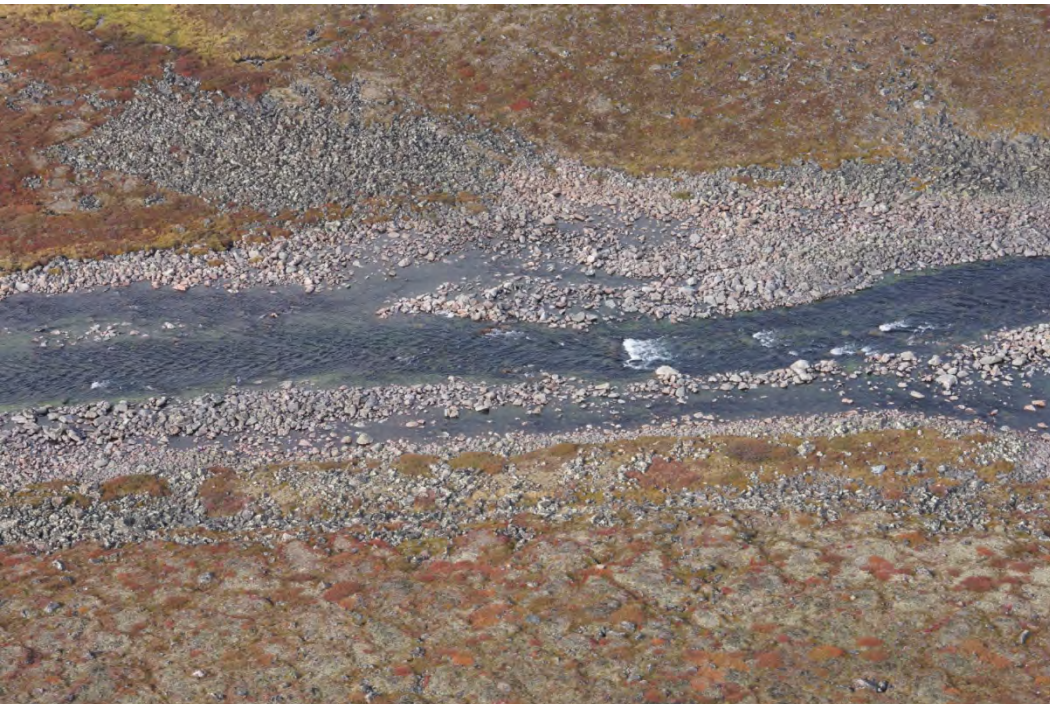
Kilometre 32.3. Oblique aerial photograph 32.3-2. June 29, 2015.

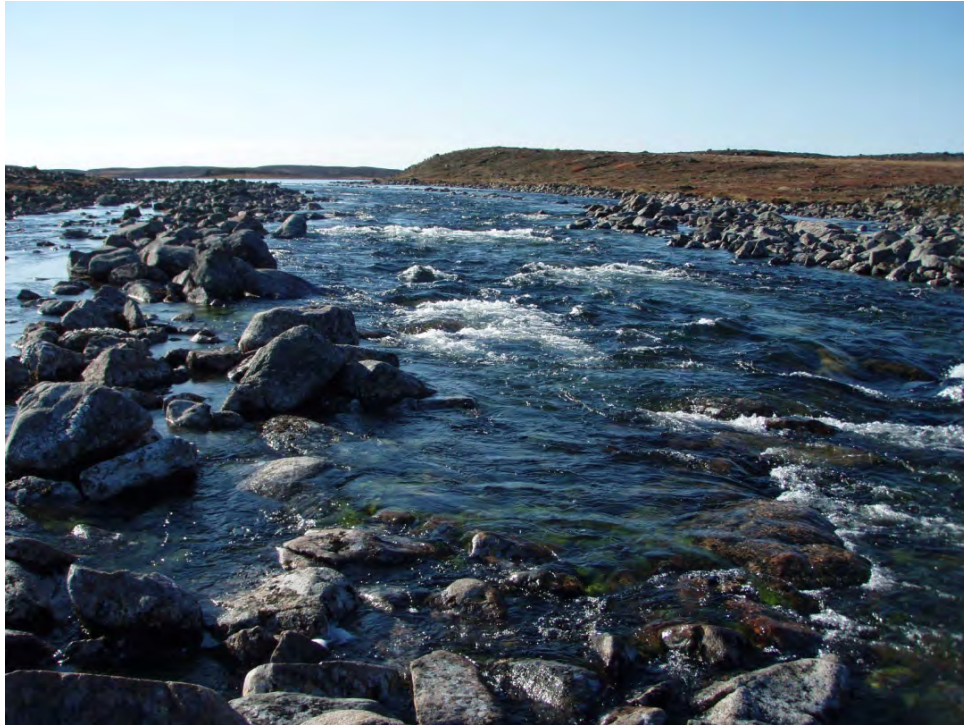
Kilometre 32.3. Photograph from the ground. Upstream view through approximate crossing located approximately 80 m from camera. September 1, 2014.

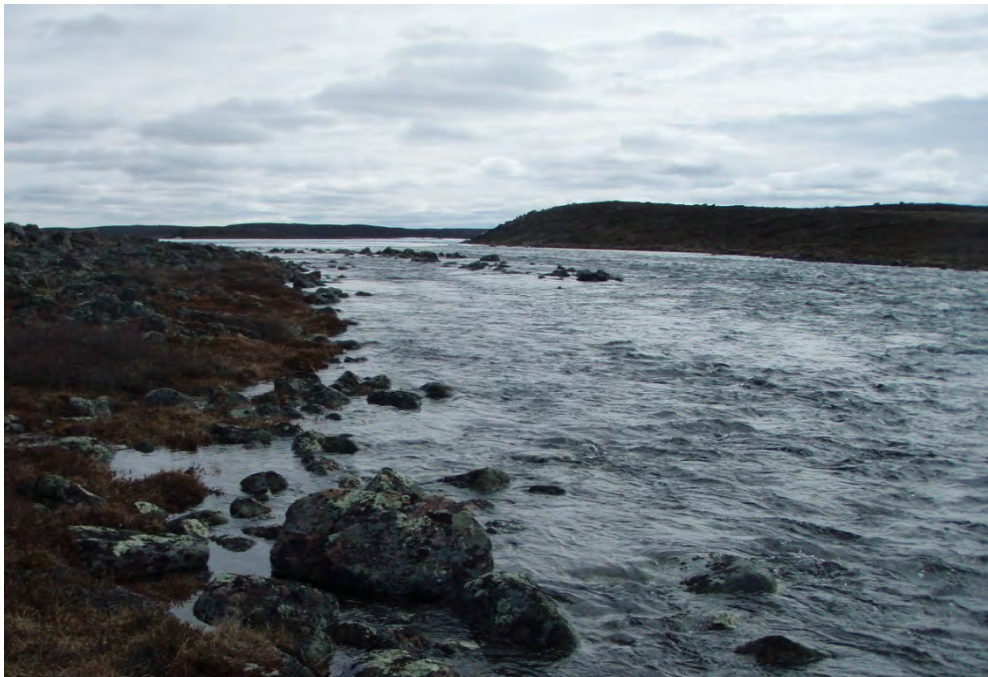
Kilometre 32.3. Photograph from the ground. Upstream view through approximate crossing located approximately 60 m from camera. June 23, 2015.

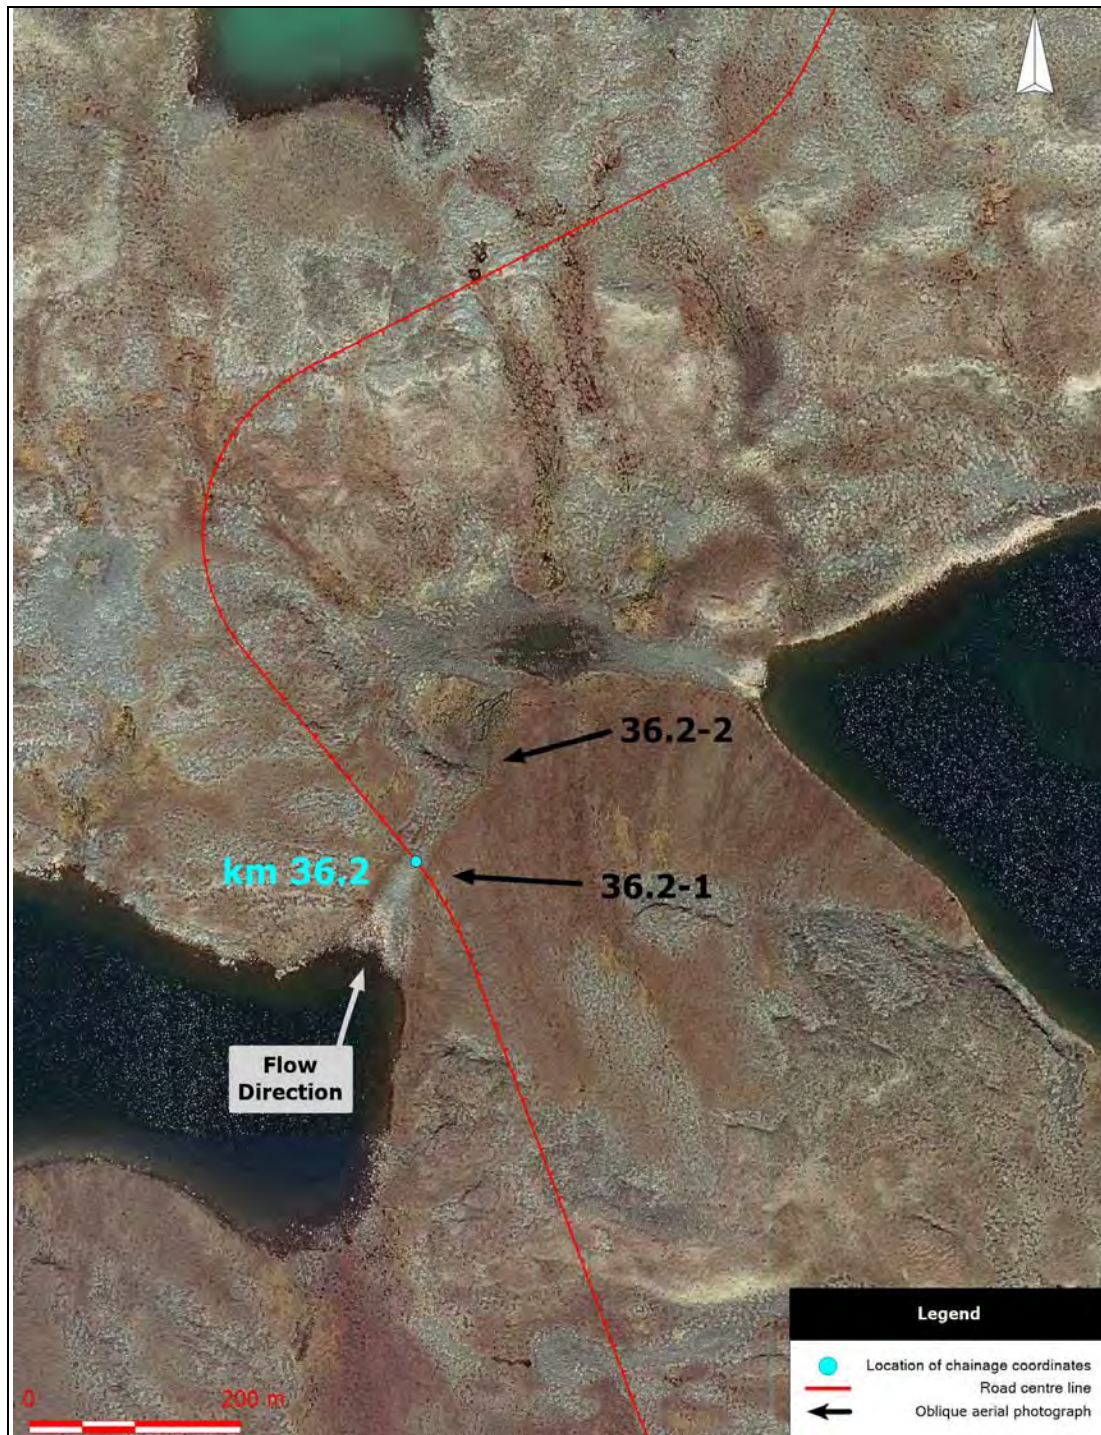
Kilometre 36.2. Aerial photograph showing the road centre line, the location of chainage coordinates provided in Table 3-2, the flow direction, and the location of oblique aerial photographs.

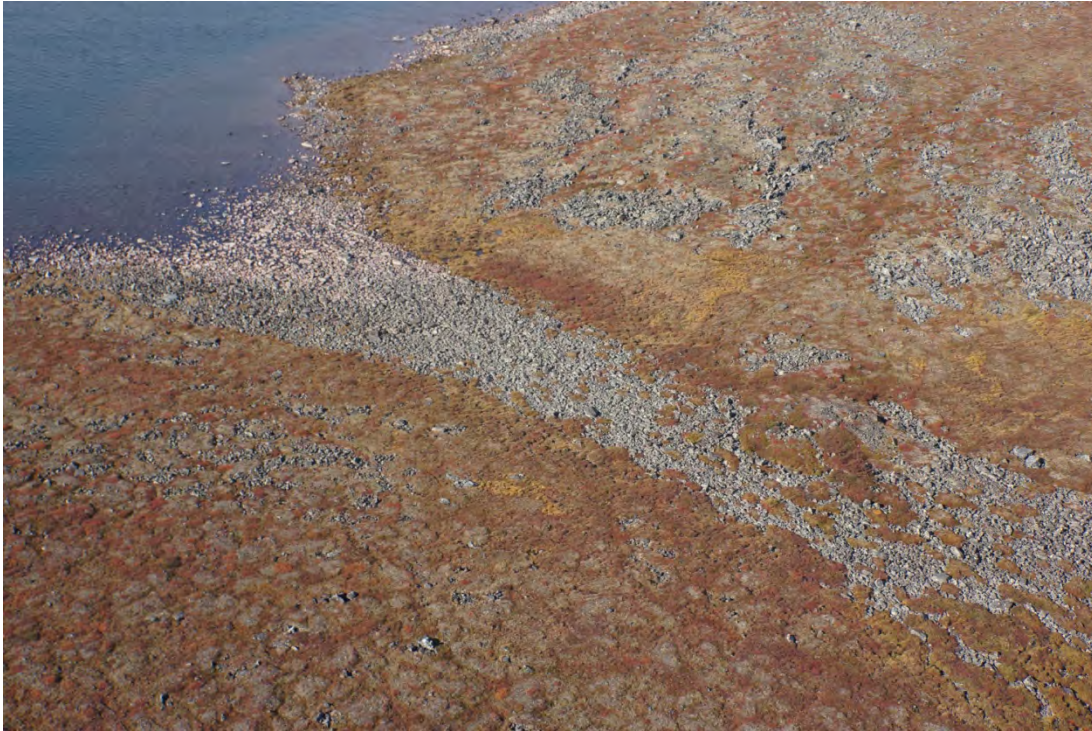
Kilometre 36.2. Oblique aerial photograph 36.2-1. August 30, 2014.

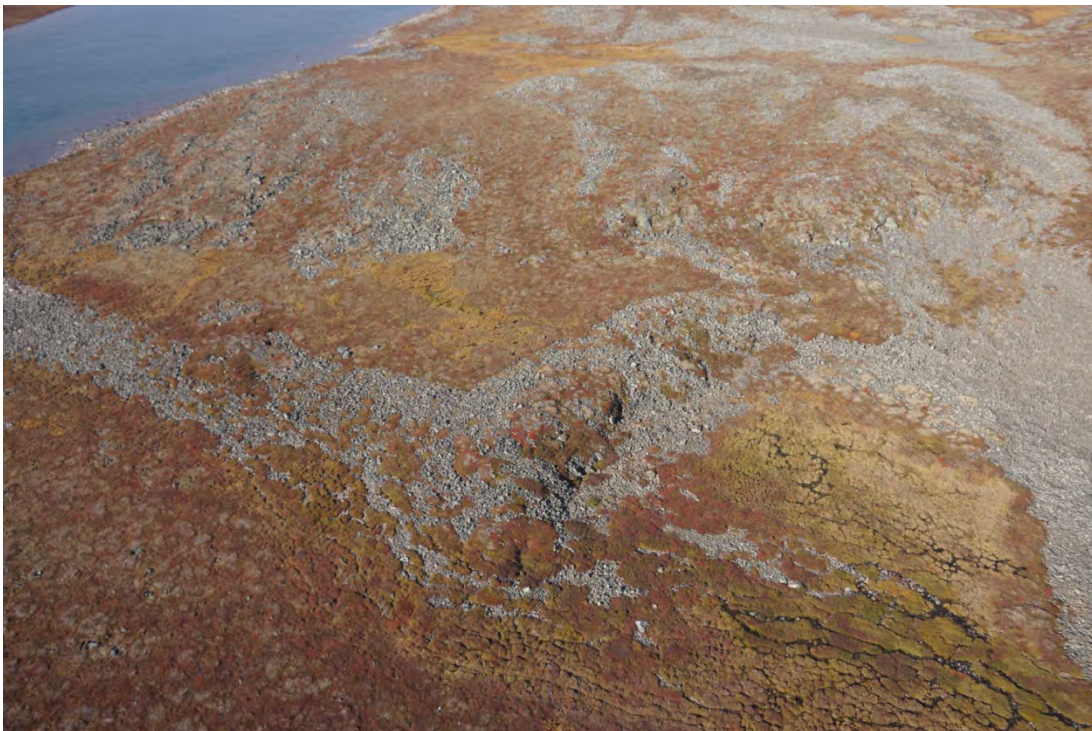
Kilometre 36.2. Oblique aerial photograph 36.2-2. August 30, 2014.

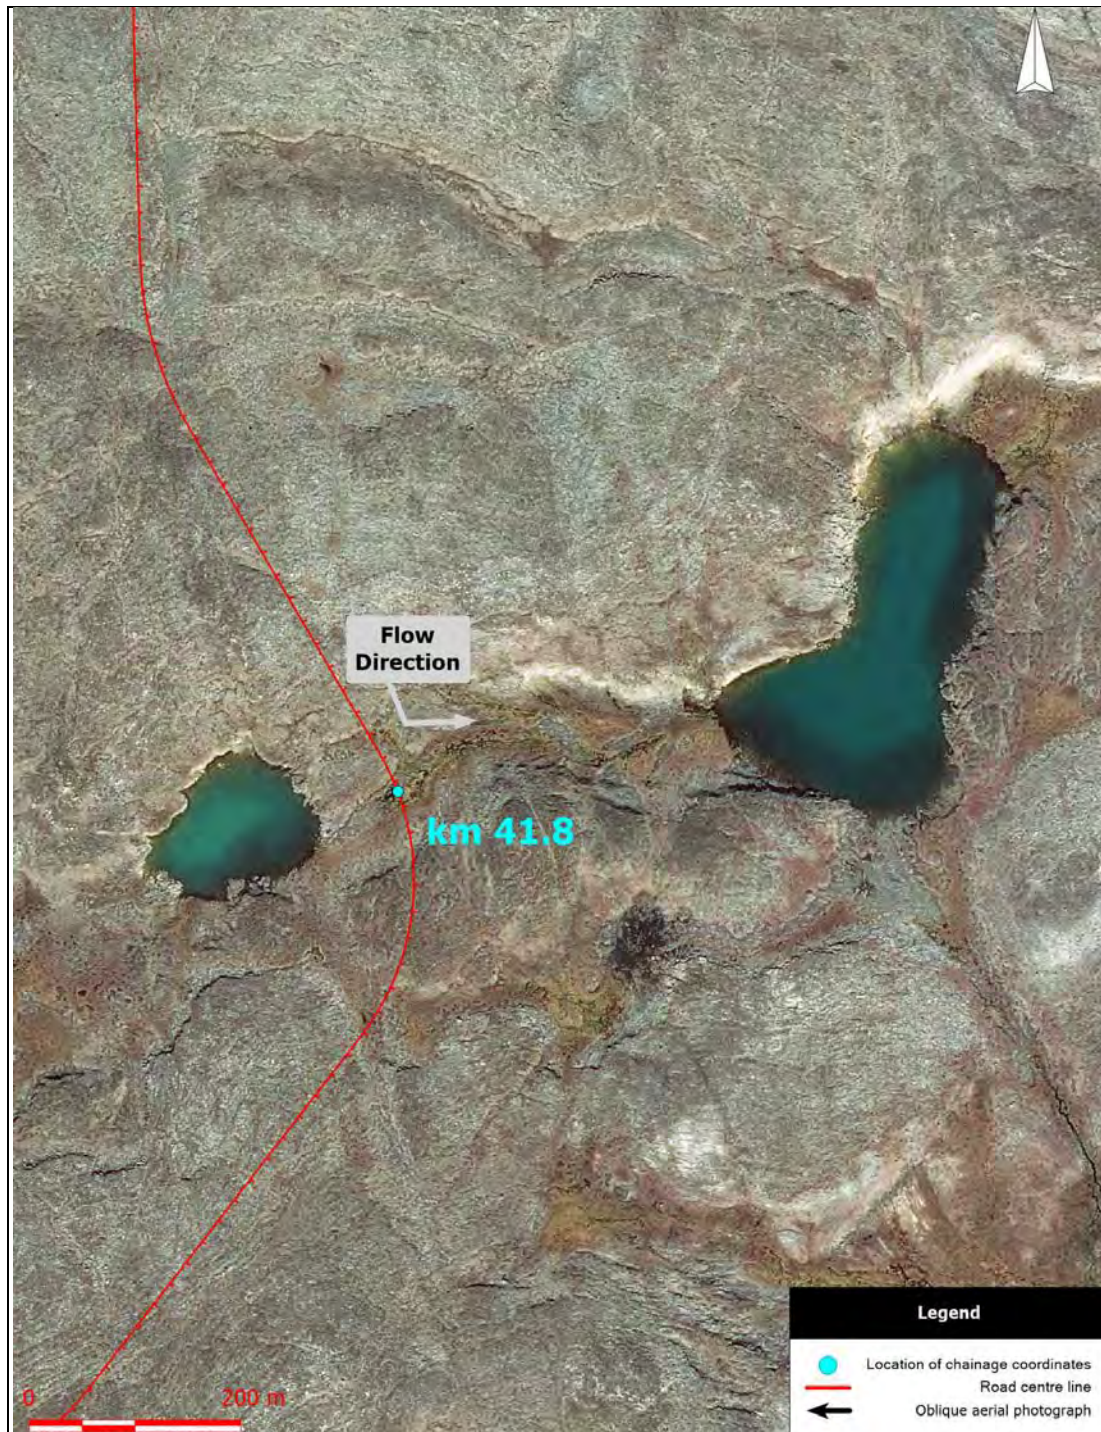
Kilometre 41.8. Aerial photograph showing the road centre line, the location of chainage coordinates provided in Table 3-2, and the flow direction.

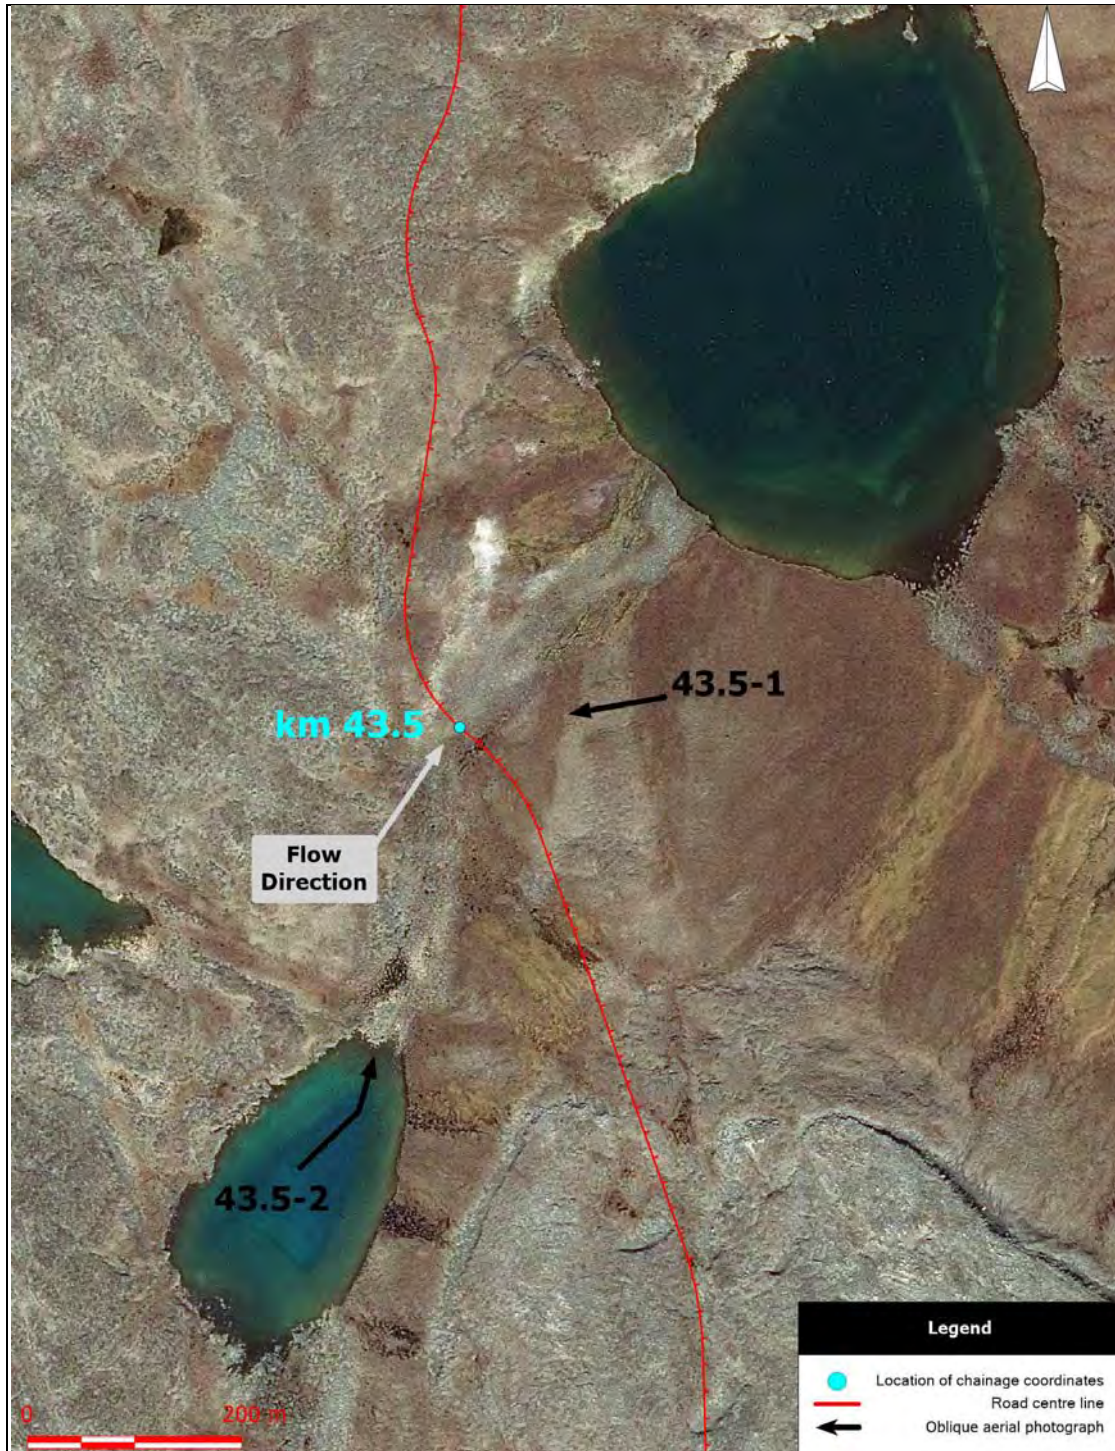
Kilometre 43.5. Aerial photograph showing the road centre line, the location of chainage coordinates provided in Table 3-2, the flow direction, and the location of oblique aerial photographs.

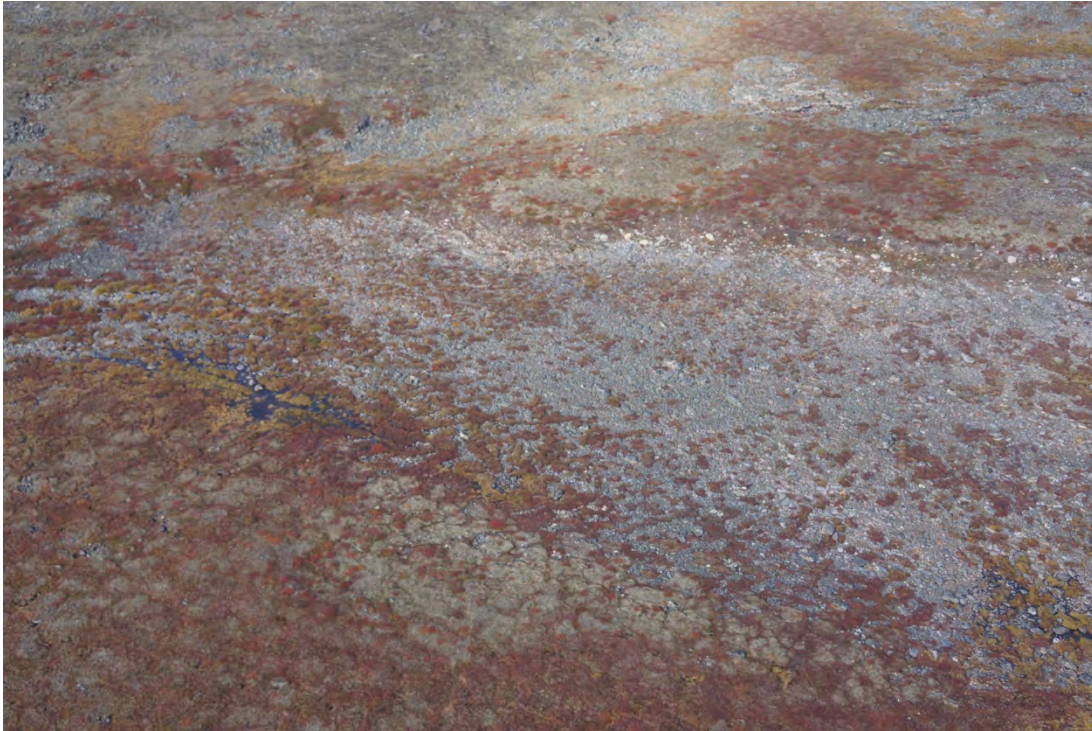
Kilometre 43.5. Oblique aerial photograph 43.5-1. August 30, 2014.

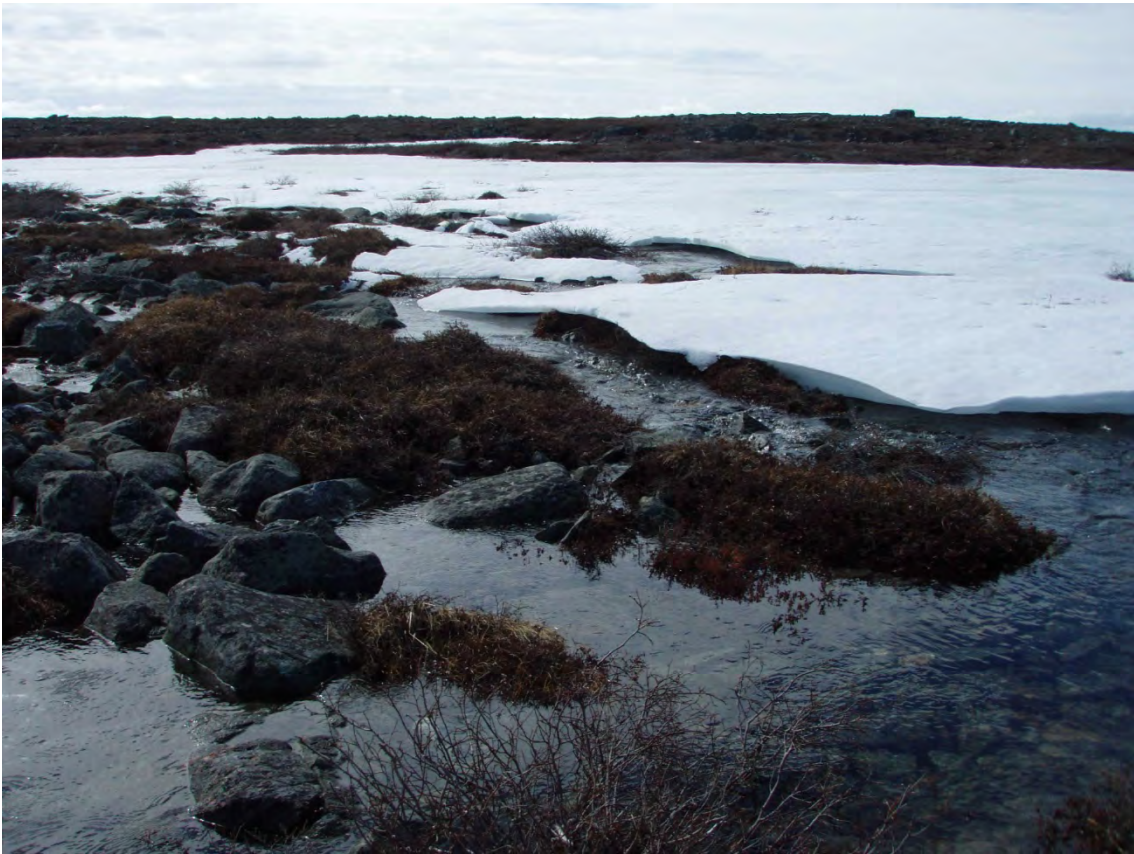
Kilometre 43.5. Photograph from the ground. Road crossing location. June 23, 2015.

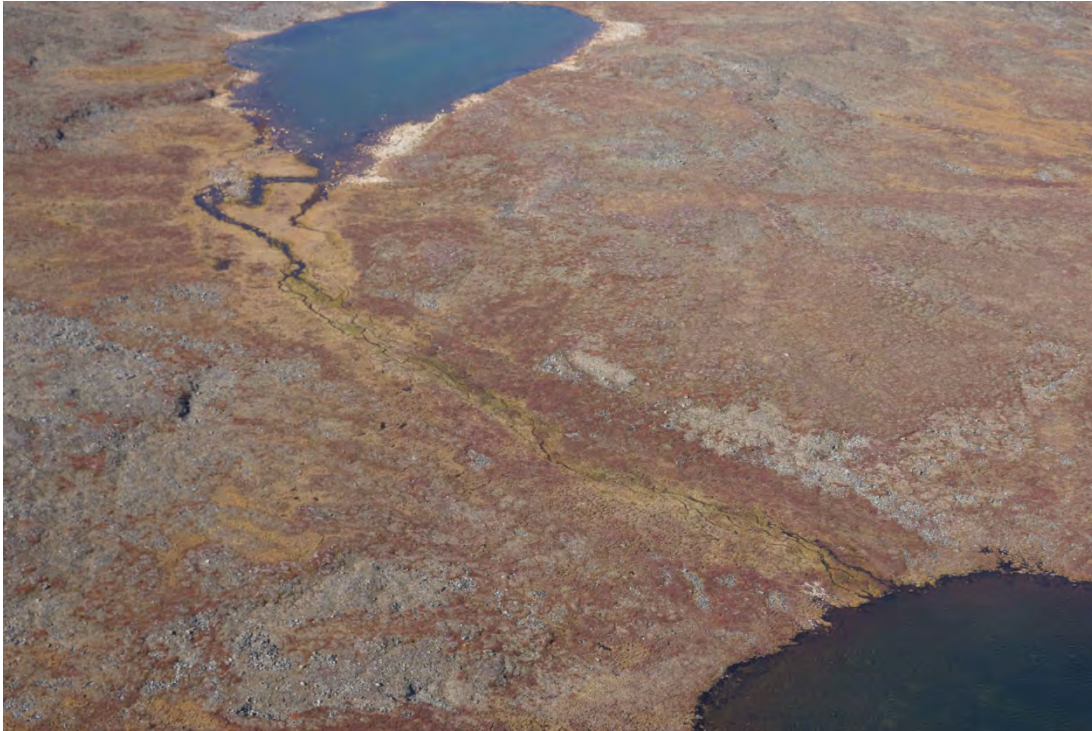
Kilometre 44.4. Oblique aerial photograph 44.4-1. September 1, 2014.

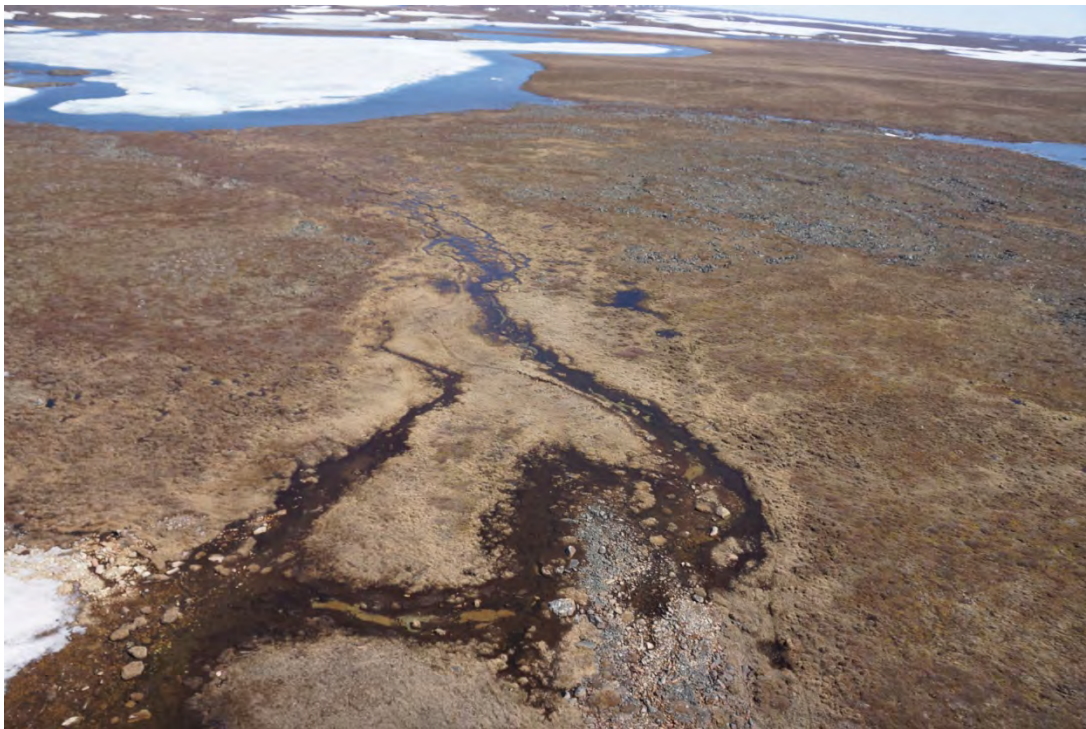
Kilometre 44.4. Oblique aerial photograph 44.4-2. June 29, 2015.

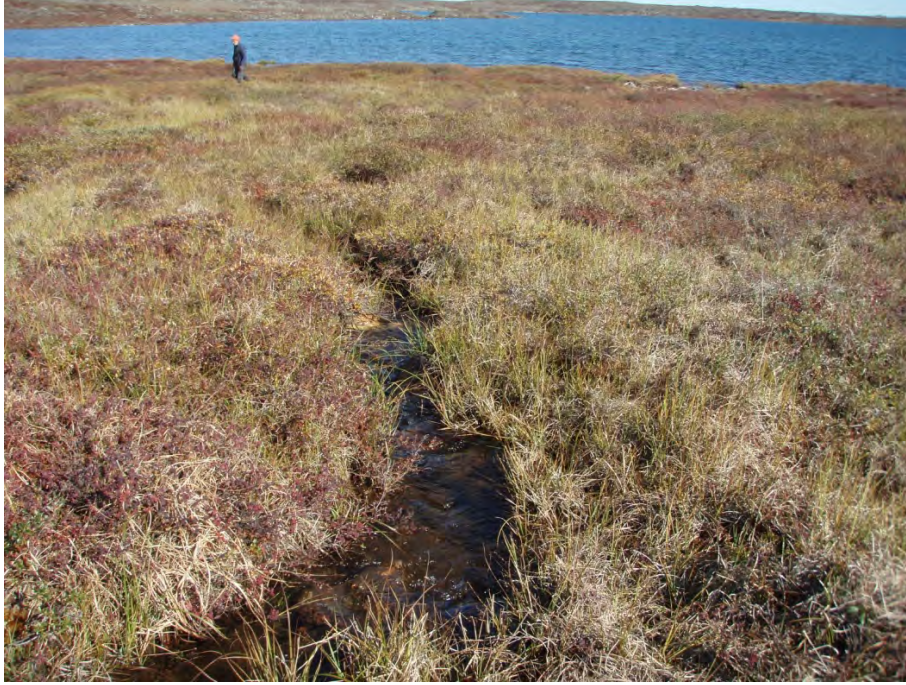
Kilometre 44.4. Photograph from the ground. Downstream view of one channel from 270 m downstream from the approximate crossing location. Rocky section of watercourse. September 1, 2014.

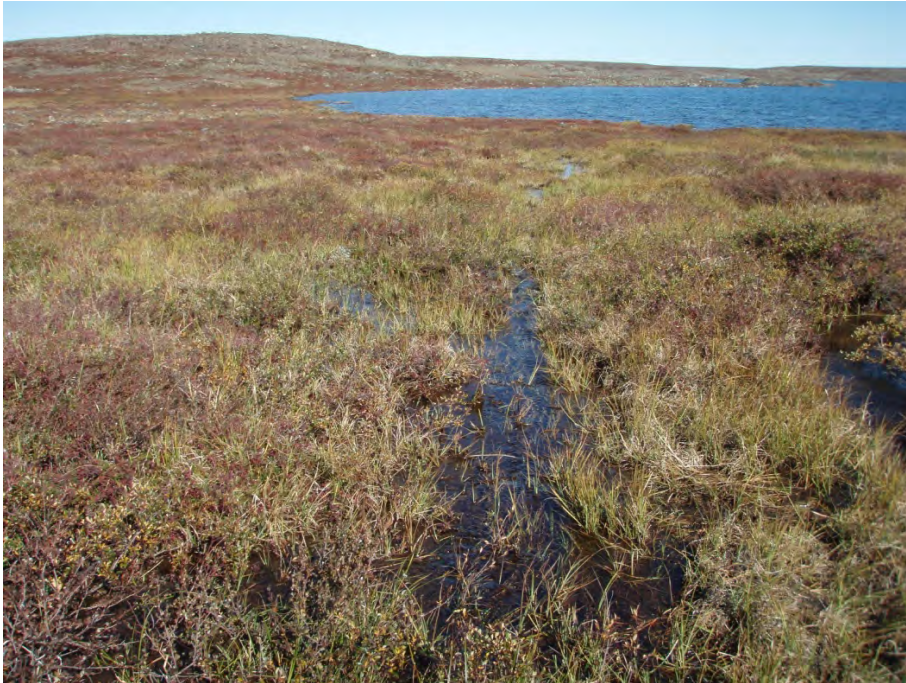
Kilometre 44.4. Photograph from the ground. Downstream view of one channel from 270 m downstream from the approximate crossing location. Diffuse flow through vegetation. September 1, 2014.

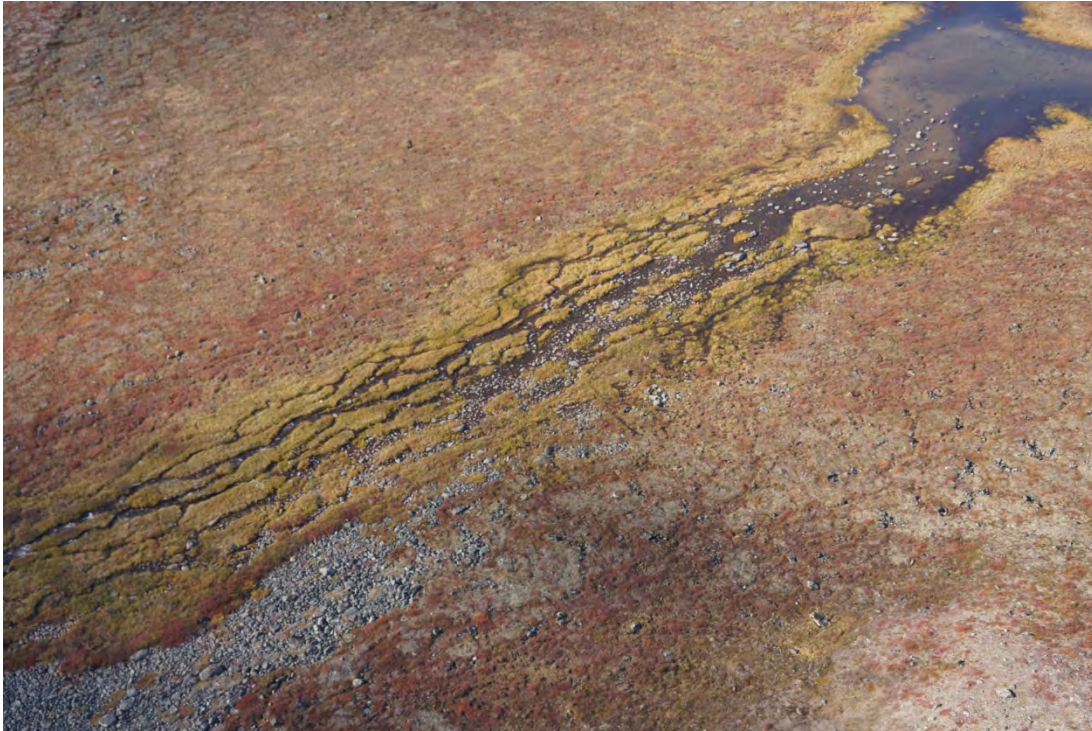
Kilometre 44.8. Oblique aerial photograph 44.8-1. August 30, 2014.

A juvenile Arctic Grayling was captured in the watercourse at km 44.8 in both 2014 and 2015 and there is gravel substrate suitable for Arctic Grayling spawning at numerous places within this watercourse, although no Arctic Grayling or disturbed gravel that might be indicative of Arctic Grayling spawning were observed here in the spring of 2015. This watercourse also provides a connection to a series of upstream lakes and therefore could be an important migration corridor. Due to the potential habitat significance, a clear-span bridge is also recommended at this location.
