# APPENDIX 6-D

# **AMARUQ EXPLORATION ACCESS ROAD AQUATICS BASELINE REPORT 2015 AGNICO EAGLE MINES LTD. - MEADOWBANK DIVISION**

Submitted to:

November 25, 2015.

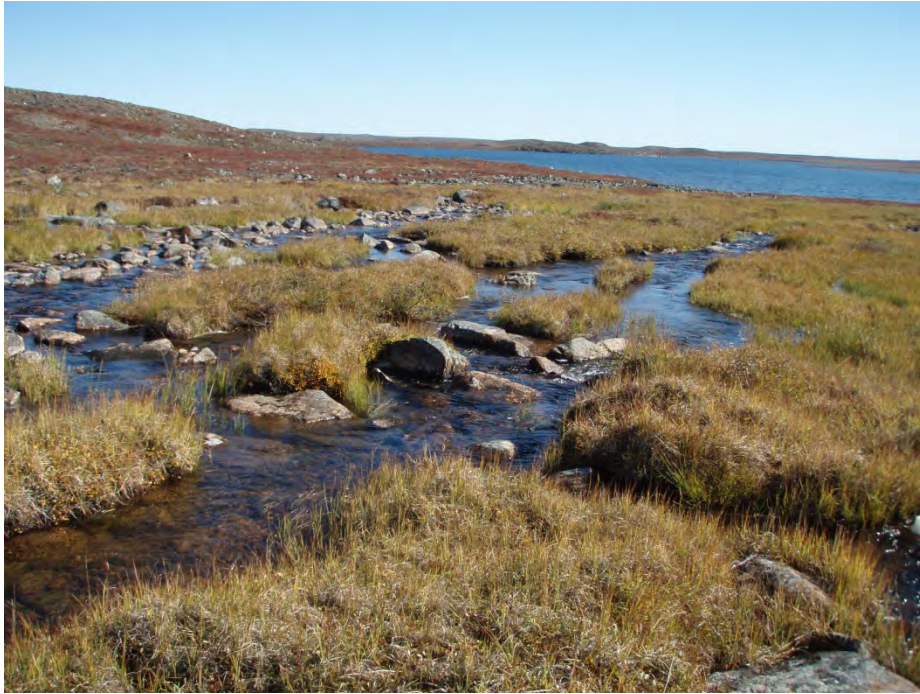
Kilometre 44.8. Photograph from the ground. Downstream view from downstream of the road crossing location. September 1, 2014.

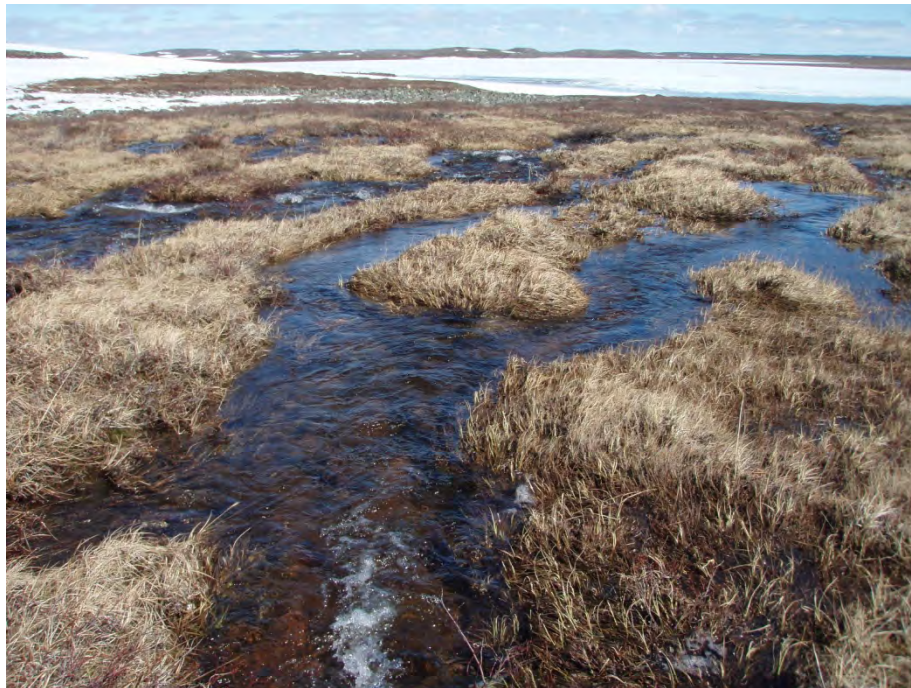
Kilometre 44.8. Photograph from the ground. Downstream view from downstream of the road crossing location. June 23, 2015.

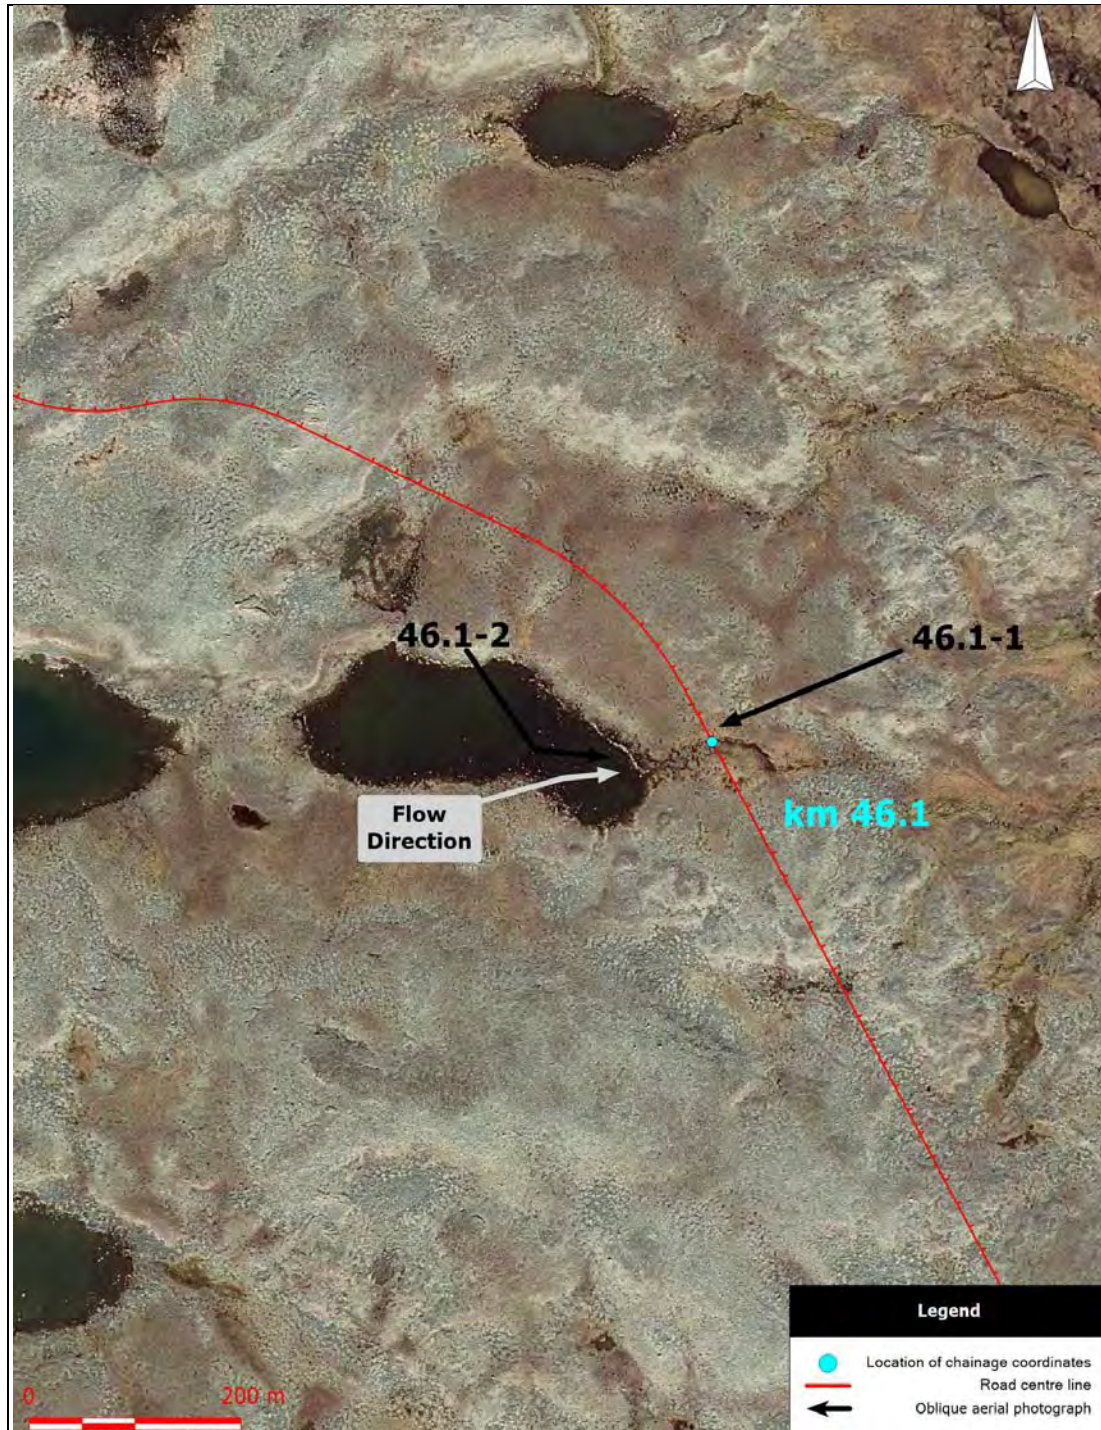
Kilometre 46.1. Aerial photograph showing the road centre line, the location of chainage coordinates provided in Table 3-2, the flow direction, and the location of oblique aerial photographs.

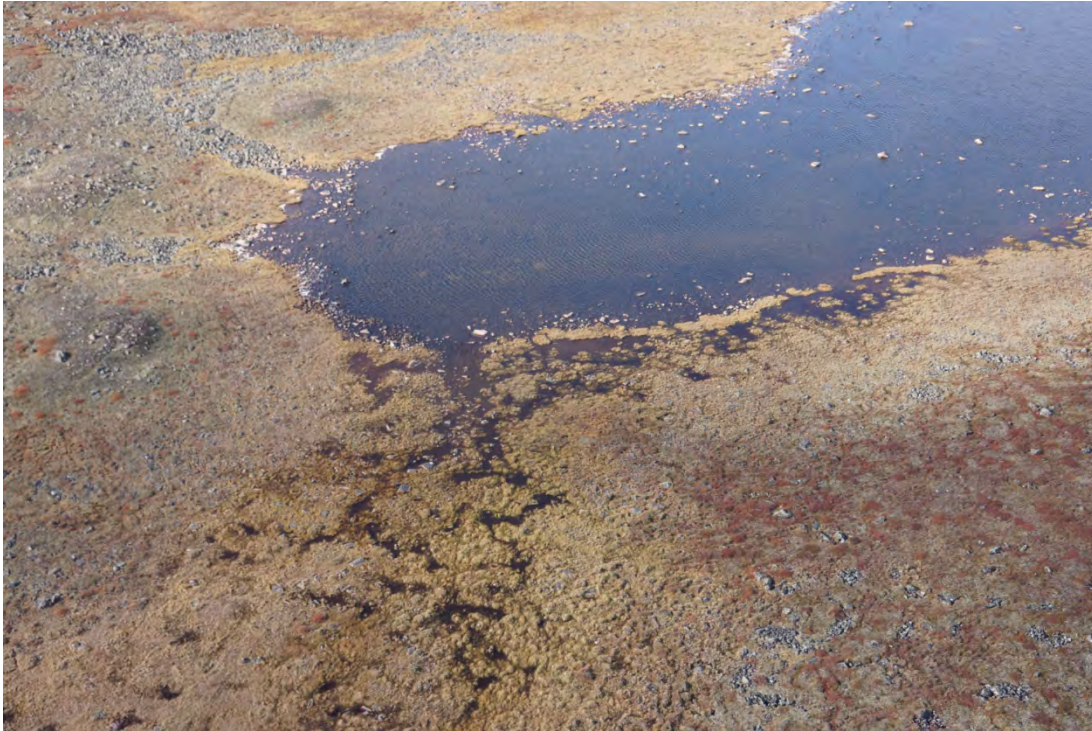
Kilometre 46.1. Oblique aerial photograph 46.1-1. August 30, 2014.

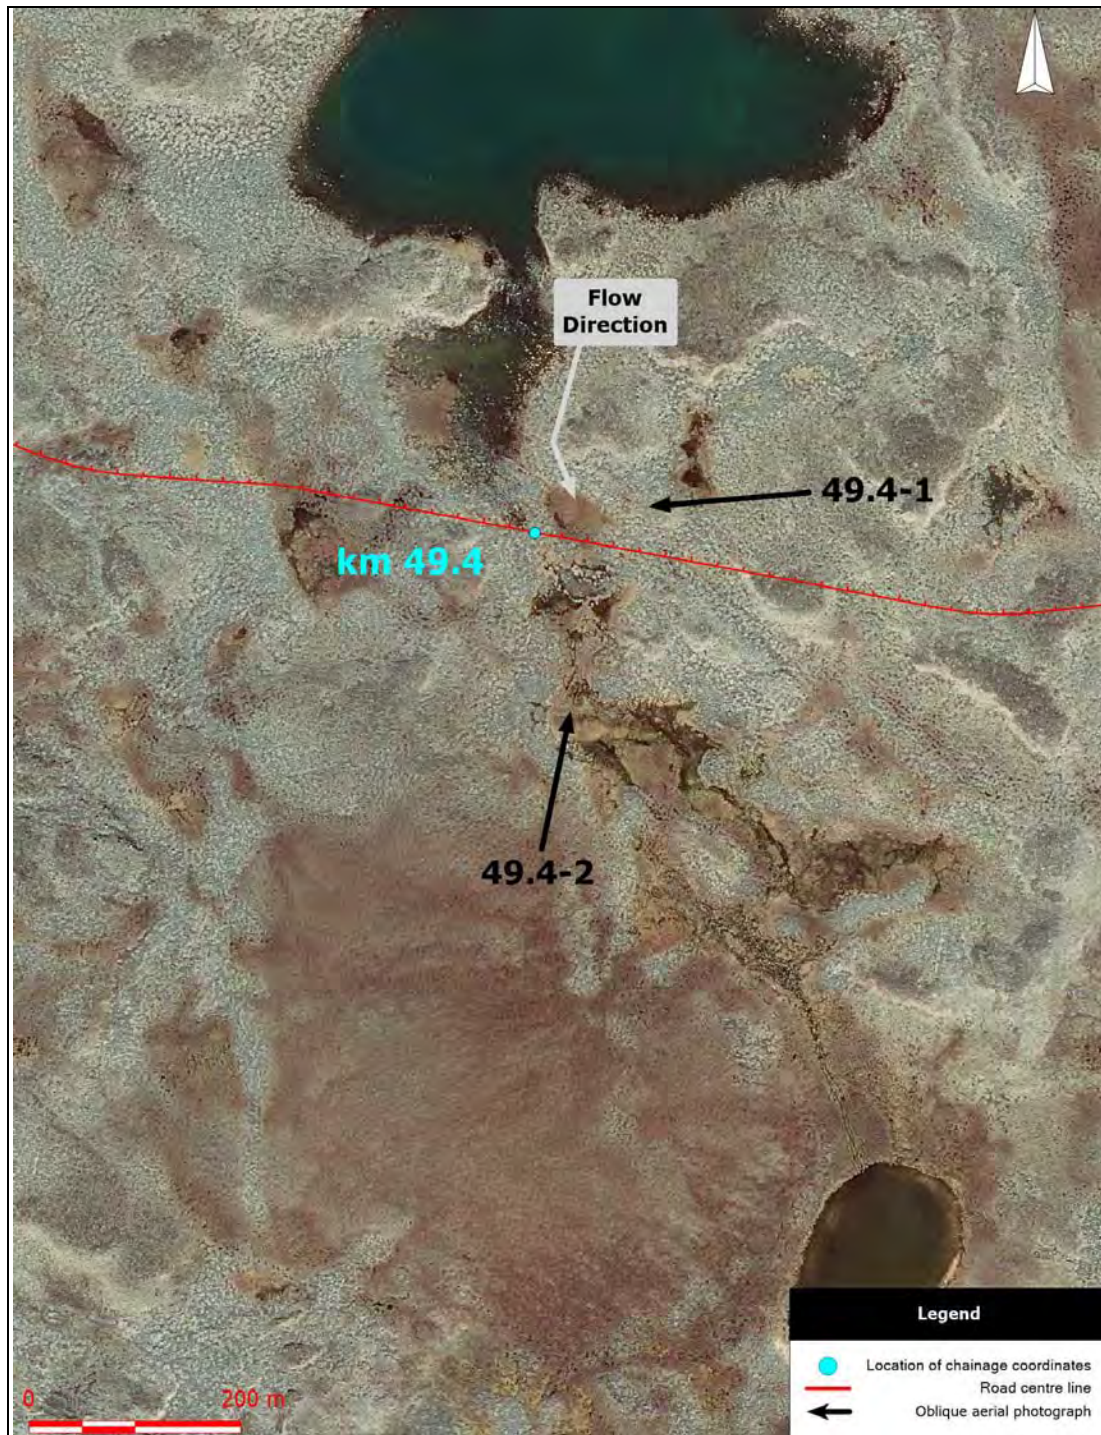
Kilometre 49.4. Aerial photograph showing the road centre line, the location of chainage coordinates provided in Table 3-2, the flow direction, and the location of oblique aerial photographs.

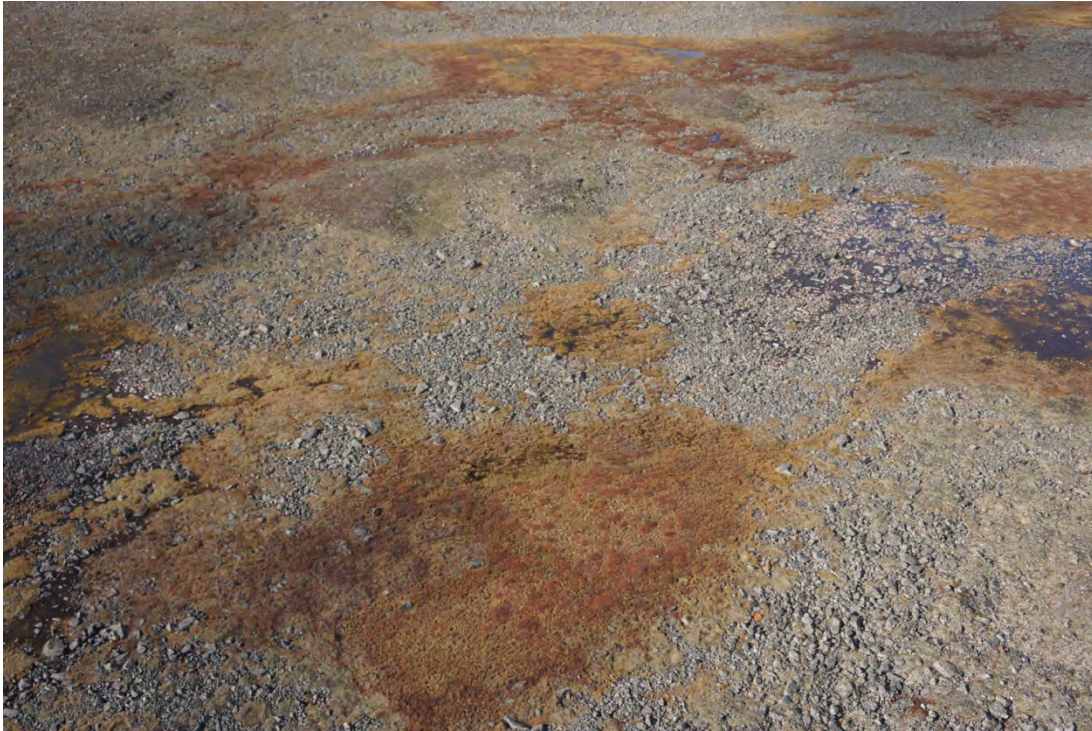
Kilometre 49.4. Oblique aerial photograph 49.4-1. August 30, 2014.

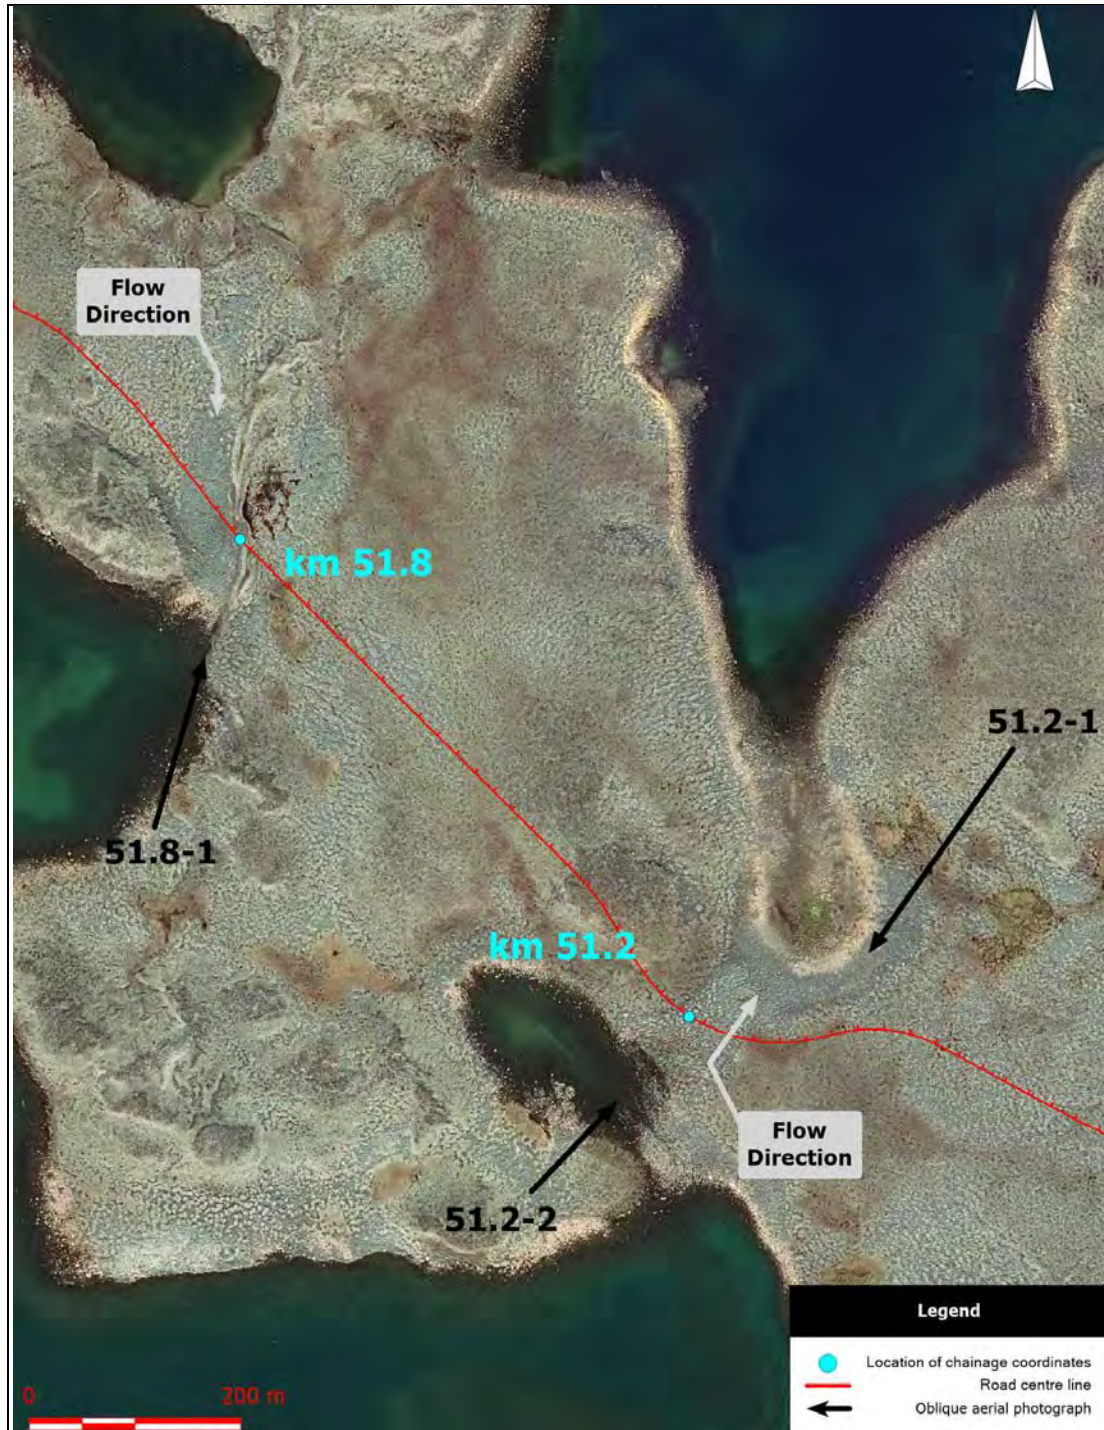
Kilometres 51.2 and 51.8. Aerial photograph showing the road centre line, the location of chainage coordinates provided in Table 3-2, the flow direction, and the location of oblique aerial photographs.

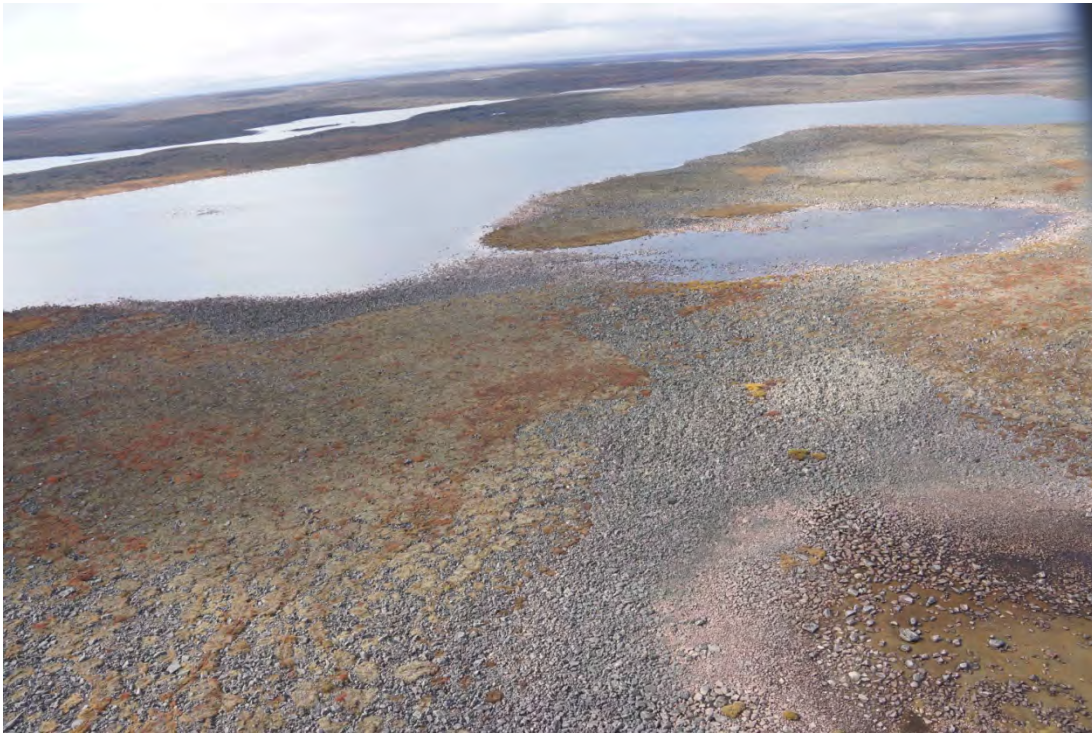
Kilometre 51.2. Oblique aerial photograph 51.2-1. August 30, 2014.

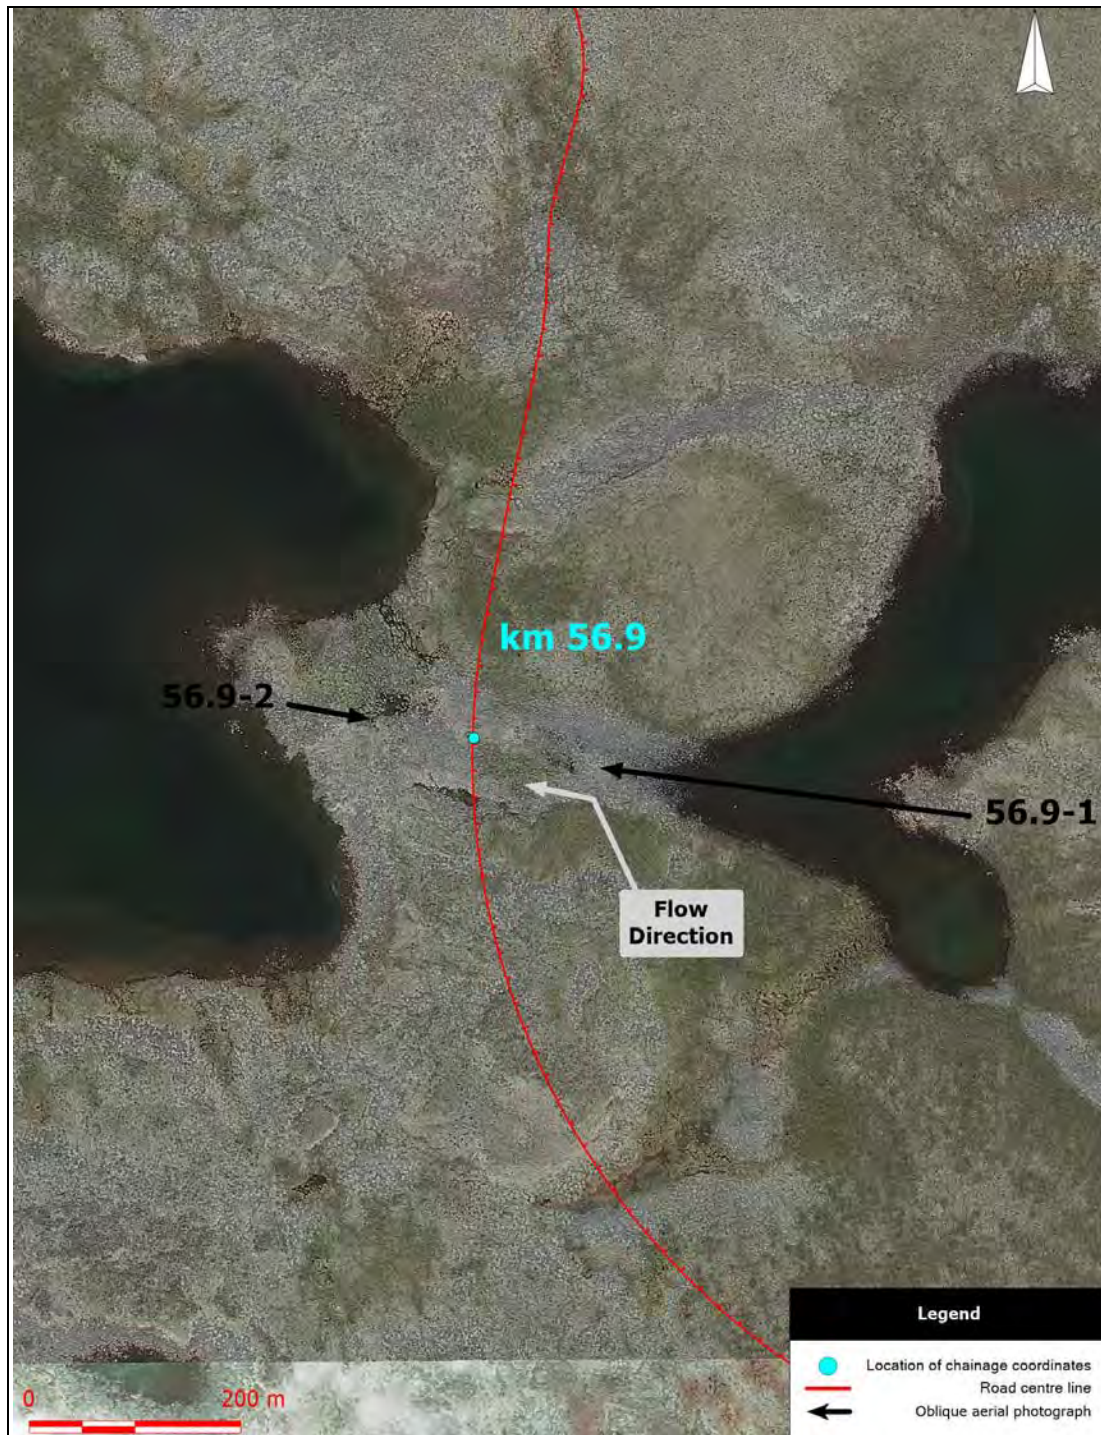
Kilometre 56.9. Aerial photograph showing the road centre line, the location of chainage coordinates provided in Table 3-2, the flow direction, and the location of oblique aerial photographs.

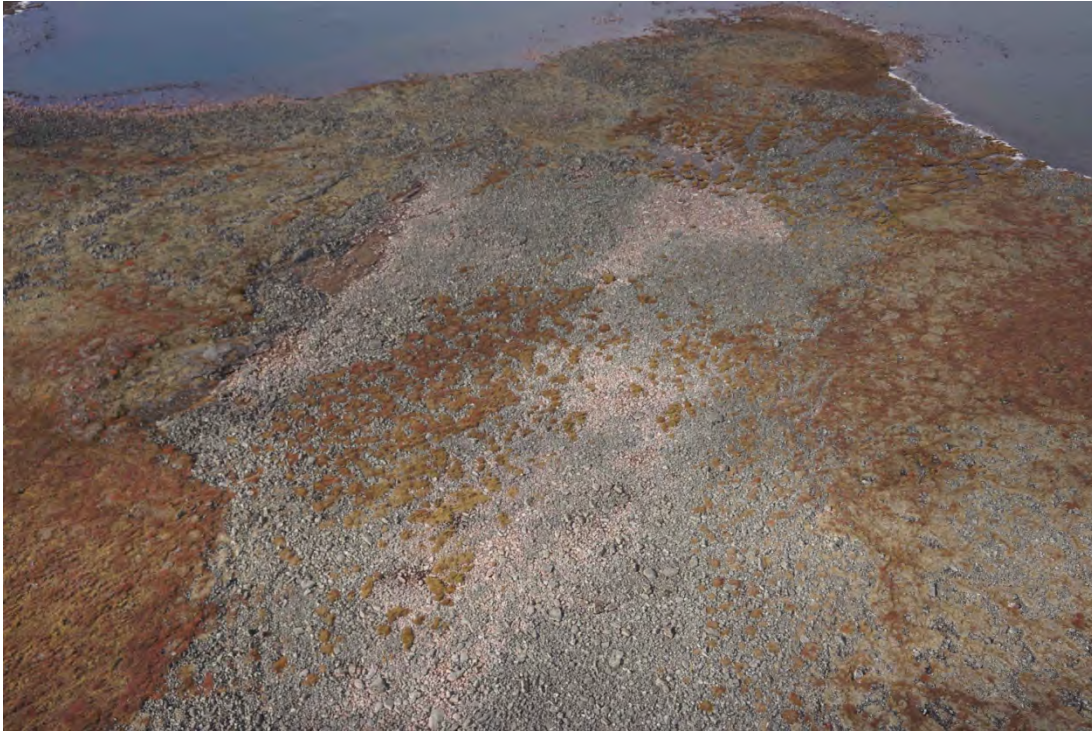
Kilometre 56.9. Oblique aerial photograph 56.9-1. August 30, 2014.

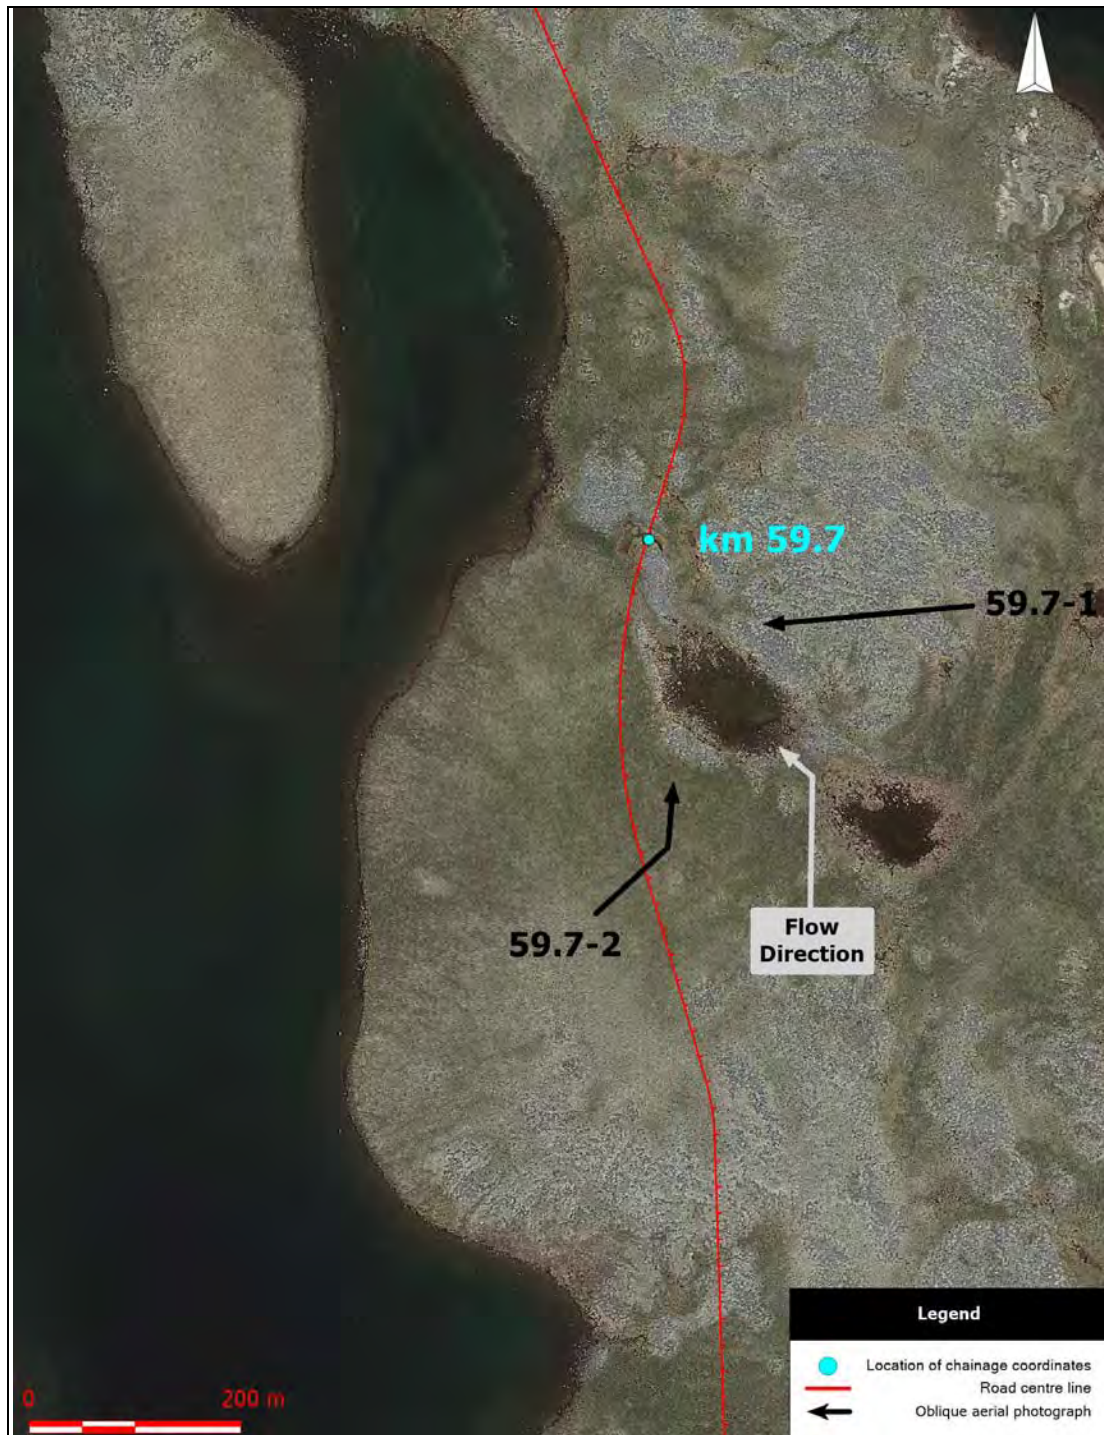
Kilometre 59.7. Aerial photograph showing the road centre line, the location of chainage coordinates provided in Table 3-2, the flow direction, and the location of oblique aerial photographs.

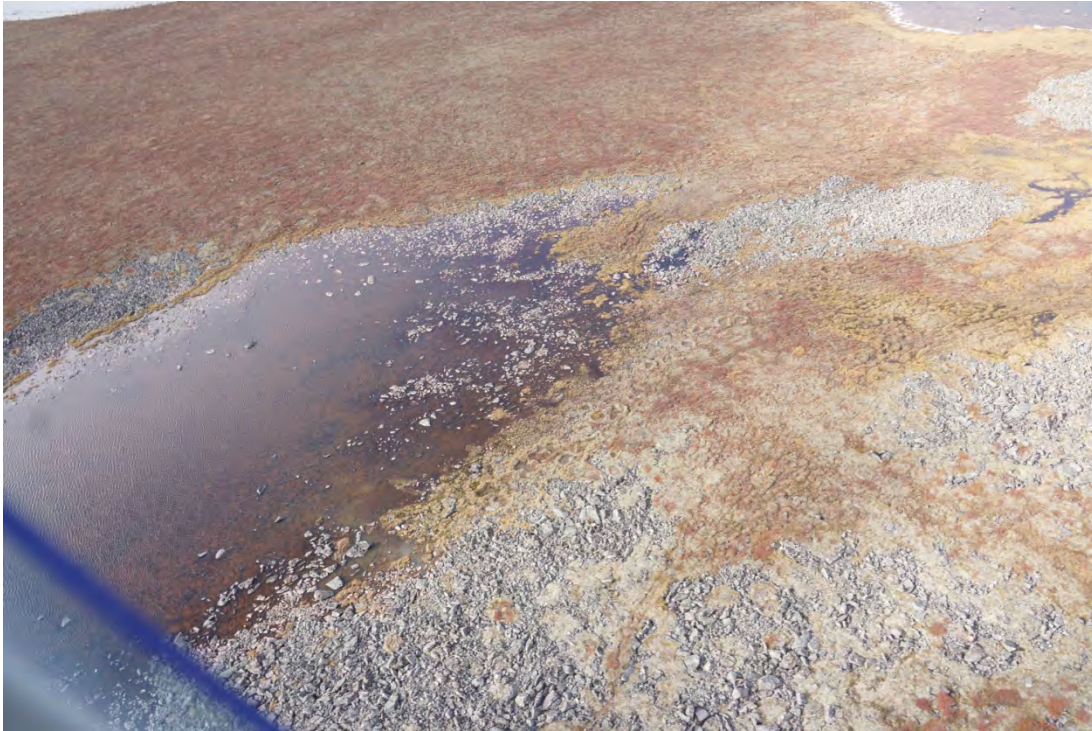
Kilometre 59.7. Oblique aerial photograph 59.7-1. August 30, 2014.

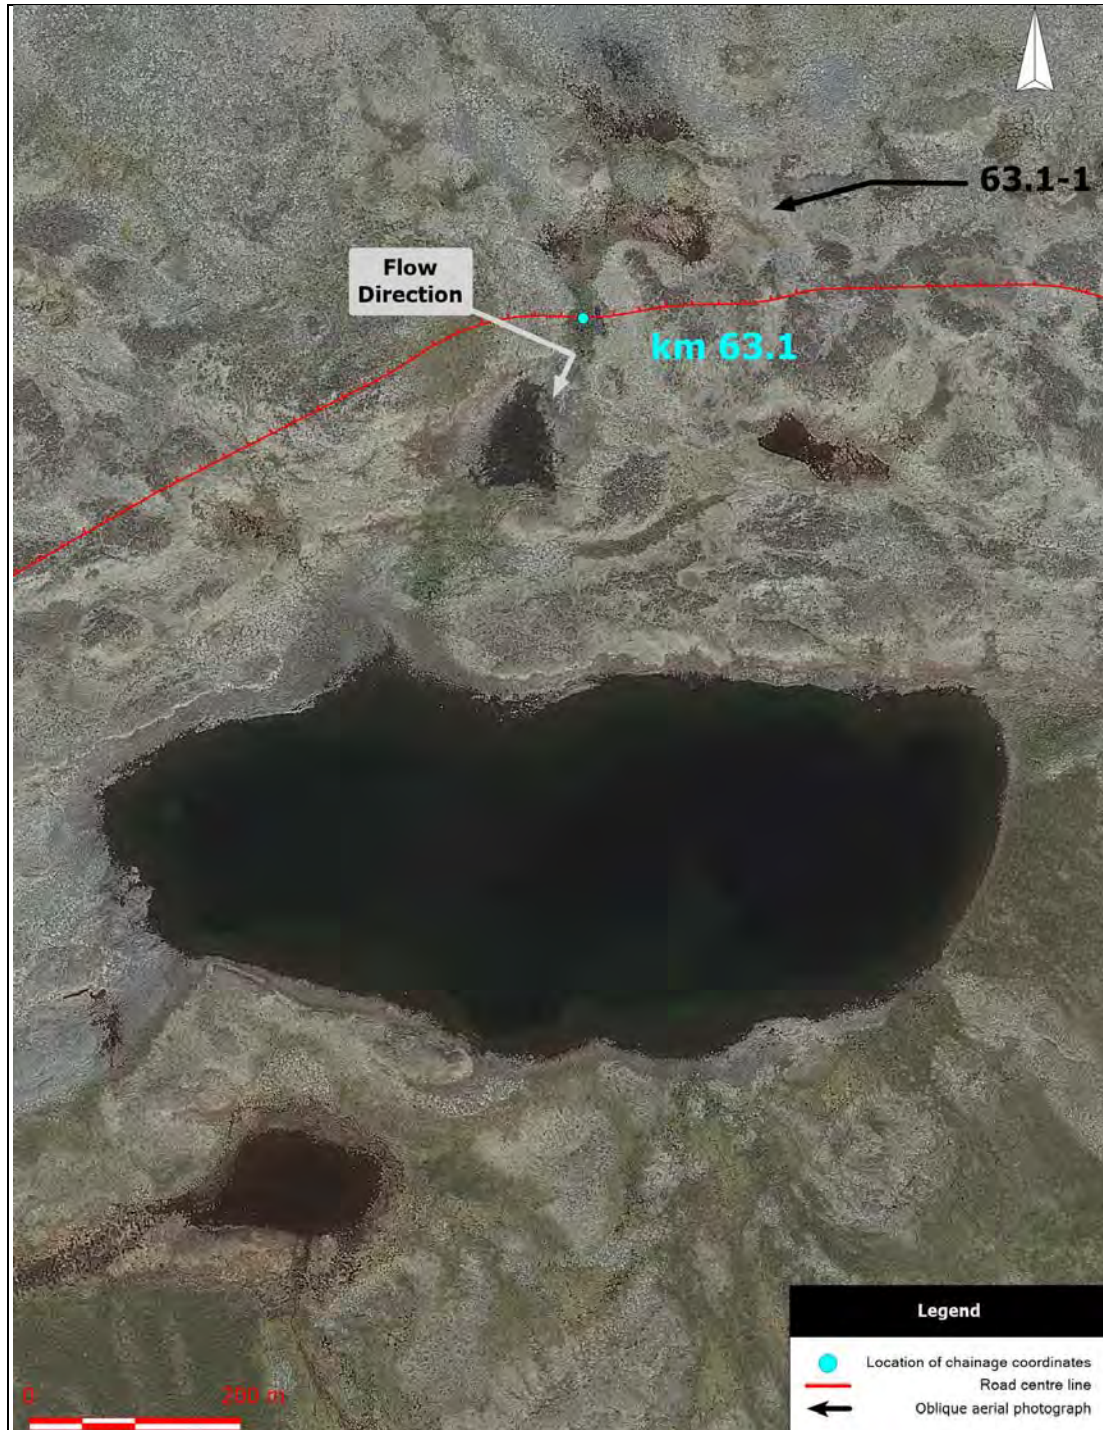
Kilometre 63.1. Aerial photograph showing the road centre line, the location of chainage coordinates provided in Table 3-2, the flow direction, and the location of oblique aerial photographs.
