Re: Agnico Eagle's response to Meadowbank (2AM-MEA1526) and Whale Tail (2AM-WTP1826) 2018 Annual Report comments

The following information are intended to address the regulator's comments regarding the Meadowbank (2AM-MEA1526) and Whale Tail (2AM-WTP1826) 2018 Annual Report:

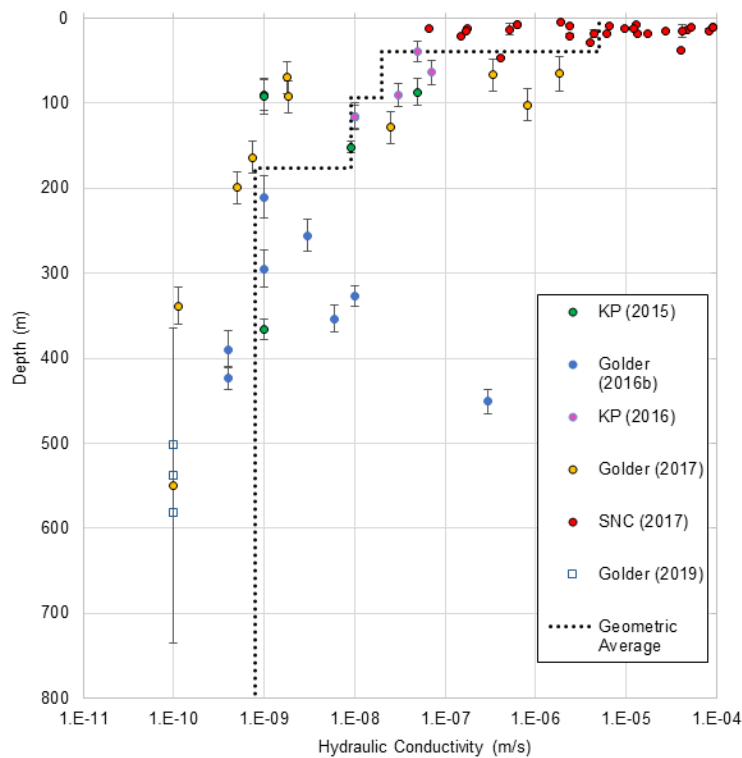
Since submission of the FEIS for the Approved project, a significant number of additional measurements of bedrock hydraulic conductivity have been made to verify assumptions in the modelling and improve the accuracy of model predictions. Figure below presents a summary of measurements made to date, which includes 58 measurements in unfrozen rock between 2015 and 2019.

Summary of Hydraulic Conductivity Test Results

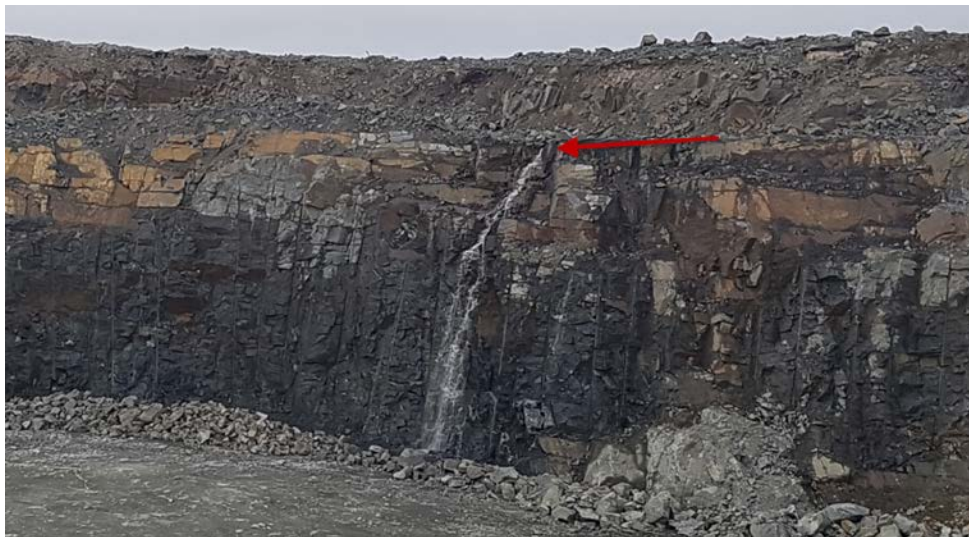
Agnico Eagle would like to clarify that the non-cohesive overburden described in the annual report could be defined as a mix of boulder, lake bed sediment and residual waste rock material from the surrounding blasting activity. The observed water flow was located in a small topographic depression between the Quarry 1 and the Whale Tail North Basin. This surface water movement should not be considered as a groundwater flow in any case. The following picture is showing the surface water flowing within the Quarry 1. The surface water flow was observed within the footprint of the future Whale Tail Pit and in a close distance from the Whale Tail Lake. Agnico Eagle does not consider that this event suggests the installation of any additional instrumentation as the Whale Tail Lake North Basin has been dewatered and the flow stopped since the water level of the Whale Tail Lake North Basin was below the elevation of the small depression by which the water was flowing in the Quarry 1.

Water flowing within the Quarry 1

...from Whale Tail Lake to Quarry 1 through non-cohesive overburden that was most likely fractured after blasting the Quarry 1 top benches.
