7.5.1.5 Fouling Prevention

7.5.1.5 MBR WWTP Fouling Control & Troubleshooting Chart

8.2.3 Membranes

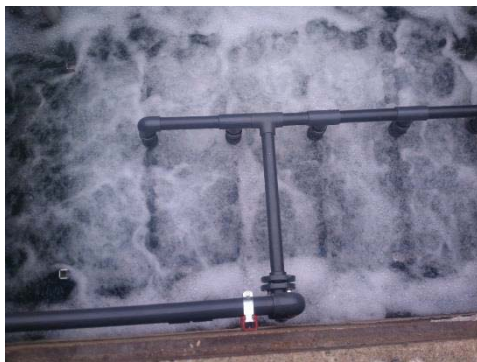
**Proper air scouring
in membrane tank**

Membrane air scouring check is essential procedure for newterra MBR WWTP. Air scour has to be observed for uniformity of bubbling action all across the membrane module/cassette on regular basis. It is easy to observe through clear window in membrane tank. Operator should note any unusual patterns of air distribution. Operator has to check for:

If there is insufficient air scouring, localized dewatering (**clogging**, **sludging**, **caking** and **plugging**) may occur and as a result, membrane fouling occurs.

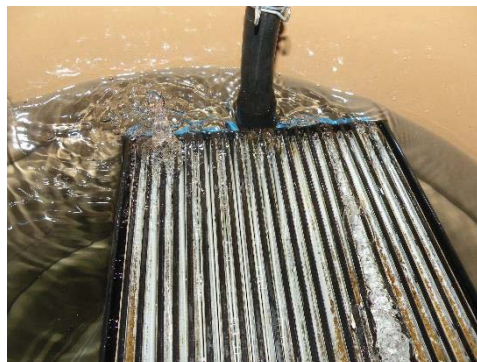
**Uneven aeration in
membrane tank**

Condition	Possible Cause	Potential Remedies
Uneven aeration of membrane module	Membrane diffuser clogging;	Wash or clean the diffusers
	Loose air piping connections	Tighten pipe connections
Uneven aeration in membrane tank	Membrane diffusers or membrane modules are not level	Level the equipment
Air scour rate fails to reach the specified values	Improper operation of membrane blowers and/or air scour system, malfunctioning diffusers	Repair or replace the blowers Review and repair air piping as necessary Repair the diffusers

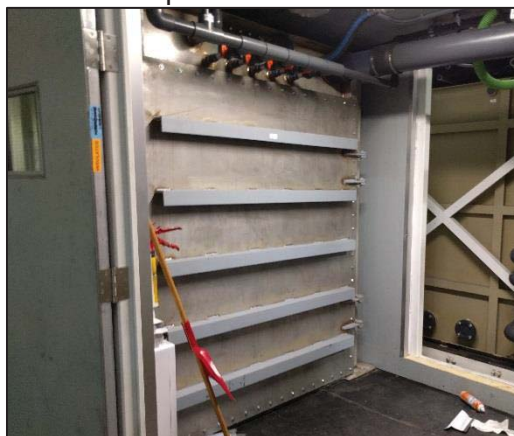
- Ensure that the membrane tanks (TNK-601/602) are drained before opening the membrane tanks.
- Open TNK-601/602 doors with hand/power tools.

- Using a garden hose, wash the inside of the tanks and vac out any remaining waste water. **DO NOT USE A PRESSURE WASHER!**
- Disconnect the permeate hoses from the top of membrane the membrane stack.
- Remove the membranes from the membrane frame using hand tools.

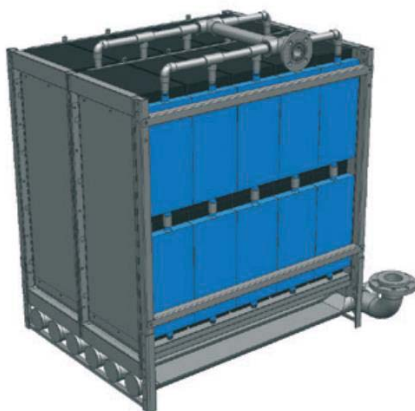
- **CAUTION** – the membranes are contaminated with waste water. PPE required.
- **NOTE.** The membranes are double stacked. The bottom membrane has a plug in the bottom opening. Do not remove this plug. Note the membrane orientations for re-installation. The membranes are joined together with either a PVC union with two O-Rings on each side OR clear PVC hose and hose clamps.

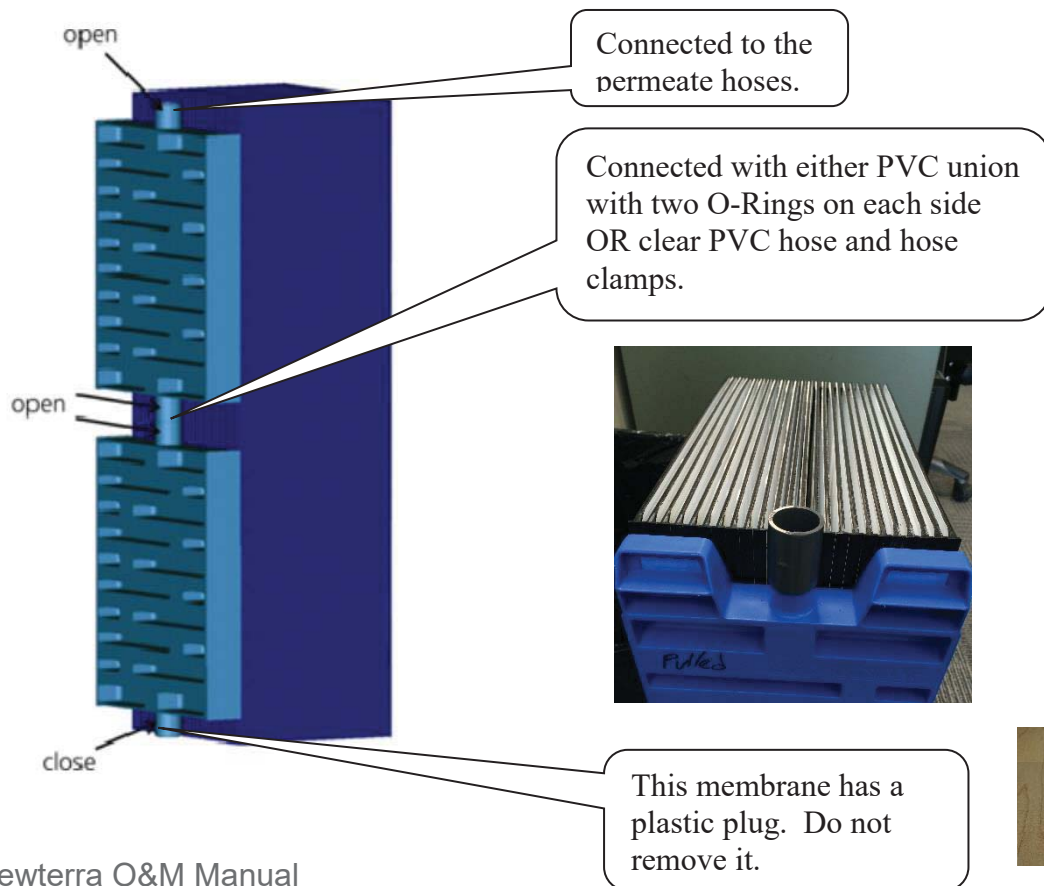
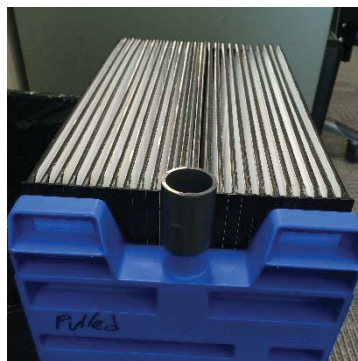
- After membranes are separated, wash with clean water. Remove the blue backing plate and gently separate the membrane plates and clean with water to remove any debris.

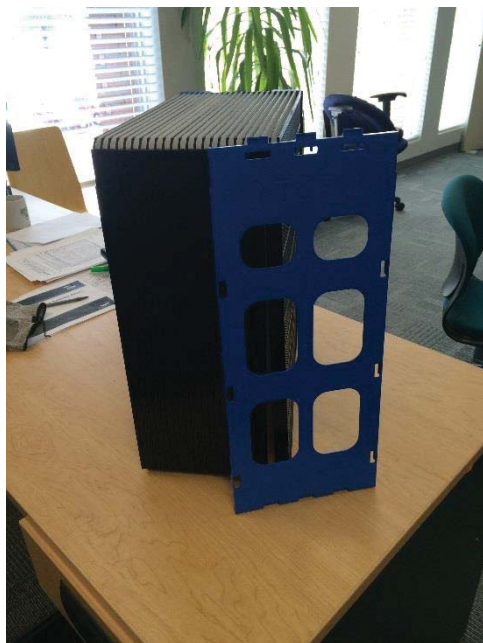
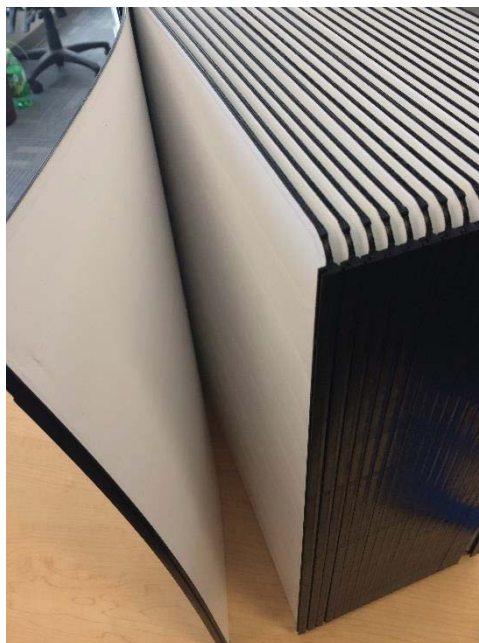
- Replace backing plate and let the membranes dry out.
- Shrink wrap the membrane cassettes in multiple film layers and seal the membranes cassettes with tape. Note and mark which membranes have the bottom plug in them.
- Store the preserved membrane cassettes at room temperature (never expose the membrane cassettes to frost, dust, or direct sunlight).

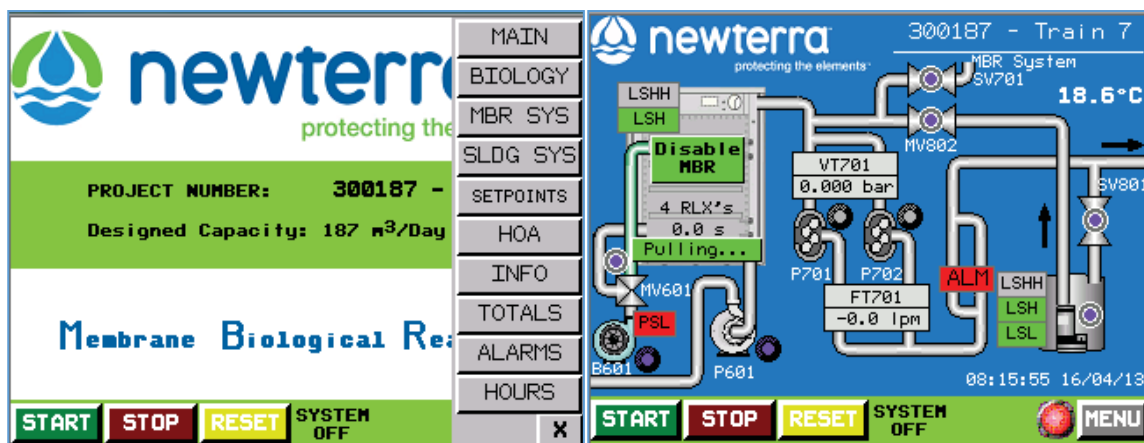
newterra SITE-LINK is a customized software program and hardware configuration which provides a real-time link to a treatment system via cellular modem or customer supplied internet connection using our secure Site-Link Server.

- Customized P&ID layout with system status
- Start/Stop/Reset of system
- Manual control of all system components
- Data logging downloads in .csv format[†]
- Daily system status reports (E-Monitor)
- Alarm history including current alarm status
- Hour meters for applicable equipment
- Customization of all system set points[†]
- Live and historical trending
- Immediate text & email on alarm (E-Alarm)

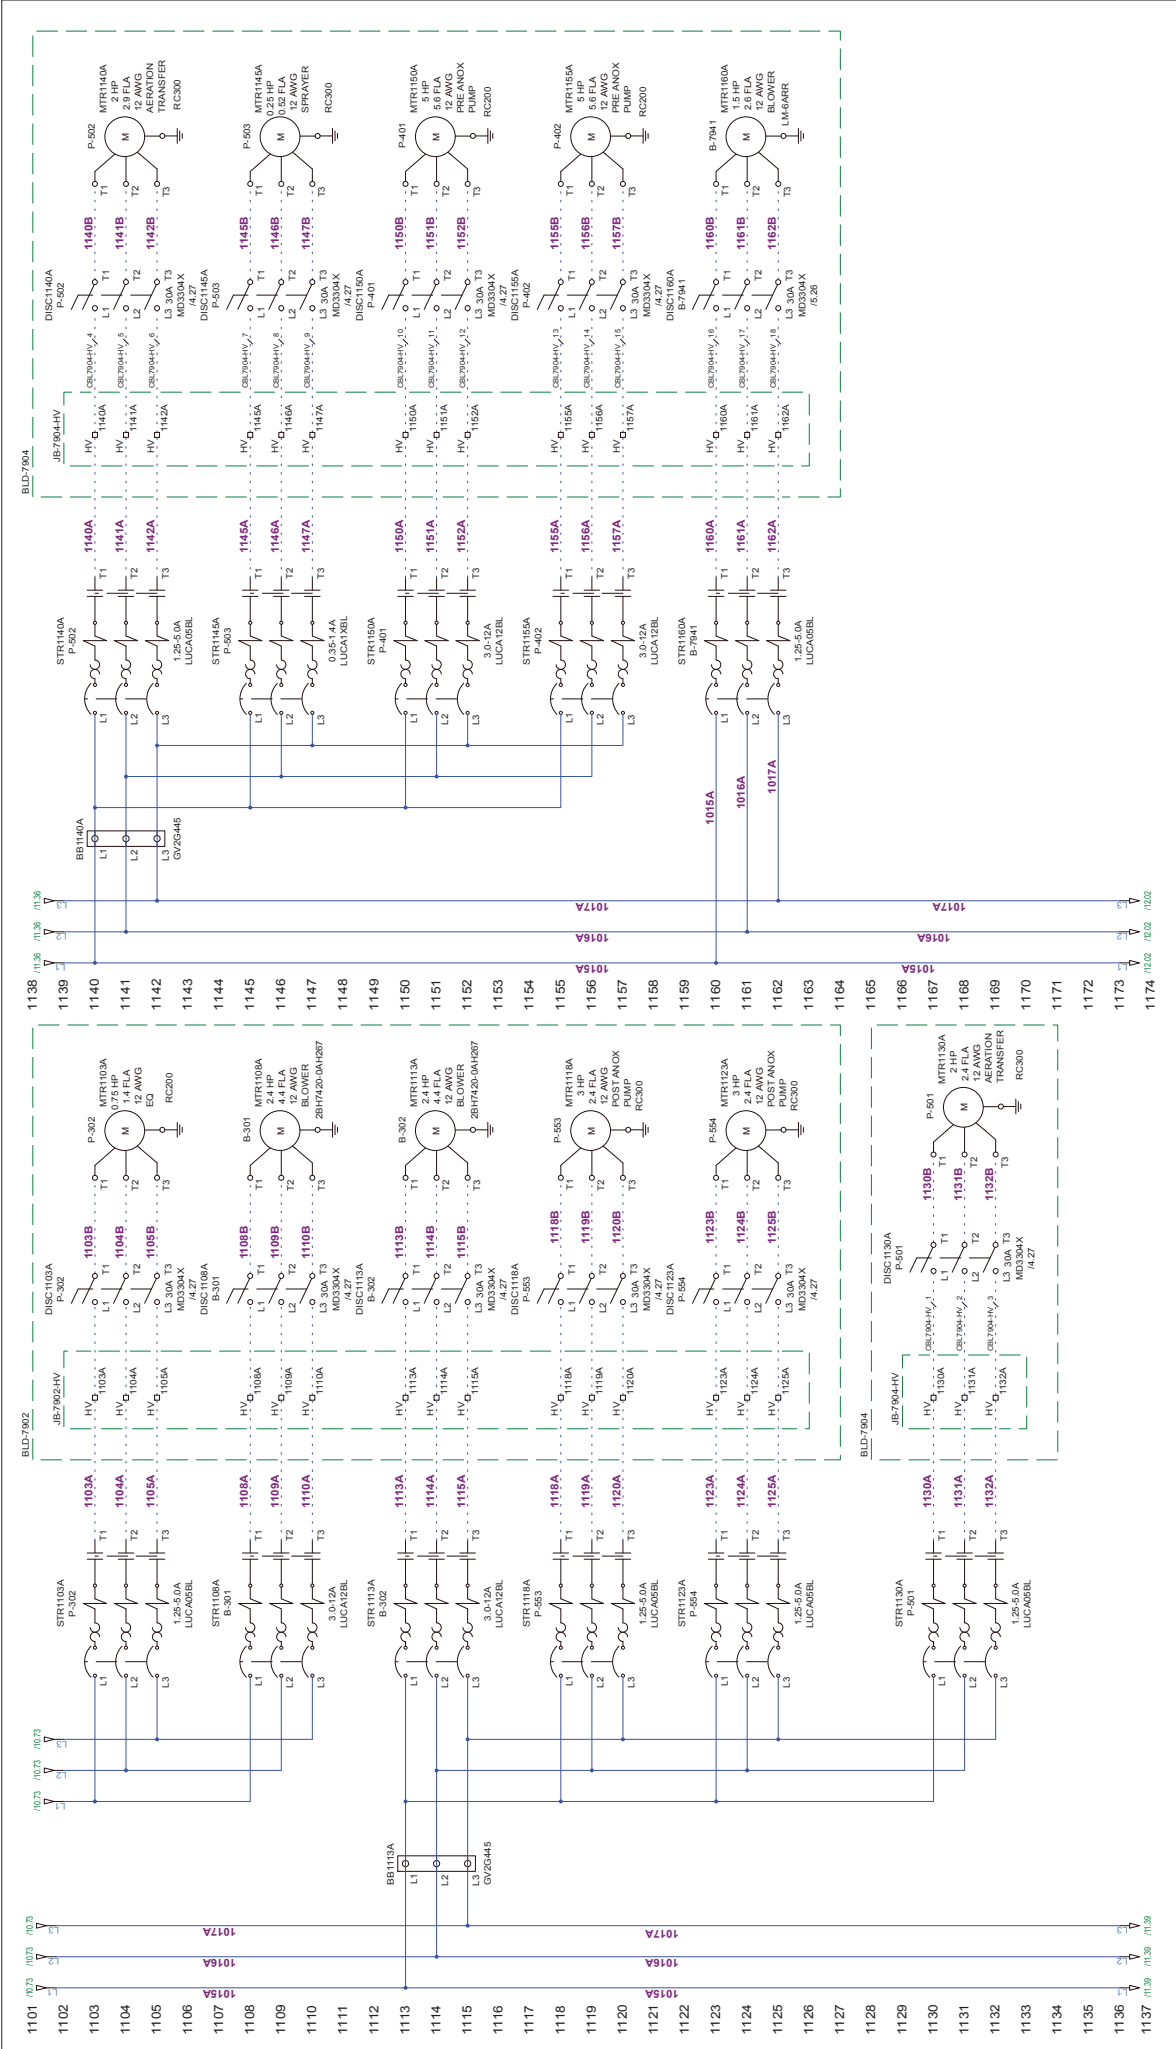
1325 CALIFORNIA AVE. BROOKVILLE, ONTARIO CANADA M1R 3X9 PHONE: (616) 548-1876 www.newterra.com	C	AS BUILT	14/08/17	DMB	PROJ. NO. 1704432	CUSTOMER: AGNICO EAGLE 600 MAN AMARJO MINE 480V POWER DISTRIBUTION SHEET 1 OF 4		
				B	FOR PRODUCTION	31/05/17	DMB				
				A1	FOR REVIEW	23/05/17	DMB				
				A	FOR SUBMITTAL	12/05/17	DMB				
				LEVEL	REVISION	DATE	BY				
										MPP	
					</

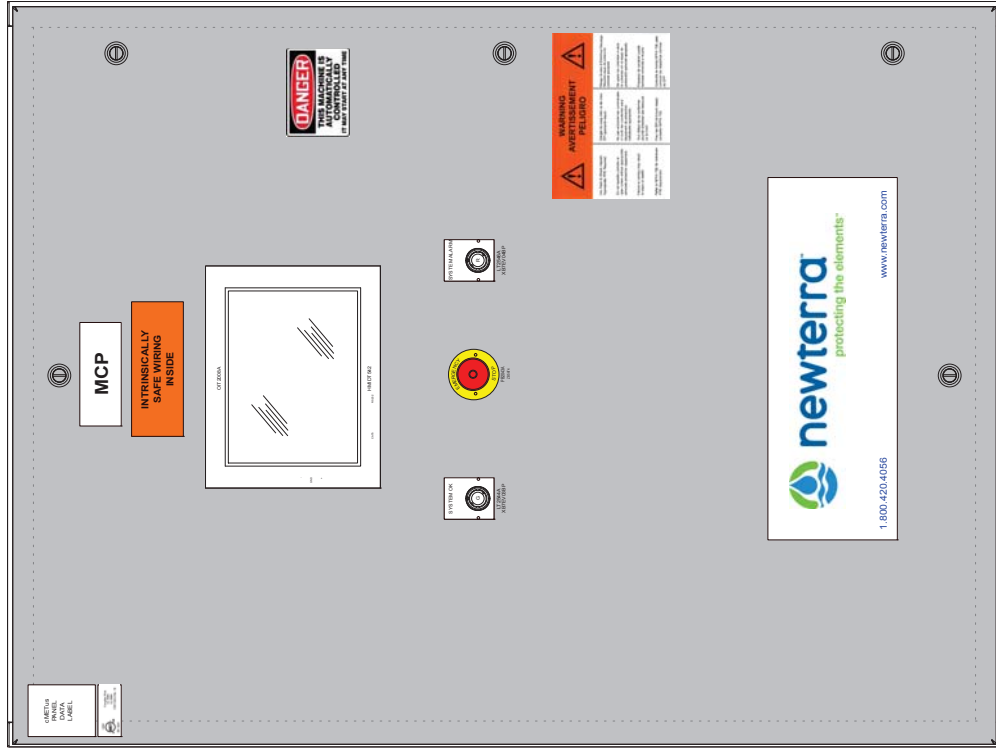
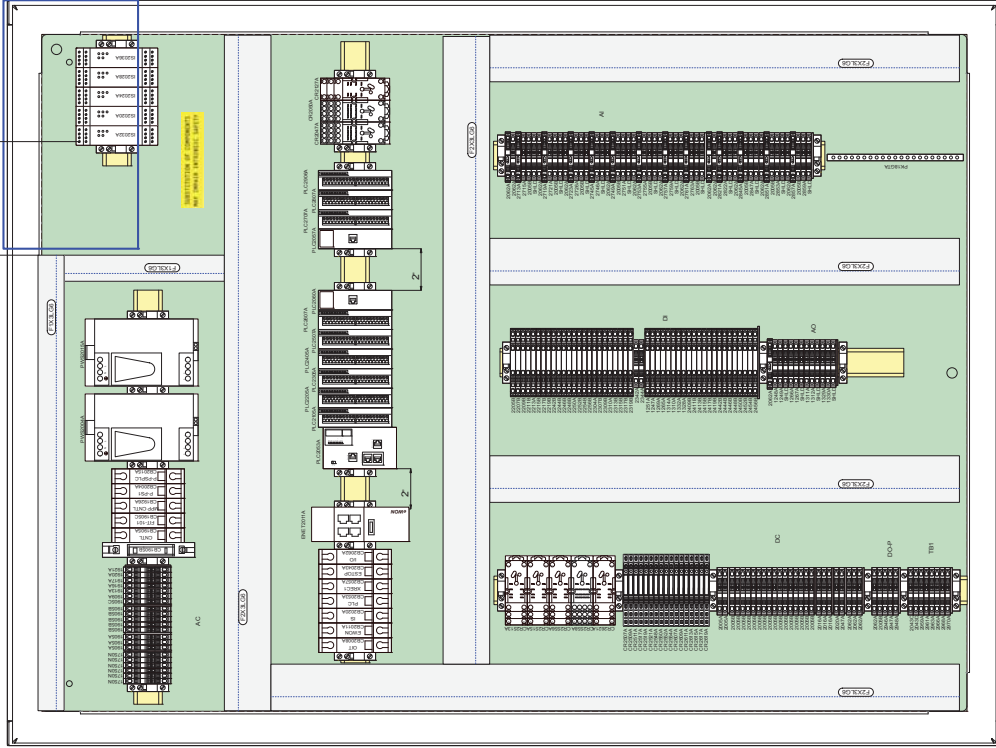
PANEL OUTER DOOR

MCP
EN4SD43612GY
PANEL INTERIOR

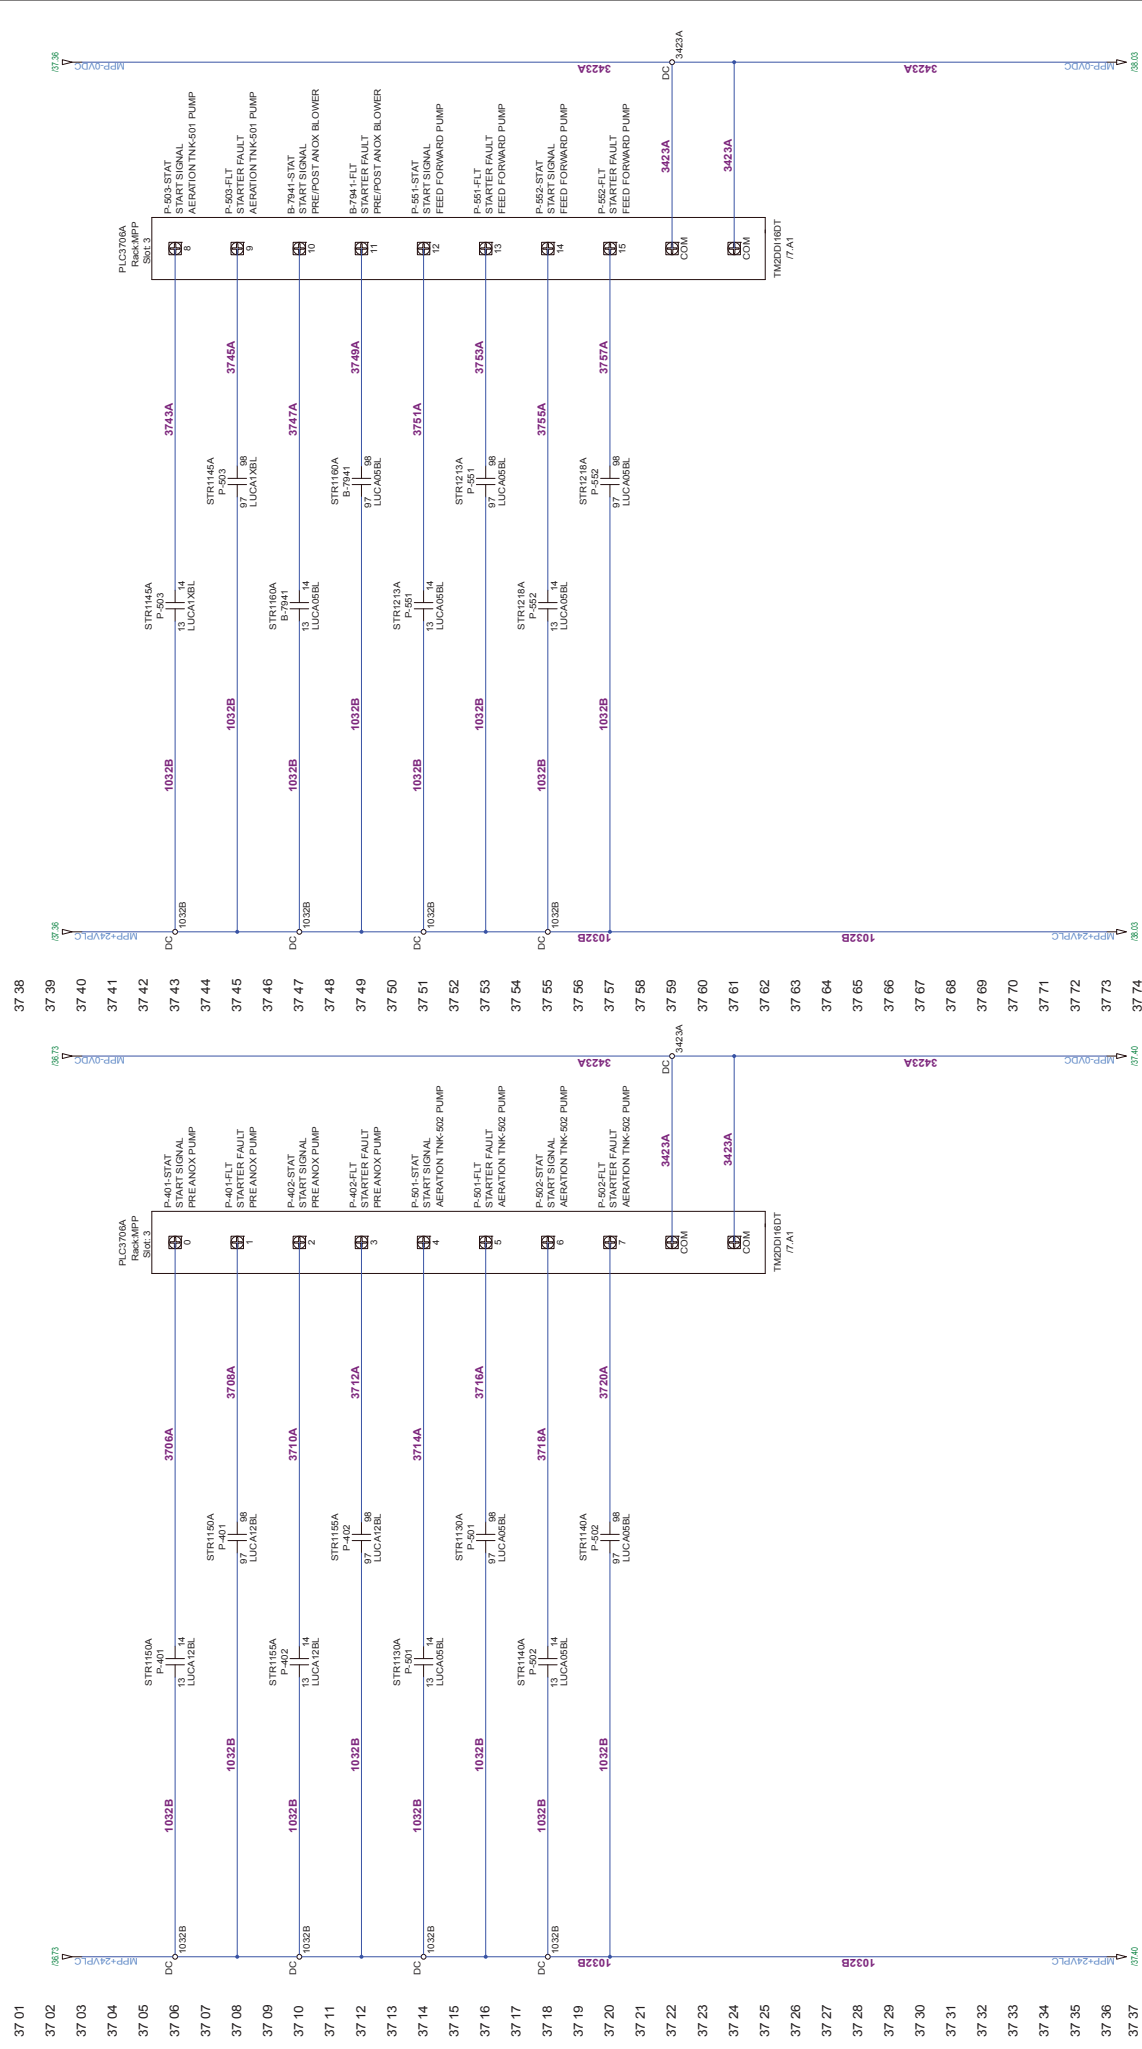
newterra 1325 CALIFORNIA AVE. BROOKVILLE, ONTARIO CANADA L4R 0A1 PHONE: (616) 548-1876 www.newterra.com	C		AS BUILT	14/09/17	DMB	PROJ. NO. 1704432	CUSTOMER: AGNICO EAGLE 600 MAN AMIRAUQ MINE	
			B		FOR PRODUCTION	31/05/17	DMB			TITLE AND LOCATION: MPP DISCRETE INPUTS SHEET 2 OF 2
			A1		FOR REVIEW	23/05/17	DMB			
			A		FOR SUBMITTAL	23/05/17	DMB			
			LEVEL	REVISION	DATE	BY
