HOPE BAY PROJECT 2019 Nunavut Water Board Annual Report

Prepared by
TMAC Resources Inc.
Toronto, ON

Prepared for
Nunavut Water Board

March 2020

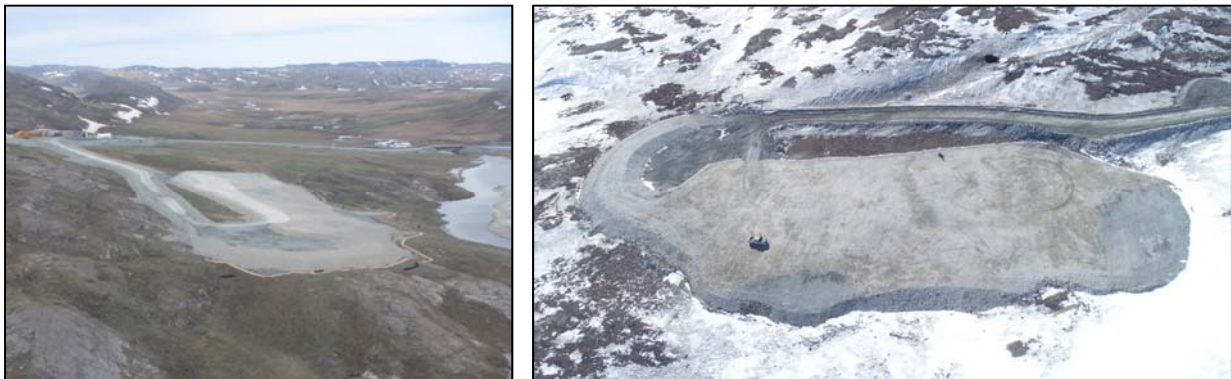
Figure 13-1. Doris Crown Pillar Recovery Trench Post-Reclamation Activities

For aerial photos of the Doris Crown Pillar Recovery Trench post-reclamation activities see Figure 13-1.
