PROJECT				KIGGAVIK PROJECT			
TITLE				HABITAT MAP THELON RIVER (CROSSING 18) 2008			
PROJECT		09-1362-0610		FILE No.			
DESIGN				SCALE		AS SHOWN	
CADD		AJL		22/04/09		REV.	
CHECK		FA		05/10/09		0	
REVIEW		JDH		05/10/09

The team focused their attention on the crossing location identified in the 2007 Pre-Feasibility study prepared by EBA which was completed with large scale mapping and satellite imagery and did not include any field investigation. During the reconnaissance the team identified an alternate crossing location. Both locations are illustrated in figure 1. The second location was identified because of potential concerns with slope stability, and uncertainty of ground conditions and bedrock depth at the first location.

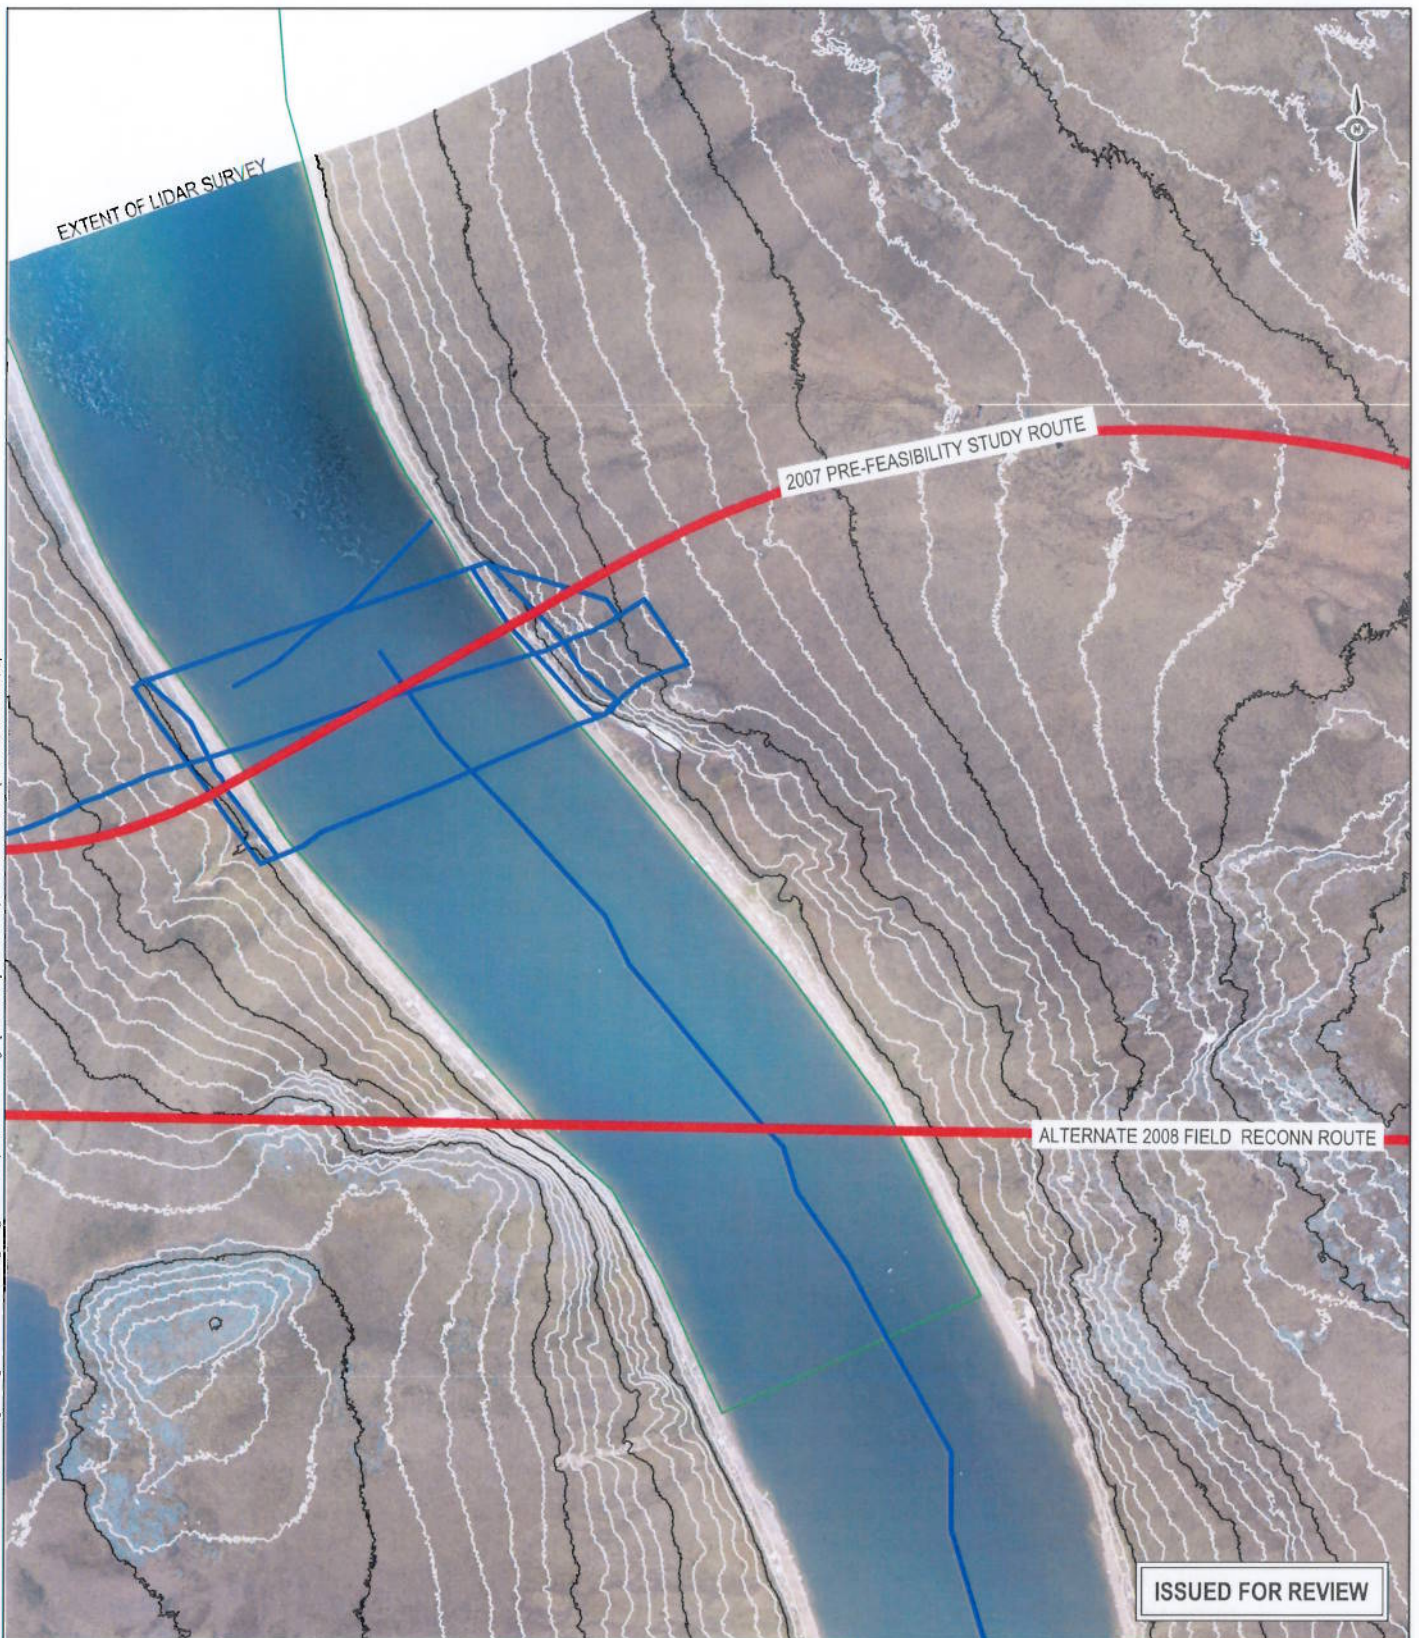
Figure 1

Q:\Vancouver\Transportation\V3310\Projects\V33101016 - Areva\CADD\2009 Conceptual Design\Design Files\624-627\Bridge Alignment Comparison Sketch.dwg [FIGURE 1] October 08, 2009 - 10:34:01 am (BY: DREW DAVIDGE)

EBA completed a Bathymetric survey of the Thelon River crossing locations being considered on August 3, 2008. The survey was completed by 2 EBA staff along with a local guide/boat driver. The extent of the survey is shown on figure 1.

In conjunction with the Bathymetric survey in August 2008 EBA also collected data with a GPR unit. The same EBA geophysicist returned to the Thelon River in April 2009 to collect additional GPR information and also collected information with an Ohm Mapper. The data collection lines are illustrated on figure 1.

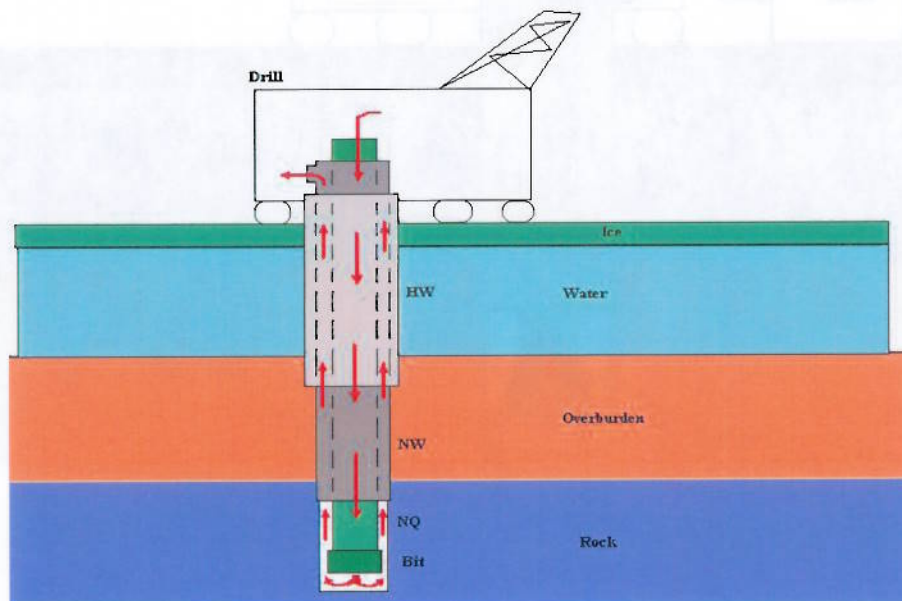
Figure 4. Circulation of Drill Fluids

Water or drill fluid is pumped down the hole, through the bit, and back up the outside of the NQ rod, but because the hole is sealed it returns to the surface inside the NW casing (see Figure 4). While coring, the drill fluids are under pressure forcing the “cuttings” (a gritty mud from the bit cutting the rock) away from the bit and out the top of the casing. This drill fluid full of cuttings coming out the top of the hole is called the “return”. When this return fluid reaches the surface it is run through a filter called a Polydrill filter. This filter separates out the cuttings and packs them in a cylindrical bag for disposal. The drill fluids are then pumped back down the hole or re-circulated (see Figure 5).
