ABANDONMENT AND RESTORATION PLAN

WATER LICENCE N7L2-0925

ECHO BAY MINES LTD.

LUPIN OPERATIONS

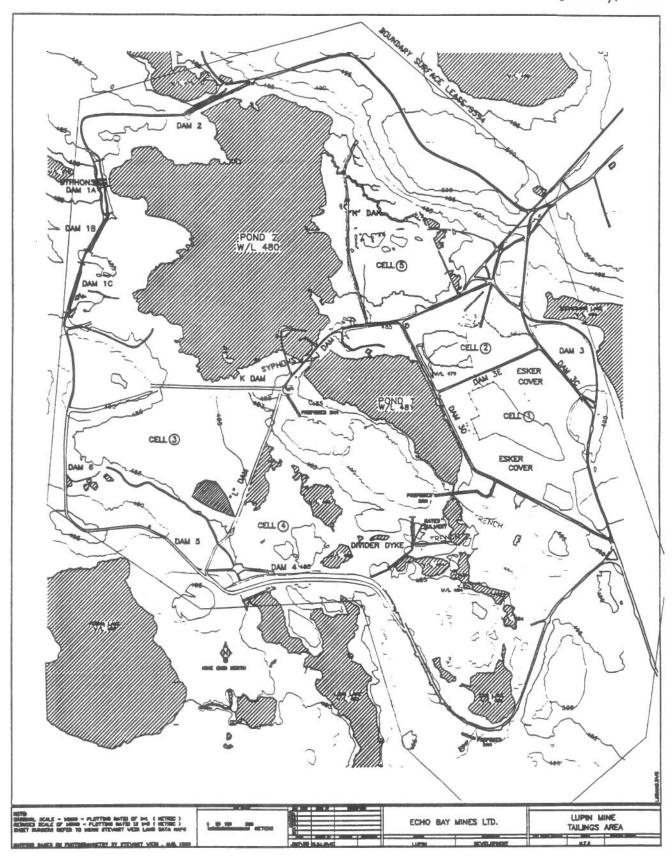
Figure 3; Lupin Mine Tailings Area - 1995

The TCA is impounded through natural terrain relief and a series of engineered retaining structures (Figure 3; Lupin Mine Tailings Area - 1995). The main water retaining dams are those in Pond No.2 (labelled Dams 1a, 1b, 1c and Dam2) and for the present, Dam4 in Cell No.4. With future tailings solids deposition, Cell No.4 may receive enough solids to beach Dam4 and restrict water access. Dams No.5 and 6 within Cell No.3 are low level dams. A water head is not expected on these structures upon closure.

All perimeter dams have been designed with a synthetic liner for initial control of seepage and are expected to freeze through the core during operations. The KDam, which is an internal structure, was also designed with a synthetic liner for initial seepage control. A tailings beach, approximately 10 metres in depth, has been placed on the upstream side of this dam and temperature monitoring indicates that the core remains frozen year-round.

Tailings Cells No.1 and 2 are separated from the remainder of the impoundment by Dam3d. This dam was constructed as a "permeable dam" and allows solutions from the two cells to report to Pond No.1. The esker fill dam has a downslope constructed of quarry rock placed in 1995 for stability and erosion protection. The last of the structures, the JDam, separates the two ponds for treatment purposes.

There are several engineered dams utilized in the design of the TCA that are of a concern during closure and abandonment. These dams have been constructed with synthetic liners for the initial control of seepage and will ultimately freeze through to the core as a result of permafrost migration.

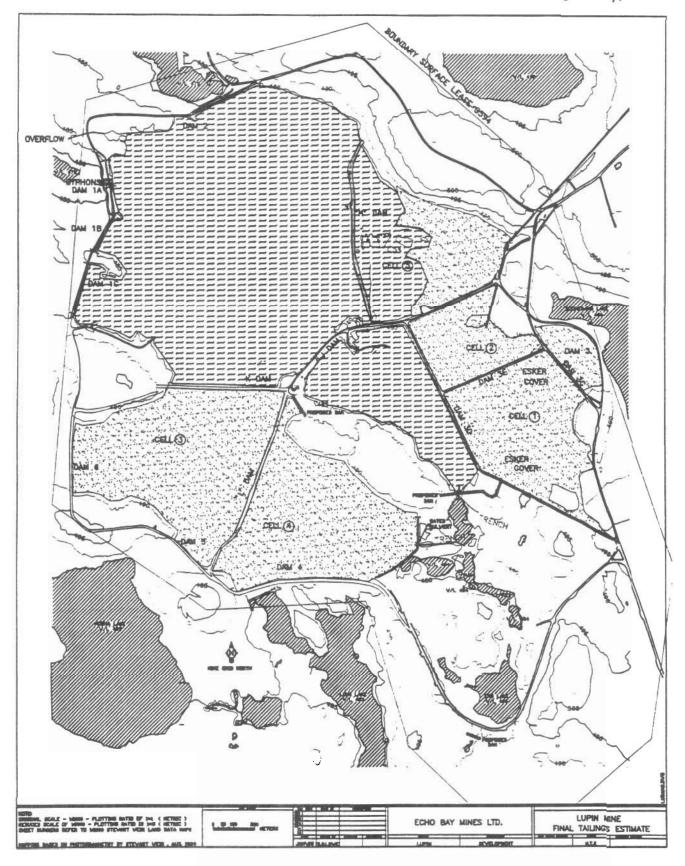
Figure 4; Lupin Mine Final Tailings Estimate

The Pond No.2, Pond No.1 and End Lake watershed areas of the TCA will be allowed to naturally rise in water level to eventually cover an area of approx. 198 hectares. This would be controlled via an overflow channel designed in bedrock north of Dam1a set to an elevation of 484.5 metres. Water levels would increase approximately four meters within the Pond areas and one meter in the End Lake area (Figure 4; Lupin Mine Final Tailings Estimate) from the current 1995 conditions.

An estimated 5-8 years of natural infiltration is required to increase the water level to 484.5m, one meter below the lowest point on any dam. During this time an evaluation of the water chemistry will be made to ensure that when overflow occurs, all water quality guidelines are met. The overflow would amount to an estimated average water volume of 2-250,000 m³, the majority of flow occurring in June and early July. With an elevation difference of approximately 5 meters from the planned overflow to the receiving stream, the channel will be initially designed to prevent the migration by fish species (eg. arctic grayling) into the containment area through the use of a natural barrier.

The areas that will require the esker cover at closure. Based on previous temperature evaluations of esker covered tailings, an estimated maximum cover of 2 metres may be required to maintain frozen conditions within the tailings. Further delineation of the cover depth is being studied with the current thermistor program initiated in 1995 within cells 1 and 2.
