Geotechnical Investigation

Liquid and Solid Waste Management
Hamlet of Igloolik, Nunavut

Project No: OTGE00019838B
Report date: March 16, 2010

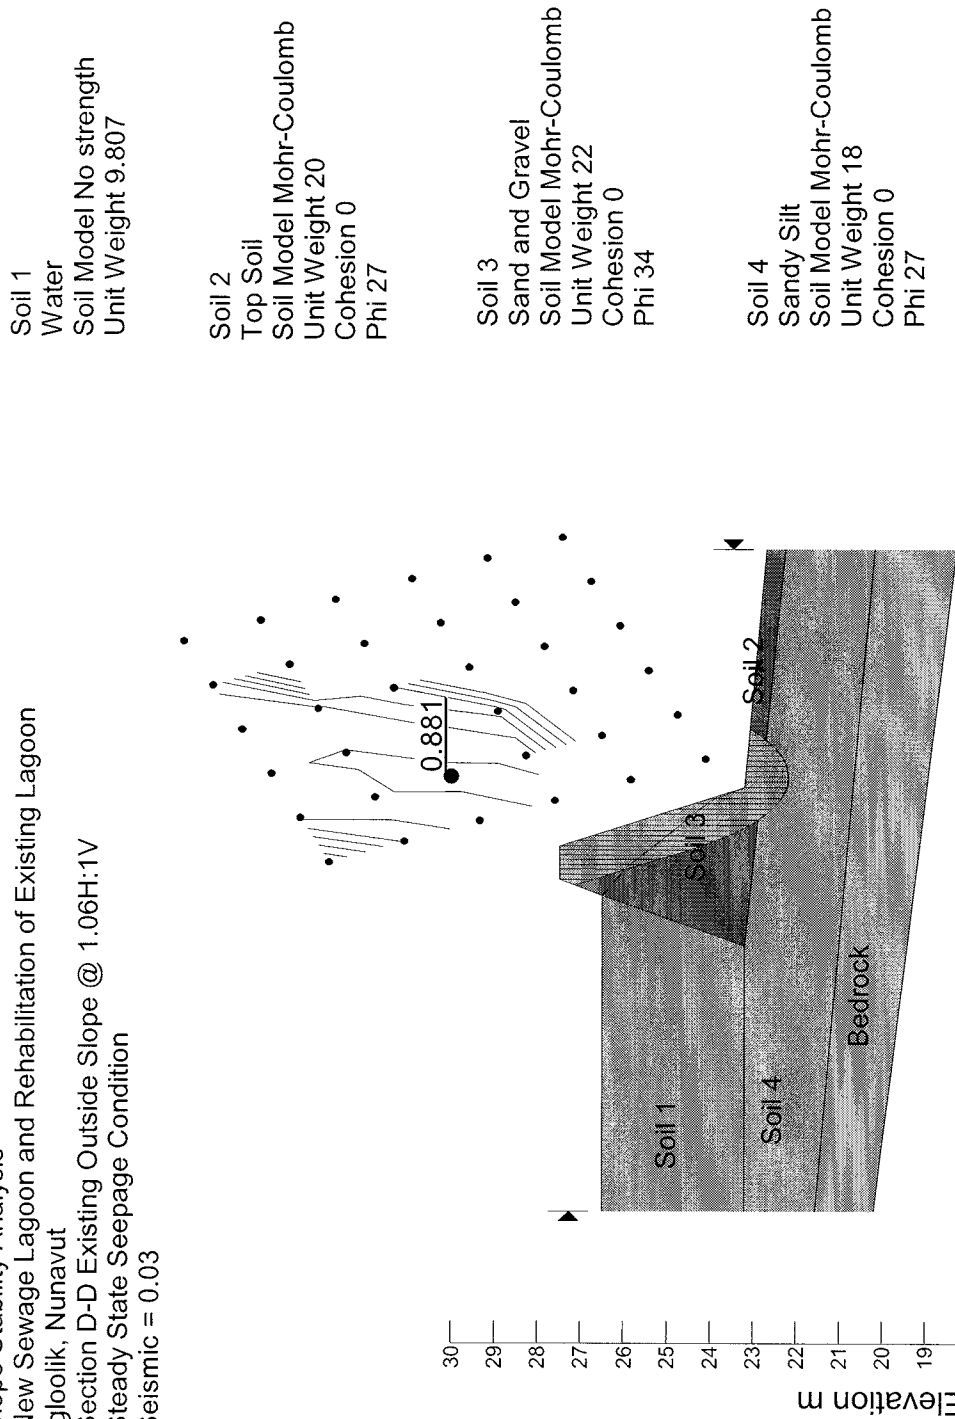
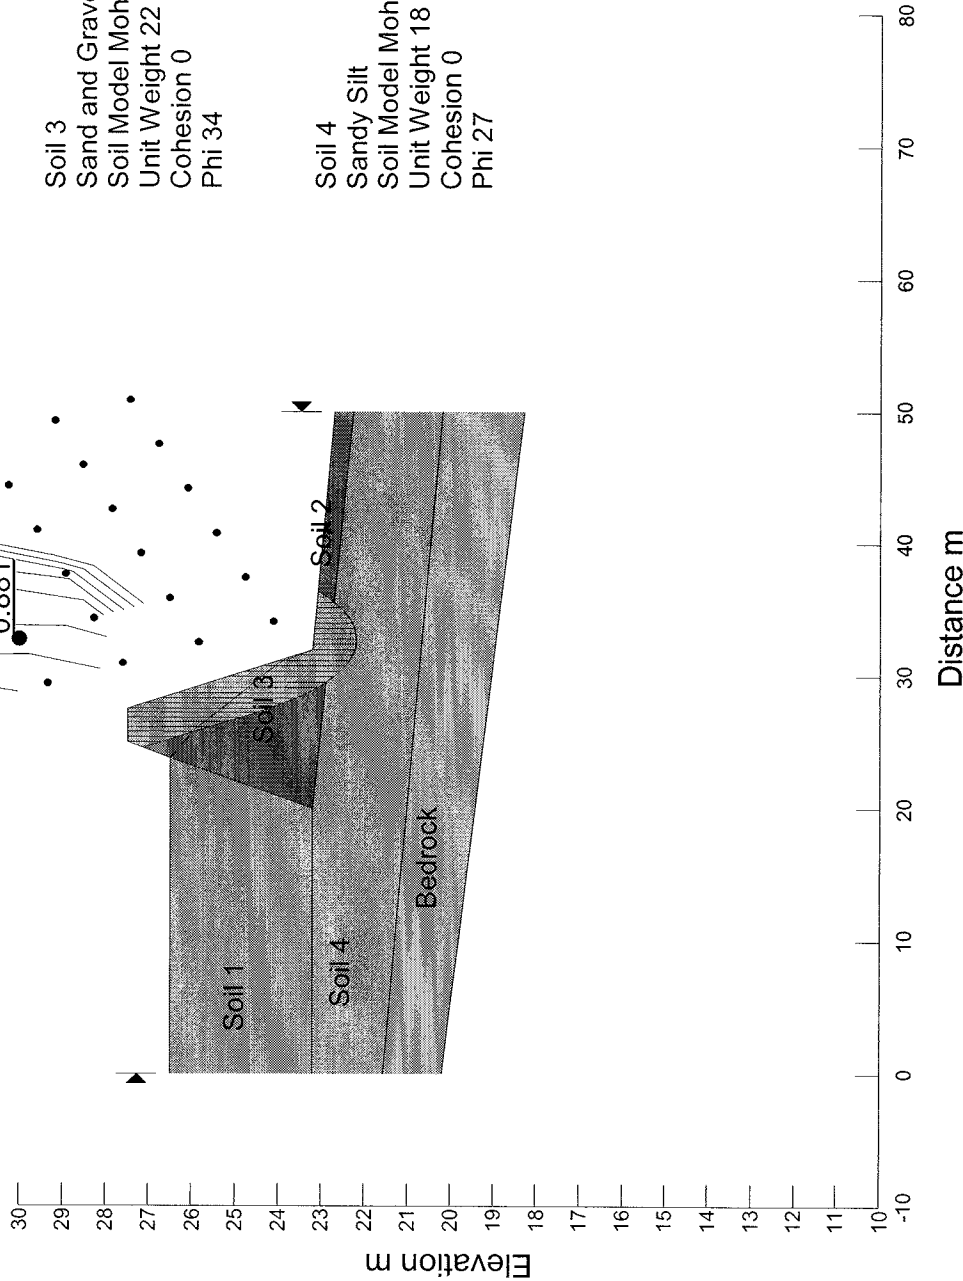
Figure 41

OTGE00019838B
Slope Stability Analysis
New Sewage Lagoon and Rehabilitation of Existing Lagoon
Igloodik, Nunavut
Section D-D Existing Outside Slope @ 1.06H:1V
Steady State Seepage Condition
Seismic = 0.03
