Geotechnical Investigation Sewage Lagoon City of Iqaluit, Nunavut

Trow Associates Inc.

October 8, 2003

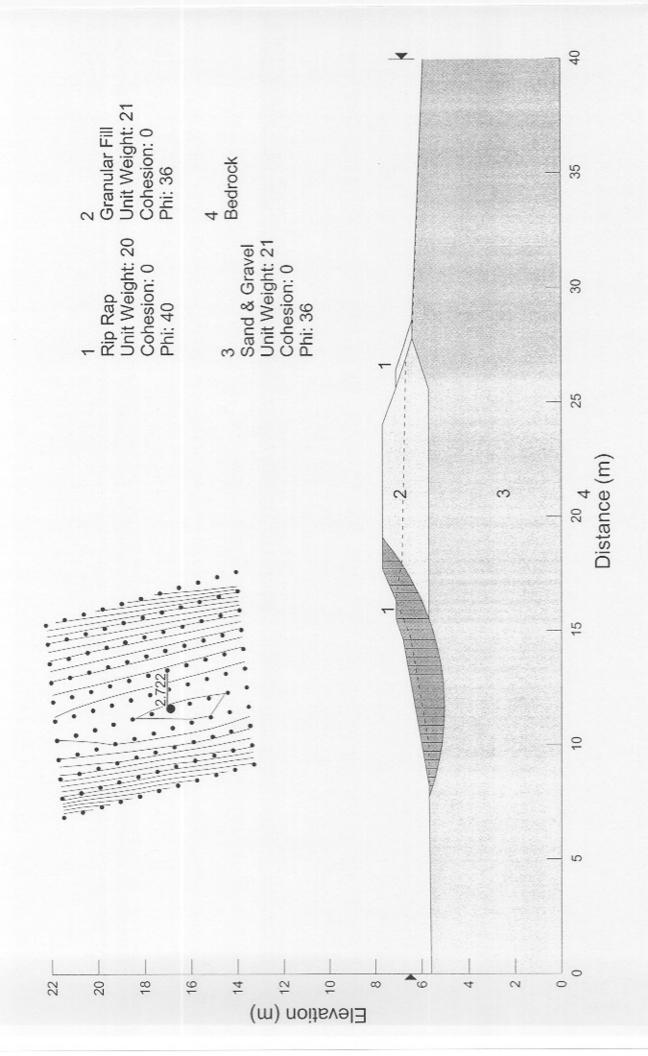
Iqaluit Sewage Lagoon Review of Dyke Slope Stability Section 1 - East Dyke

Rapid Drawdown Condition Seismic Loading 0.04g
