**Geotechnical Investigation  
Sewage Lagoon  
Hamlet of Arctic Bay, Nunavut**

Prepared for:  
**Government of Nunavut  
Department of Community and Government Services  
Project Management Division – Baffin Region**

OTGE00019054B  
April 24, 2008

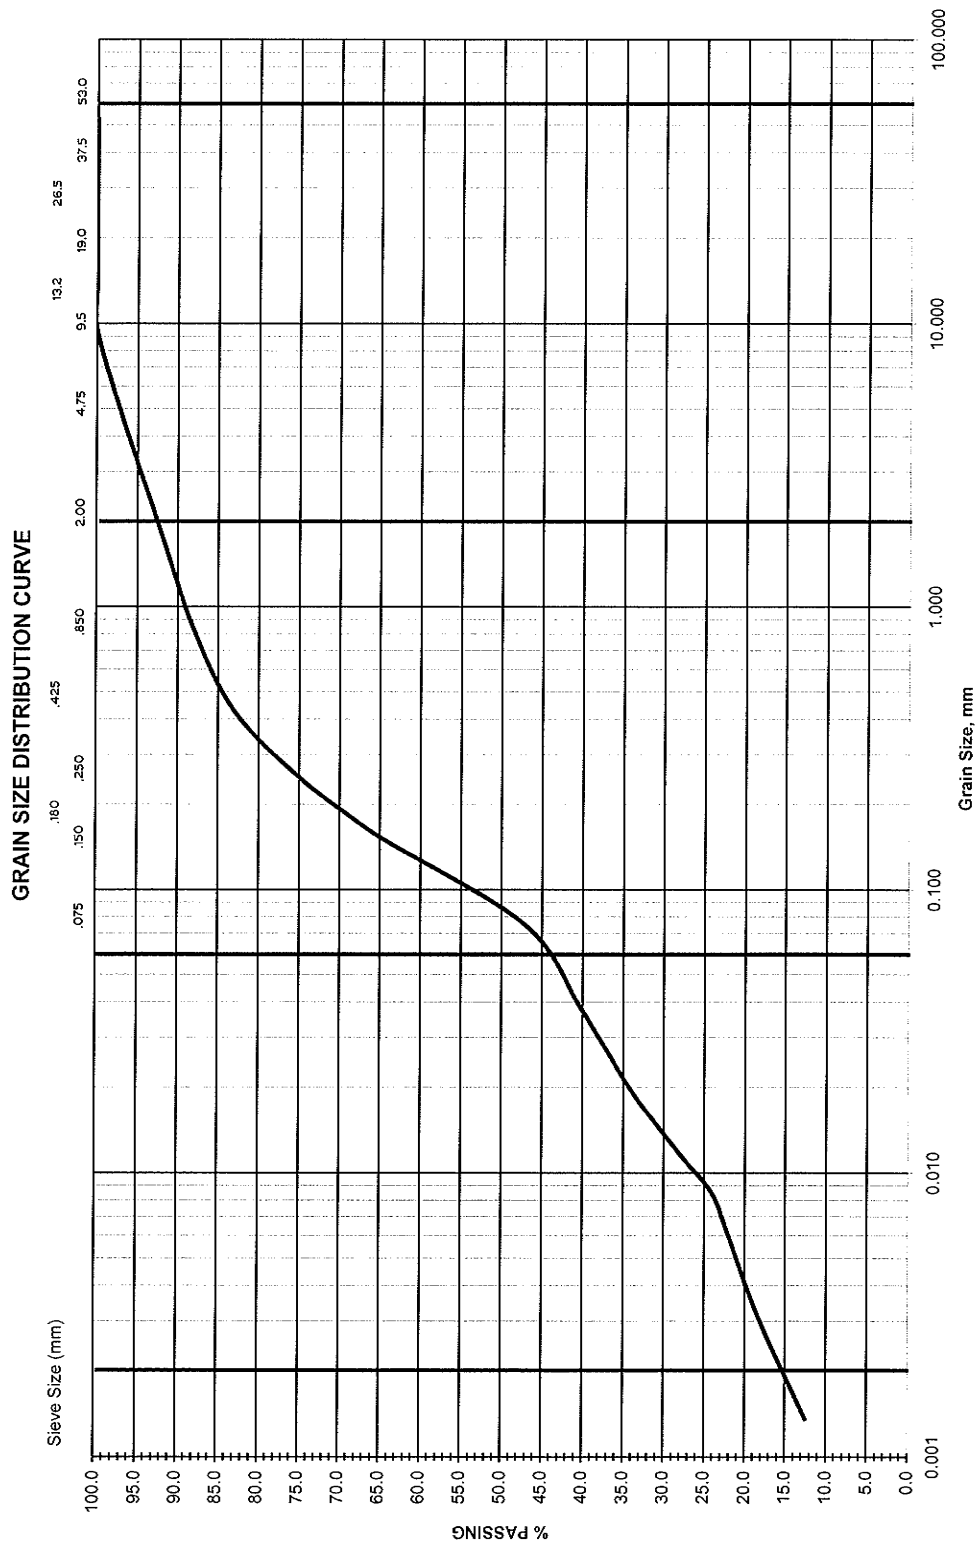
**FIGURE: 16**

PROJECT :	OTGE00019054B	NAME & LOCATION:			Proposed Sewage Lagoon - Arctic Bay, Nunavut (Existing Lagoon)		
DATE SAMPLED:	September 17, 2007	BOREHOLE No.:	BH 5	SAMPLE No.:	SS1	DEPTH ( m ):	0 to 0.5
SAMPLE DESCRIPTION:							
Silty sand, Some Clay, Trace Gravel (Topsoil)

The area of the proposed lagoon contains 50 mm to 400 mm of topsoil. A grain size analysis performed on a sample of the topsoil from Borehole 5 revealed a soil composition of 15 percent clay, 29 percent silt, 49 percent sand and 7 percent gravel (Figure 16). The topsoil in Boreholes 5, 7, 8 and 12 is underlain by a sand and gravel stratum which extends to 1.2 m to 2.8 m depth (Elevation 94.2 m to 95.7 m). Two grain size analyses performed on this stratum are given on Figures 17 and 18. A review of these figures indicates that this stratum contains 4 to 5 percent clay, 11 to 16 percent silt, 34 to 35 percent sand and 45 to 50 percent gravel. Its permeability varies from  $4 \times 10^{-4}$  cm/sec to  $1.7 \times 10^{-4}$  cm/sec.

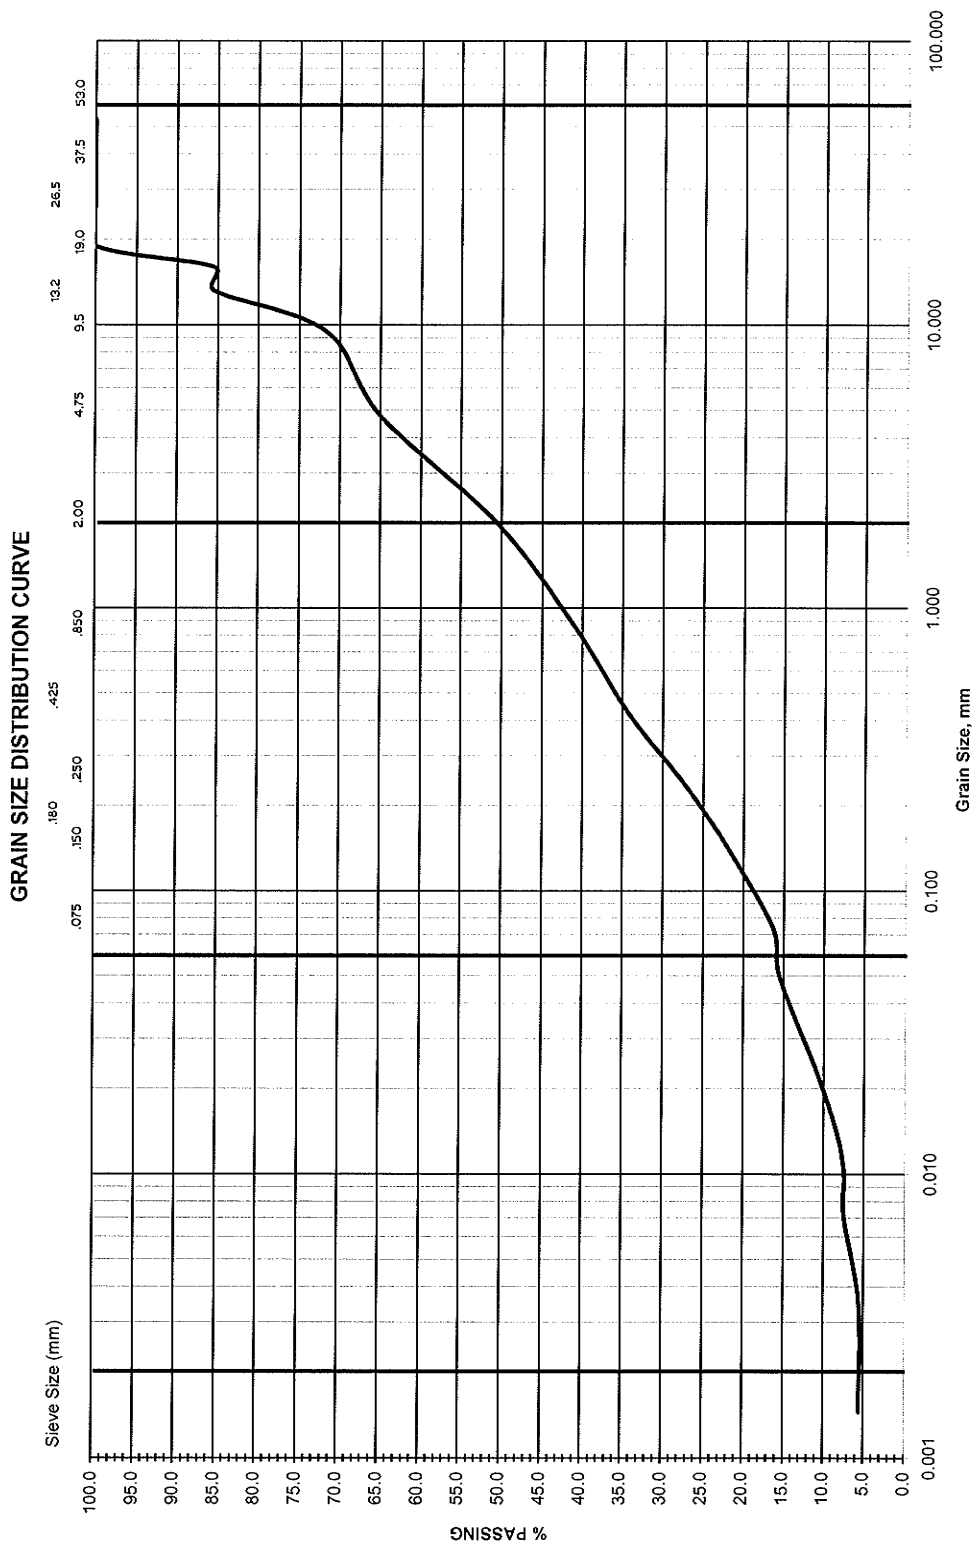
PROJECT :	OTGE00019054B	NAME & LOCATION:			Proposed Sewage Lagoon - Arctic Bay, Nunavut		
DATE SAMPLED:	September 17, 2007	BOREHOLE No.:	BH 8	SAMPLE No.:	SS1	DEPTH ( m ):	0 to 0.6
SAMPLE DESCRIPTION:							
Sandy Gravel, Trace Silt and Clay

Borehole #	Depth (m)	Soil Description	Estimated Permeability (cm/sec)	Figure No.
1	0.6 – 1.2	Sandy gravel, some silt (fill)	$2.5 \times 10^{-5}$	14
2	1.2 – 1.8	Gravel, some sand	$1.6 \times 10^{-3}$	15
5	0 – 0.6	Silty sand, some clay (topsoil)	$<1 \times 10^{-6}$	16
8	0.3 – 0.6	Sandy gravel, some silt	$4 \times 10^{-4}$	17
12	0.6 – 1.2	Sand and gravel, some silt	$1.7 \times 10^{-4}$	18
10	1.3 – 1.6	Sand, some silt and gravel	$3.6 \times 10^{-5}$	19
11	1.2 – 1.5	Gravelly sand, some silt, trace clay	$4 \times 10^{-6}$	20
9	0.6 – 1.2	Silty gravelly sand	$1.2 \times 10^{-5}$	21

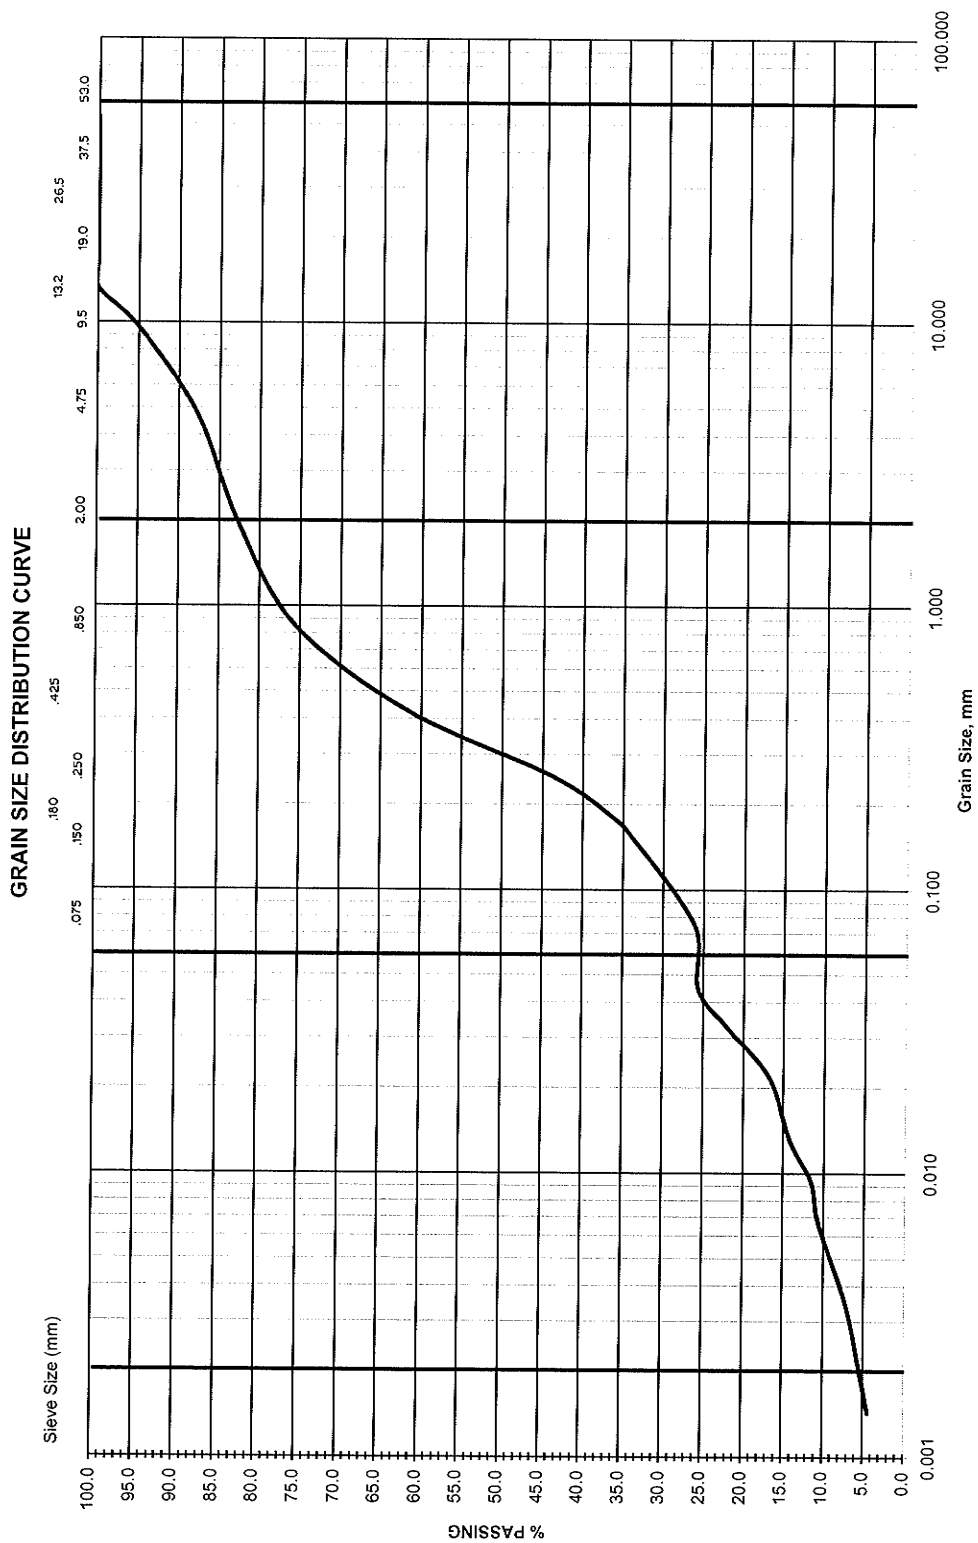
PROJECT :	OTGE00019054B	NAME & LOCATION:		Proposed Sewage Lagoon - Arctic Bay, Nunavut	
DATE SAMPLED:	September 17, 2007	BOREHOLE No.:	BH 10	SAMPLE No.:	SS2
SAMPLE DESCRIPTION:		DEPTH ( m ):			
		1.3 to 1.6			
Sand, Some Silt and Gravel, Trace Clay

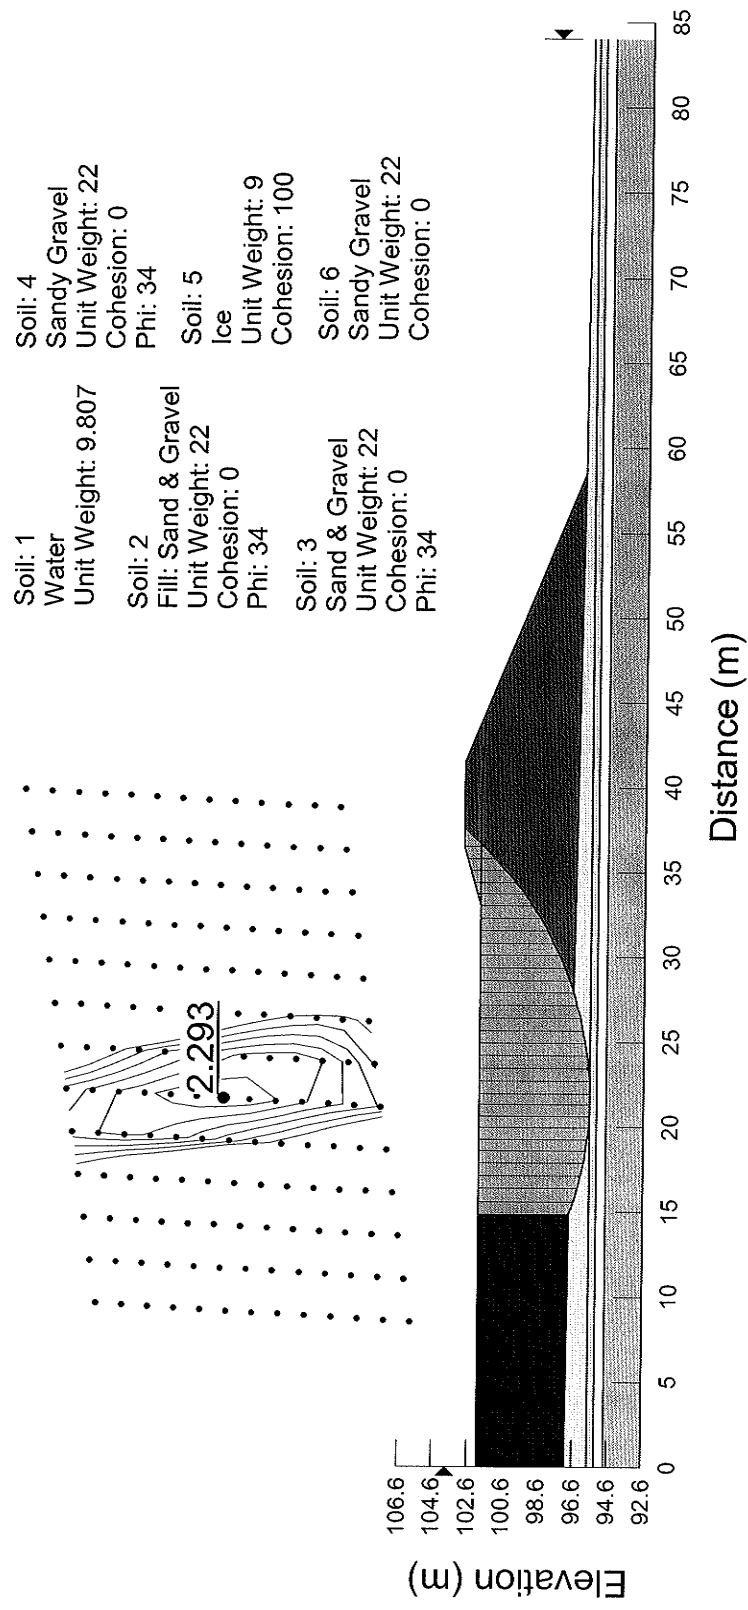
Figure 22

OTGE00019054B  
New Sewage Lagoon & Decommission of Existing Sewage Lagoon  
Arctic Bay  
Nunavut  
Slope Stability Analysis  
Section A-A  
Inner Slope @ 3.0H to 1V  
Completely Submerged

The results of the analyses are given on Figures 22 to 41 inclusive and have been tabulated on Table 3.

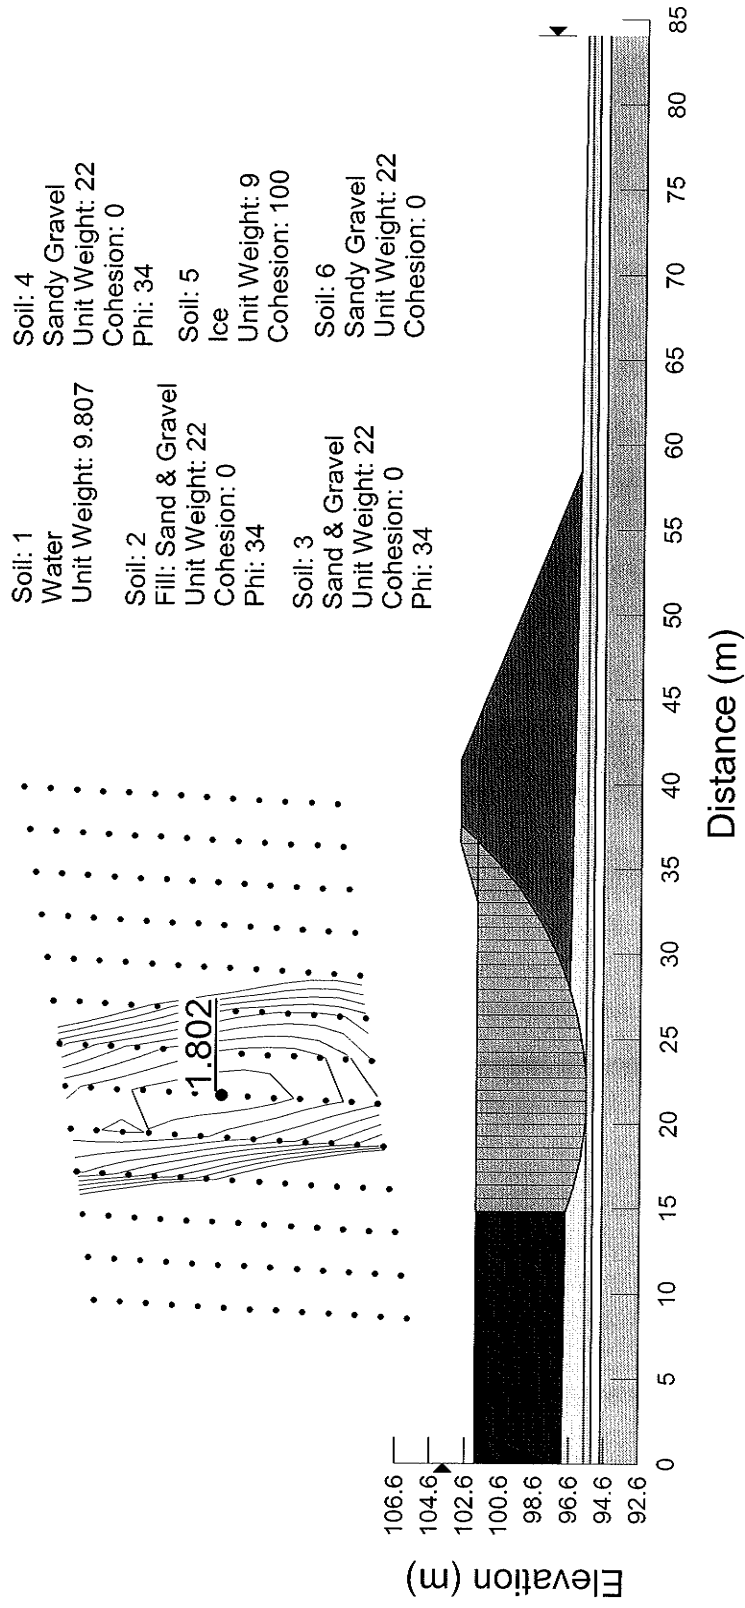
Figure 23

OTGE00019054B  
 New Sewage Lagoon & Decommission of Existing Sewage Lagoon  
 Arctic Bay  
 Nunavut  
 Slope Stability Analysis  
 Section A-A  
 Inner Slope @ 3.0H to 1V  
 Completely Submerged  
 Seismic = 0.05g

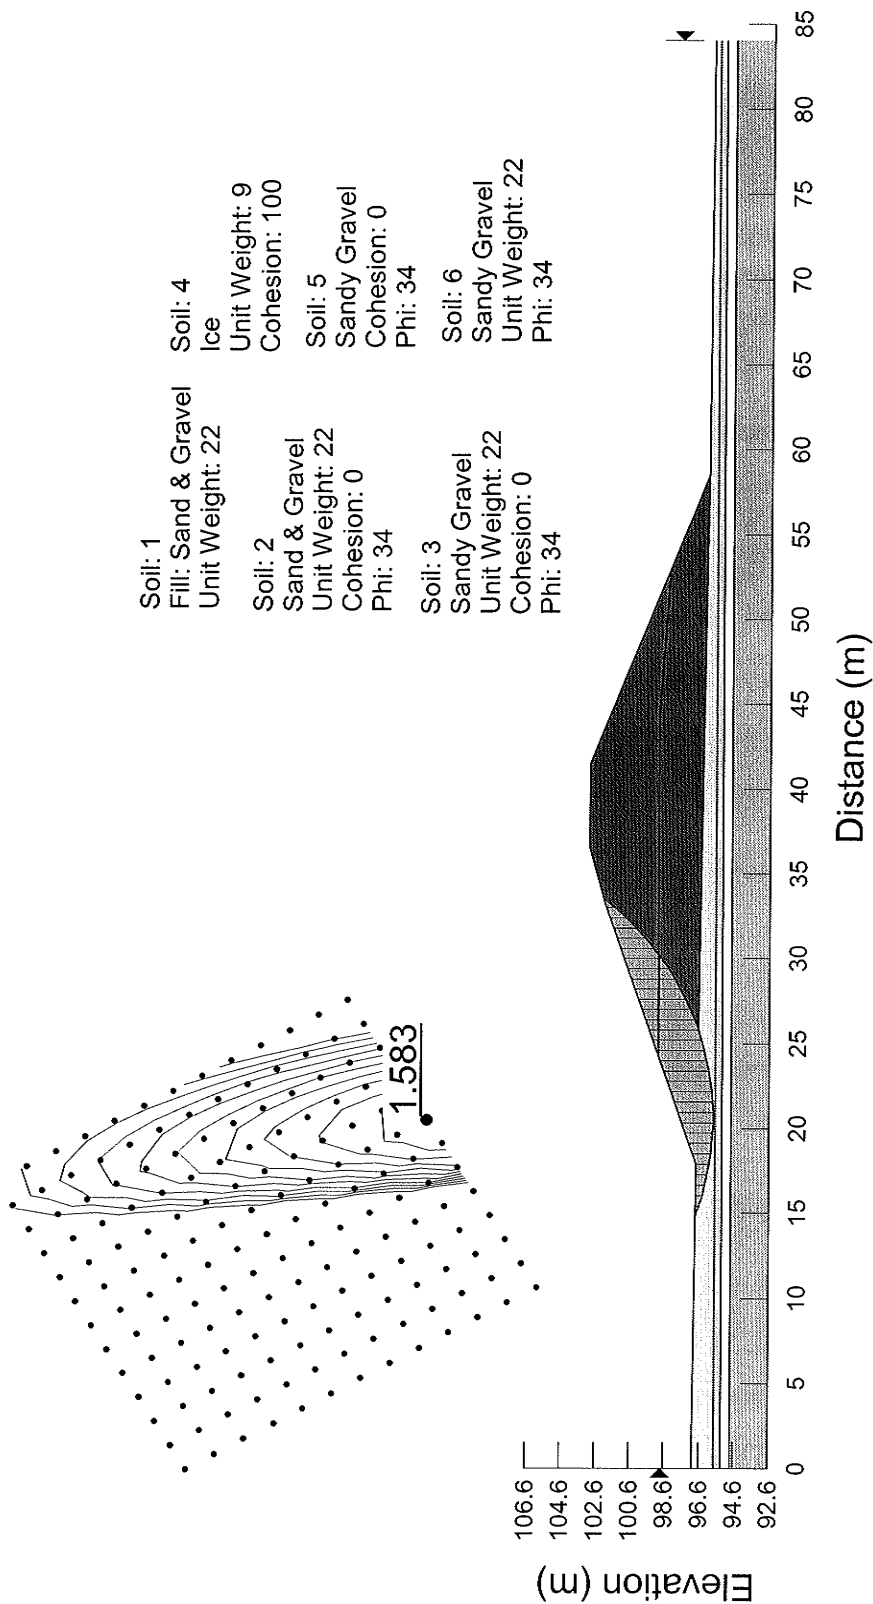
Figure 24

OTGE00019054B  
New Sewage Lagoon & Decommission of Existing Sewage Lagoon  
Arctic Bay  
Nunavut  
Slope Stability Analysis  
Section A-A  
Inner Slope @ 3.0H to 1V  
Water in Berm at 99.0, Lagoon Empty

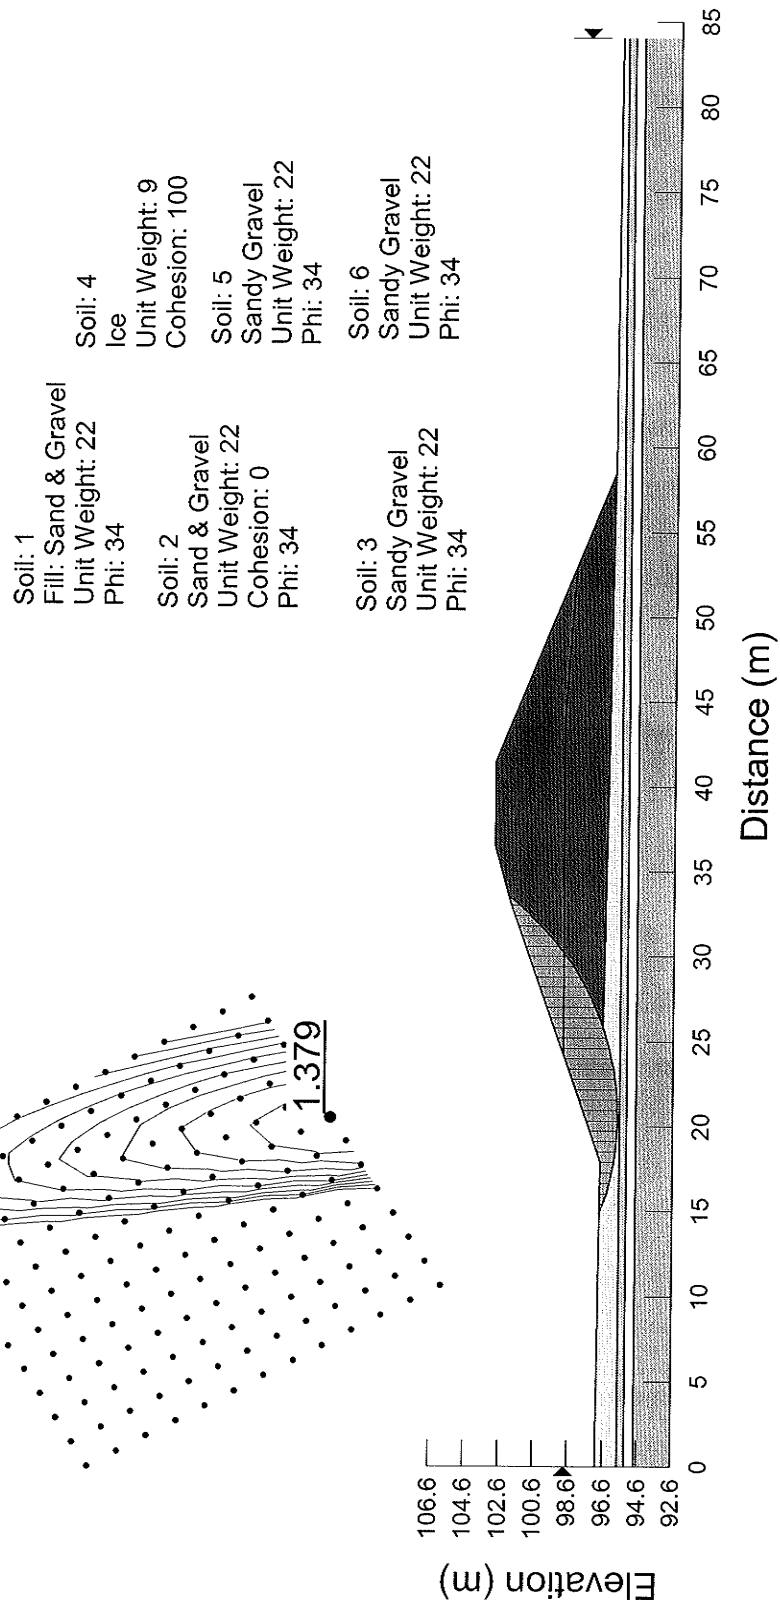
Figure 25

OTGE00019054B  
 New Sewage Lagoon & Decommission of Existing Sewage Lagoon  
 Arctic Bay  
 Nunavut  
 Slope Stability Analysis  
 Section A-A  
 Inner Slope @ 3.0H to 1V  
 Water in Berm at 99.0 Lagoon Empty  
 Seismic = 0.05g

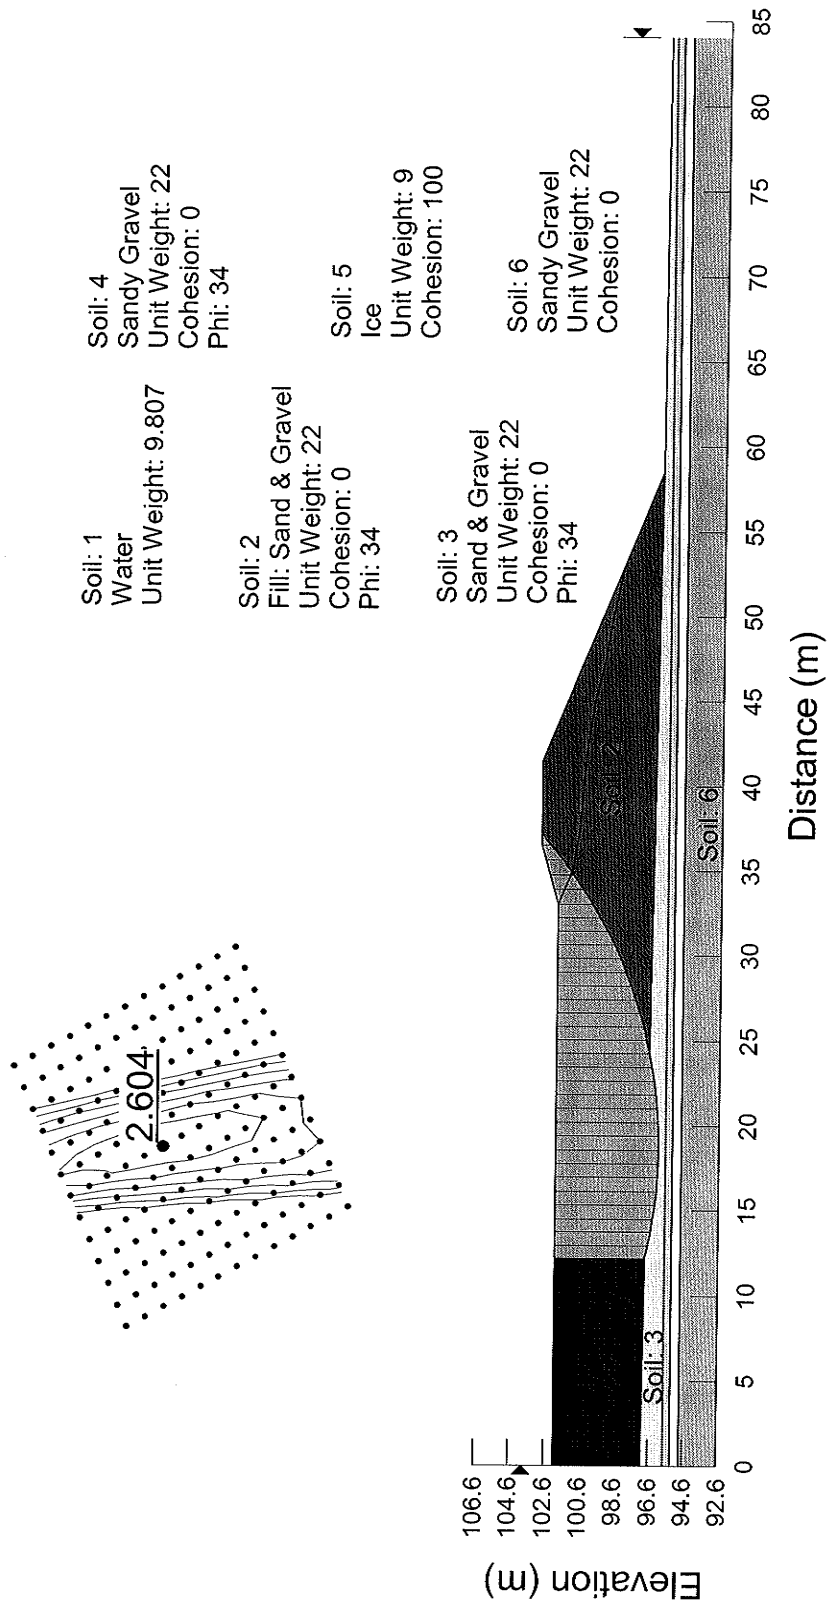
Figure 26

OTGE00019054B  
 New Sewage Lagoon & Decommission of Existing Sewage Lagoon  
 Arctic Bay  
 Nunavut  
 Slope Stability Analysis  
 Section A-A  
 Inner Slope @ 3.5H to 1V  
 Completely Submerged

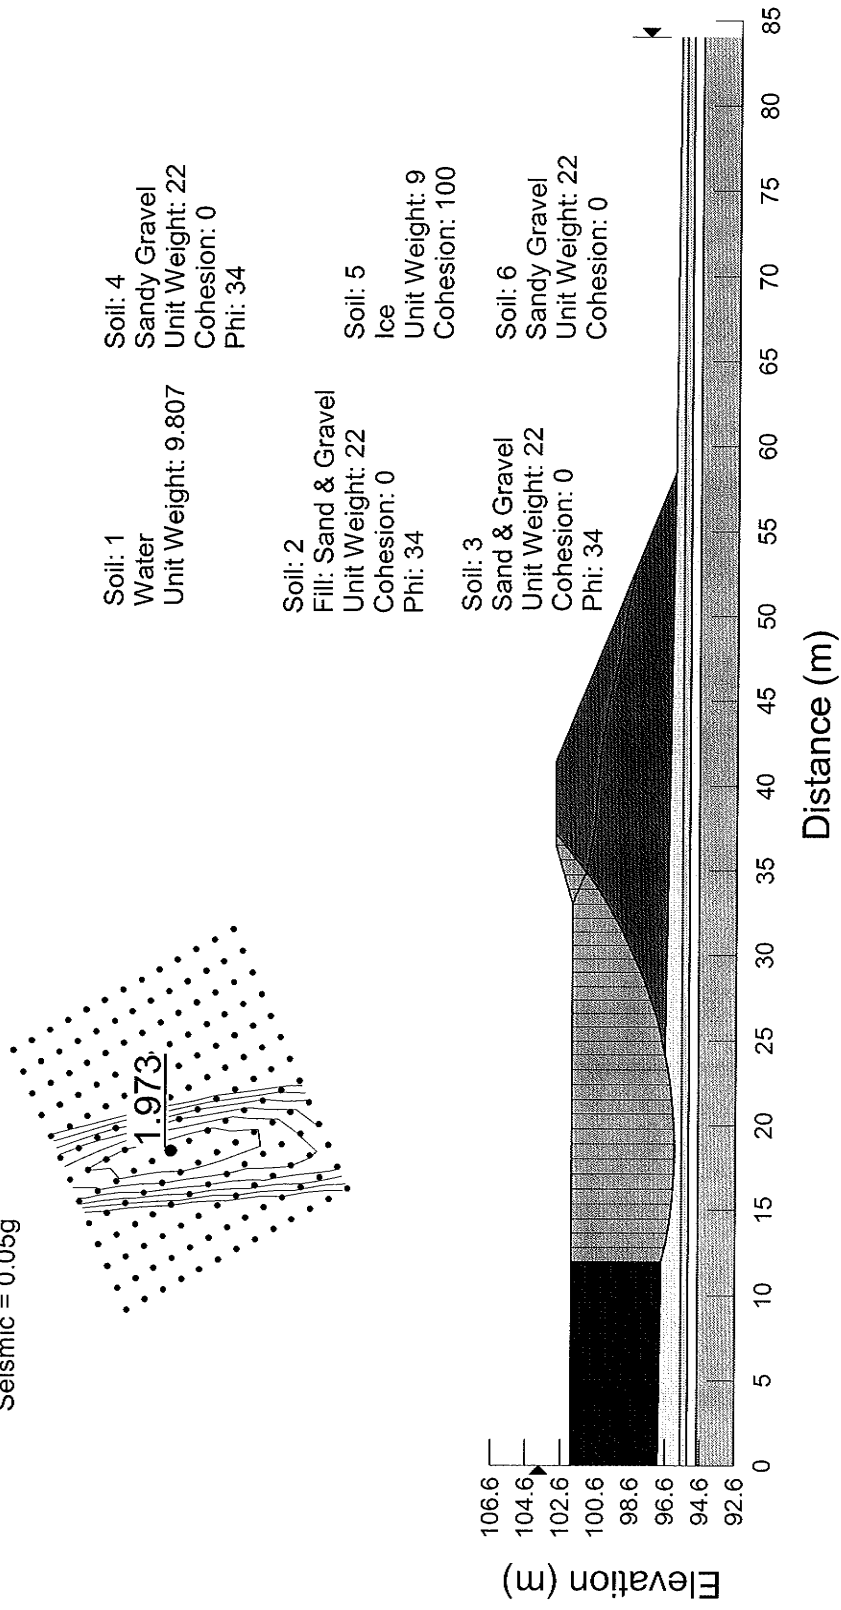
Figure 27

OTGE00019054B  
 New Sewage Lagoon & Decommission of Existing Sewage Lagoon  
 Arctic Bay  
 Nunavut  
 Slope Stability Analysis  
 Section A-A  
 Inner Slope @ 3.5H to 1V  
 Completely Submerged  
 Seismic = 0.05g

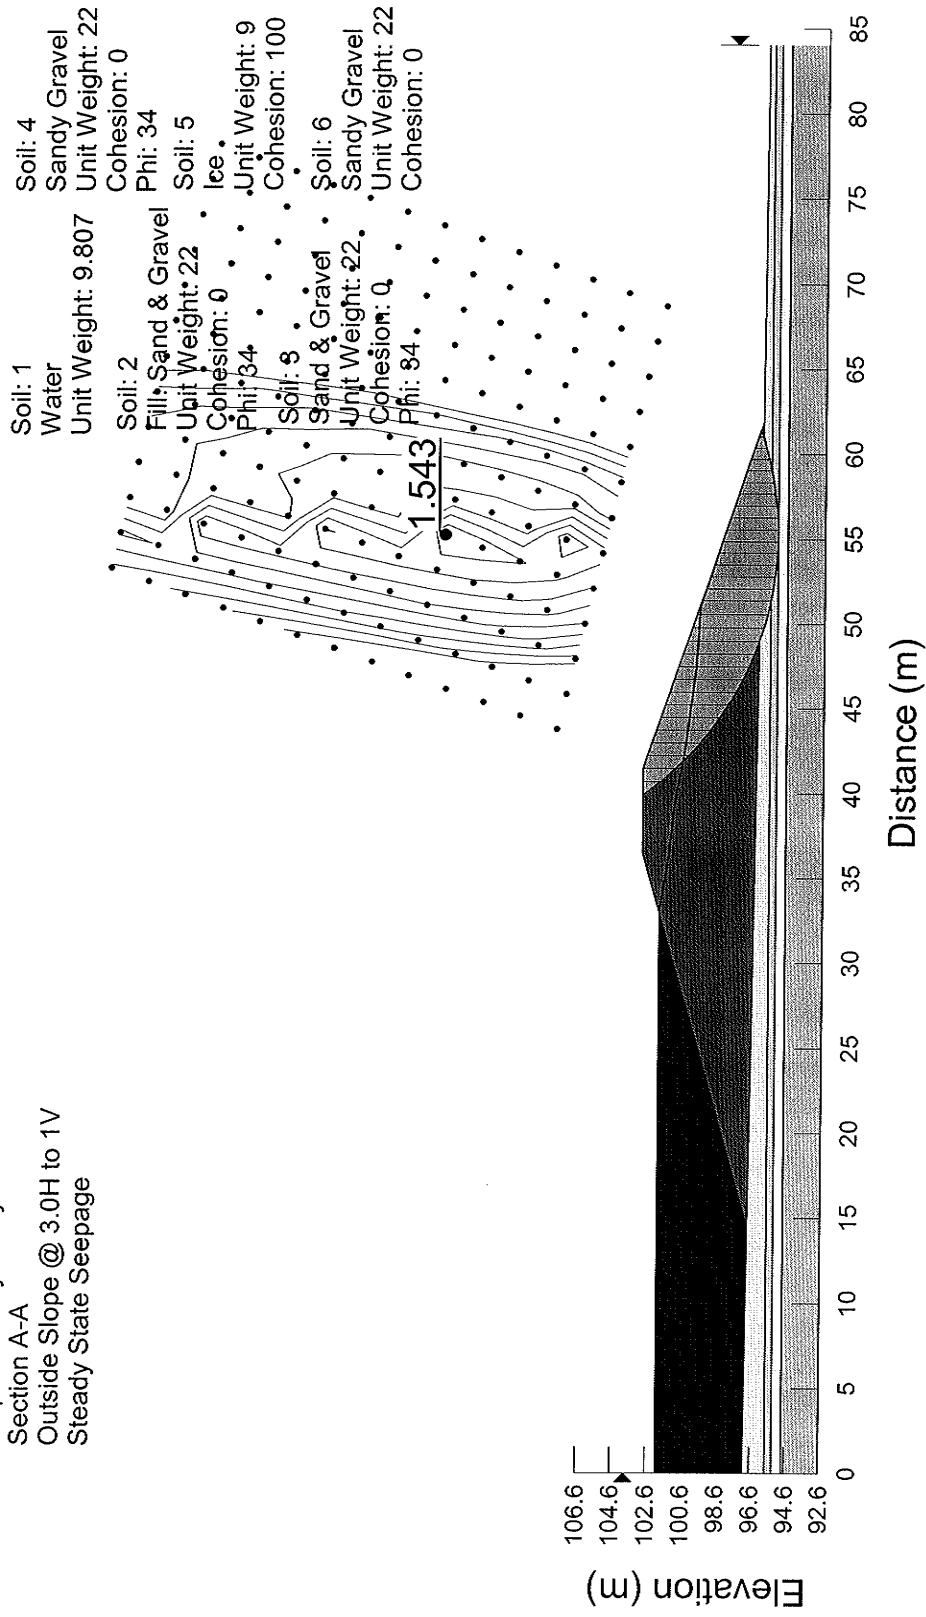
Figure 28

OTGE00019054B  
 New Sewage Lagoon & Decommission of Existing Sewage Lagoon  
 Arctic Bay  
 Nunavut  
 Slope Stability Analysis  
 Section A-A  
 Outside Slope @ 3.0H to 1V  
 Steady State Seepage

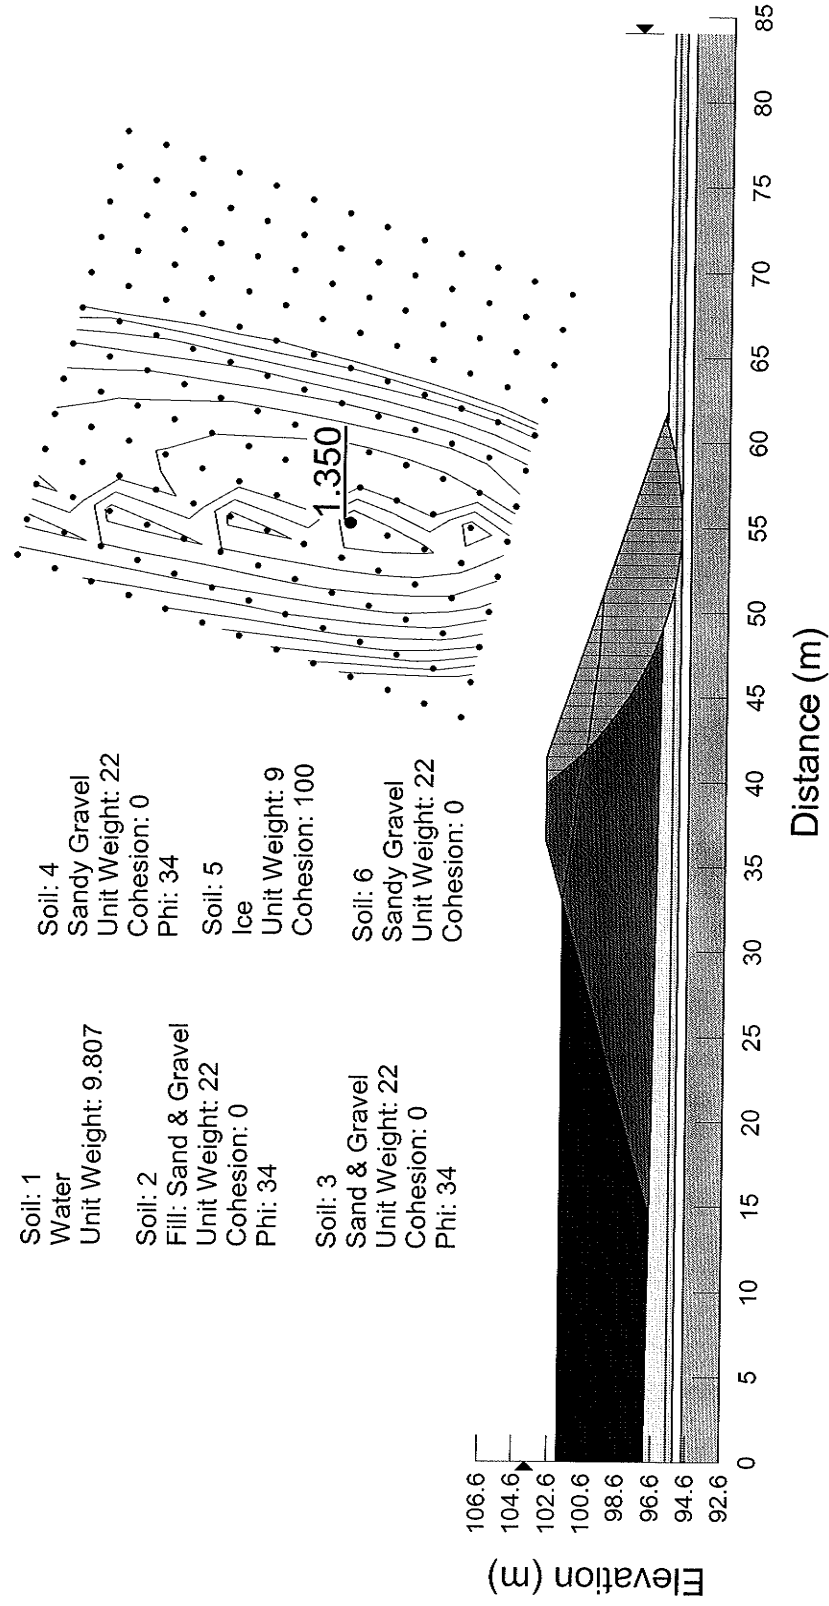
Figure 29

OTGE00019054B  
New Sewage Lagoon & Decommission of Existing Sewage Lagoon  
Arctic Bay  
Nunavut  
Slope Stability Analysis  
Section A-A  
Outside Slope @ 3H to 1V  
Steady State Seepage  
Seismic = 0.05 g

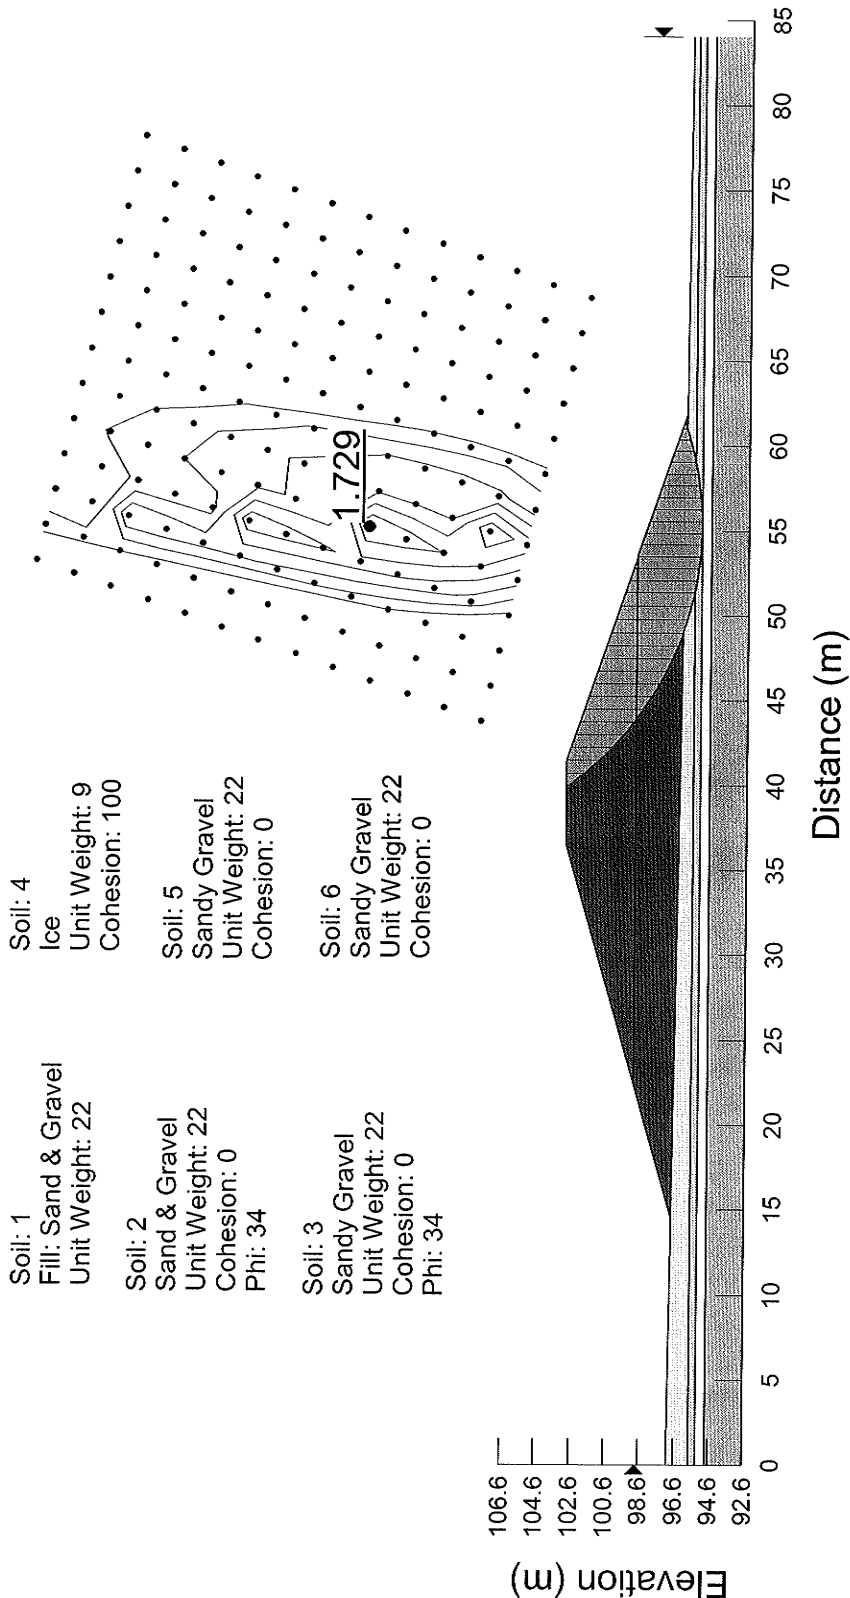
Figure 30

OTGE00019054B  
New Sewage Lagoon & Decommission of Existing Sewage Lagoon  
Arctic Bay  
Nunavut  
Slope Stability Analysis  
Section A-A  
Outside Slope @ 3.0H to 1V  
Pond Empty- Water at 99.0 m

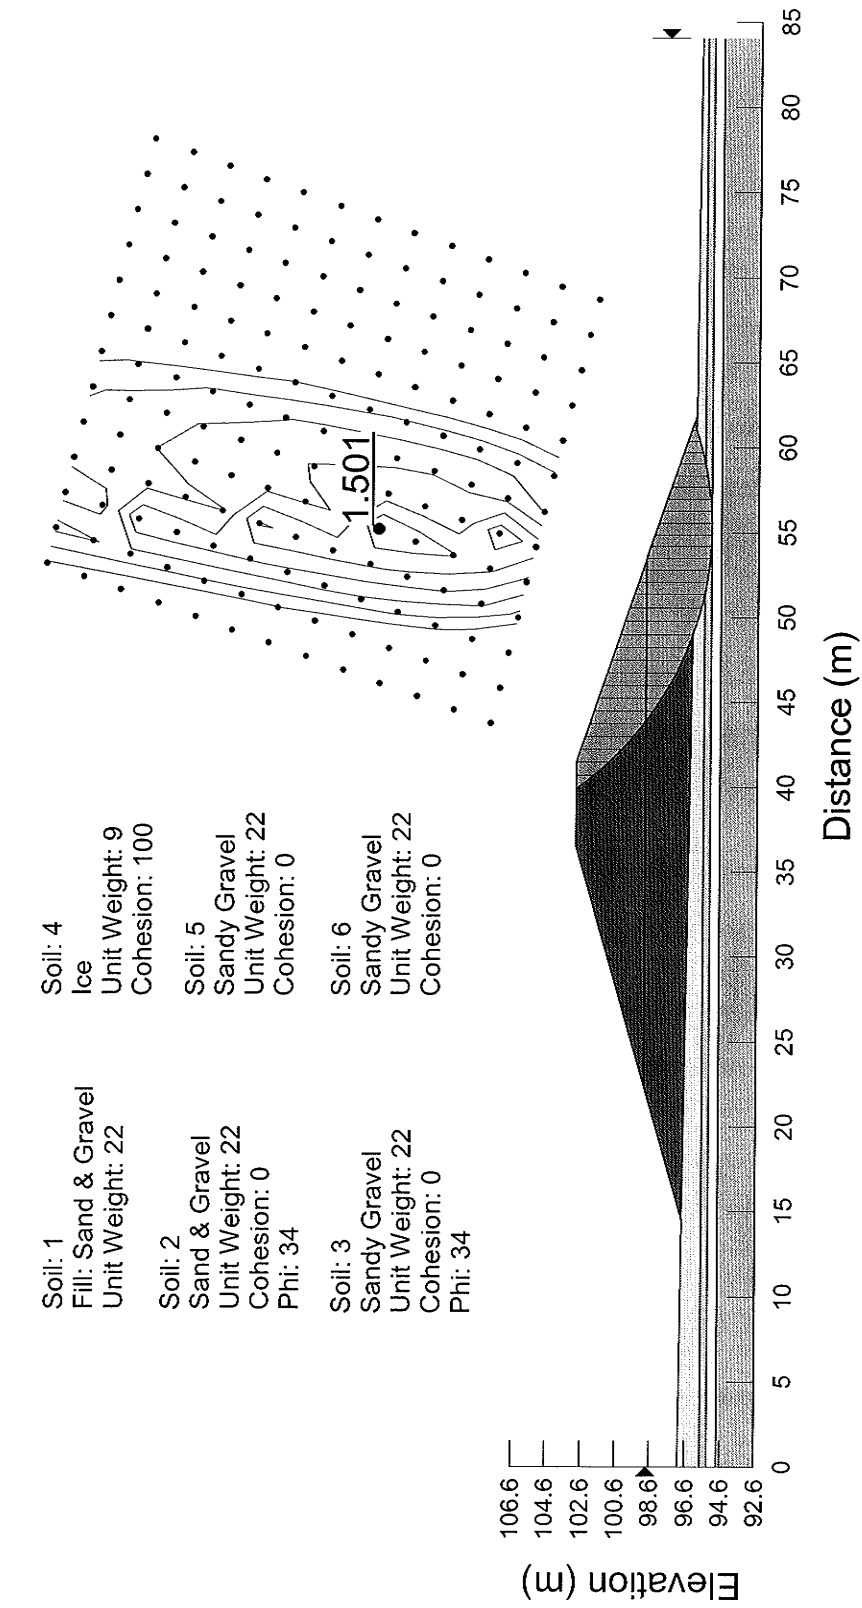
Figure 31

OTGE00019054B  
 New Sewage Lagoon & Decommission of Existing Sewage Lagoon  
 Arctic Bay  
 Nunavut  
 Slope Stability Analysis  
 Section A-A  
 Pond Empty- Water at 99.0 m  
 Seismic = 0.05g

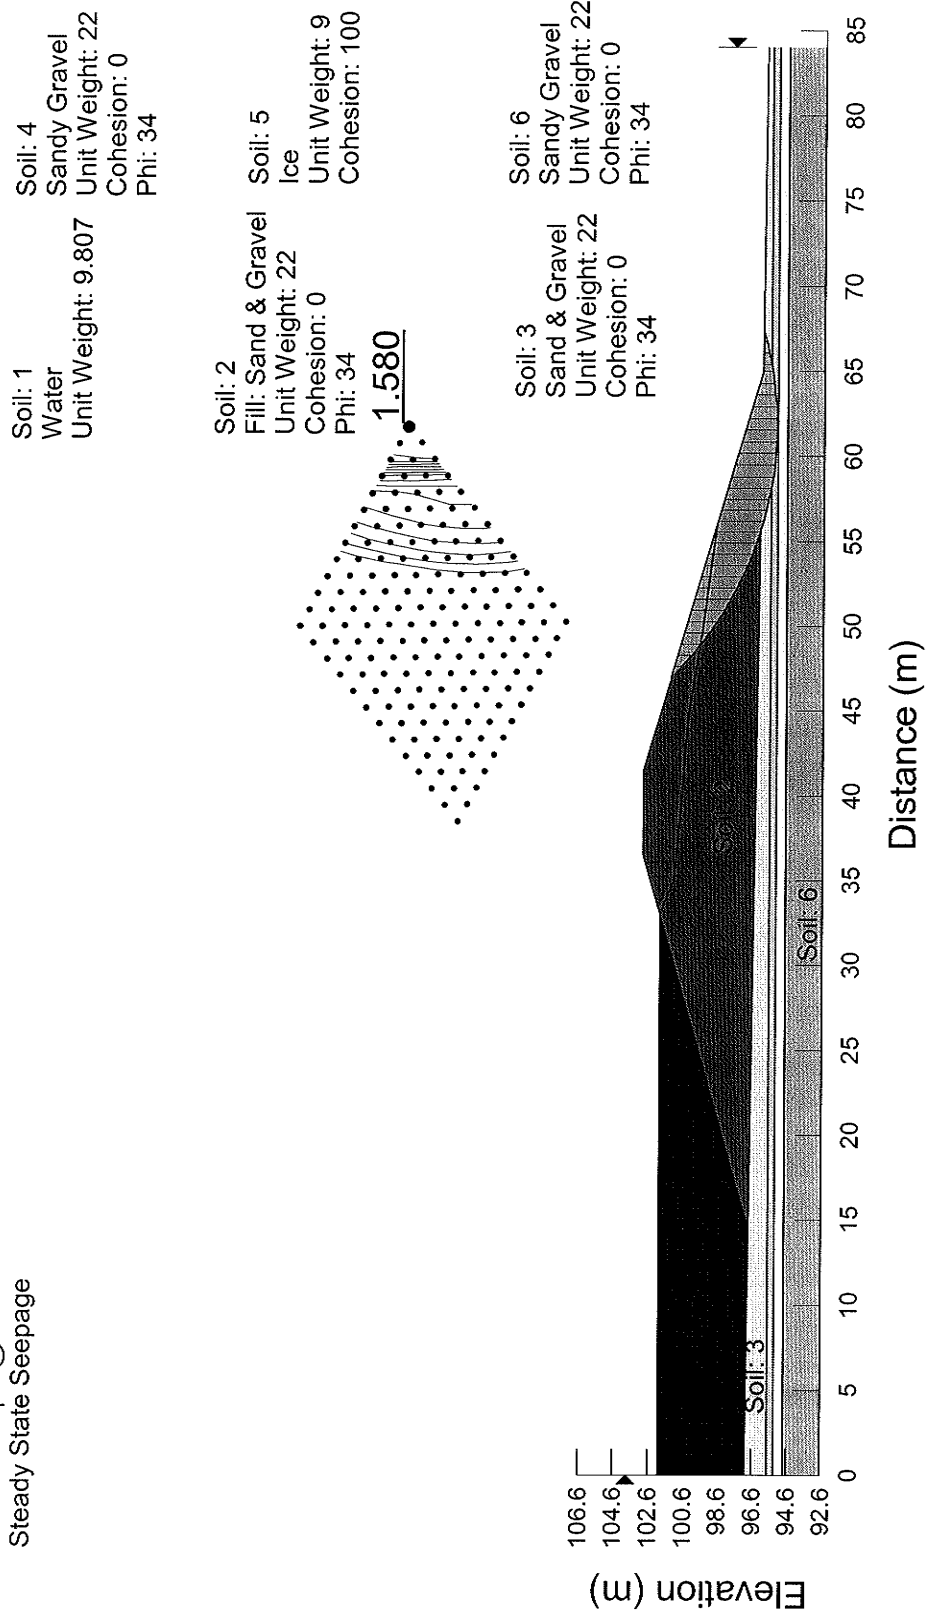
Figure 32

OTGE00019054B  
 New Sewage Lagoon & Decommission of Existing Sewage Lagoon  
 Arctic Bay  
 Nunavut  
 Slope Stability Analysis  
 Section A-A  
 Outside Slope @ 3.5H to 1V  
 Steady State Seepage

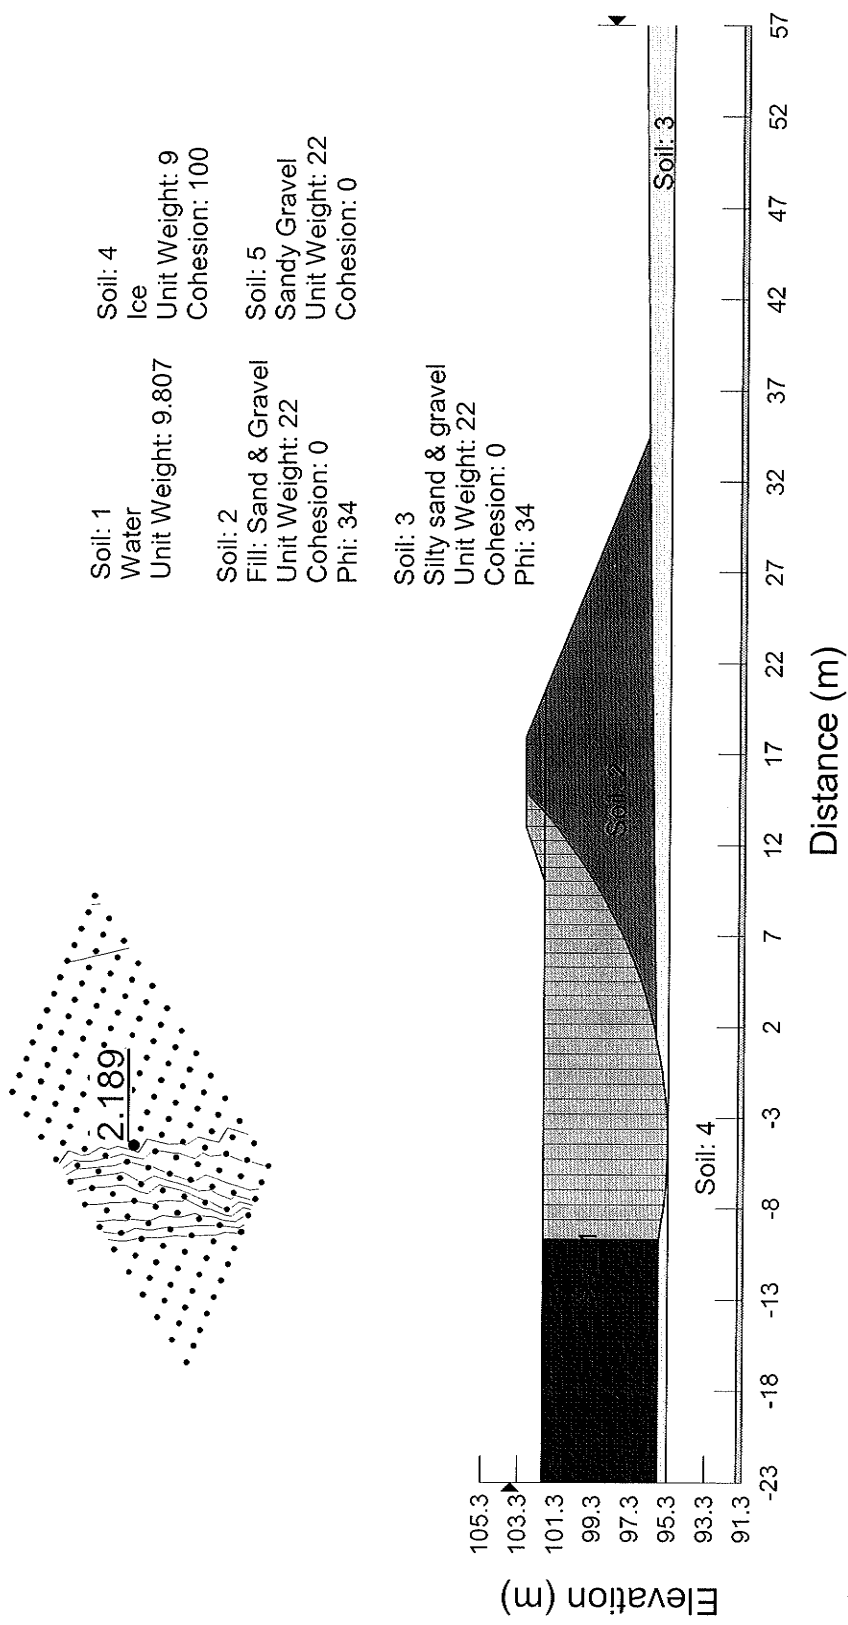
Figure 34

OTGE00019054B  
New Sewage Lagoon & Decommission of Existing Sewage Lagoon  
Arctic Bay  
Nunavut  
Slope Stability Analysis  
Section B-B  
Inner Slope @ 3H to 1V  
Completely Submerged
