**Geotechnical Investigation  
Sewage Lagoon  
Hamlet of Arctic Bay, Nunavut**

Prepared for:  
**Government of Nunavut  
Department of Community and Government Services  
Project Management Division – Baffin Region**

OTGE00019054B  
April 24, 2008

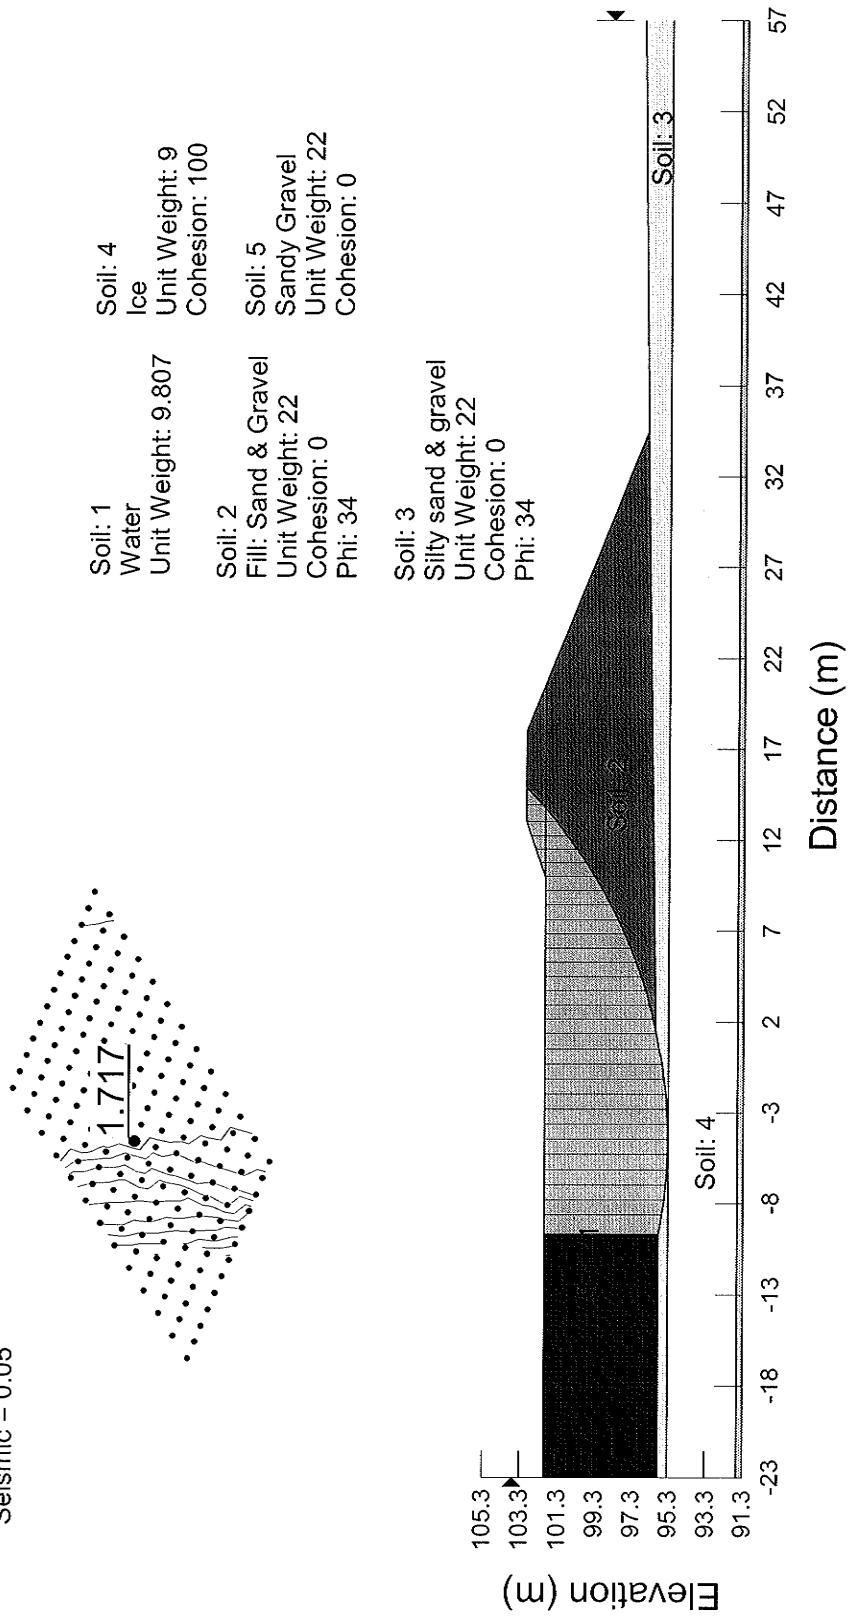
Figure 35

OTGE00019054B  
 New Sewage Lagoon & Decommission of Existing Sewage Lagoon  
 Arctic Bay  
 Nunavut  
 Slope Stability Analysis  
 Section B-B  
 Inner Slope @ 3H to 1V  
 Completely Submerged  
 Seismic = 0.05

The results of the analyses are given on Figures 22 to 41 inclusive and have been tabulated on Table 3.

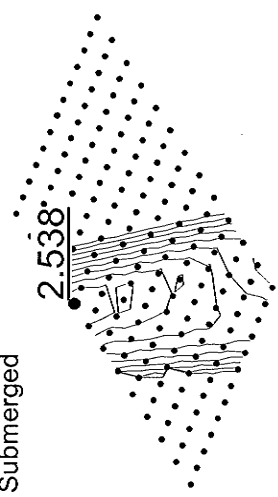
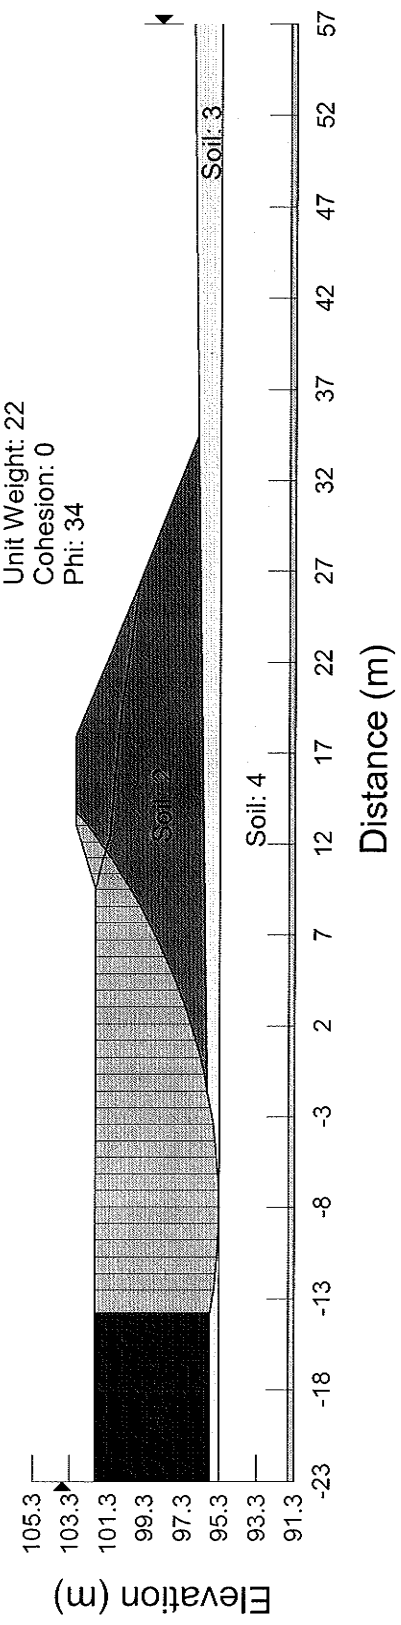
Figure 36

OTGE00019054B  
New Sewage Lagoon & Decommission of Existing Sewage Lagoon  
Arctic Bay  
Nunavut  
Slope Stability Analysis  
Section B-B  
Inner Slope @ 3.5H to 1V  
Completely Submerged

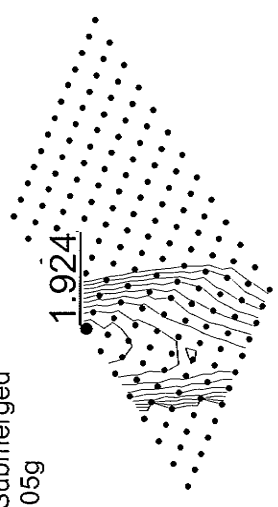
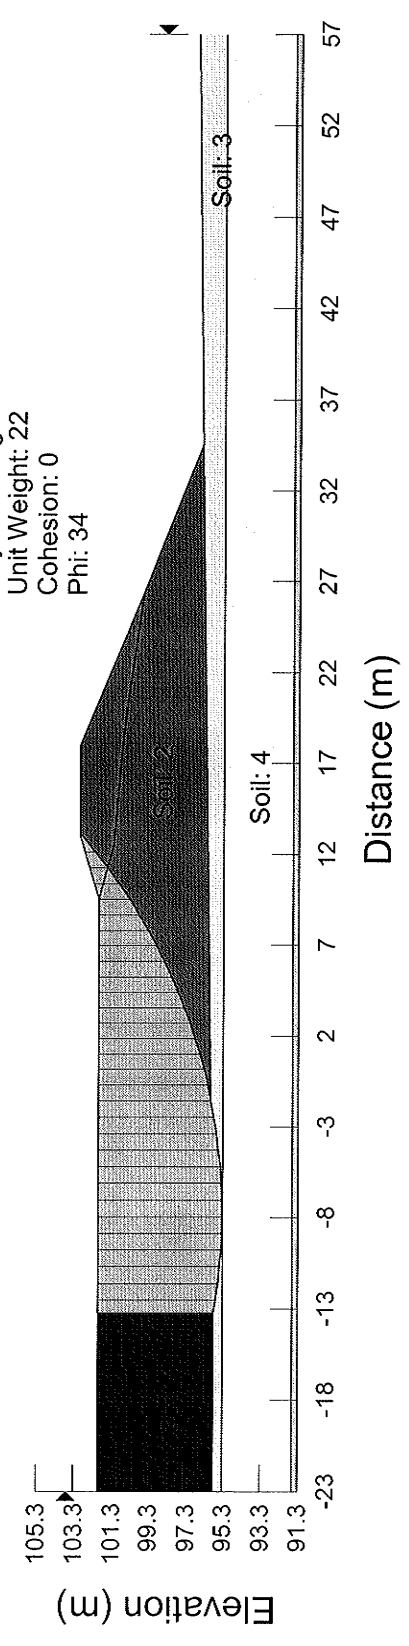
Figure 37

OTGE00019054B  
New Sewage Lagoon & Decommission of Existing Sewage Lagoon  
Arctic Bay  
Nunavut  
Slope Stability Analysis  
Section B-B  
Inner Slope @ 3.5H to 1V  
Completely Submerged  
Seismic = 0.05g

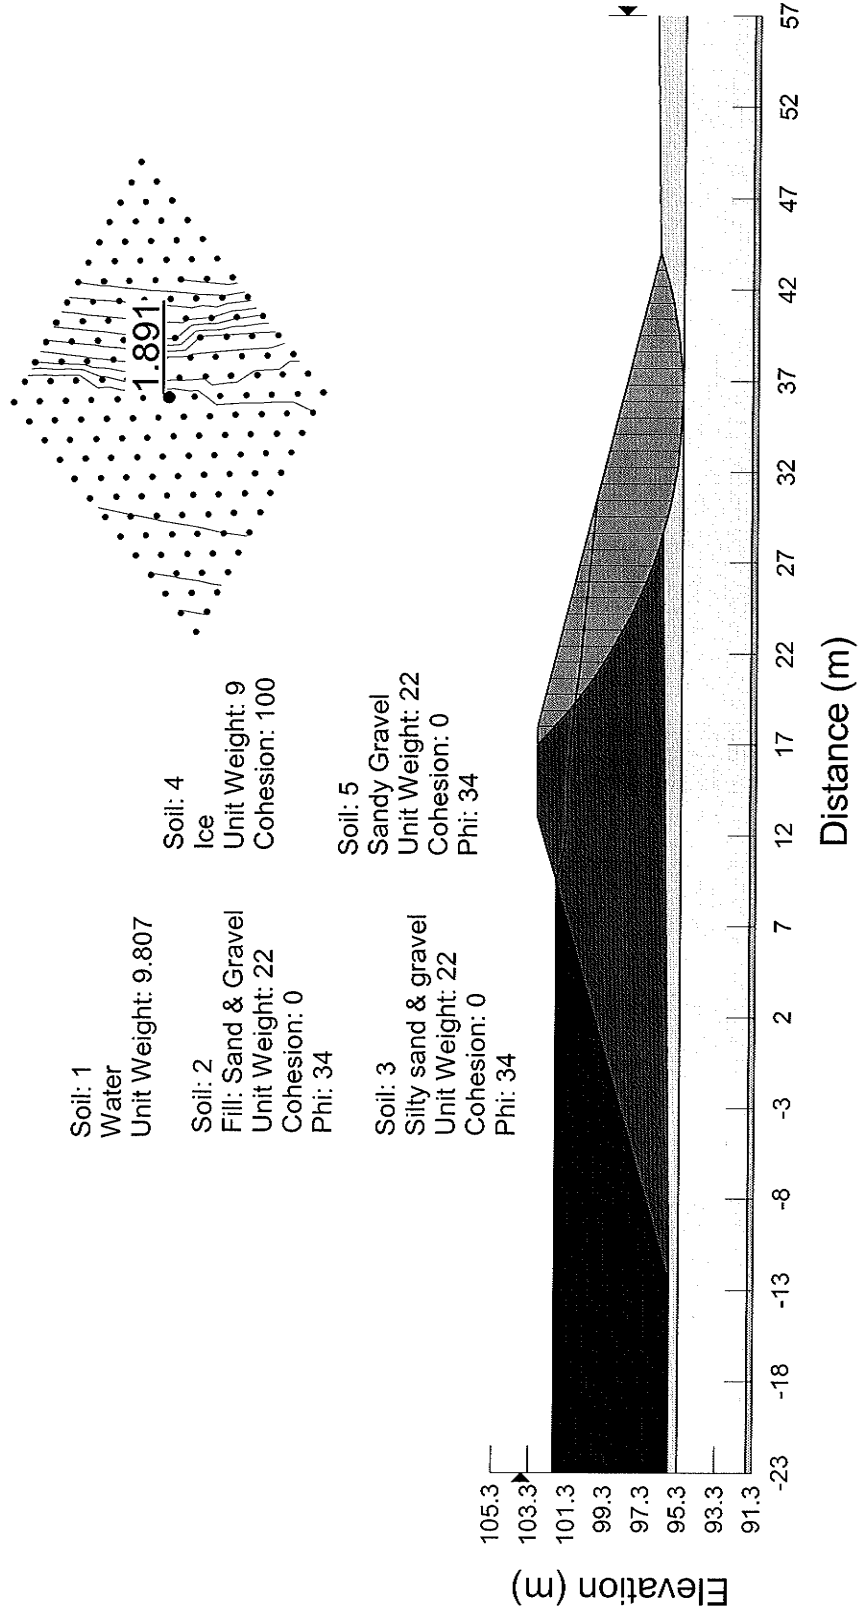
Figure 40

OTGE00019054B  
 New Sewage Lagoon & Decommission of Existing Sewage Lagoon  
 Arctic Bay  
 Nunavut  
 Slope Stability Analysis  
 Section B-B  
 Outside Slope @ 4H to 1V  
 Steady State Seepage

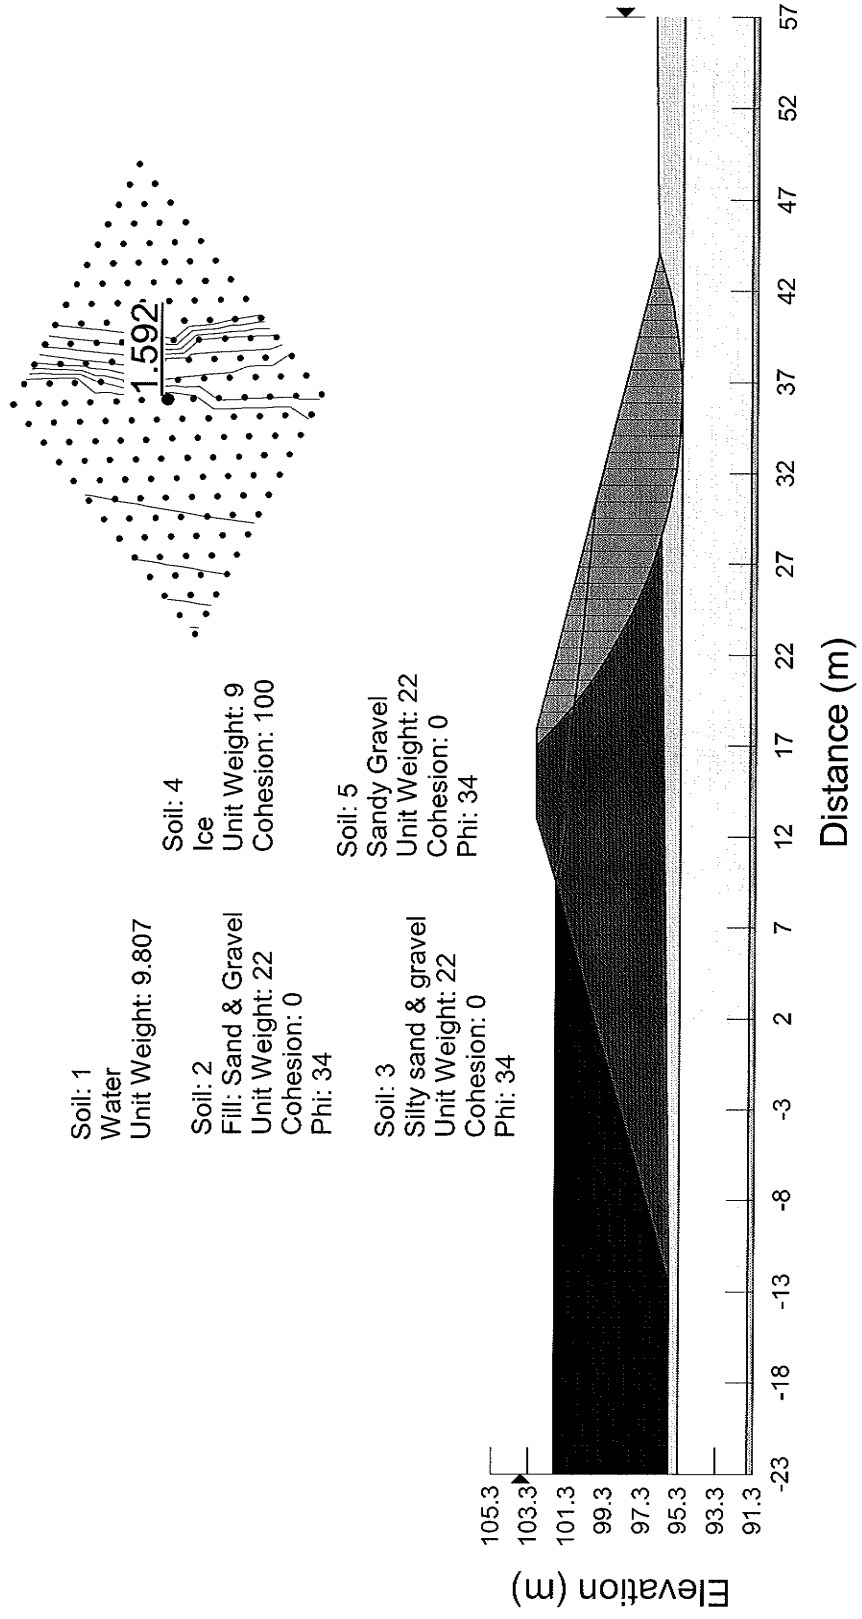
Figure 41

OTGE00019054B  
 New Sewage Lagoon & Decommission of Existing Sewage Lagoon  
 Arctic Bay  
 Nunavut  
 Slope Stability Analysis  
 Section B-B  
 Outside Slope @ 4H to 1V  
 Steady State Seepage  
 Seismic = 0.05

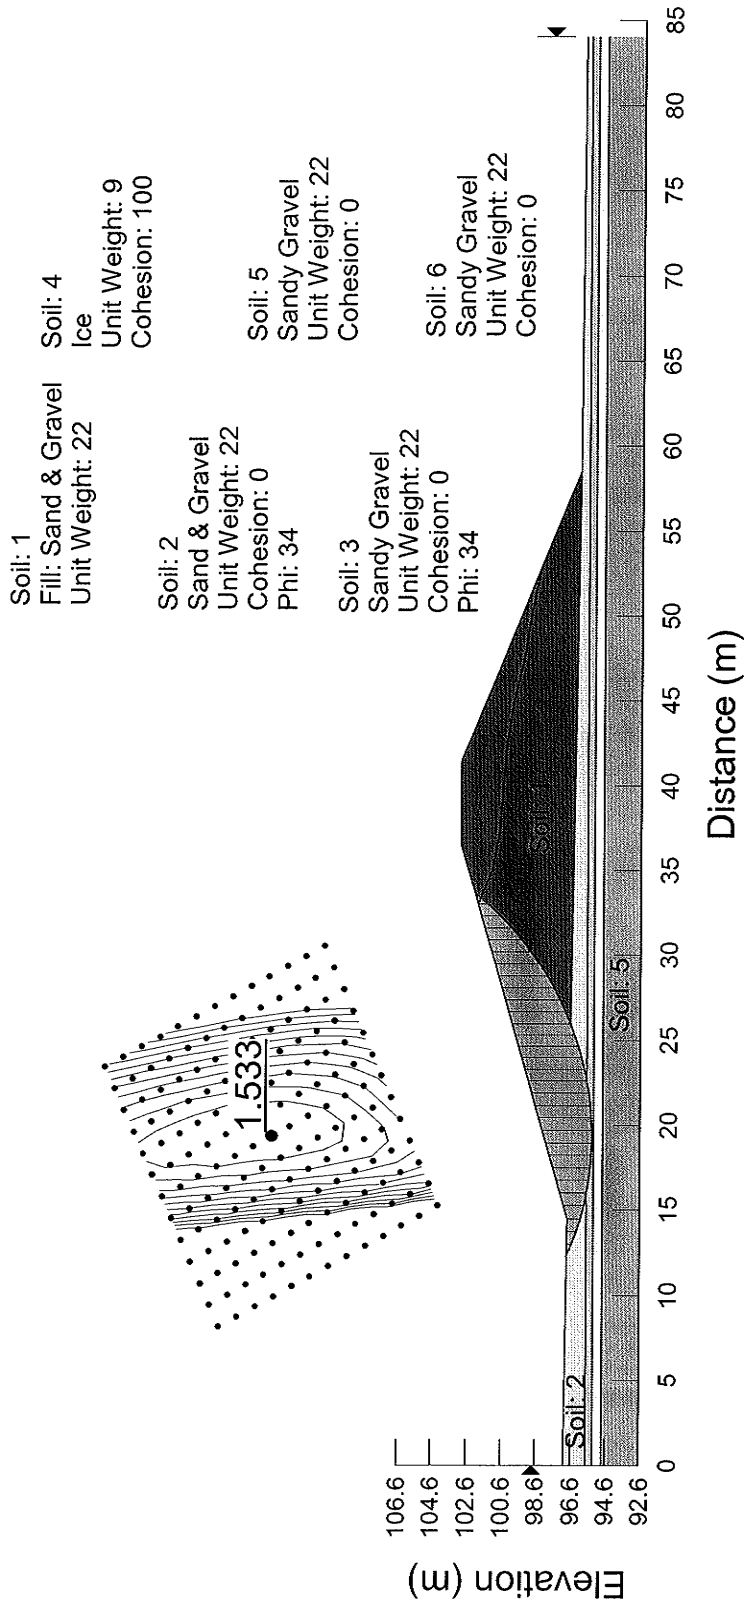
Figure 42

OTGE00019054B  
 New Sewage Lagoon & Decommission of Existing Sewage Lagoon  
 Arctic Bay  
 Nunavut  
 Slope Stability Analysis  
 Section A-A  
 Inner Slope @ 3.5H to 1V  
 Rapid Drawdown

Section	Slope Inclination	Loading Condition	Computed Factor of Safety	Figure #
AA	3.5H:1V	Static	1.53	42
AA	3.5H:1V	Seismic	1.33	43
BB	4H:1V	Static	1.51	44
BB	4H:1V	Seismic	1.29	45

A review of Table 4 indicates that an upstream slope of 3.5H:1V would have adequate factor of safety for the rapid drawdown condition in the case of the southeast berm. A slope inclination of 4H:1V would have adequate factor of safety against the rapid drawdown condition in the case of the northwest berm. Consequently, if the berms are to be designed to satisfy rapid drawdown conditions, the inside slope of the southeast berm should be constructed at a slope of 3.5H:1V whereas the inside slope of the northwest berm should be constructed at an inclination of 4H:1V.

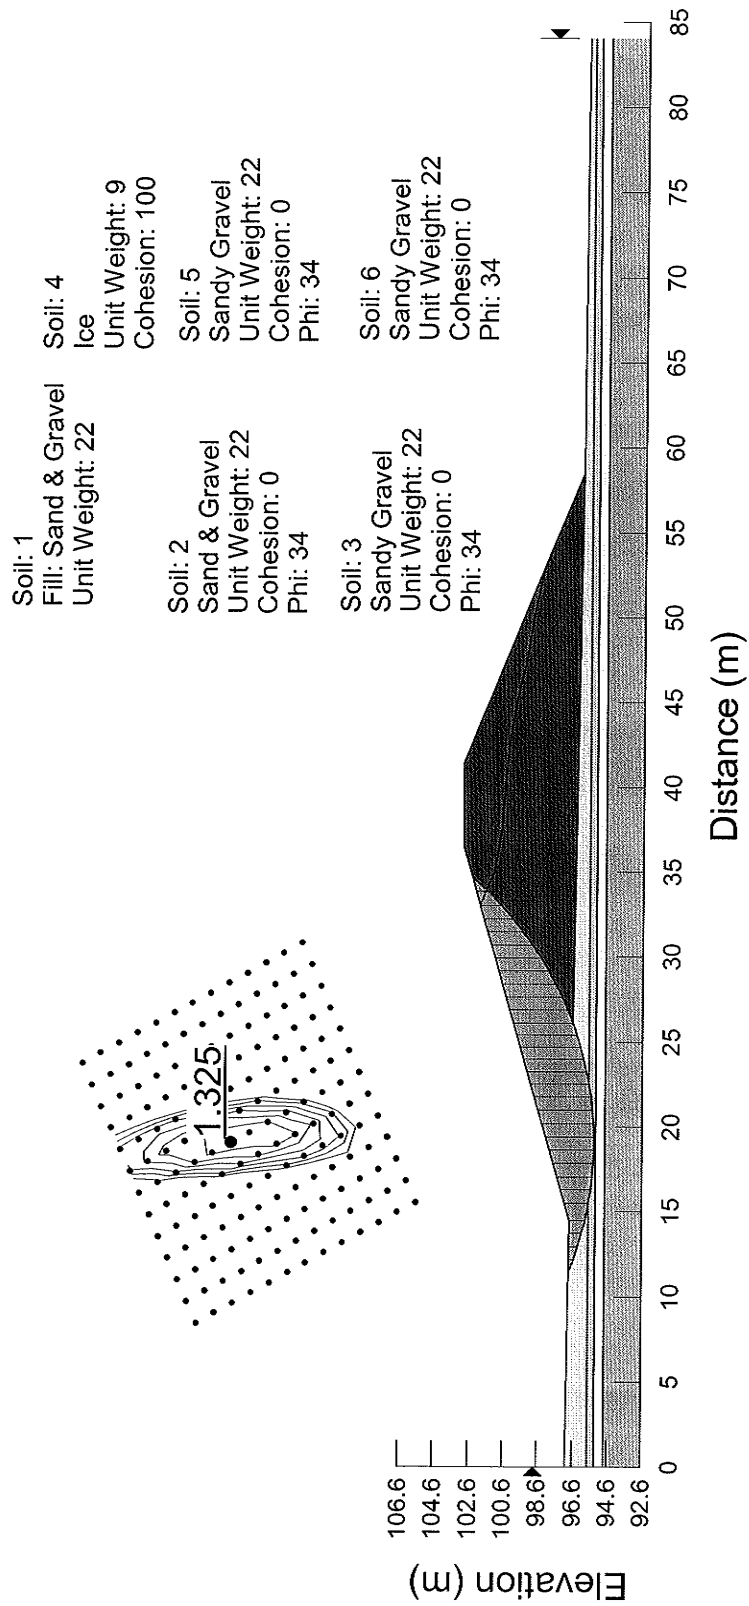
Figure 43

OTGE00019054B  
 New Sewage Lagoon & Decommission of Existing Sewage Lagoon  
 Arctic Bay  
 Nunavut  
 Slope Stability Analysis  
 Section A-A  
 Inner Slope @ 3.5H to 1V  
 Rapid Drawdown  
 Seismic = 0.05g

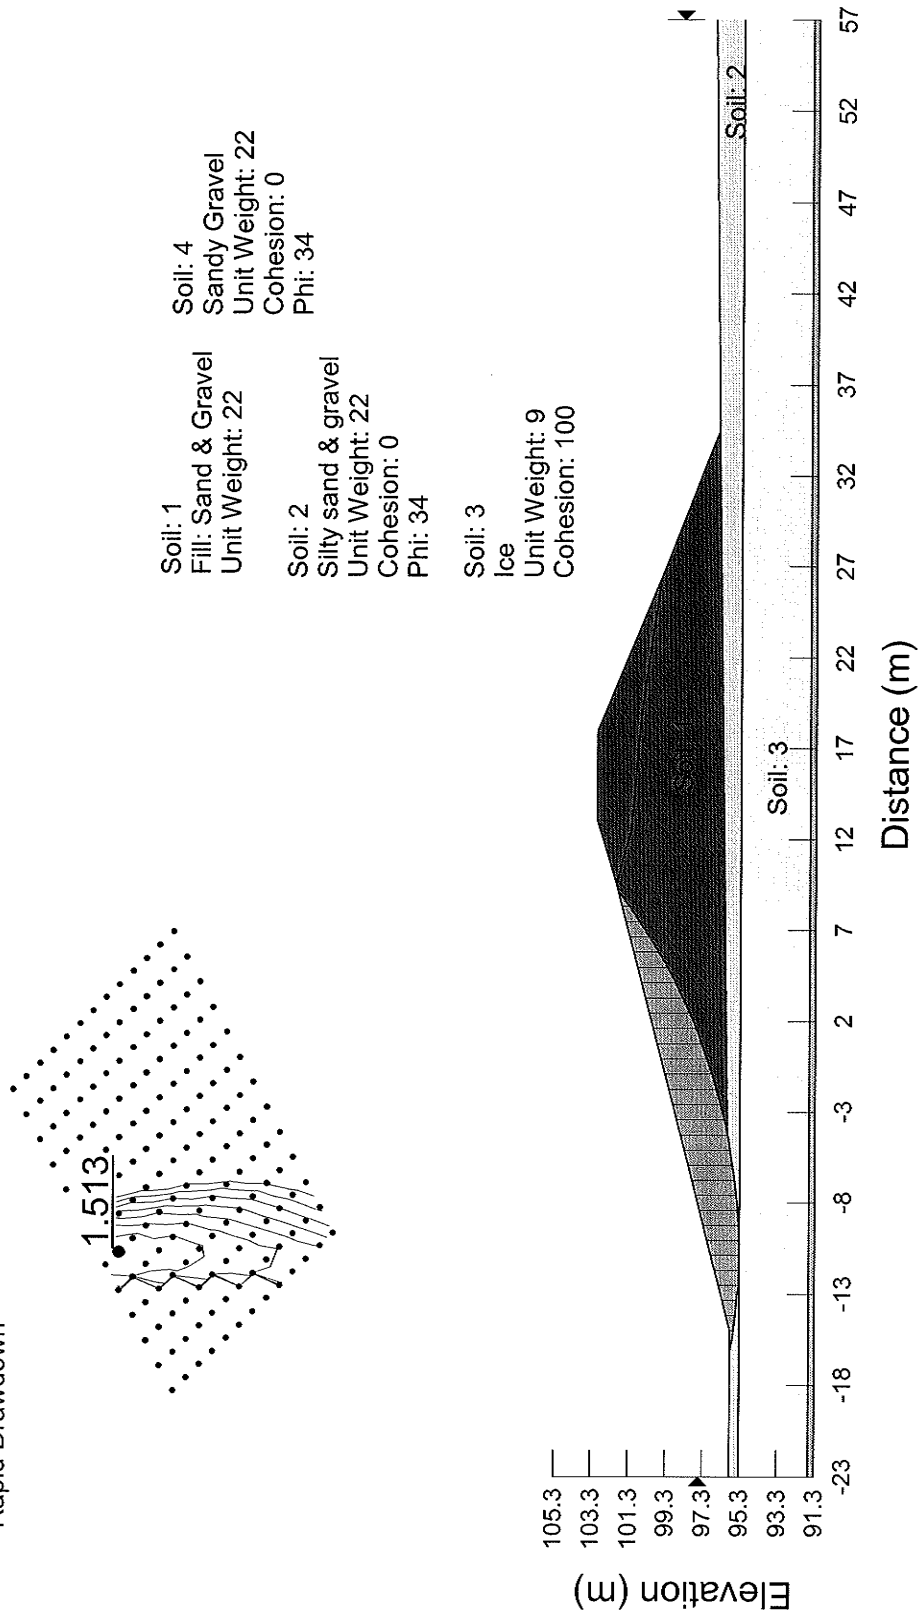
Figure 44

OTGE00019054B  
New Sewage Lagoon & Decommission of Existing Sewage Lagoon  
Arctic Bay  
Nunavut  
Slope Stability Analysis  
Section B-B  
Inner Slope @ 4H to 1V  
Rapid Drawdown

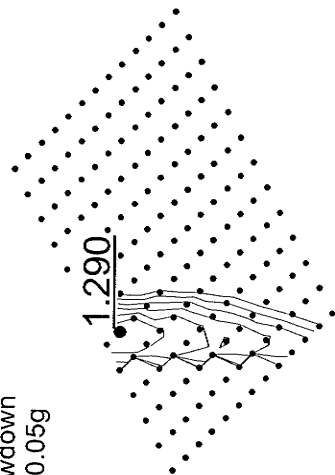
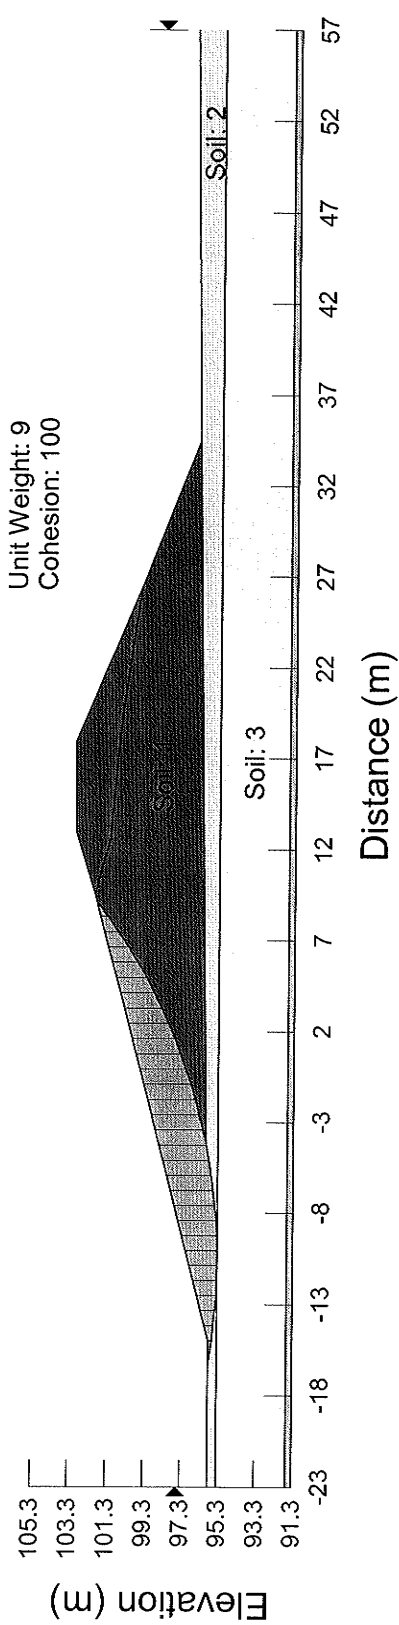
Figure 45

OTGE00019054B  
New Sewage Lagoon & Decommission of Existing Sewage Lagoon  
Arctic Bay  
Nunavut  
Slope Stability Analysis  
Section B-B  
Inner Slope @ 4H to 1V  
Rapid Drawdown  
Seismic = 0.05g
