**Re: Additional Stability and Seepage Analyses for P-Lake Sewage Lagoon,  
Cape Dorset, NU**

## **1.0 INTRODUCTION AND BACKGROUND**

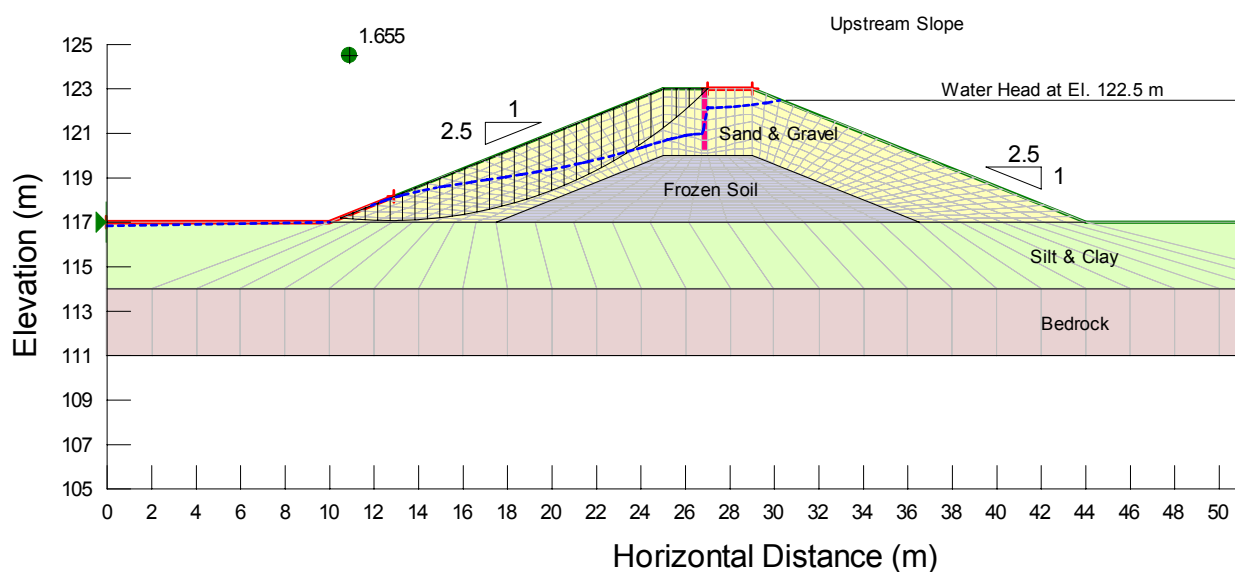
Figure 1 presents the potential failure slip which yields the lower factor of safety of 1.6. Insignificant changes in the present location of the failure slip would be expected if the liner is modeled as a "low strength element." The phreatic surface for the upper bound value of the saturated hydraulic conductivity (i.e.  $1 \times 10^{-3}$  m/s) is also shown on Figure 1.

**Figure 1: Factor of Safety and Phreatic Surface for Downstream Slope with Opening along Liner**

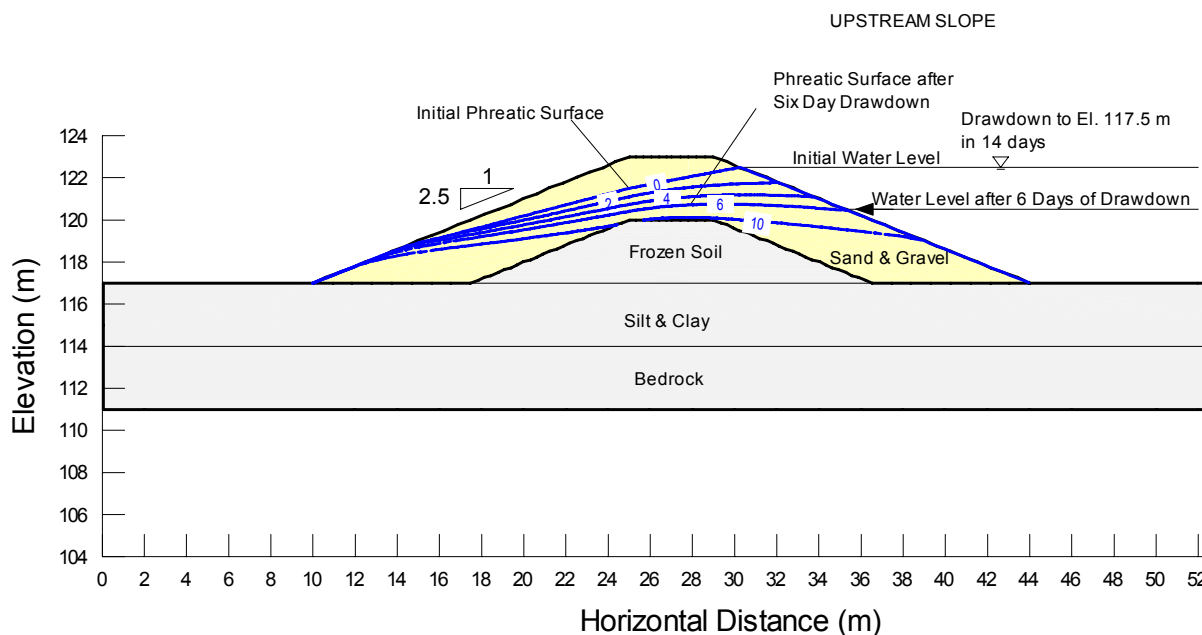
Figure 4 presents a similar scenario by assuming that the GCL liner was installed improperly and malfunctions. Locations for the phreatic surface at the berm upstream slope under this scenario are similar to that provided in Figure 3.

**Figure 4: Phreatic Surface at Upstream Slope During Drawdown (berm with no liner)**

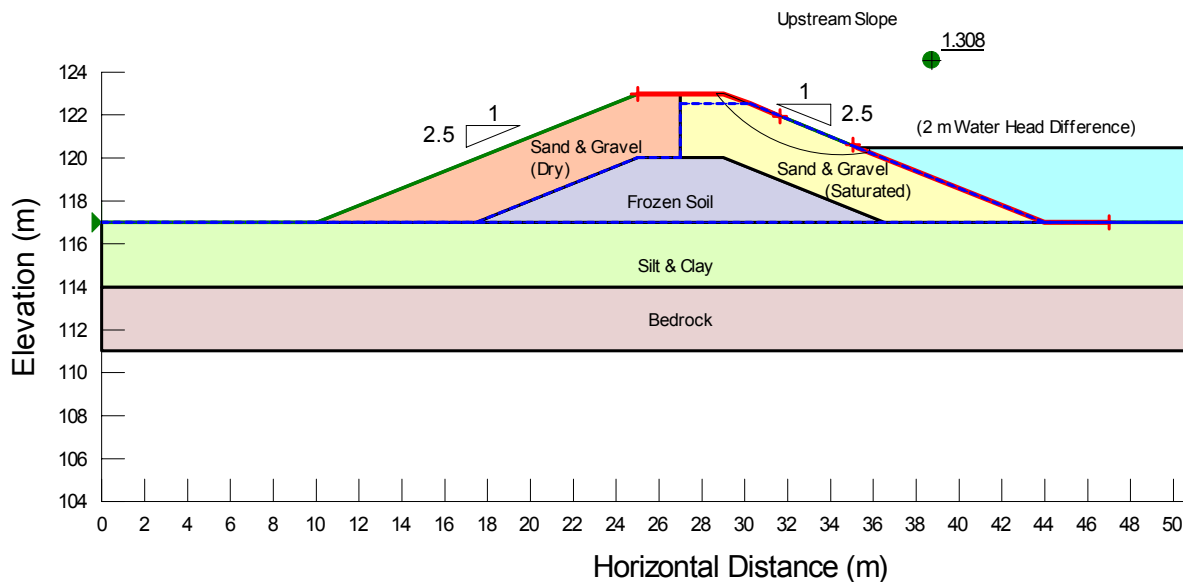
**Figure 6: Factor of Safety for Upstream Slope with 2 m Water Head Difference**

For this scenario, no noticeable change of the failure slip location is expected, if the liner is modeled as a low strength element.

For stability analysis, a conservative phreatic surface was assigned at the upstream slope, i.e. the phreatic surface was modeled at 1 m or 2 m higher than the water level in the impoundment during the drawdown. The berm material at the downstream slope (behind the liner) was assumed to be unsaturated. The factor of safety against slope failure is calculated to be 1.5 and 1.3 for 1 m and 2 m water head difference respectively, which meets the minimum requirement outlined in the Dam Safety Guidelines (1999) for short term condition. Figure 5 and 6 present the potential failure slip and factor of safety.

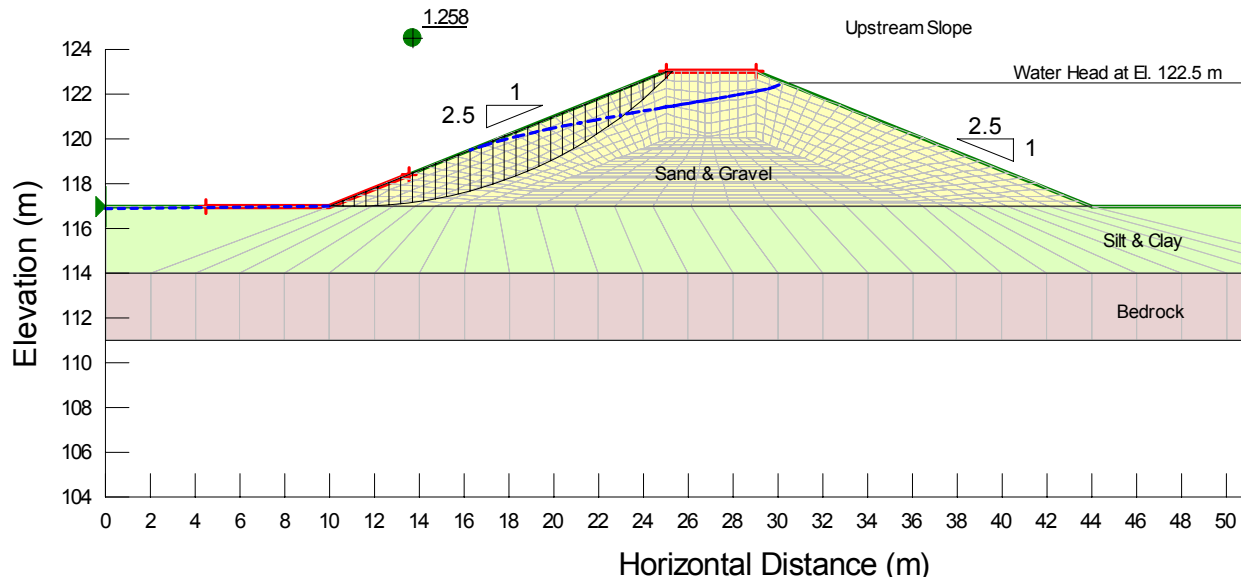
As mentioned above, modeling of this scenario was not listed in the pre-hearing meeting/teleconference scope of work or in the BGC memorandum. This case is considered to be the worst assumption when the fill material of the lagoon berm remains unfrozen and the installed liner is malfunction during operation of the facilities. It was assumed that the lagoon water will infiltrate through the berm and emerge on the downstream slope. The estimated phreatic surface and potential failure slip are summarized at Figure 7 below.

**Figure 7: Factor of Safety for Downstream Slope (berm with no frozen core and liner)**

The factor of safety is estimated to be 1.3 which is less than the minimum requirement of 1.5 recommended in the Dam Safety Guidelines (1999) for long term consideration. However, this scenario is very unlikely and the above factor of safety should be sufficient. It is considered that should this condition occur, mitigation strategies such as:
