**Geotechnical Investigation
Proposed Sewage Lagoon
Hamlet of Clyde River, Nunavut**

A geotechnical investigation was undertaken at the site of the existing sewage lagoon and the proposed sewage lagoon in the Hamlet of Clyde River, Nunavut. This work was requested by the Government of Nunavut on July 18, 2007.

It is proposed to rehabilitate the existing lagoon and to construct a new lagoon south of the existing lagoon in order to increase the storage capacity.

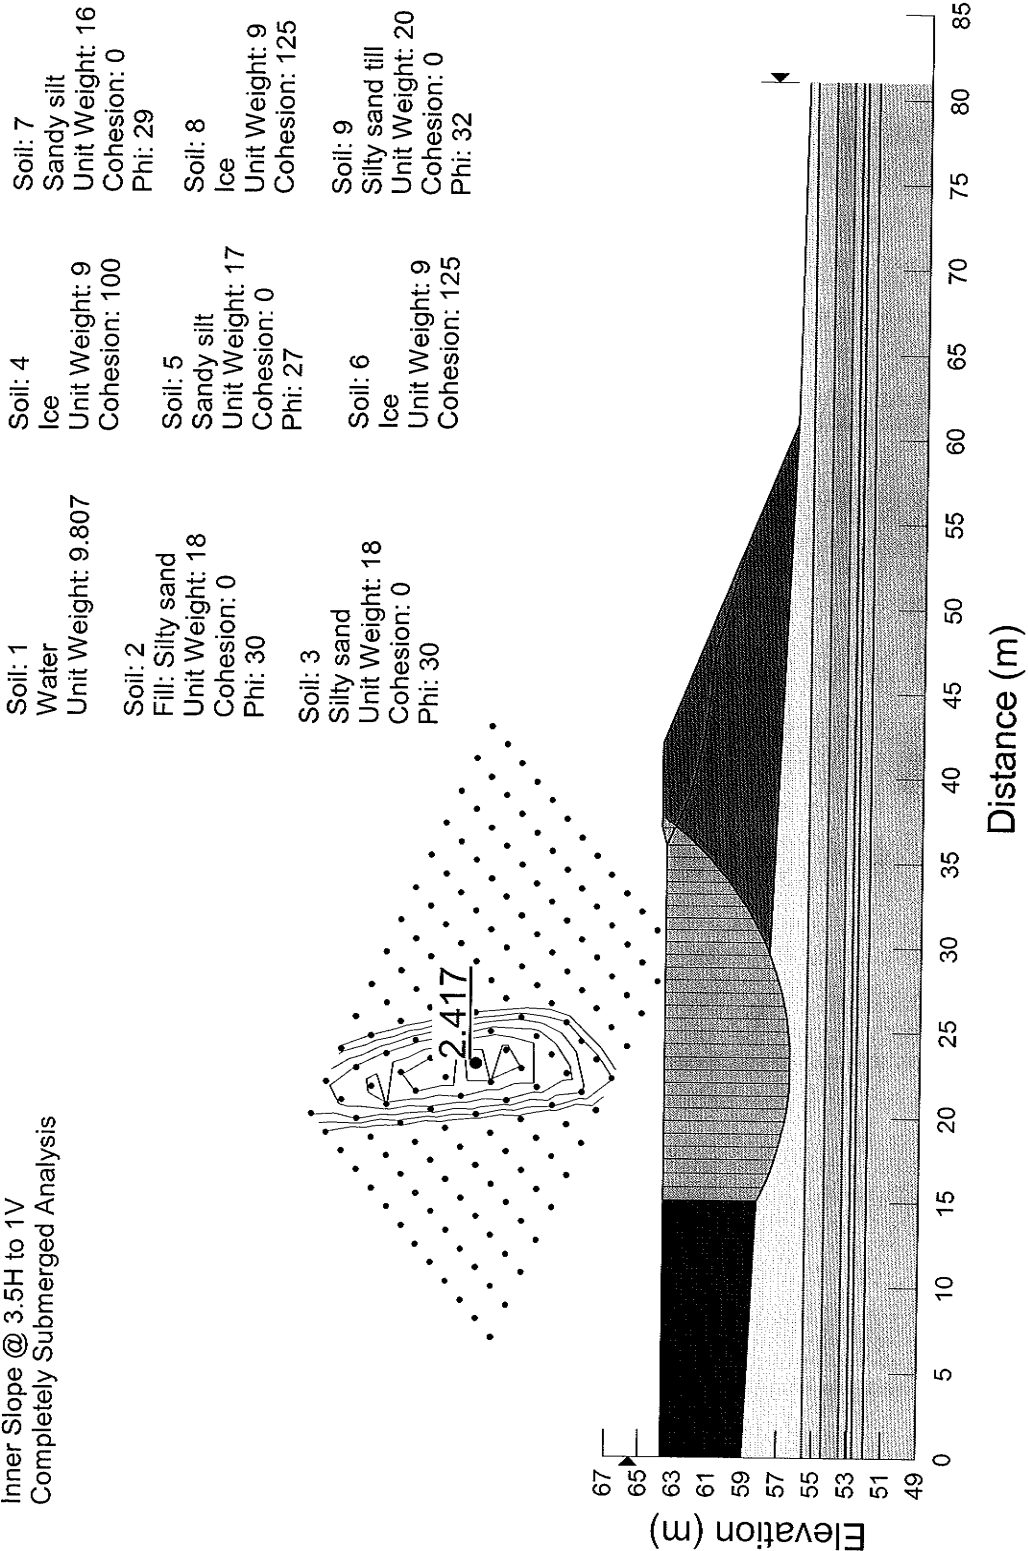
Figure 20

OTGE00019055B
 Slope Stability Analysis
 New Sewage Lagoon & Rehabilitation of Existing Lagoon
 Clyde River
 Nunavut
 Inner Slope @ 3.5H to 1V
 Completely Submerged Analysis
 Seismic = 0.15g

Based on current practice in the industry, a minimum factor of safety of 1.5 is required for static loading conditions and a factor of safety of 1.1 for seismic loading conditions. A review of Table 3 indicates that a 3.5H:1V upstream slope and 2.75H:1V downstream slope would satisfy the requisite factors of safety. Therefore, these slopes may be used in the design. However, it is noted that geothermal considerations may require the inside slope of the berms to be constructed at a flatter inclination than the 3.5H:1V recommended.

It is recommended that the inside slope of the berms should be flattened to 3.5H:1V and the outside slope to 2.75H:1V.

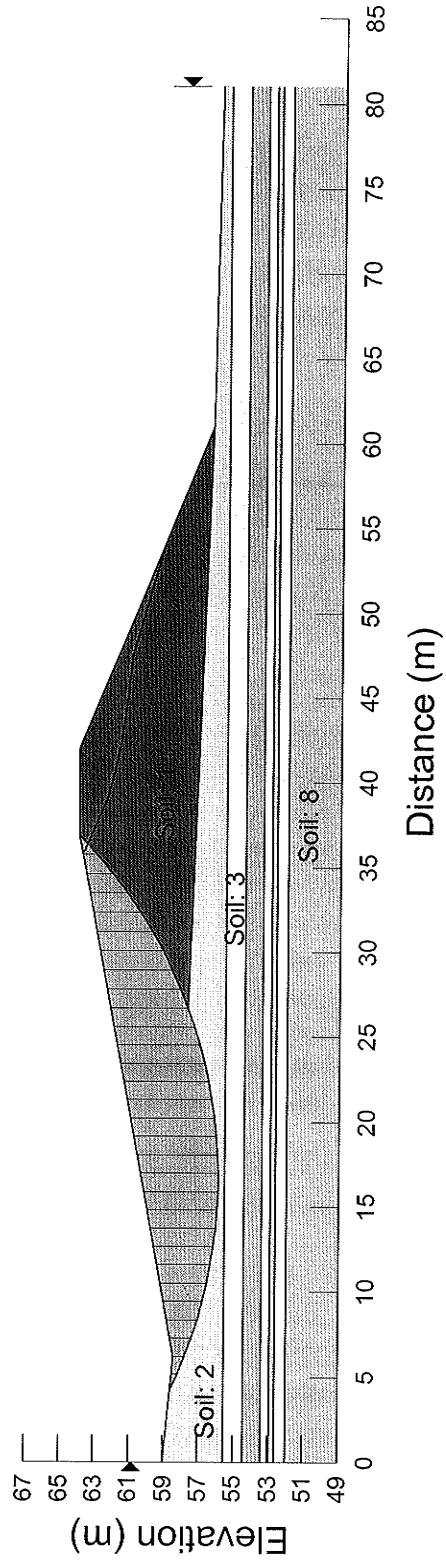
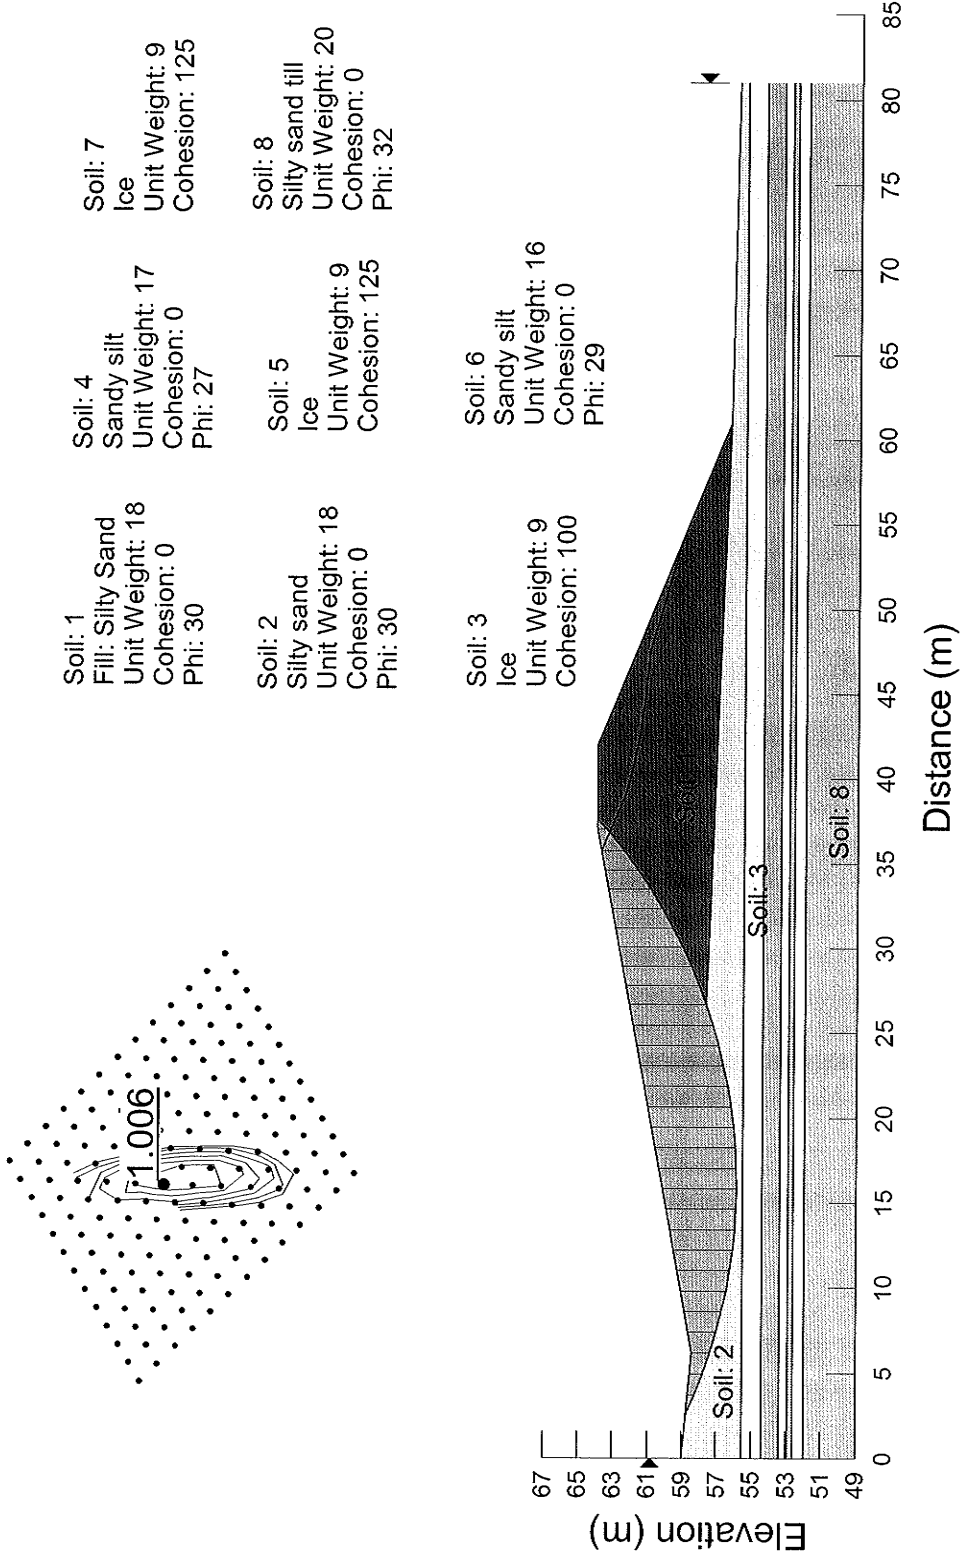
Figure 34

OTGE00019055B
Slope Stability Analysis
New Sewage Lagoon & Rehabilitation of Existing Lagoon
Clyde River
Nunavut
Inner Slope @ 5.5H to 1V
Rapid Drawdown Analysis
Seismic = 0.15g

The upstream slope was also analysed for rapid drawdown condition. The results are given on Table 4. The analysis indicates that a 5.5H:1V slope would have a factor of safety of 1.65 under static loading conditions and 1.01 under seismic loading conditions. It is therefore concluded that if the berm would be subjected to a rapid drawdown condition, the stable upstream slope would be 5.5H:1V or flatter.

Slope Inclination	Loading Condition	Computed Factor of Safety	Figure #
4H:1V	Static	1.39	27
4H:1V	Seismic	0.94	28
4.5:1V	Static	1.41	29
4.5:1V	Seismic	0.93	30
5H:1V	Static	1.56	31
5H:1V	Seismic	0.99	32
5.5H:1V	Static	1.65	33
5.5H:1V	Seismic	1.01	34
