**Geotechnical Investigation
Proposed Sewage Lagoon
Hamlet of Clyde River, Nunavut**

A geotechnical investigation was undertaken at the site of the existing sewage lagoon and the proposed sewage lagoon in the Hamlet of Clyde River, Nunavut. This work was requested by the Government of Nunavut on July 18, 2007.

It is proposed to rehabilitate the existing lagoon and to construct a new lagoon south of the existing lagoon in order to increase the storage capacity.

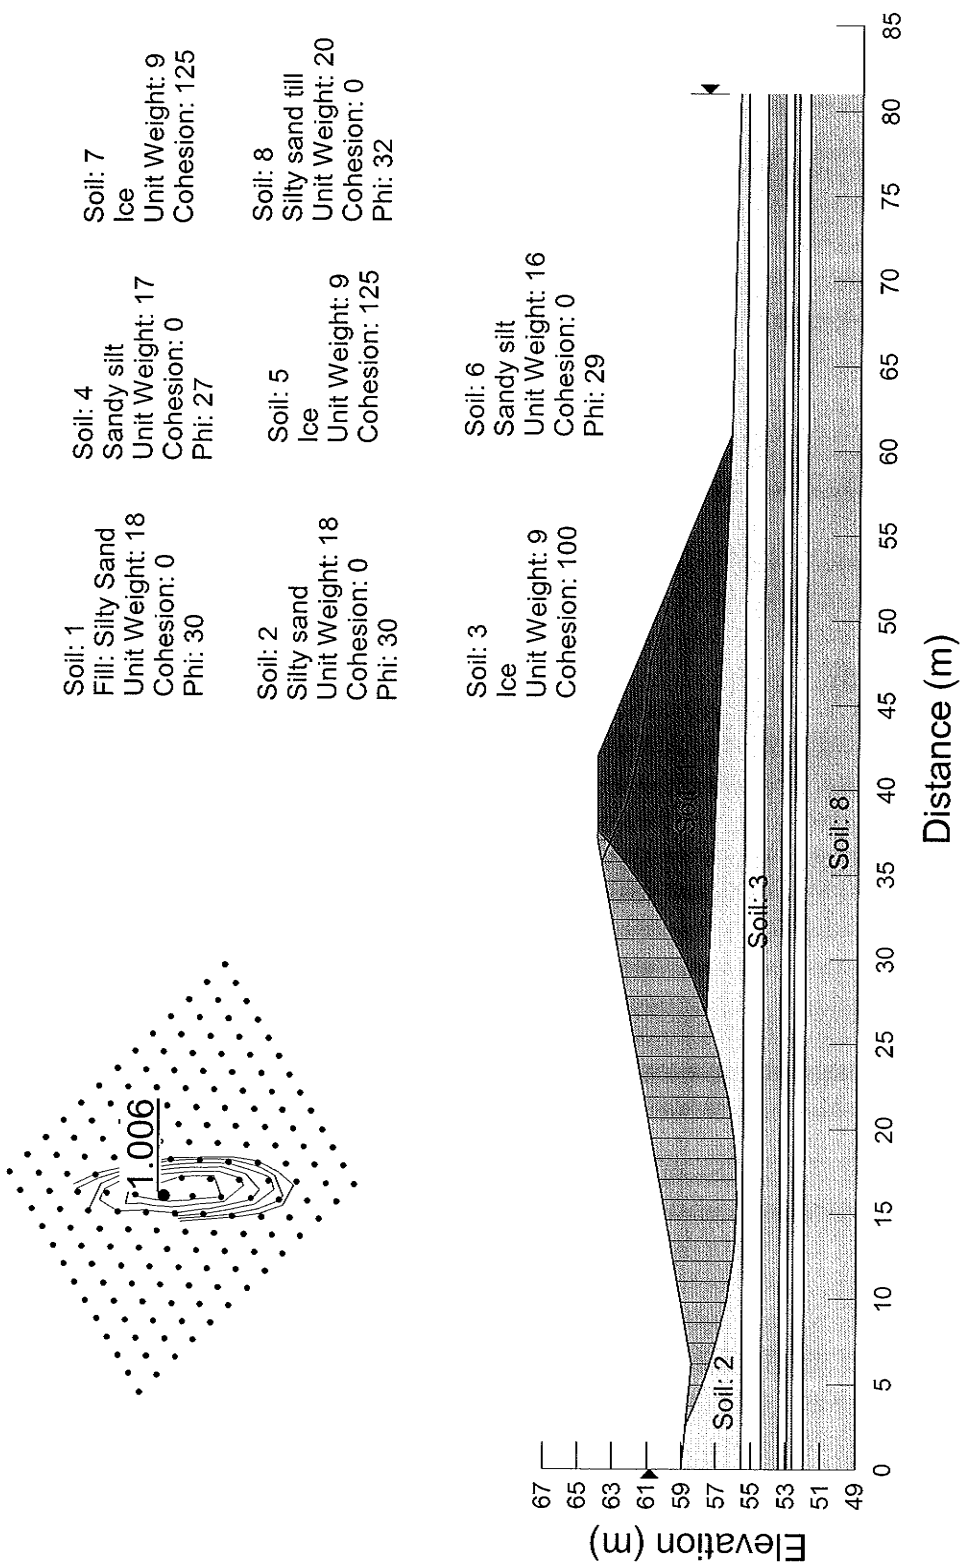
Figure 34

OTGE00019055B
Slope Stability Analysis
New Sewage Lagoon & Rehabilitation of Existing Lagoon
Clyde River
Nunavut
Inner Slope @ 5.5H to 1V
Rapid Drawdown Analysis
Seismic = 0.15g

The upstream slope was also analysed for rapid drawdown condition. The results are given on Table 4. The analysis indicates that a 5.5H:1V slope would have a factor of safety of 1.65 under static loading conditions and 1.01 under seismic loading conditions. It is therefore concluded that if the berm would be subjected to a rapid drawdown condition, the stable upstream slope would be 5.5H:1V or flatter.

Slope Inclination	Loading Condition	Computed Factor of Safety	Figure #
4H:1V	Static	1.39	27
4H:1V	Seismic	0.94	28
4.5:1V	Static	1.41	29
4.5:1V	Seismic	0.93	30
5H:1V	Static	1.56	31
5H:1V	Seismic	0.99	32
5.5H:1V	Static	1.65	33
5.5H:1V	Seismic	1.01	34
