**Subject:** Hall Beach Sewage Lagoon Cell 1 Post Remediation Leak Test

### **Cell 1 Remediation**

### **Proposed Cell 1 Leak Test - Post Remediation**

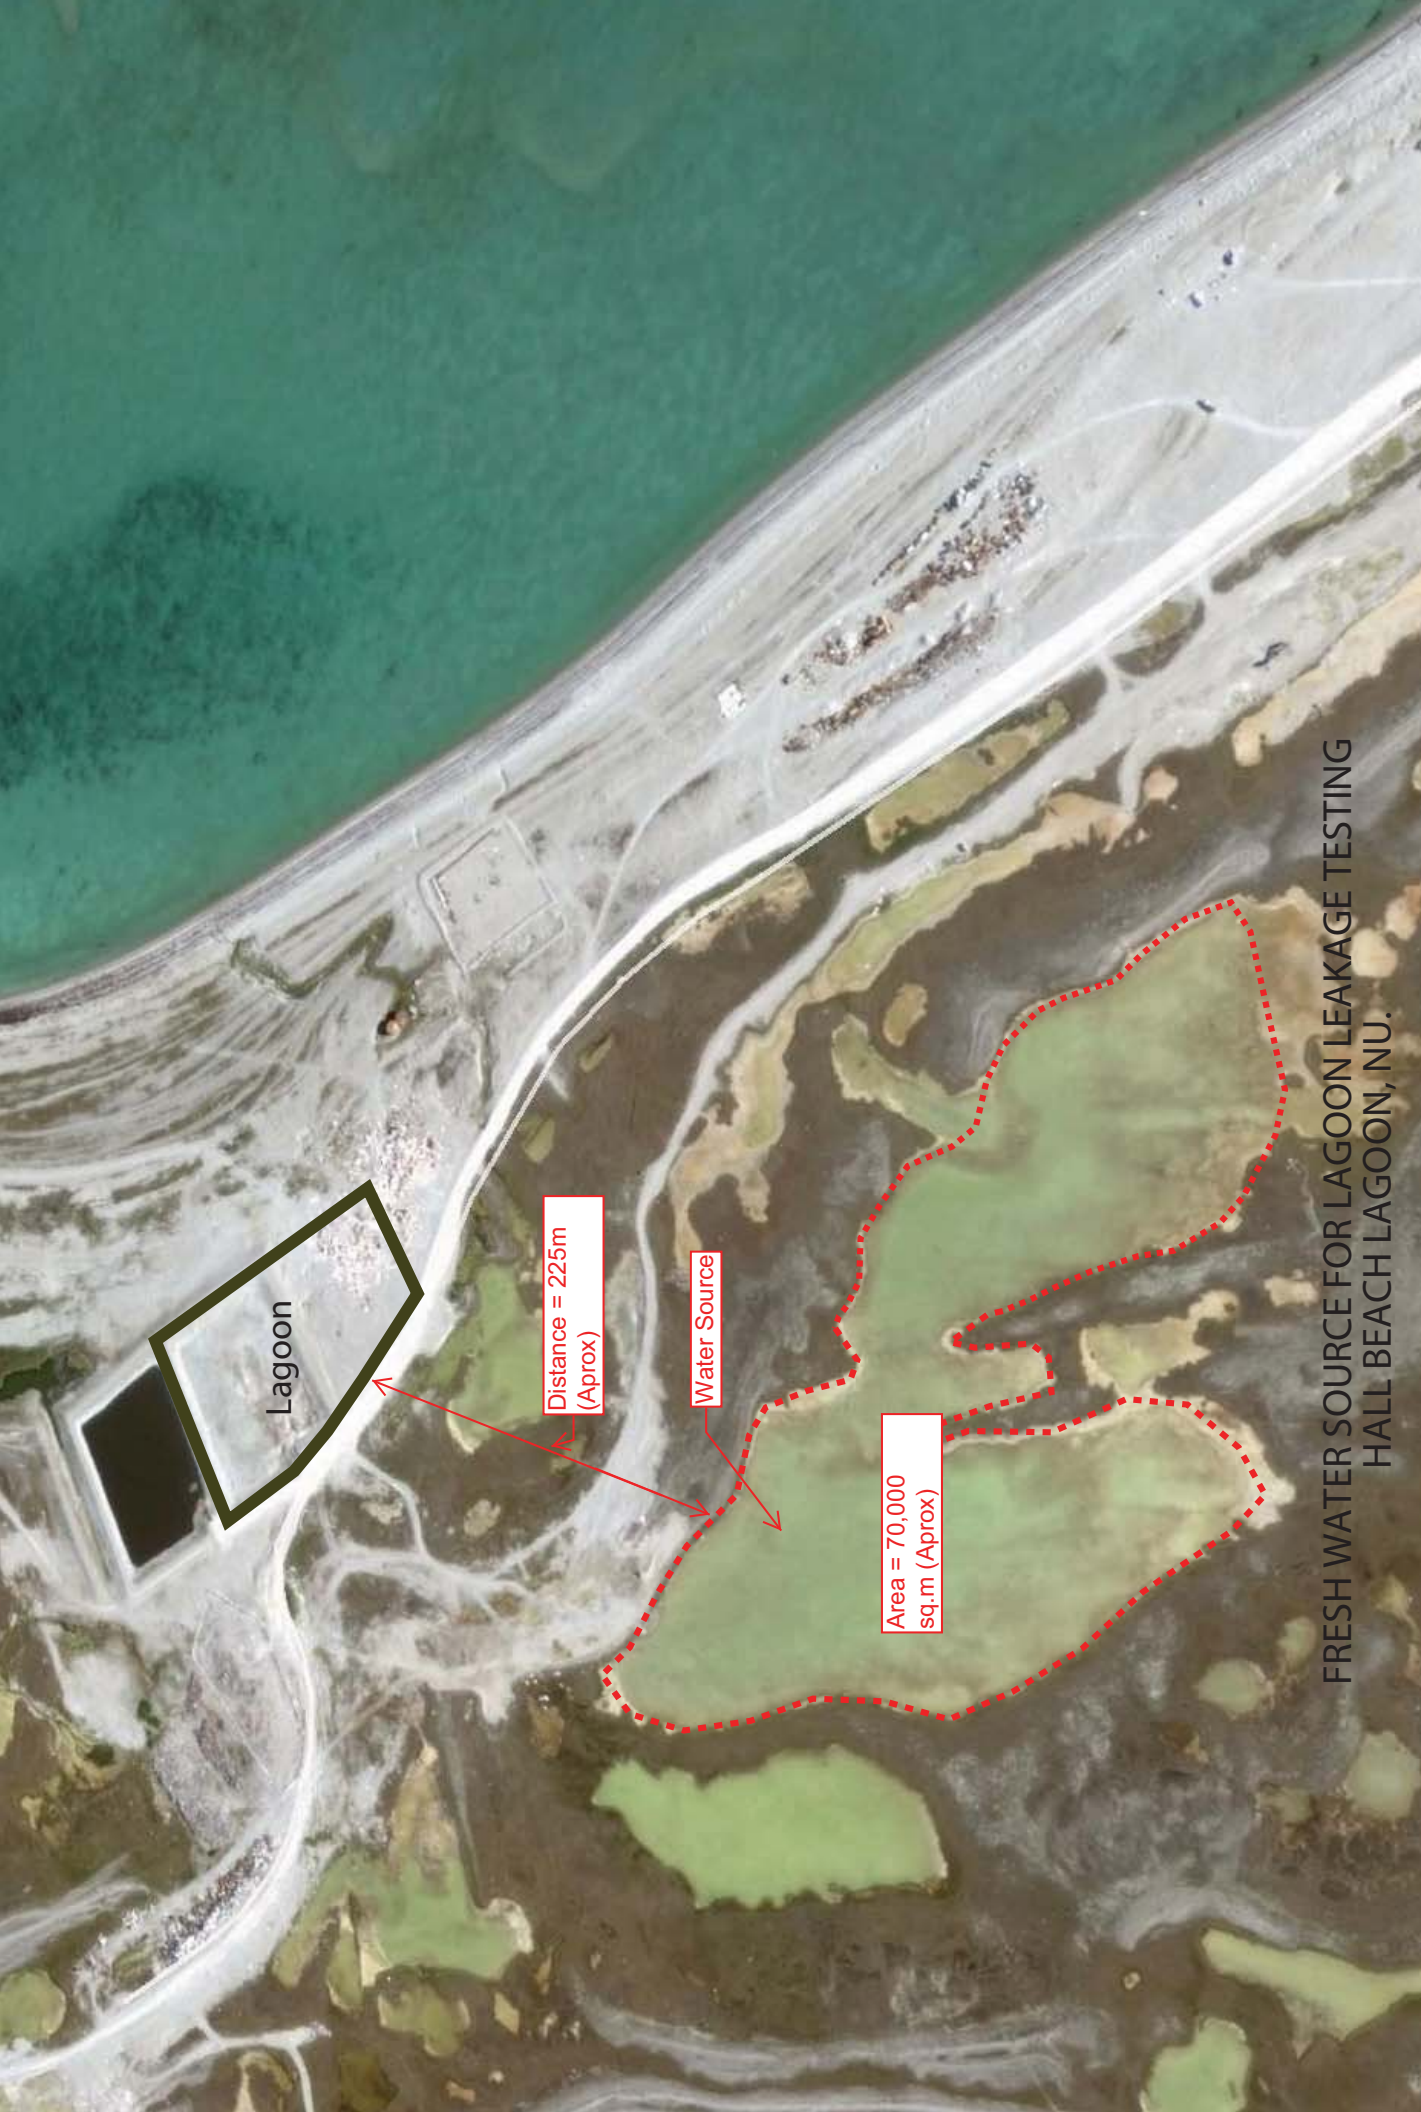
FRESH WATER SOURCE FOR LAGOON LEAKAGE TESTING  
HALL BEACH LAGOON, NU.

water source would be sufficient to provide the required water for leakage testing.
