### **Geotechnical Investigation**

Project Name Sewage Lagoon Upgrades Repulse Bay, Nunavut

Project Number OTT-00207086-A0

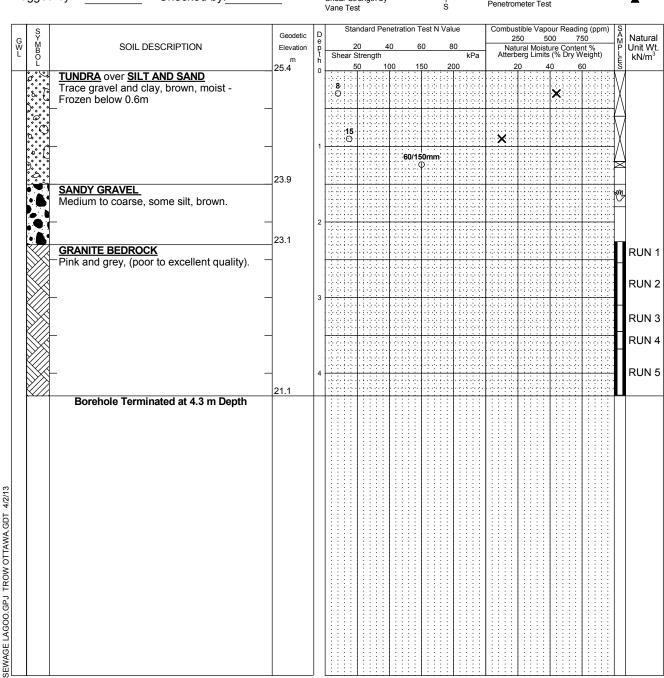
Project No: OTT-00207086-A0 Figure No. Project: Geotechnical Investigation. Proposed Sewage Lagoon 1 of 1 Page. Location: Hamlet of Repulse Bay, Nunavut Date Drilled: 'October 3, 2012 Split Spoon Sample  $\boxtimes$ Combustible Vapour Reading × Auger Sample Natural Moisture Content Drill Type: Hilti Drill SPT (N) Value 0 0 Atterberg Limits Dynamic Cone Test Datum: Undrained Triaxial at Geodetic Elevation  $\oplus$ % Strain at Failure Shelby Tube Shear Strength by Logged by: Checked by: Shear Strength by Penetrometer Test Vane Test Combustible Vapour Reading (ppm) Standard Penetration Test N Value Geodetic 250 500 750

CORE DRILLING RECORD							
Run	Run Depth % Rec. RQD %						
No.	(m)						
1	2.3 - 2.5	100	91				
2	2.5 - 3.1	93	73				
3	3.1 - 3.5	79	45				
4	3.5 - 3.7	100	44				
5	3.7 - 4.3	100	100

Detailed descriptions of the geotechnical conditions encountered in the seven boreholes drilled at the site are given on the borehole logs, Figures 4 to 10 inclusive. The borehole logs and related information depict subsurface conditions only at the specific locations and times indicated. Subsurface conditions and water levels at other locations may differ from conditions at the locations where sampling was conducted. The passage of time also may result in changes in the conditions interpreted to exist at the locations where sampling was conducted. Boreholes were drilled to provide representation of subsurface conditions as part of a geotechnical exploration program and are not intended to provide evidence of potential environmental conditions.

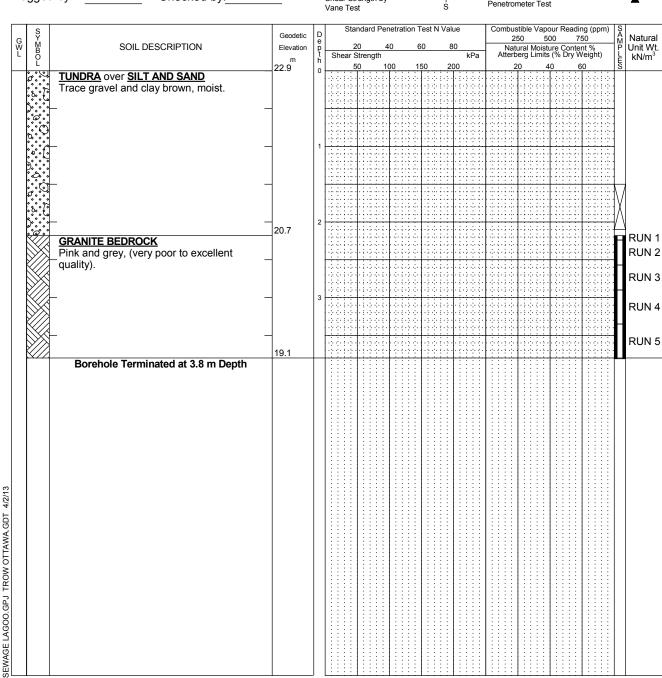
Project No: OTT-00207086-A0 Figure No. Project: Geotechnical Investigation. Proposed Sewage Lagoon Page. 1 of 1 Location: Hamlet of Repulse Bay, Nunavut Date Drilled: 'October 10, 2012 Split Spoon Sample  $\boxtimes$ Combustible Vapour Reading × Auger Sample Natural Moisture Content Drill Type: Hilti Drill SPT (N) Value 0 0 Atterberg Limits Dynamic Cone Test Datum: Undrained Triaxial at Geodetic Elevation  $\oplus$ % Strain at Failure Shelby Tube Shear Strength by Logged by: Checked by: Shear Strength by Penetrometer Test

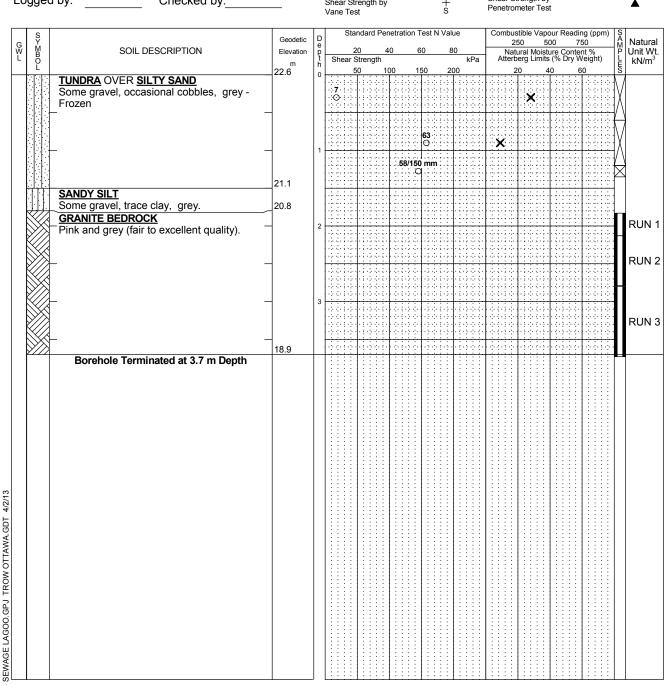
Project No: OTT-00207086-A0 Figure No. Project: Geotechnical Investigation. Proposed Sewage Lagoon Page. 1 of 1 Location: Hamlet of Repulse Bay, Nunavut Date Drilled: 'October 3, 2012 Split Spoon Sample  $\boxtimes$ Combustible Vapour Reading × Auger Sample Natural Moisture Content Drill Type: Hilti Drill SPT (N) Value 0 0 Atterberg Limits Dynamic Cone Test Datum: Undrained Triaxial at Geodetic Elevation  $\oplus$ % Strain at Failure Shelby Tube Shear Strength by Logged by: Checked by: Shear Strength by Penetrometer Test Vane Test Standard Penetration Test N Value Combustible Vapour Reading (ppm) SYMBO-Geodetic 250 500 750 SOIL DESCRIPTION Elevation Natural Moisture Content % Atterberg Limits (% Dry Weight) Shear Strength

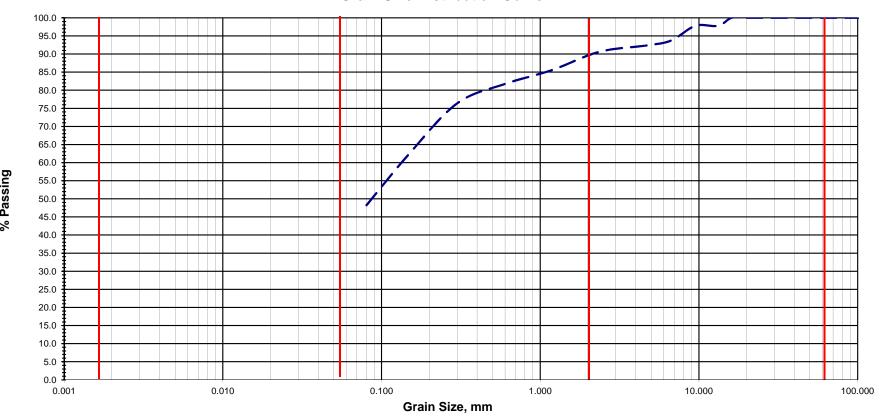
Exp Project No.:	OTT-000207086-AO	Project Name :	Sewage Lagoon Upgrades				
Client :	Government of Nunavut	Project Location :	Hamlet of Repulse Bay, Nunavut				
Date Sampled	October 3, 2012	Borehole	1	Sample No.:	SS2	Depth (m):	0.6 to 1.2
Sample Description :		Silty Sand, some	Gravel			Figure :	11

The results of the six grain-size analyses performed on this stratum are given in Figures 11 to 16 inclusive. These figures indicate that this stratum comprises of 14 to 43 percent clay and silt, 24 to 54 percent sand and 10 to 62 percent gravel. Based on the grain-size analyses, the permeability of this stratum was estimated to vary from  $4 \times 10^{-8}$  to  $6.4 \times 10^{-7}$  m/sec (Table No. I).

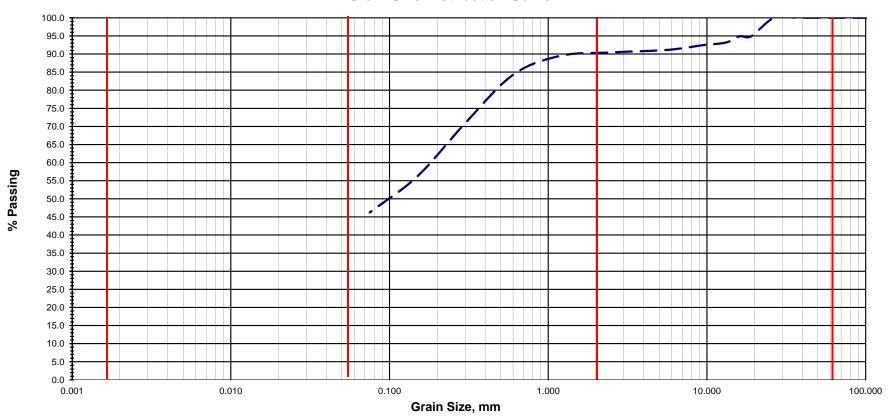
Exp Project No.:	OTT-000207086-AO	Project Name :		Sewage Lagoon Upgrades					
Client :	<b>Government of Nunavut</b>	Project Location :		Hamlet of Repulse Bay, Nunavut					
Date Sampled	October 11, 2012	Borehole	4	Sample No.:	SS2	Depth (m):	3.0 m		
Sample Description :	Silt	Silt and Sand, Some Gravel, Trace Clay

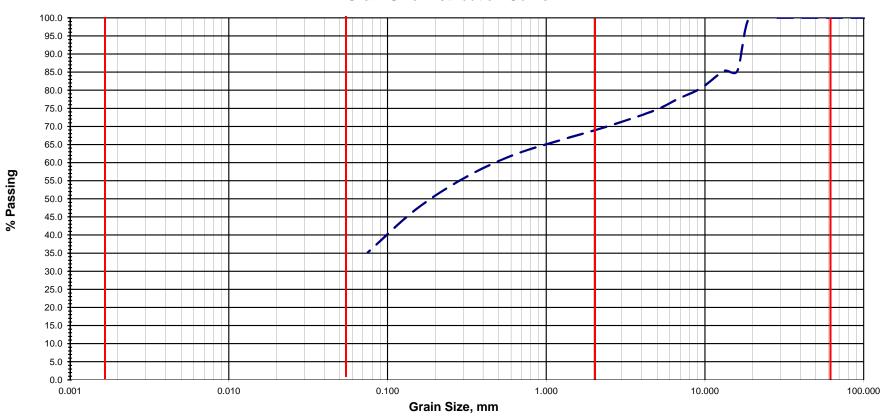
Exp Project No.:	OTT-000207086-AO	Project Name :		Sewage Lagoon Upgrades					
Client :	<b>Government of Nunavut</b>	Project Location :	Hamlet of Repulse Bay, Nunavut						
Date Sampled	October 3, 2012	Borehole	6	Sample No.:	SS1	Depth (m):	0 to 0.6 m		
Sample Description :	Silty Gravelly Sand						14

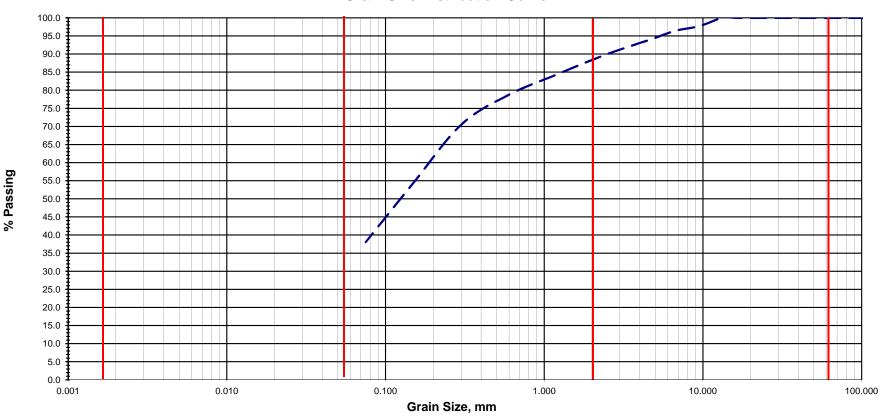
Exp Project No.:	OTT-000207086-AO	Project Name :		Sewage Lagoon Upgrades					
Client :	<b>Government of Nunavut</b>	Project Location :	Hamlet of Repulse Bay, Nunavut						
Date Sampled	October 3, 2012	Borehole	6	Sample No.:	SS2	Depth (m):	0.6 to 1.2		
Sample Description :		Silty Sand, Some	Gravel			Figure :	15

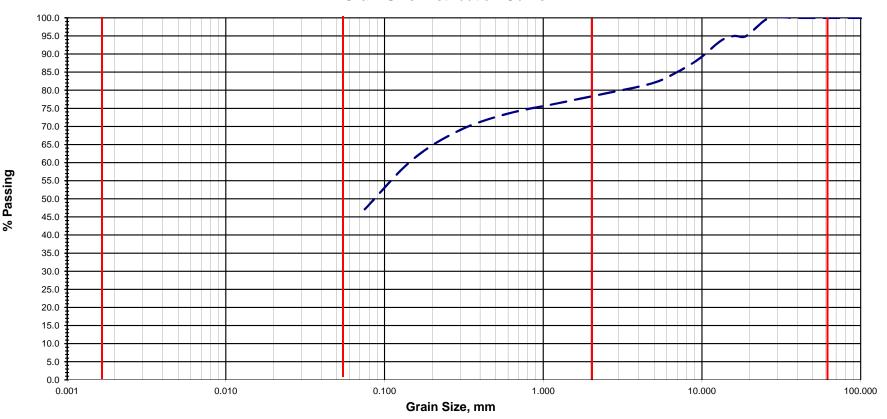
Exp Project No.:	OTT-000207086-AO	Project Name :	Sewage Lagoon Upgrades					
Client :	Government of Nunavut	Project Location :	Hamlet of Repulse Bay, Nunavut					
Date Sampled	October 3, 2012	Borehole	7	Sample No.:	SS2	Depth (m):	1.5 to 2.1	
Sample Description :		Gravelly Silt and Sand

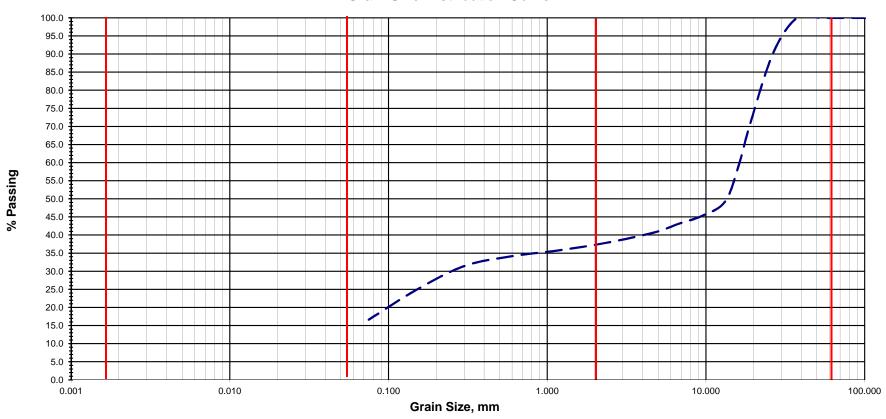
Exp Project No.:	OTT-000207086-AO	Project Name :	Project Name : Sewage Lagoon Upgrades						
Client :	<b>Government of Nunavut</b>	Project Location :	Hamlet of Repulse Bay, Nunavut						
Date Sampled	October 3, 2012	Borehole	1	Sample No.:	SS3	Depth (m):	1.5		
Sample Description :		Sandy Gravel, Some Silt
