# Volume 2 - Water System Building Assessment

**Volume 2 - Water System Building Assessment** Resolute Bay, NT

Public Works & Service - GNWT Northwest Territories

Dillon Consulting Limited

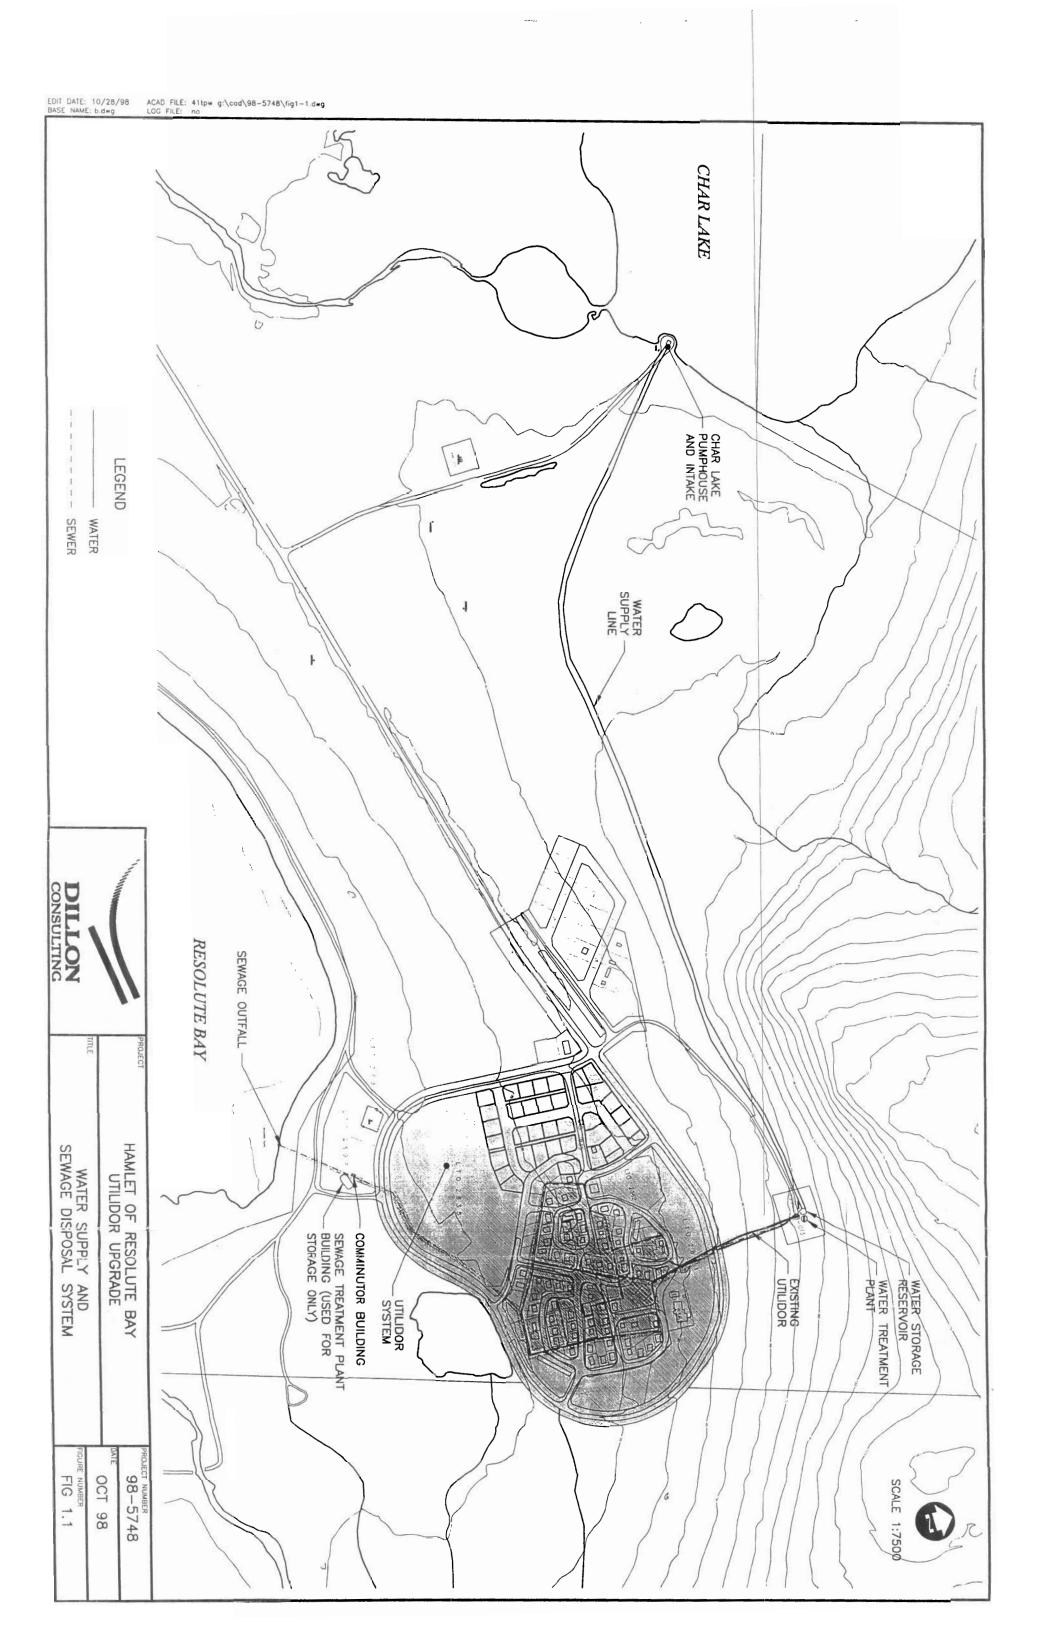
The Hamlet of Resolute Bay is serviced by a water supply system that uses a utilidor system to deliver water to houses and commercial users, and collect the sewage from these users. The water supply and sewage disposal systems are comprised of several components, namely:

- The raw water source known as Char Lake
- The Char Lake pumphouse
- The water supply line from the Char Lake pumphouse to the Water Treatment Plant (WTP)
- The utilidor system that is comprised of the water distribution system and the sewage collection system
- The Sewage Treatment Plant
- The sewage outfall.

The above components are shown in Figure 1.1 and will be described in more detail in the body of the report. Previous studies (UMA 1996) assessed each of the system components for condition, expected remaining life and required remedial action to be undertaken to extend the current facility life to 20 years. The results of this study indicated that in general the facility components are well maintained, and will meet the Hamlet's requirements for the next 20 years. The exception is the utilidor system that has experienced a number of failures over the past 5 to 7 years. The increase in failures is of significant concern to the utilidor maintainers and the Hamlet Council.
