Water Management Inspection - 14 August, 1997

- Attached for your information is a copy of the inspection report prepared as a result of the water management inspection carried out on the Hamlet of Taloyoak, NT on August 14, 1997.
- There are a number of issues that must be addressed. Specifically, the Hamlet must obtain a water licence. Attached is a 2-page application. There is a supplemental questionnaire that the Nunavut Water Board will ask the Hamlet to complete once they have received the application. As discussed in our post inspection meeting, the supplemental questionnaire is significantly reworked from the one supplied previously by the Board.
- 3. Other operational issues that must be addressed relate to the water and waste disposal facilities.

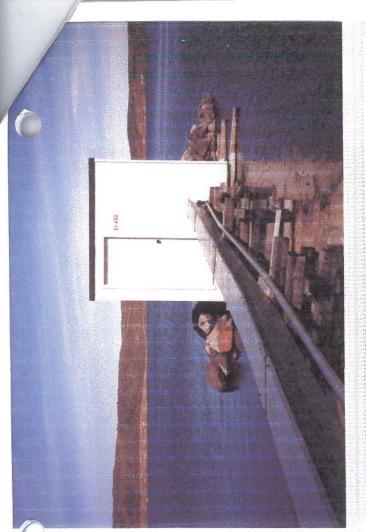
- 1. Pumphouse on water lake.
- 2. Community is immediately adjacent to water lake.
- 3. Truckfill station. Inside building are 2 large fiberglass storage tanks to give emergency supply.
- 4-5. Aerial view of sewage disposal area. "A" is sewage input area. "B" is outflow. Note greenery in photo #5.
- 6. Aerial view of solid waste disposal site. Site also shown in photo #5.
- 7-8. Sewage discharge point. Note 2 chutes to allow for safe discharge in varied wind conditions.
- 9. Bagged sewage disposal area (located at truck disposal area).
- 10-11. 2 views of dump perimeter and location of where a water sample was collected.
- 12-15. Panoramic view of waste metal and solid waste disposal site.
- 16. Waste oil storage.
- 17-18. Abanodoned waste disposal site. Note erosion and materials coming back up to the surface.
