Geotechnical Recommendations

Proposed Modifications to Sewage Lagoon
Hamlet of Whale Cove, Nunavut

OTT-00201369-A0

September, 2012

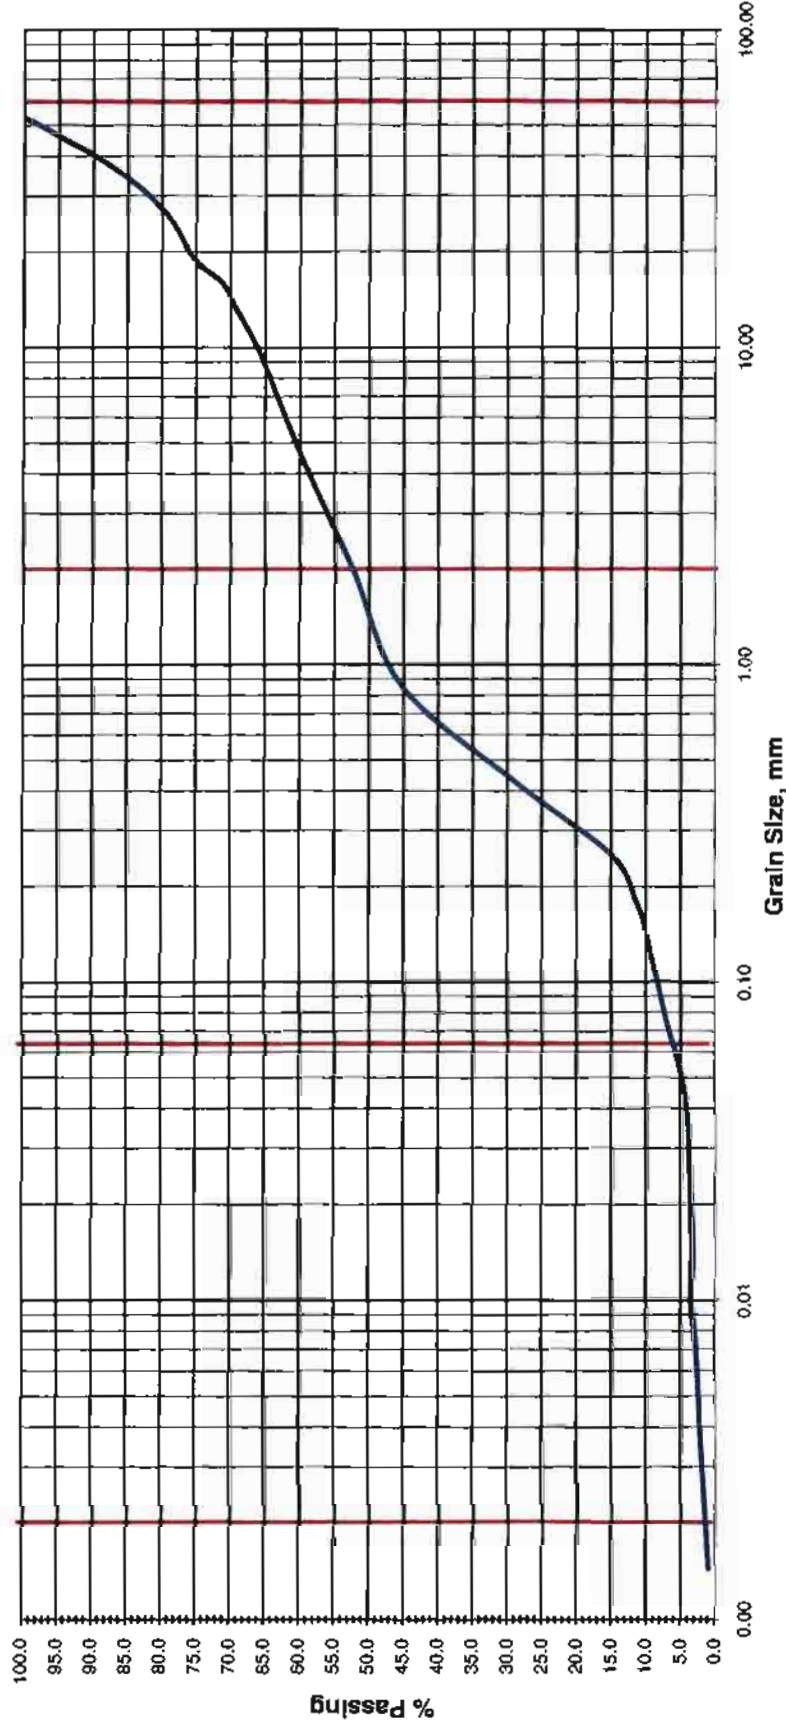
Trow Project No.:	OTT-00201369-A0	Project Name :	Geotechnical Investigation - Proposed Water Reservoir						
Client:	Government of Nunavut	Project Location :	Whale Cove - Government of Nunavut						
Date Sampled :	September 19, 2011	Bore Hole No.:	1	Sample No.:	SS2	Depth (m) :	0.6 to 1.2		
Sample Description :	Sand and Gravel					Figure :	B

Boreholes 1 and 2 were drilled on top of the existing berms and encountered fill to 1.2 m and 1.5 m depth respectively (Elevation 19.9 m and 20.4 m). The fill consists of sand and gravel with some cobbles and silt. It has a moisture content of 6 to 14 percent. The fill comprises of 1 percent clay, 5 percent silt, 46 percent sand and 48 percent gravel (Figure 8).

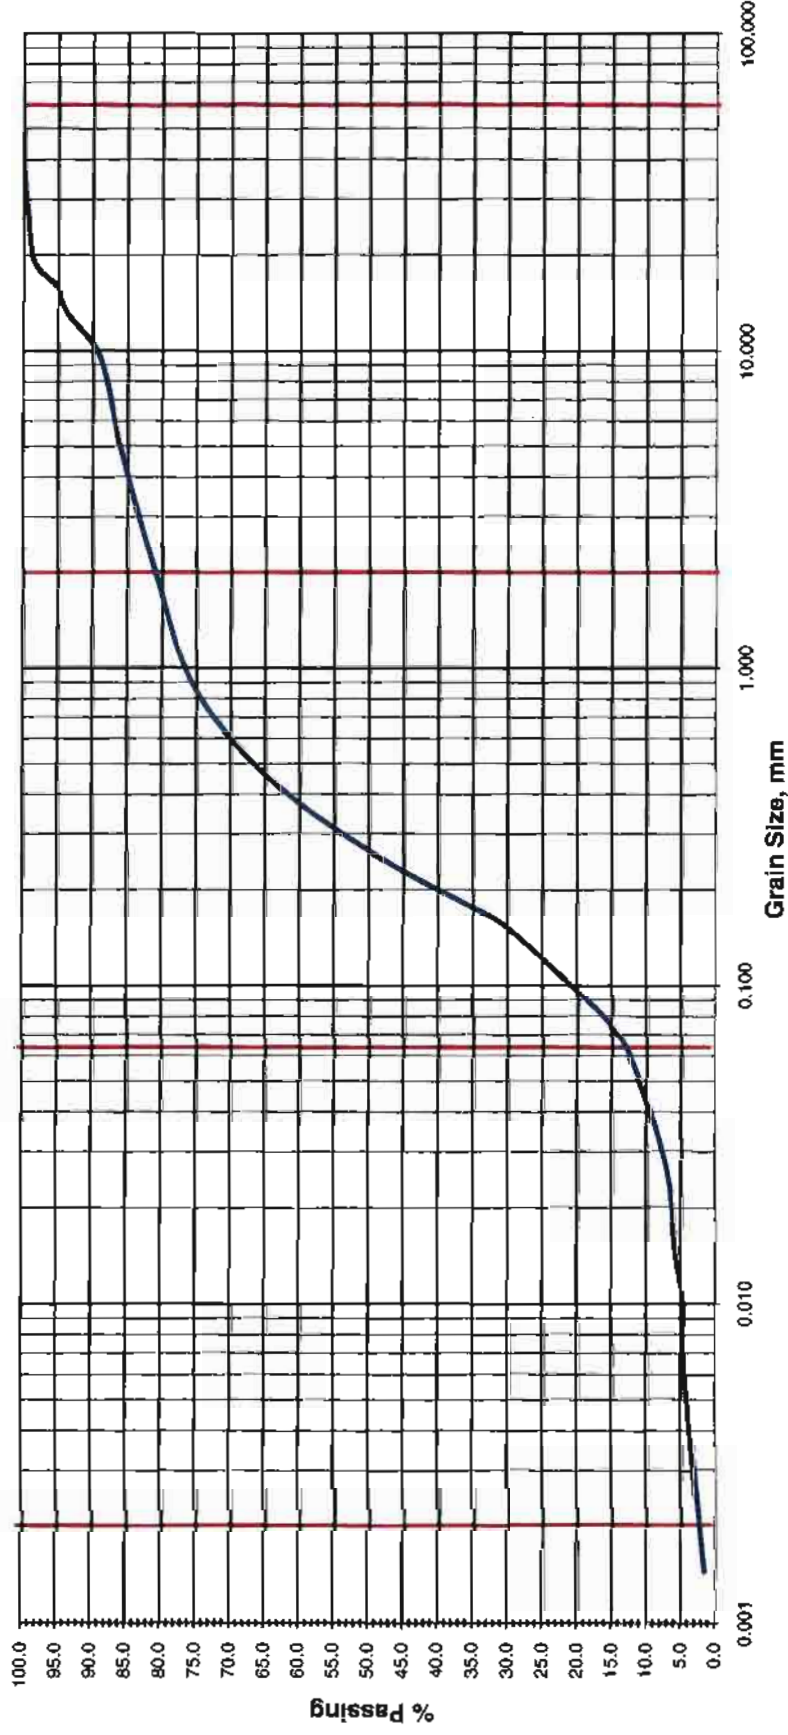
Trow Project No.:	OTT-00201369-A0	Project Name :	Geotechnical Investigation - Proposed Water Reservoir						
Client :	Government of Nunavut	Project Location :	Whale Cove - Government of Nunavut						
Date Sampled :	September 18, 2011	Bore Hole No.:	1	Sample No.:	SS8	Depth (m) :	2.7 to 3.1		
Sample Description :	Sand - Some Gravel and Silt					Figure :	9

The silt in Borehole 1 is underlain by sand which extends to 4.2 m depth (Elevation 16.9 m) and sandy silt which extends to 5.4 m (Elevation 15.7 m). The sand stratum contains some shells and occasional cobbles and boulders. Its moisture content varies from 14 to 22 percent. The sand stratum comprises of 2 percent clay, 11 percent silt, 68 percent sand and 19 percent gravel (Figure 9).

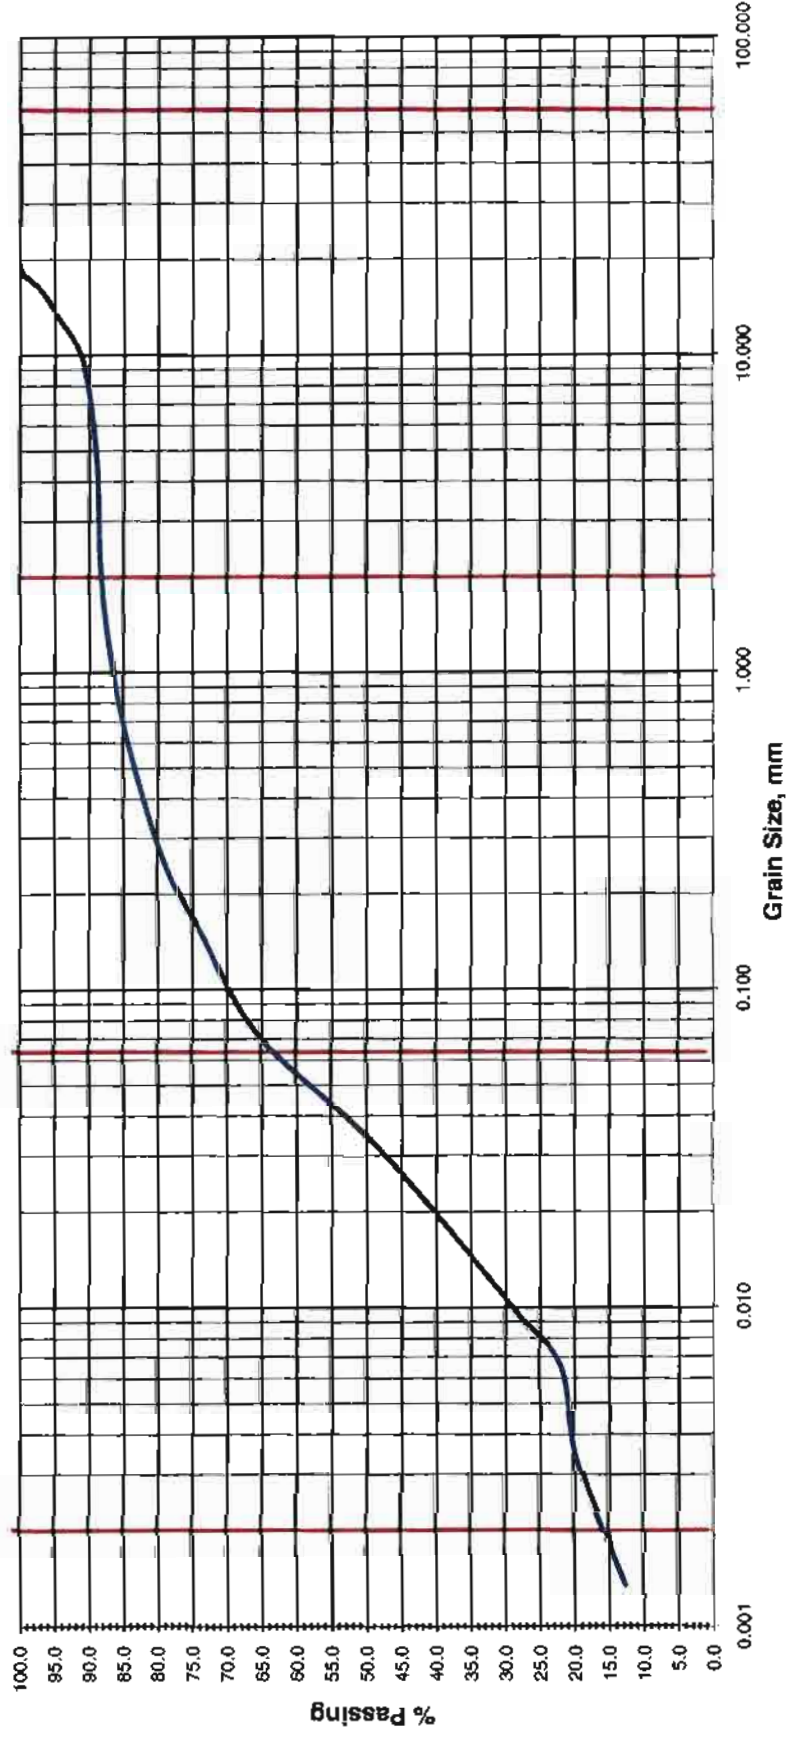
Trow Project No.:	OTT-00201369-A0	Project Name :	Geotechnical Investigation - Proposed Water Reservoir						
Client :	Government of Nunavut	Project Location :	Whale Cove - Government of Nunavut						
Date Sampled :	September 16, 2011	Bore Hole No.:	1	Sample No.:	Core 12	Depth (m) :	4.6 to 5.2		
Sample Description :	Sandy Silt , Some Clay					Figure :	10

The sandy silt has a moisture content of 20 to 24 percent. Typically, it contains 15 percent clay, 48 percent silt, 25 percent sand and 12 percent gravel (Figure 10).

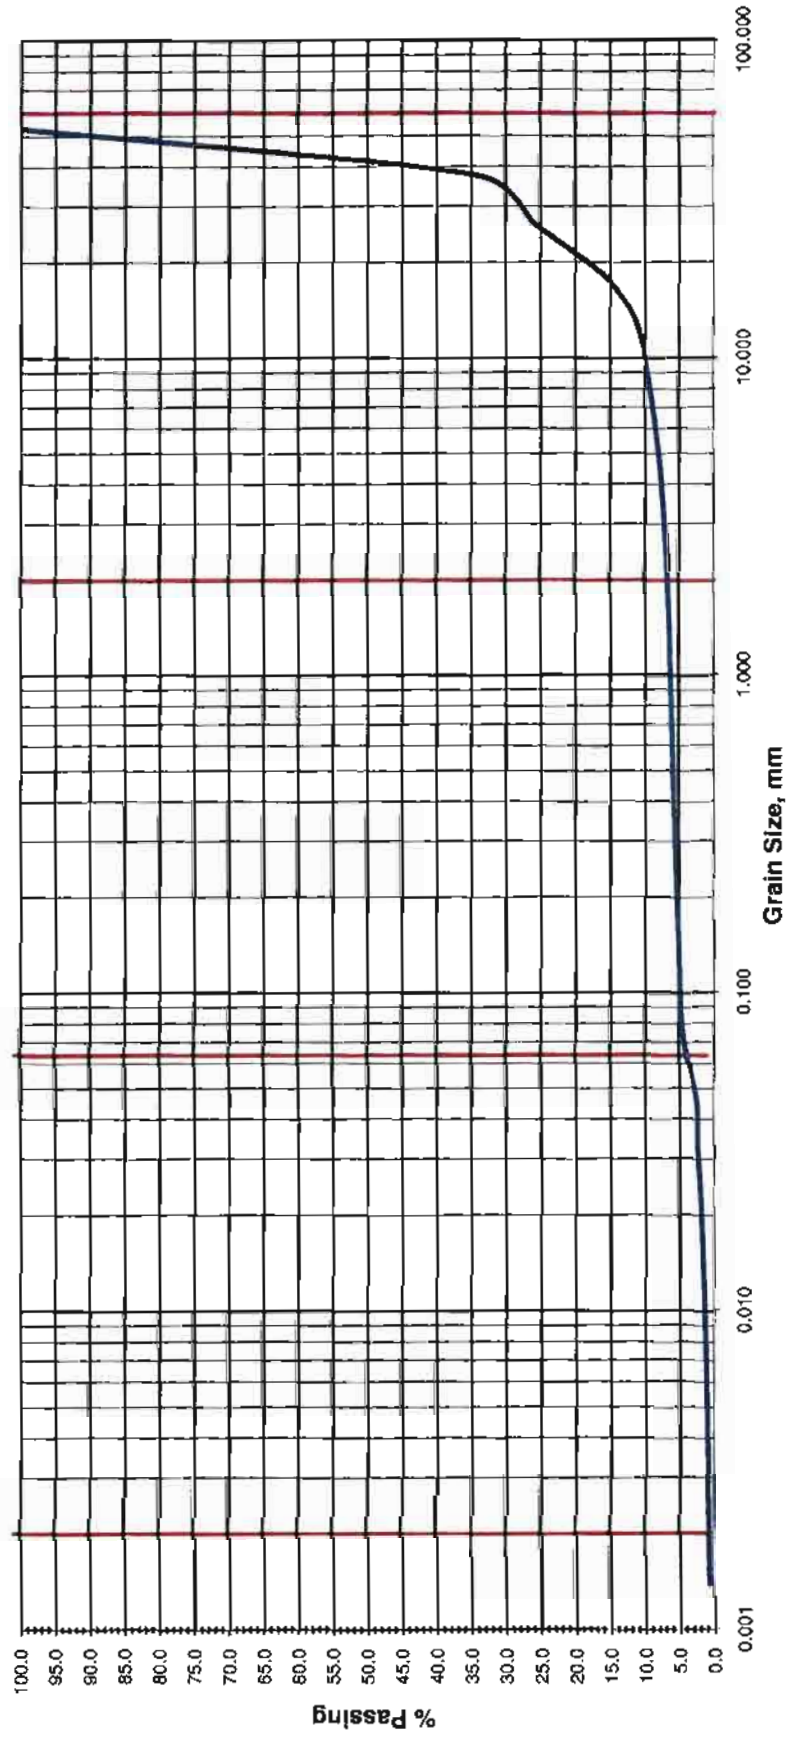
Trow Project No.:	OTT-00201369-A0	Project Name :			Geotechnical Investigation - Proposed Water Reservoir		
Client :	Government of Nunavut	Project Location :			Whale Cove - Government of Nunavut		
Date Sampled :	September 16, 2011	Bore Hole No.:		2	Sample No.:		SS5
Sample Description :		Gravel, Trace Sand					
		Depth (m) : 2.1 to 2.8					
		Figure : 11

Beneath the fill in Borehole 2 and from the existing ground surface in Boreholes 3 and 4, sand and gravel to gravel was encountered and extends to 0.4 m to 4.5 m (Elevation 17.3 m to 20.7 m). The natural moisture content of this stratum varies from 9 to 20 percent. This stratum contains 4 percent silt, 3 percent sand and 93 percent gravel (Figure 11).

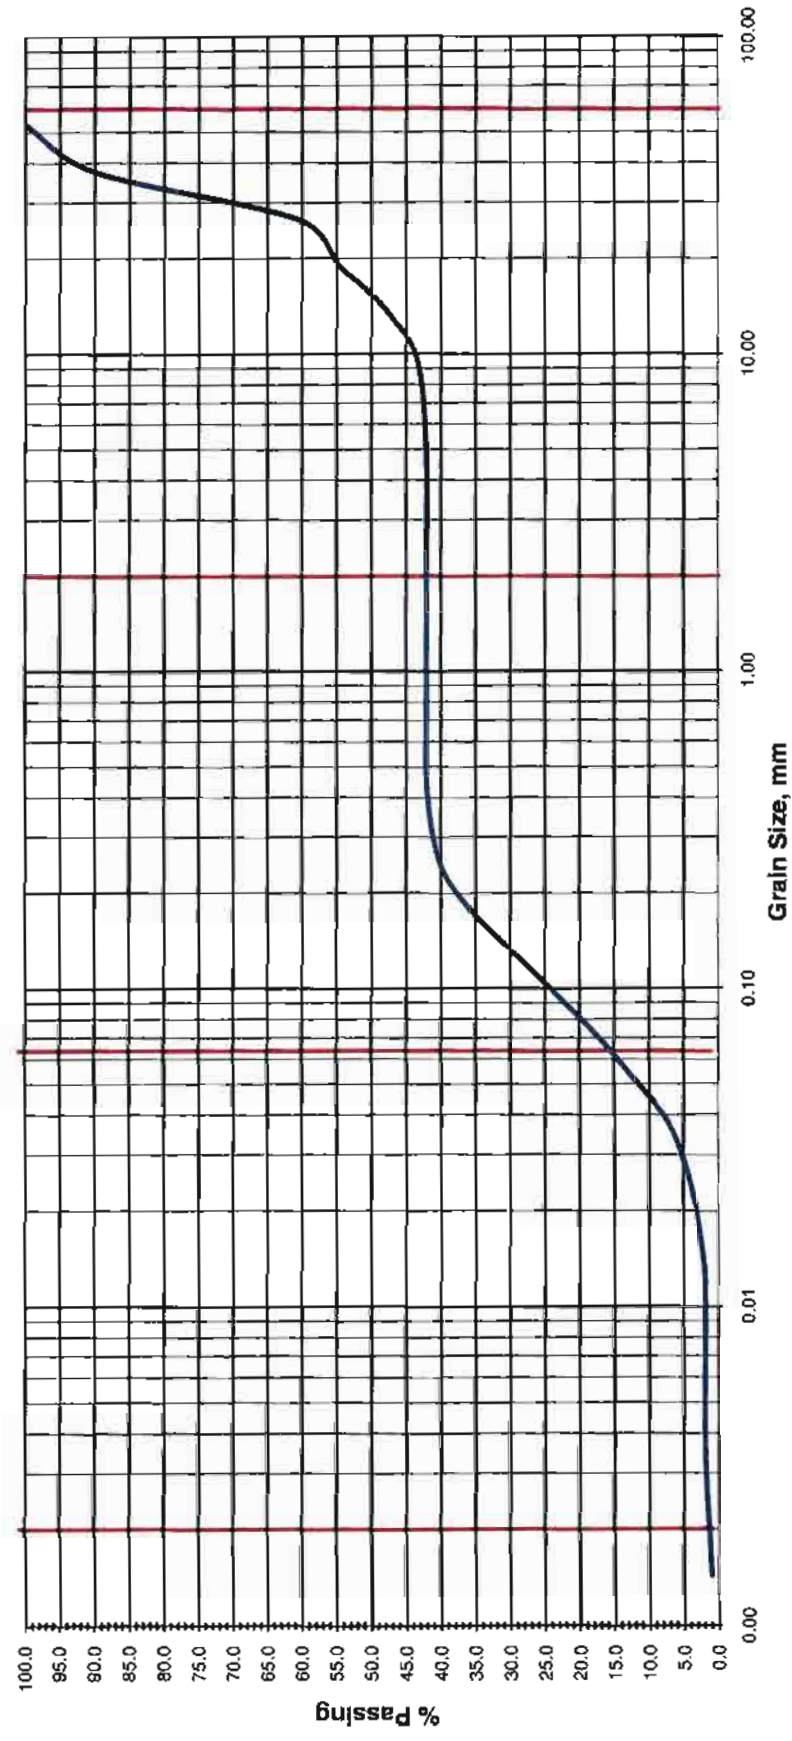
Trow Project No.:	OTT-00201369-A0	Project Name :	Geotechnical Investigation - Proposed Water Reservoir					
Client :	Government of Nunavut	Project Location :	Whale Cove - Government of Nunavut					
Date Sampled :	September 18, 2011	Bore Hole No.:	1	Sample No.:	SS15	Depth (m):	6.1 to 6.7	
Sample Description :	Sandy Gravel, Some Silt				Figure :			12

The sandy silt in Borehole 1 and the sand and gravel in Borehole 2 are underlain by sandy gravel which extends to the entire depth investigated in Borehole 1 (i.e. 7.2 m depth, Elevation 13.9 m) and to 5.7 m depth (Elevation 16.2 m) in Borehole 2. It has a moisture content of 10 to 15 percent. This stratum contains 0 to 1 percent clay, 0 to 14 percent silt, 1 to 27 percent sand and 58 to 91 percent gravel (Figure 12 and 13).

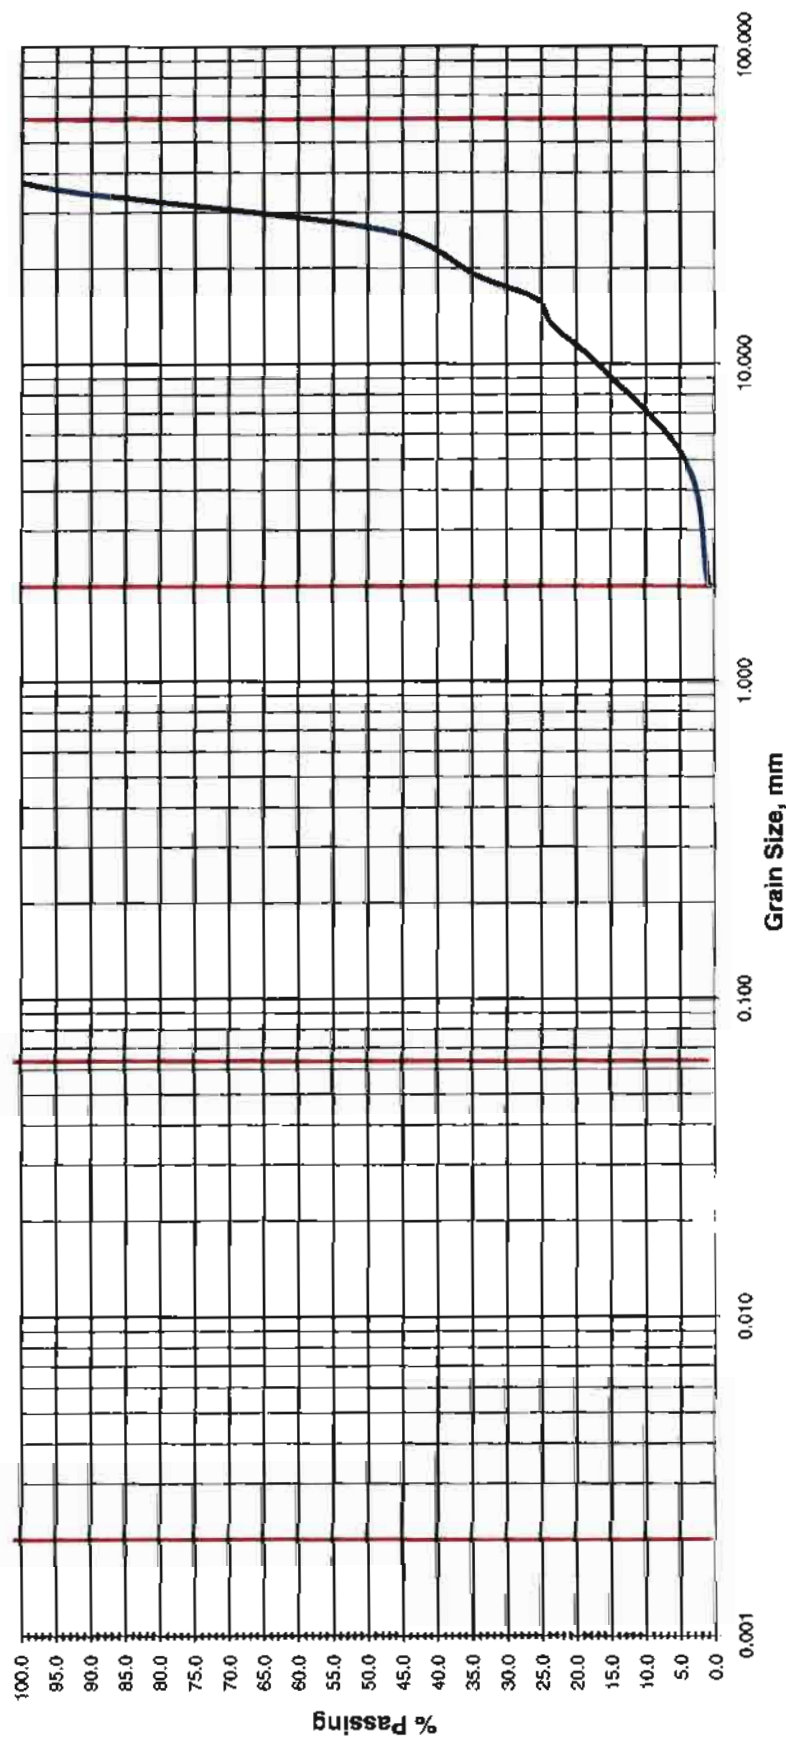
Trow Project No.:	OTT-00201369-A0	Project Name : Geotechnical Investigation - Proposed Water Reservoir		
Client :	Government of Nunavut	Project Location : Whale Cove - Government of Nunavut		
Date Sampled :	September 19, 2011	Bore Hole No.:	2	Sample No.: SS9
Sample Description :		Fine to Coarse Gravel		
		Figure : 13

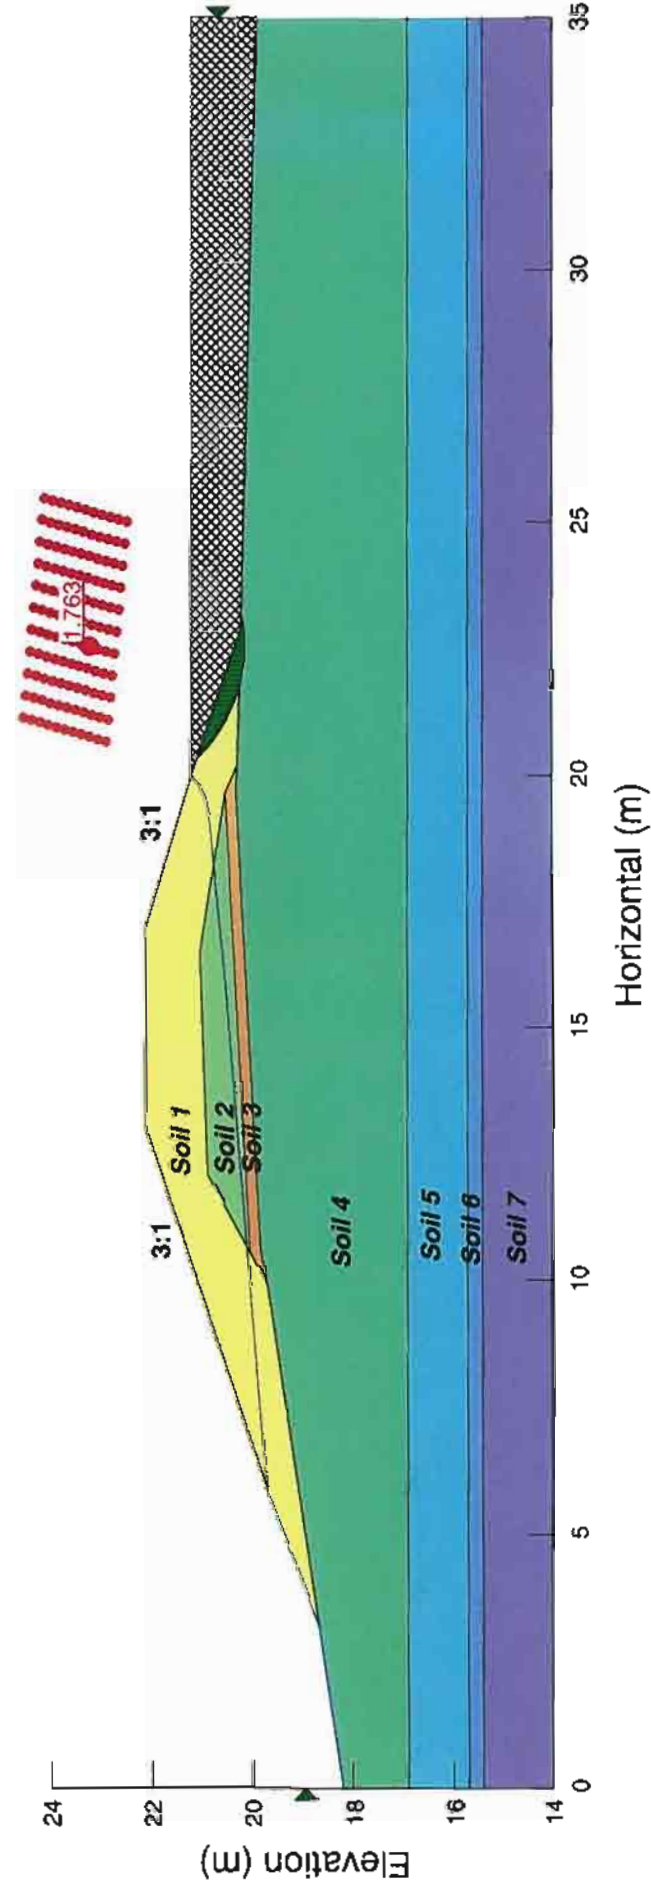
Figure 20
OTT-00201369-A0

Slope Stability Analysis - Section A-A
Upstream Slope (Rapid Drawdown)
Topsoil Removed
Existing Sewage Lagoon Modifications
Hamlet of Whale Cove

Soil: 1 Description: Proposed Fill Soil Model: Mohr-Coulomb Cohesion: 0 Phi: 38	Soil: 2 Description: Existing Fill Soil Model: Mohr-Coulomb Cohesion: 0 Phi: 32	Soil: 3 Description: Organic Silt Soil Model: Mohr-Coulomb Cohesion: 0 Phi: 20	Soil: 4 Description: Sand Soil Model: Mohr-Coulomb Cohesion: 0 Phi: 32	Soil: 5 Description: Sandy Silt Soil Model: Mohr-Coulomb Cohesion: 0 Phi: 25
Soil: 6 Description: Sandy Gravel Soil Model: Mohr-Coulomb Cohesion: 0 Phi: 35	Soil: 7 Description: Permafrost (Sandy Gravel)

Table II - Computed Factors of Safety for Upstream and Downstream Berm Slopes					
Berm Identification	Slope Identification	Slope Inclination	Loading Condition	Computed Factor of Safety	Figure #
A	Upstream	4H:1V	Rapid drawdown	1.59	20
			Rapid drawdown with seismic loading	1.35	21
			Submerged slope	2.66	22
			Submerged slope with seismic loading	2.08	23
	Downstream	3H:1V	Steady state seepage	0.96	24
			Steady state seepage with seismic loading	0.87	25
		4H:1V	Steady state seepage	1.47	26
			Steady state seepage with seismic loading	1.25	27
B	Upstream	3H:1V	Rapid drawdown	2.62	28
			Rapid drawdown with seismic loading	2.25	29
			Submerged slope	2.62	30
			Submerged slope with seismic loading	2.25	31
	Downstream	3H:1V	Steady state seepage	2.13	32
			Steady state seepage with seismic loading	1.77	33
C	Upstream	3H:1V	Rapid drawdown	2.08	34
			Rapid drawdown with seismic loading	1.72	35
			Submerged slope	2.17	36

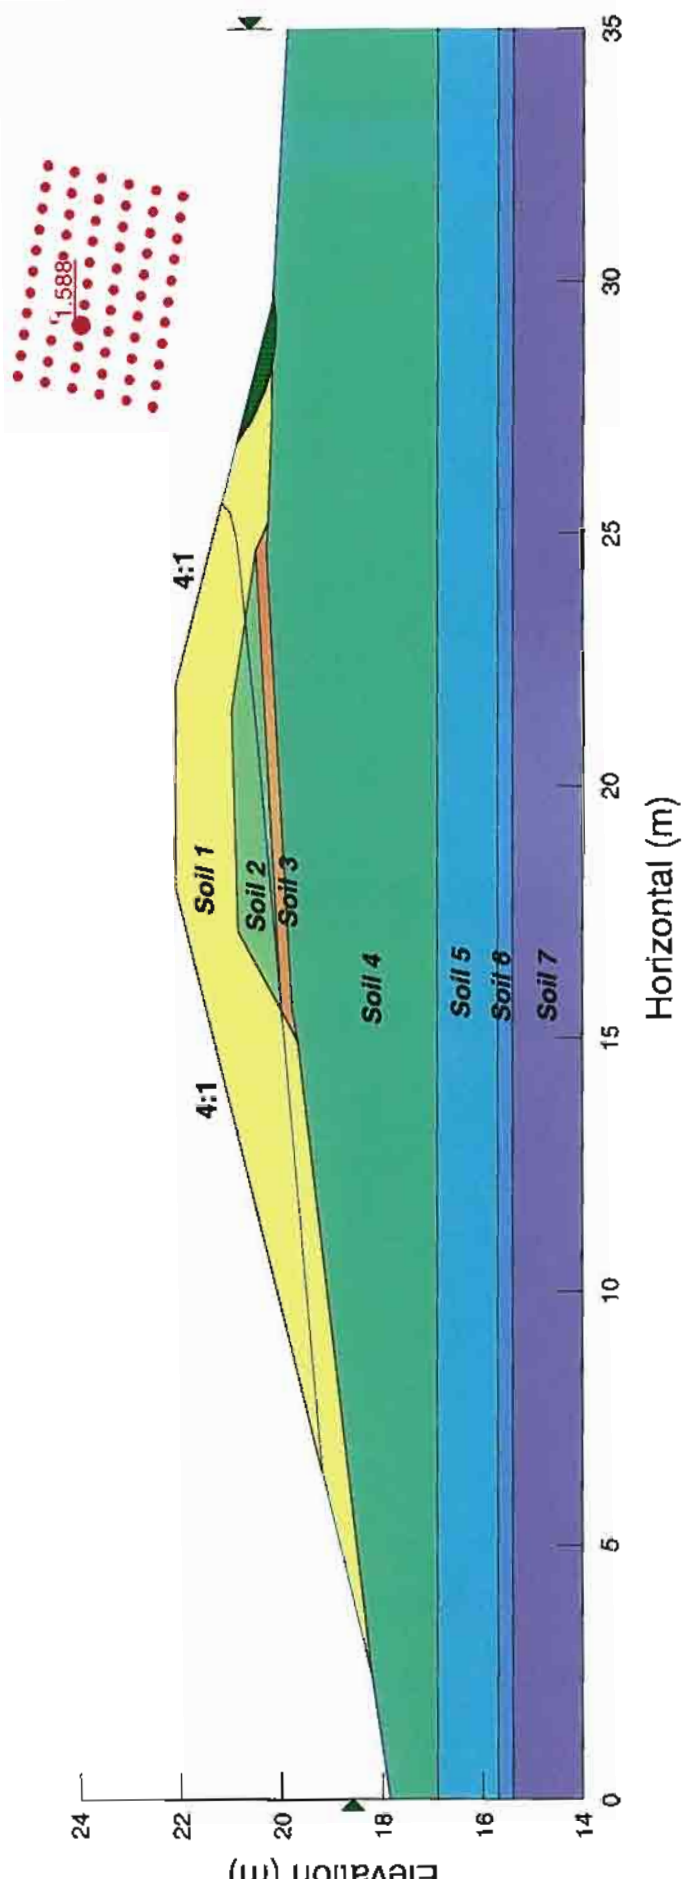
Figure 21
OTT-00201369-A0

Slope Stability Analysis - Section A-A
Upstream Slope (Rapid Drawdown + Seismic Loading)
Topsoil Removed
Existing Sewage Lagoon Modifications
Hamlet of Whale Cove

Soil: 1 Description: Proposed Fill Soil Model: Mohr-Coulomb Cohesion: 0 Phi: 38	Soil: 2 Description: Existing Fill Soil Model: Mohr-Coulomb Cohesion: 0 Phi: 32	Soil: 3 Description: Organic Silt Soil Model: Mohr-Coulomb Cohesion: 0 Phi: 20	Soil: 4 Description: Sand Soil Model: Mohr-Coulomb Cohesion: 0 Phi: 32	Soil: 5 Description: Sandy Silt Soil Model: Mohr-Coulomb Cohesion: 0 Phi: 25
Soil: 6 Description: Sandy Gravel Soil Model: Mohr-Coulomb Cohesion: 0 Phi: 35	Soil: 7 Description: Permafrost (Sandy Gravel)

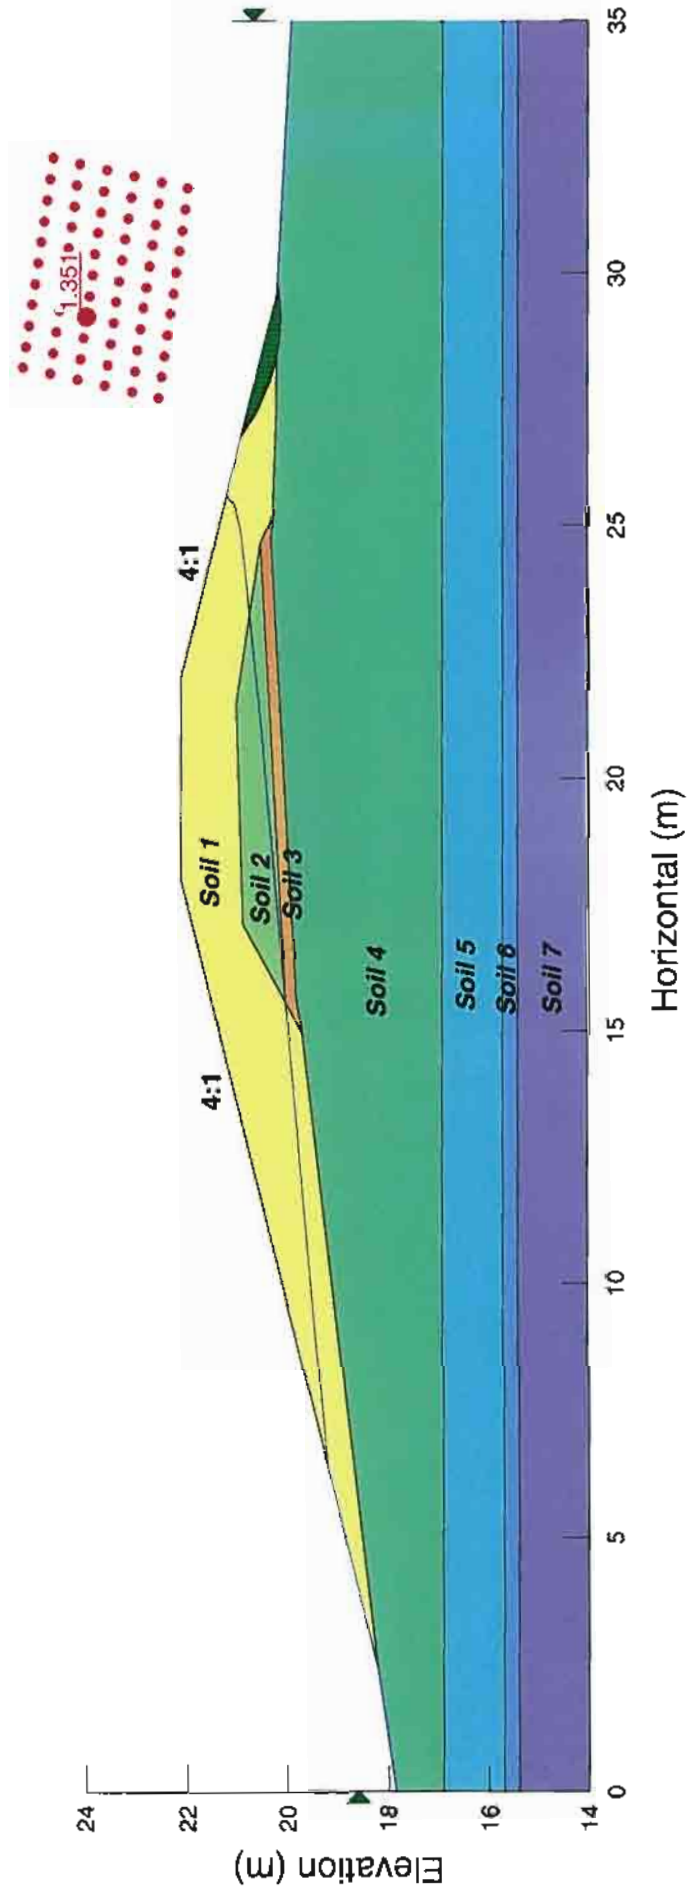
Figure 22
OTT-00201369-A0

Slope Stability Analysis - Section A-A
Upstream Slope (Submerged Slope)
Topsoil Removed
Existing Sewage Lagoon Modifications
Hamlet of Whale Cove

Soil: 6
Description: Sandy Gravel
Soil Model: Mohr-Coulomb
Cohesion: 0
Phi: 35

Soil: 7
Description: Permafrost (Sandy Gravel)

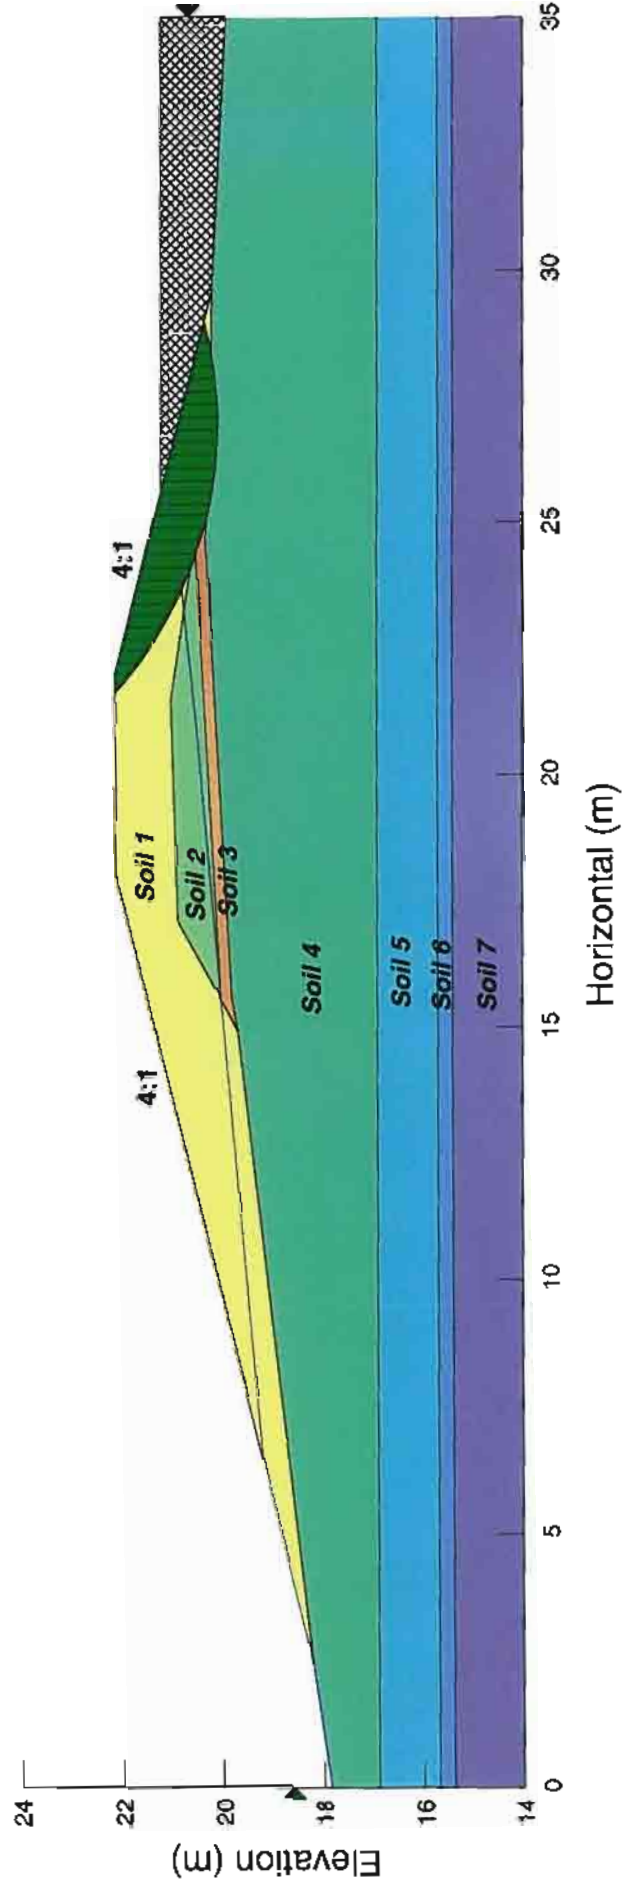
Figure 23
OTT-00201369-A0

Slope Stability Analysis - Section A-A
Upstream Slope (Submerged Slope + Seismic Loading)
Topsoil Removed
Existing Sewage Lagoon Modifications
Hamlet of Whale Cove

Soil: 6
Description: Sandy Gravel
Soil Model: Mohr-Coulomb
Cohesion: 0
Phi: 35

Soil: 7
Description: Permafrost (Sandy Gravel)

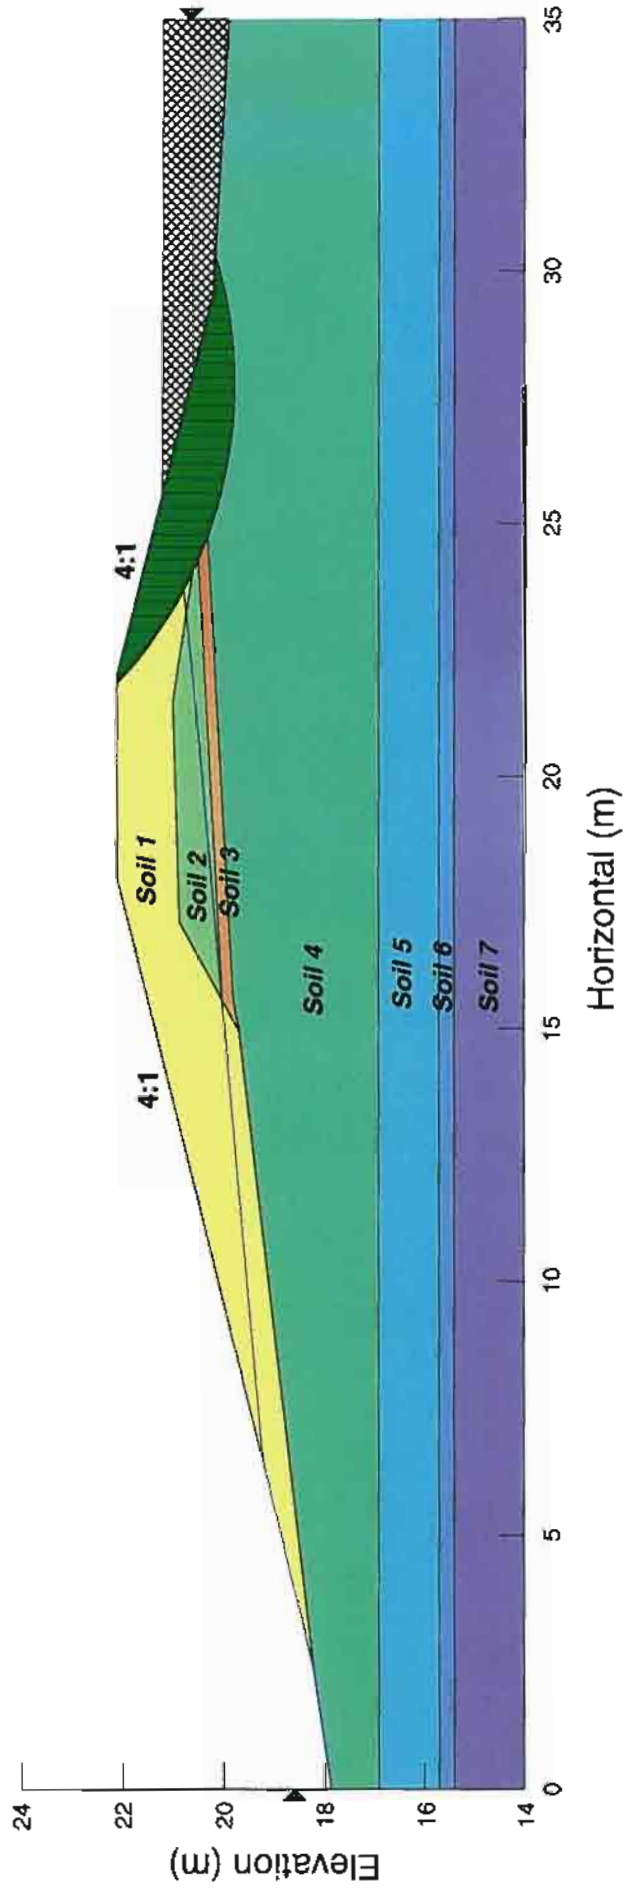
Figure 24
OTT-00201369-A0

Slope Stability Analysis - Section A-A
Downstream (Steady State Seepage)
Topsoil Removed
Existing Sewage Lagoon Modifications
Hamlet of Whale Cove

Soil: 1 Description: Proposed Fill Soil Model: Mohr-Coulomb Cohesion: 0 Phi: 38	Soil: 2 Description: Existing Fill Soil Model: Mohr-Coulomb Cohesion: 0 Phi: 32	Soil: 3 Description: Organic Silt Soil Model: Mohr-Coulomb Cohesion: 0 Phi: 20	Soil: 4 Description: Sand Soil Model: Mohr-Coulomb Cohesion: 0 Phi: 32	Soil: 5 Description: Sandy Silt Soil Model: Mohr-Coulomb Cohesion: 0 Phi: 25
Soil: 6 Description: Sandy Gravel Soil Model: Mohr-Coulomb Cohesion: 0 Phi: 35	Soil: 7 Description: Permafrost (Sandy Gravel)

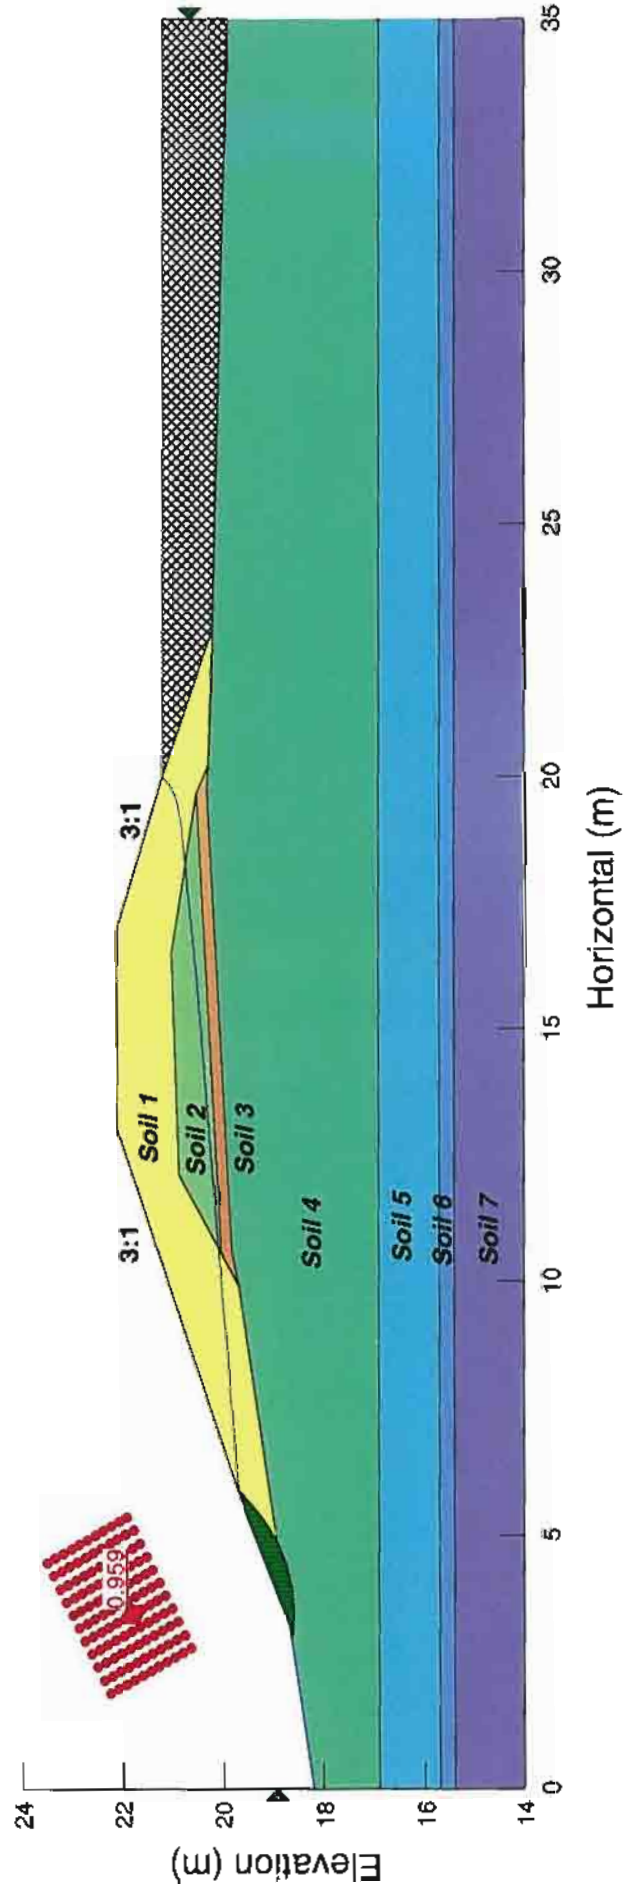
Figure 25
OTT-00201369-A0

Slope Stability Analysis - Section A-A
Downstream (Steady State Seepage + Seismic Loading)
Topsoil Removed
Existing Sewage Lagoon Modifications
Hamlet of Whale Cove

Soil: 1 Description: Proposed Fill Soil Model: Mohr-Coulomb Cohesion: 0 Phi: 38	Soil: 2 Description: Existing Fill Soil Model: Mohr-Coulomb Cohesion: 0 Phi: 32	Soil: 3 Description: Organic Silt Soil Model: Mohr-Coulomb Cohesion: 0 Phi: 20	Soil: 4 Description: Sand Soil Model: Mohr-Coulomb Cohesion: 0 Phi: 32	Soil: 5 Description: Sandy Silt Soil Model: Mohr-Coulomb Cohesion: 0 Phi: 25
Soil: 6 Description: Sandy Gravel Soil Model: Mohr-Coulomb Cohesion: 0 Phi: 35	Soil: 7 Description: Permafrost (Sandy Gravel)

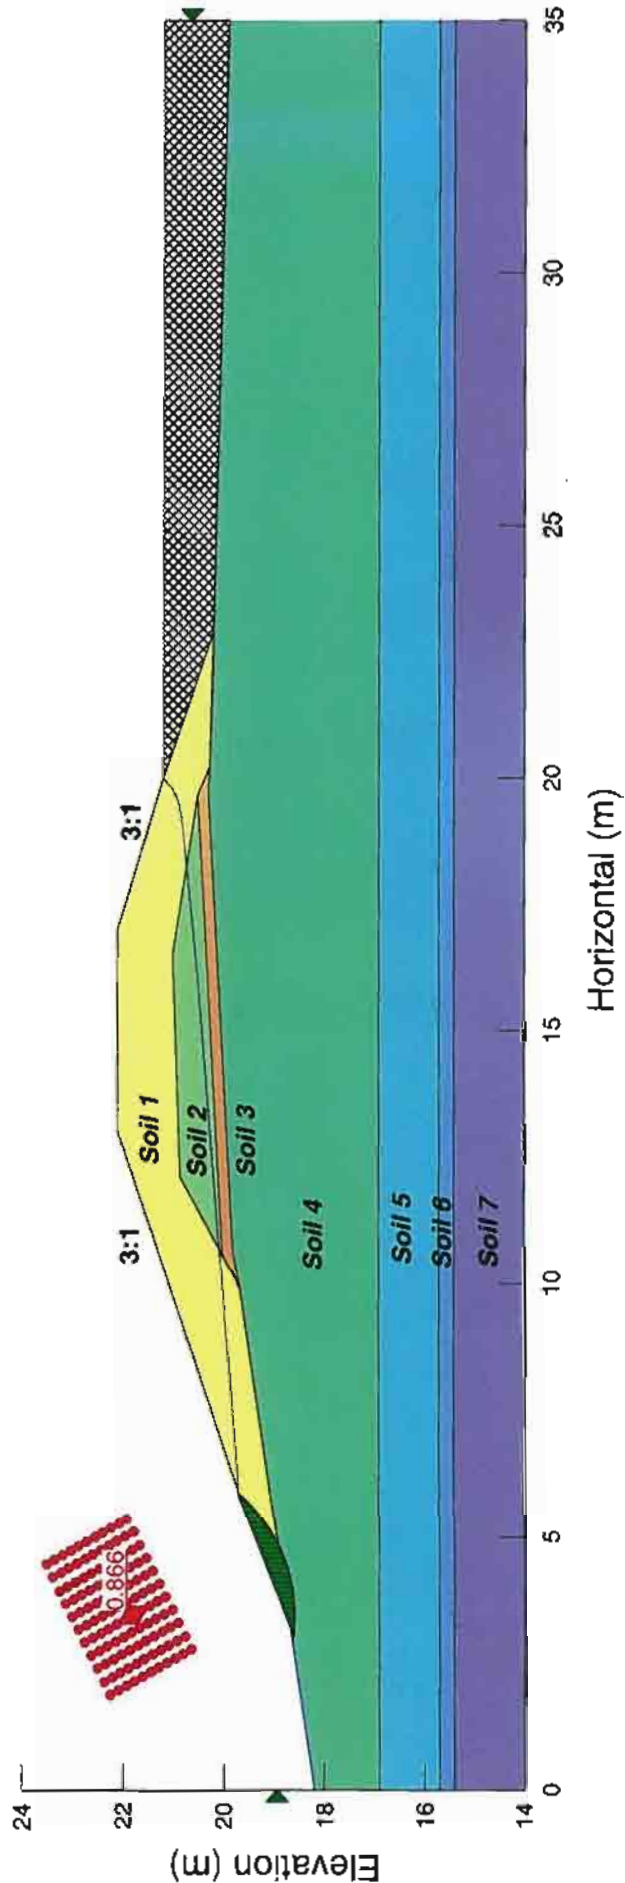
Figure 26
OTT-00201369-A0

Slope Stability Analysis - Section A-A
Downstream Slope (Steady State Seepage)
Topsoil Removed
Existing Sewage Lagoon Modifications
Hamlet of Whale Cove

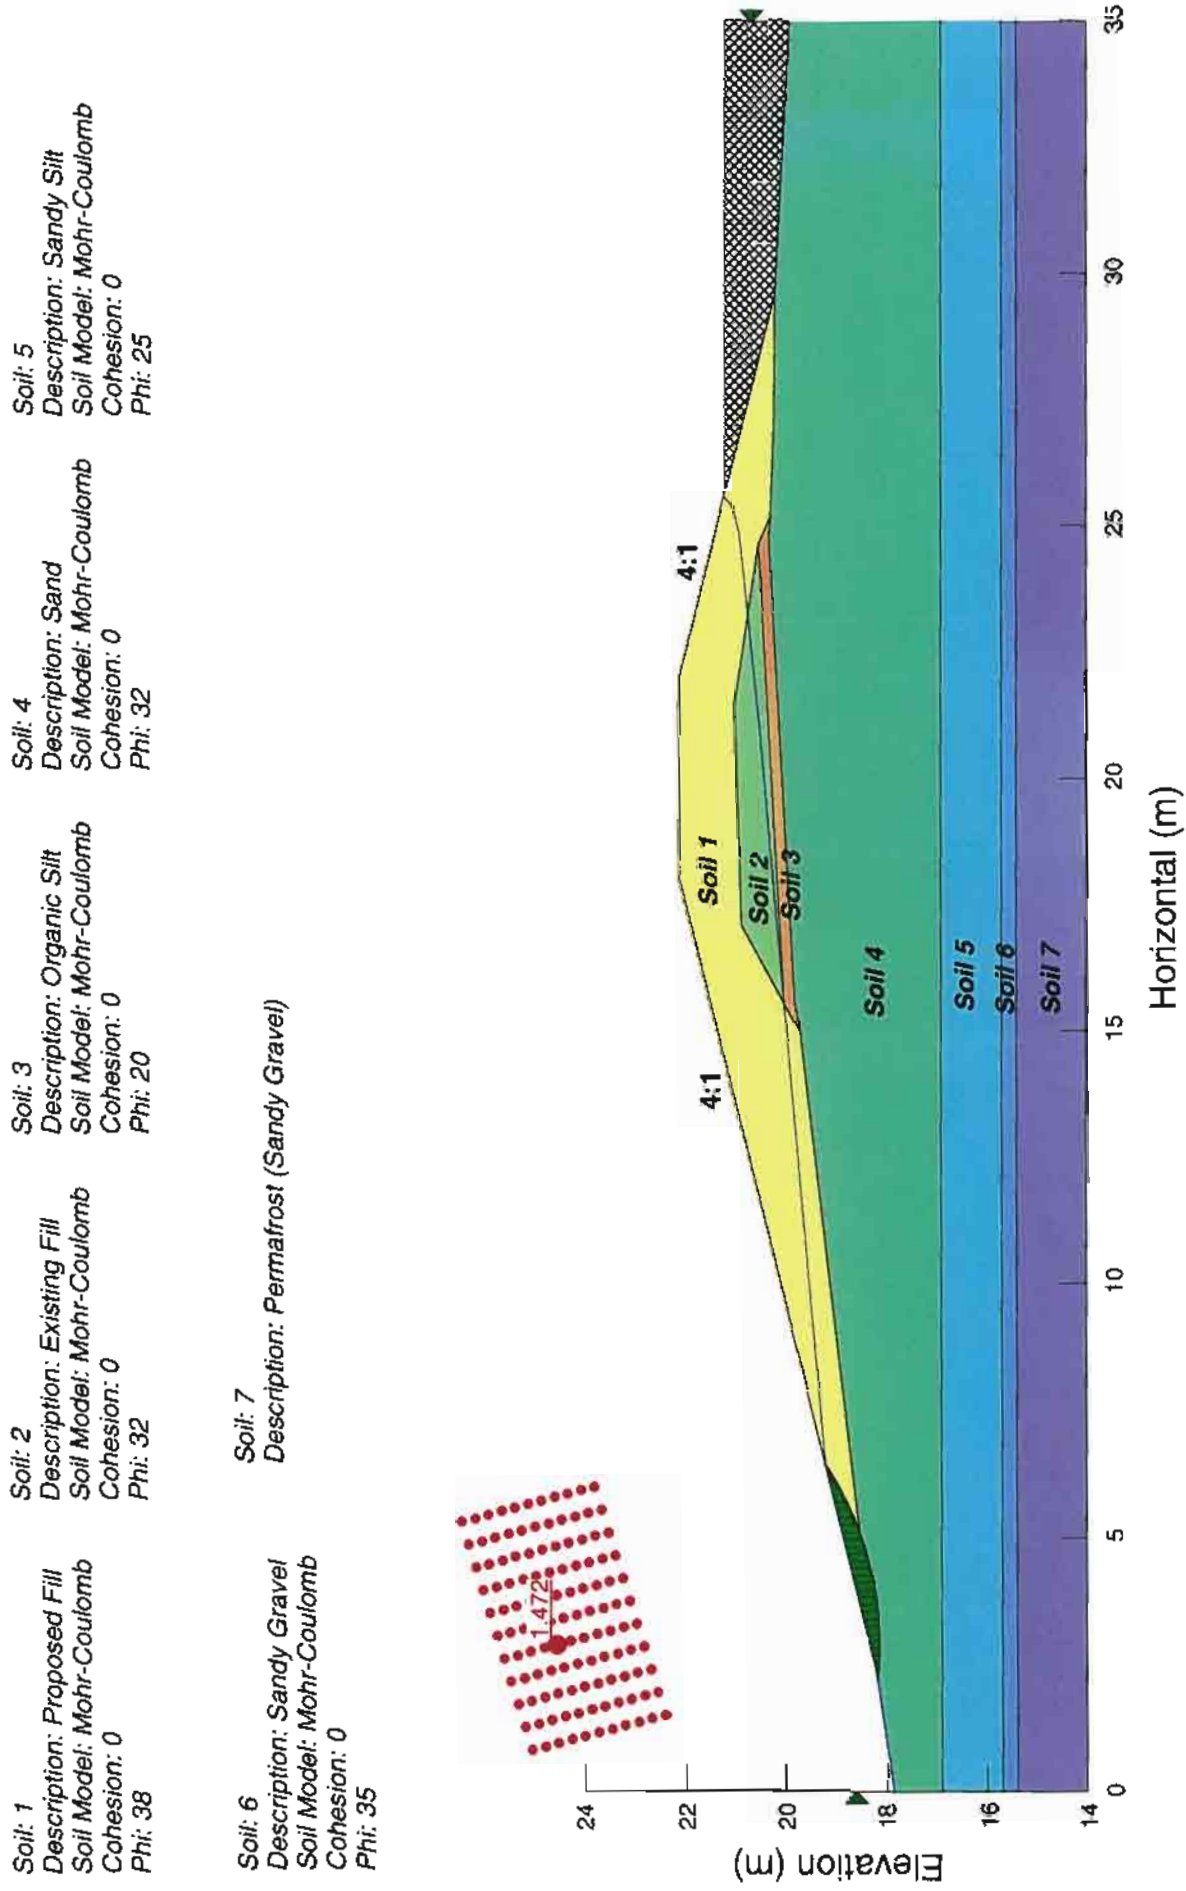
Figure 27
OTT-00201369-A0

Slope Stability Analysis - Section A-A
Downstream Slope (Steady State Seepage + Seismic Loading)
Topsoil Removed
Existing Sewage Lagoon Modifications
Hamlet of Whale Cove
