Geotechnical Recommendations

Proposed Modifications to Sewage Lagoon
Hamlet of Whale Cove, Nunavut

OTT-00201369-A0

September, 2012

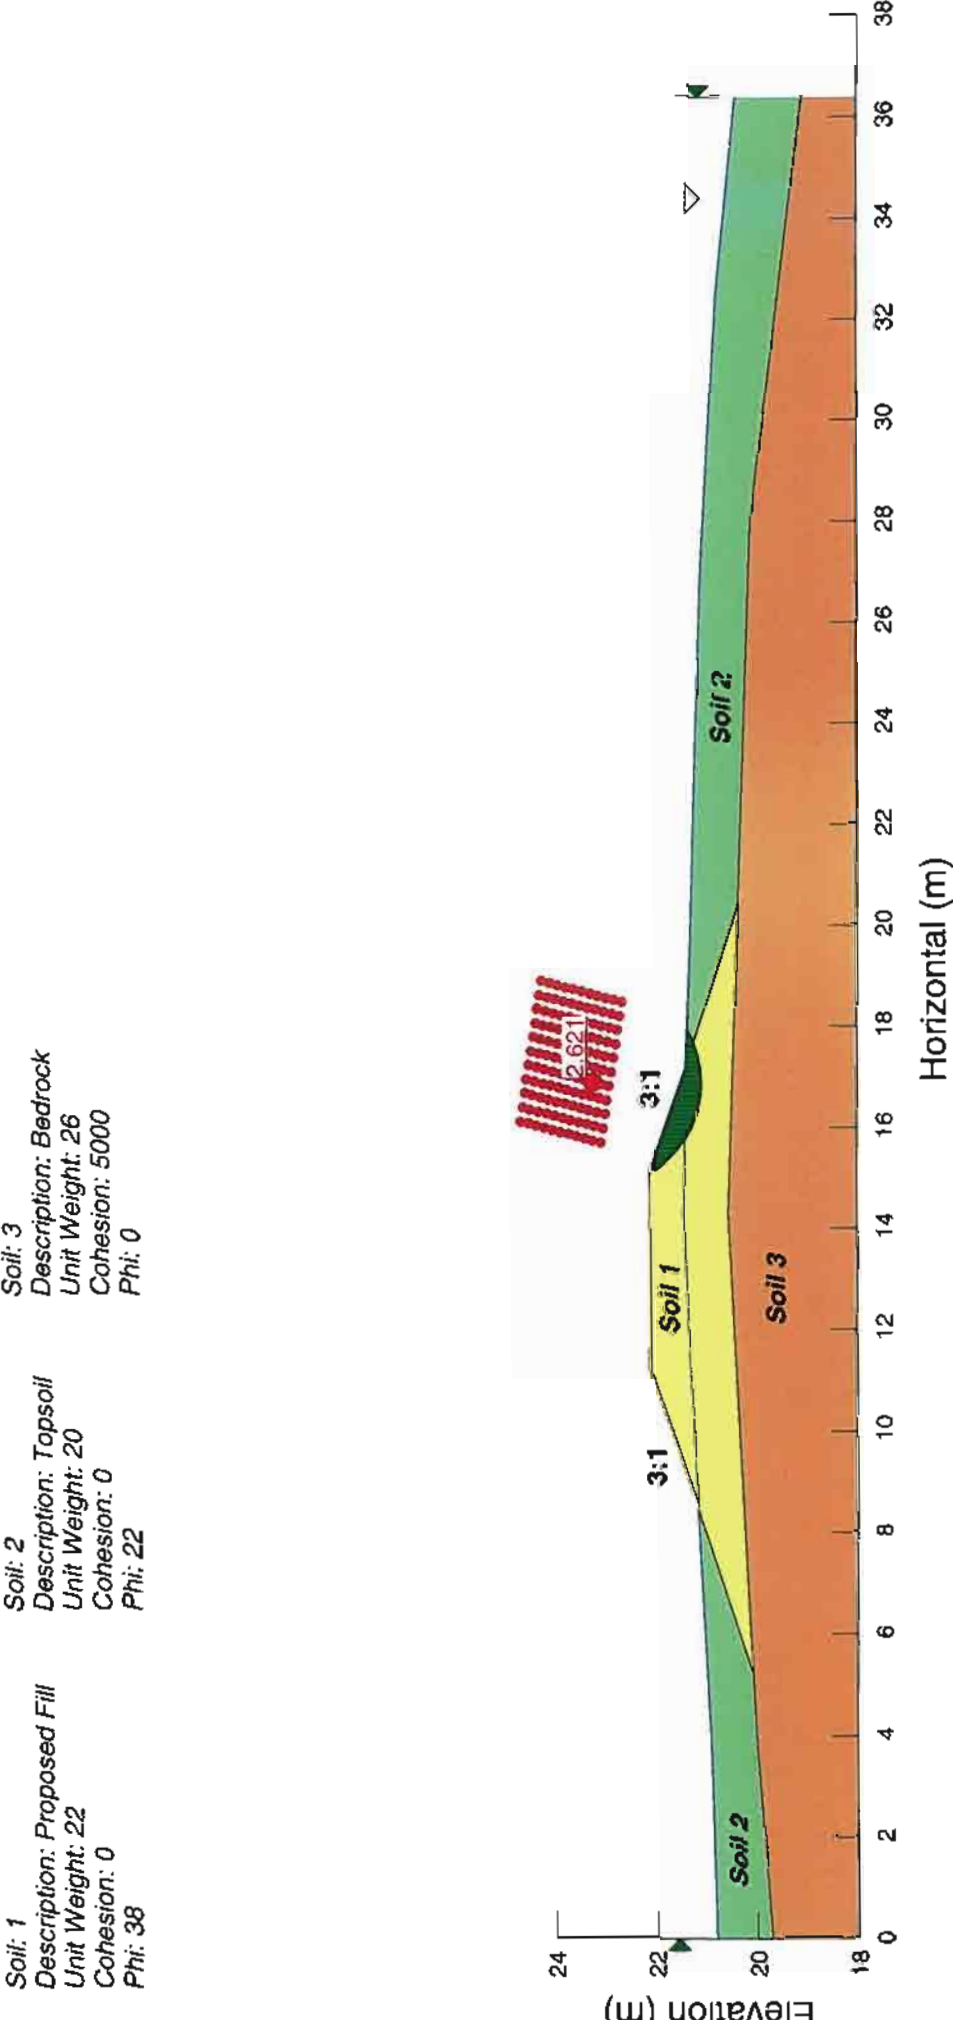
Figure 29
OTT-00201369-A0

Slope Stability Analysis - Section B-B
Upstream Slope (Rapid Drawdown + Seismic Loading)
Topsoil Removed
Existing Sewage Lagoon Modifications
Hamlet of Whale Cove

Table II - Computed Factors of Safety for Upstream and Downstream Berm Slopes					
Berm Identification	Slope Identification	Slope Inclination	Loading Condition	Computed Factor of Safety	Figure #
A	Upstream	4H:1V	Rapid drawdown	1.59	20
			Rapid drawdown with seismic loading	1.35	21
			Submerged slope	2.66	22
			Submerged slope with seismic loading	2.08	23
	Downstream	3H:1V	Steady state seepage	0.96	24
			Steady state seepage with seismic loading	0.87	25
		4H:1V	Steady state seepage	1.47	26
			Steady state seepage with seismic loading	1.25	27
B	Upstream	3H:1V	Rapid drawdown	2.62	28
			Rapid drawdown with seismic loading	2.25	29
			Submerged slope	2.62	30
			Submerged slope with seismic loading	2.25	31
	Downstream	3H:1V	Steady state seepage	2.13	32
			Steady state seepage with seismic loading	1.77	33
C	Upstream	3H:1V	Rapid drawdown	2.08	34
			Rapid drawdown with seismic loading	1.72	35
			Submerged slope	2.17	36

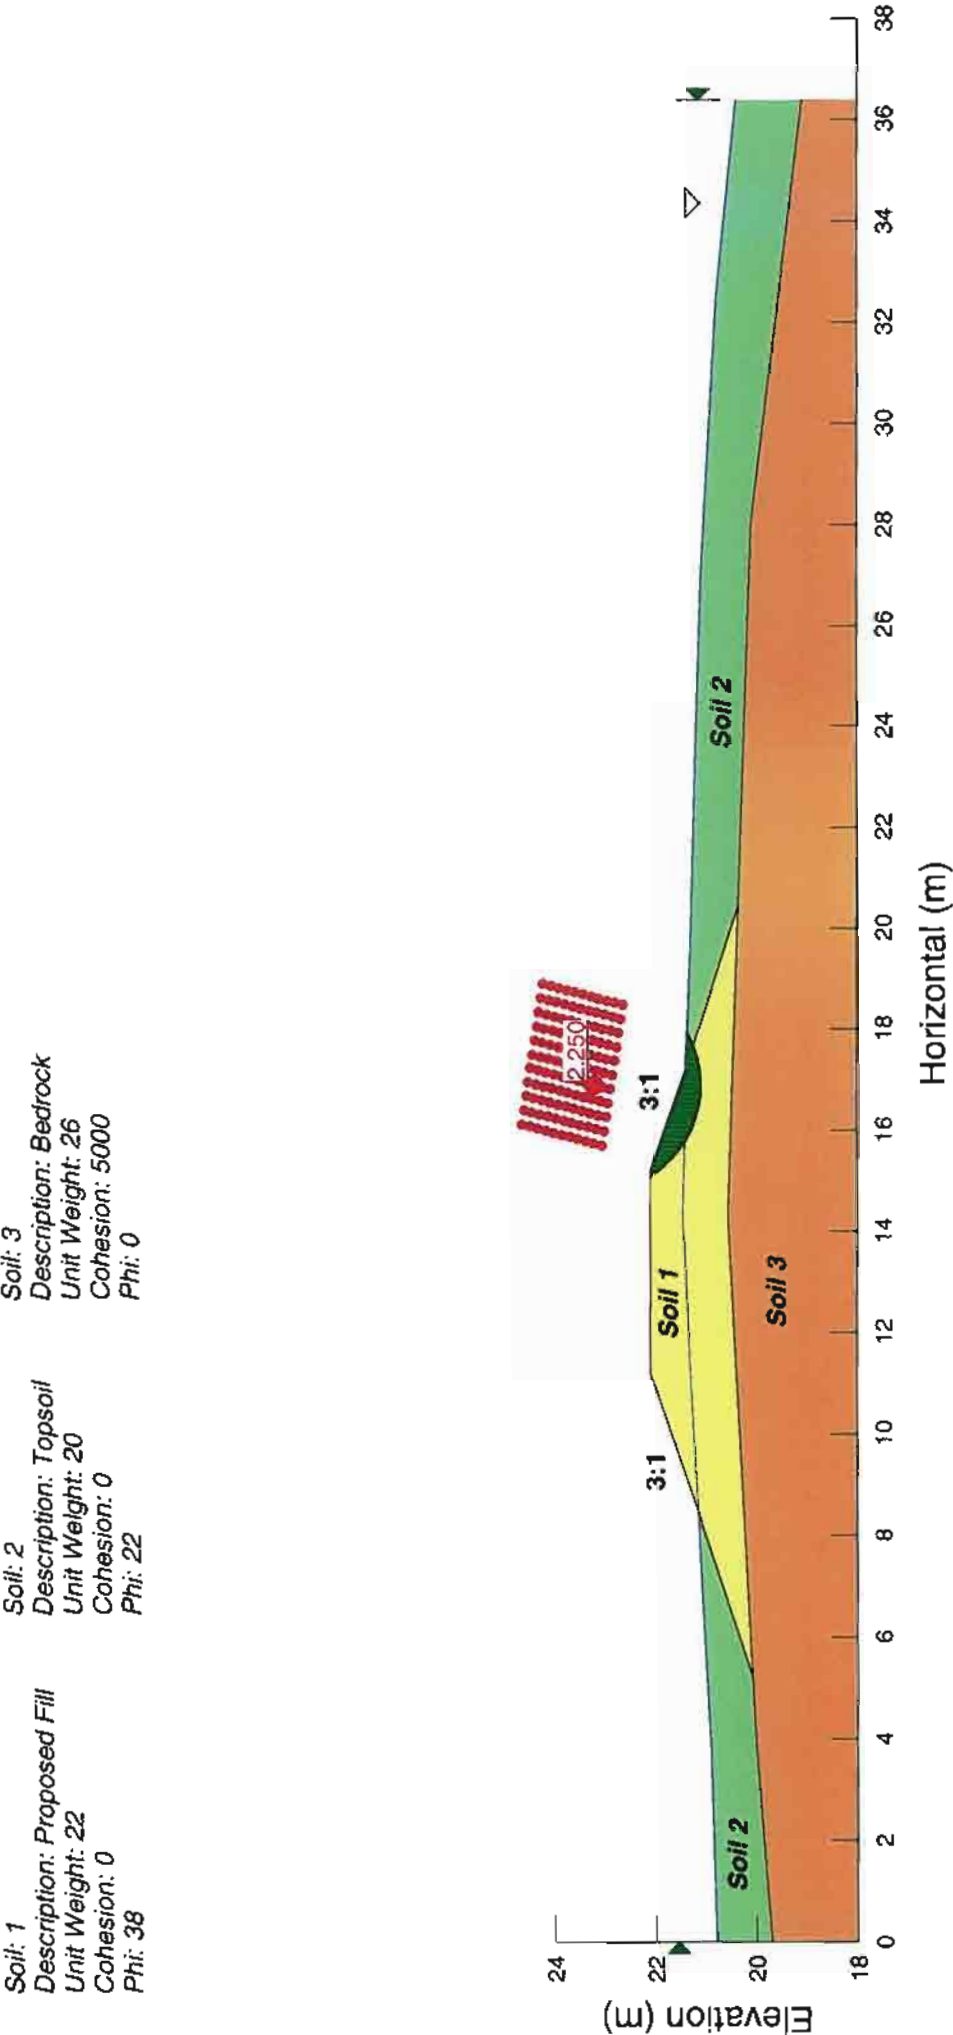
Figure 30
OTT-00201369-A0

Slope Stability Analysis - Section B-B
Upstream Slope (Submerged Slope)
Topsoil Removed
Existing Sewage Lagoon Modifications
Hamlet of Whale Cove

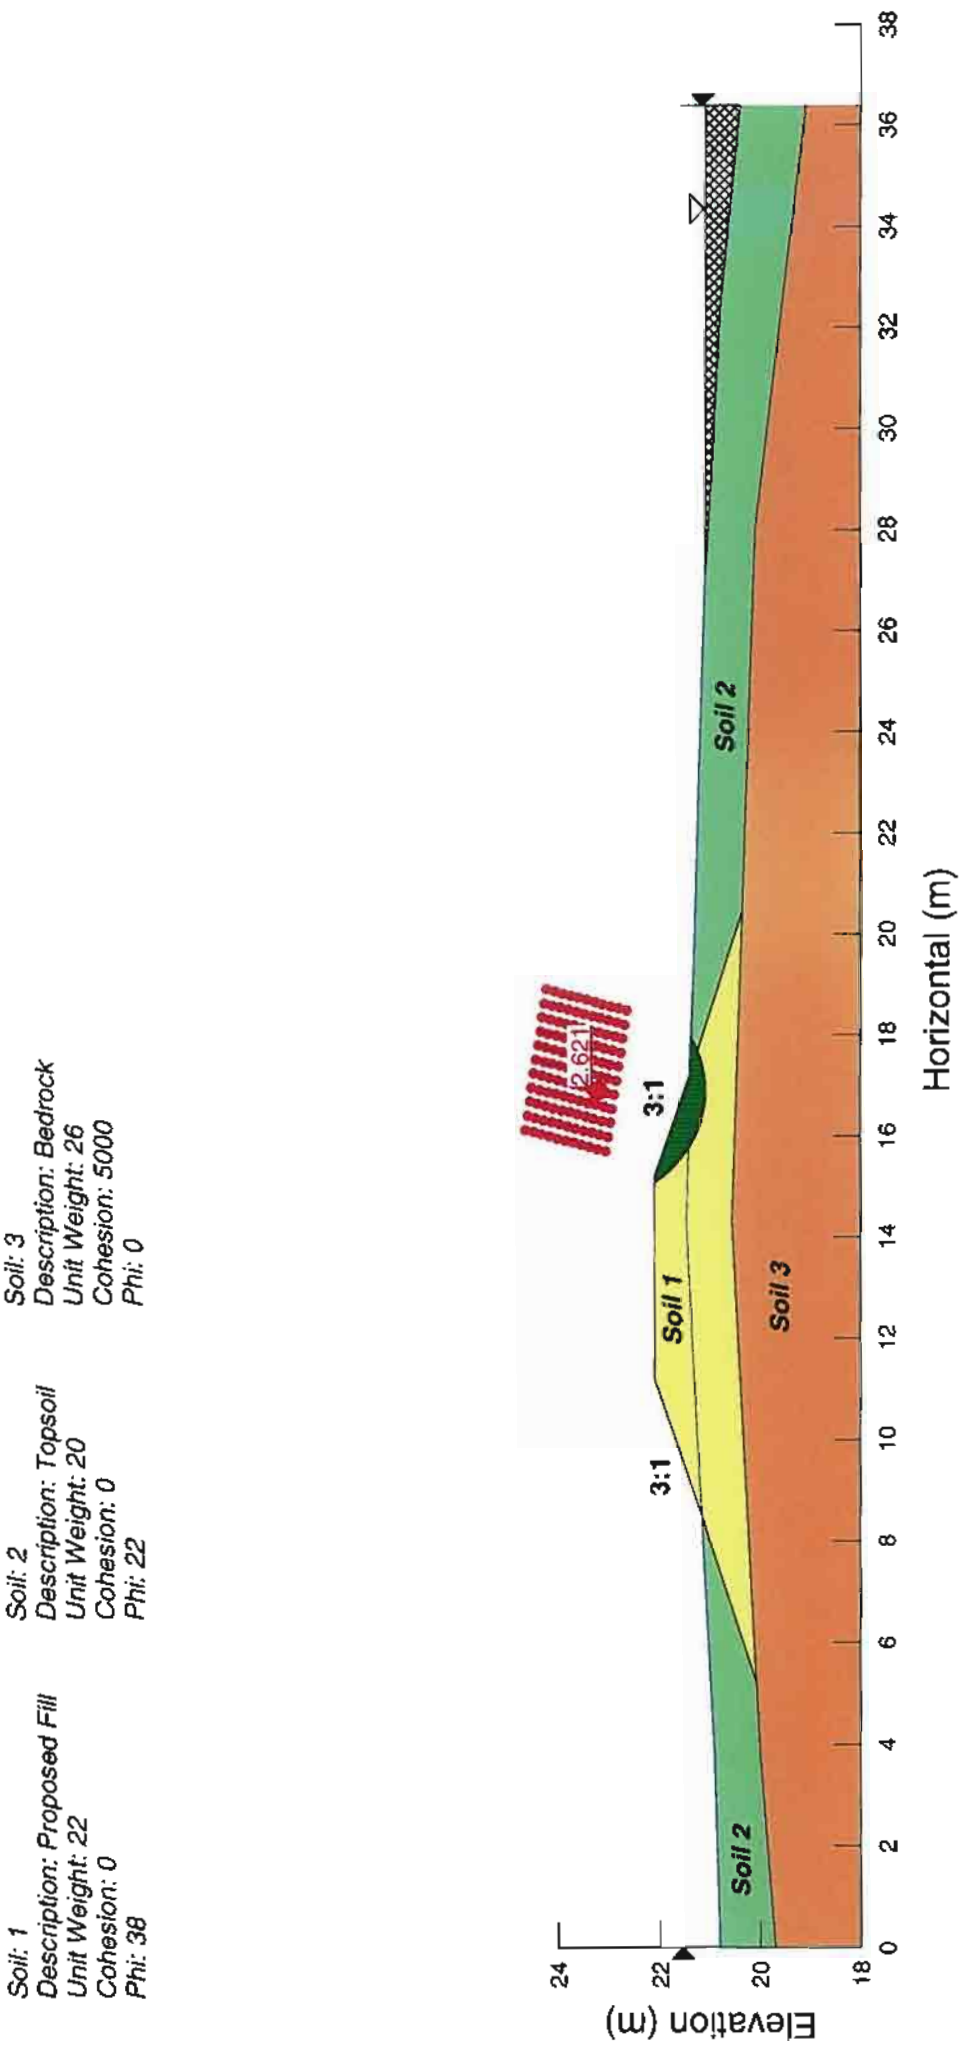
Figure 31
OTT-00201369-A0

Slope Stability Analysis - Section B-B
Upstream Slope (Submerged Slope + Seismic Loading)
Topsoil Removed
Existing Sewage Lagoon Modifications
Hamlet of Whale Cove

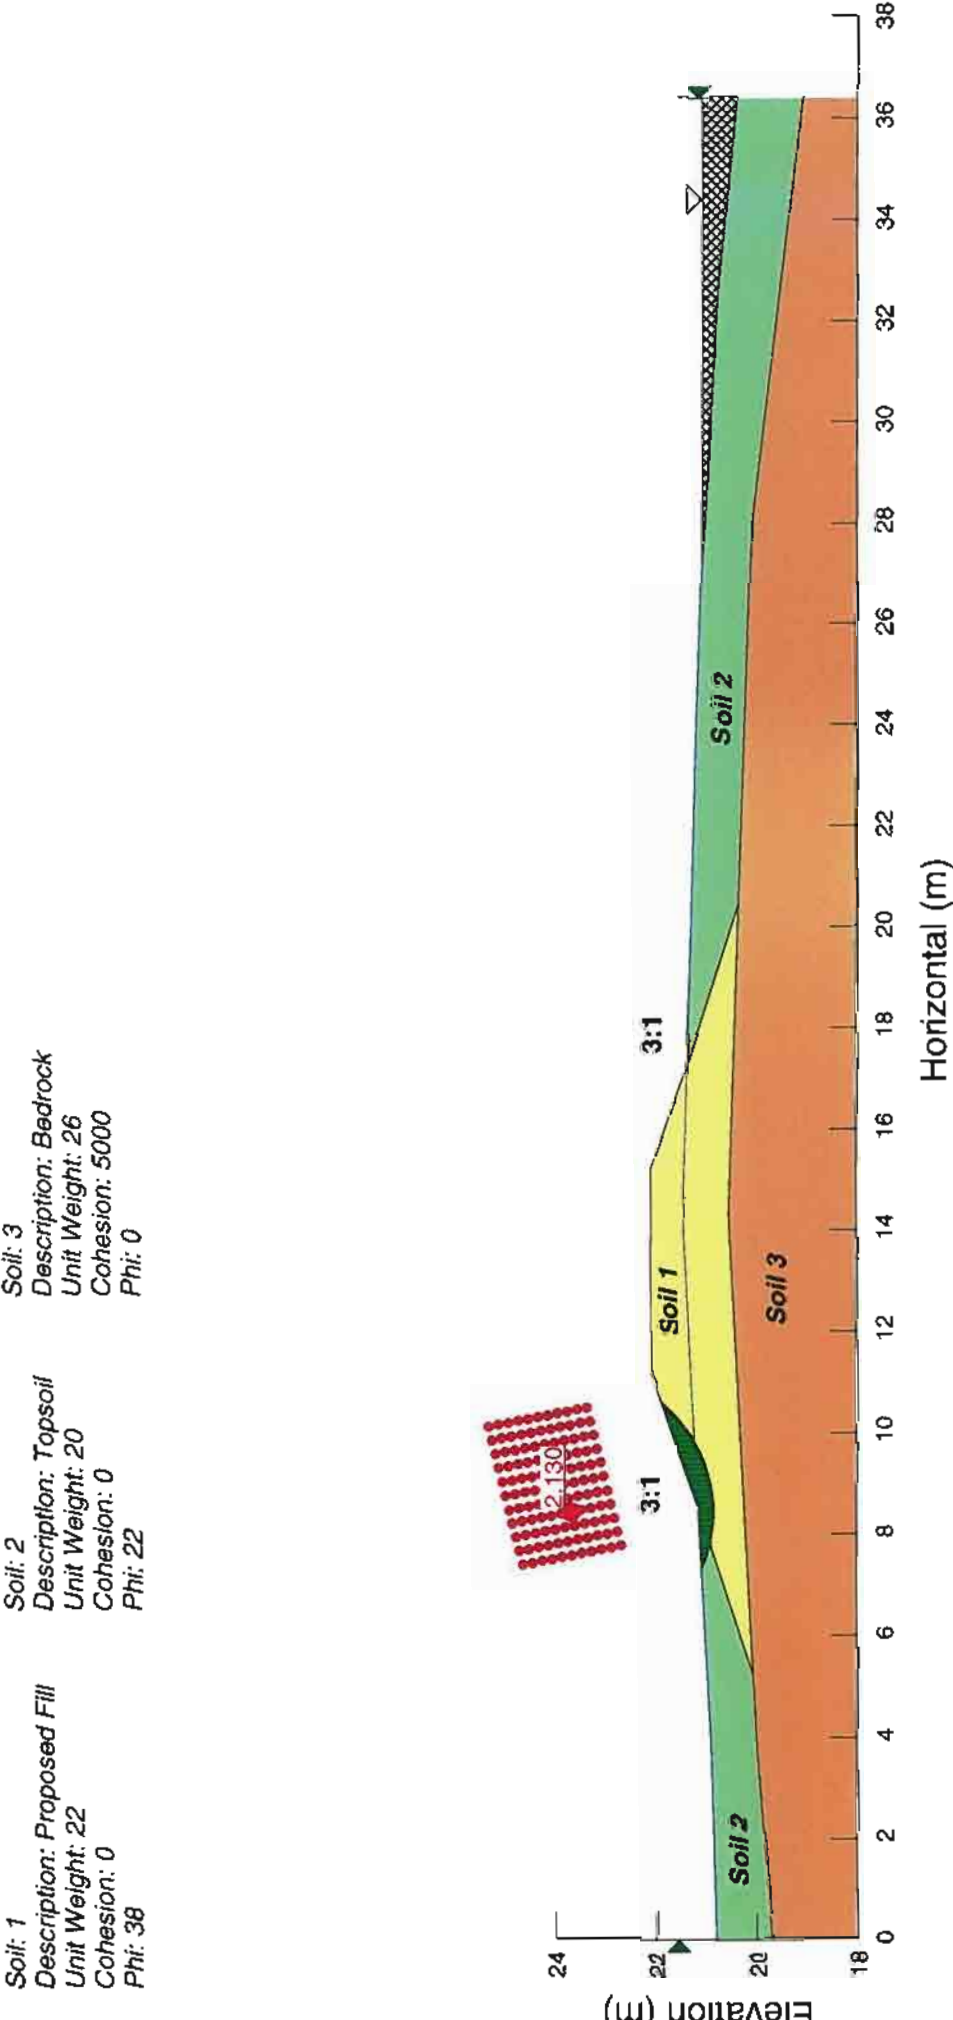
Figure 32

Slope Stability Analysis - Section B-B

Downstream Slope (Steady State Seepage)

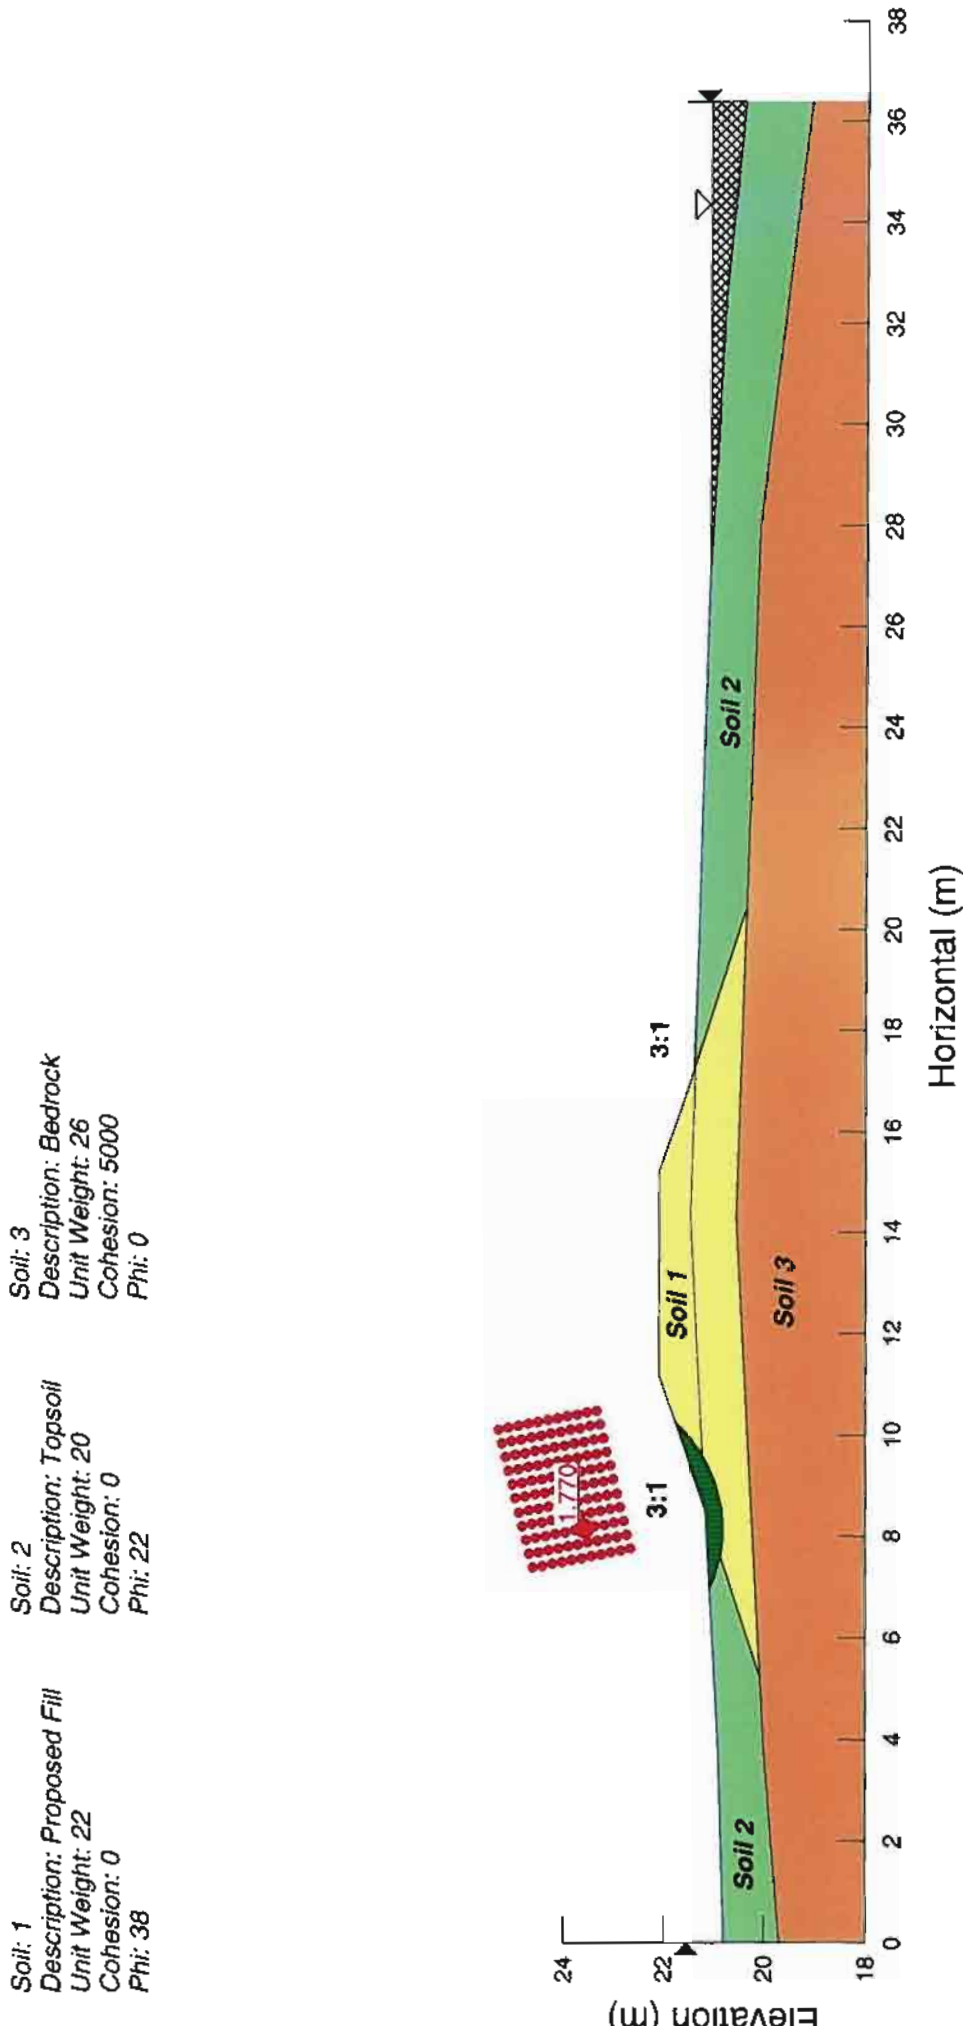
Figure 33
OTT-00201369-A0

Slope Stability Analysis - Section B-B
Downstream Slope (Steady State Seepage + Seismic Loading)
Topsoil Removed
Existing Sewage Lagoon Modifications
Hamlet of Whale Cove

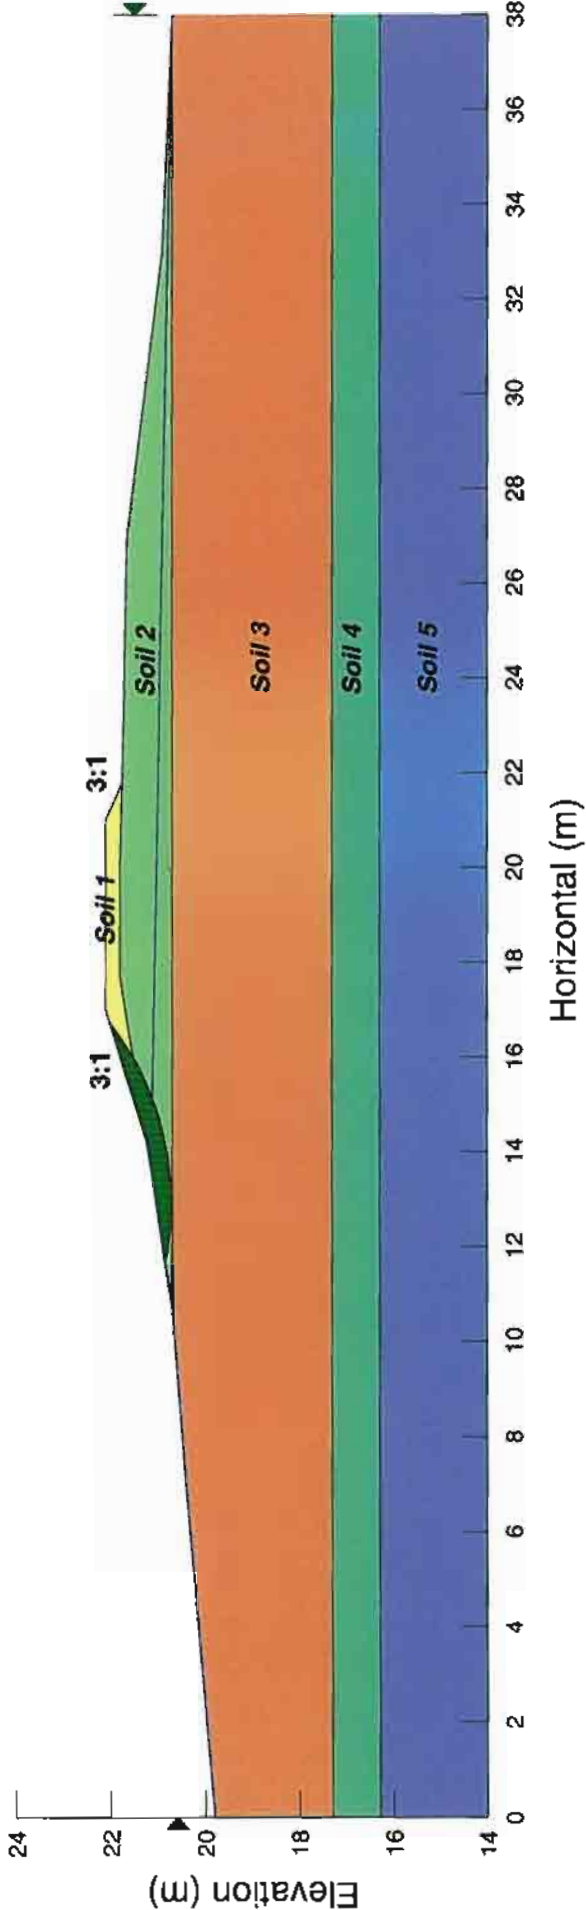
Figure 34
OTT-00201369-A0

Slope Stability Analysis - Section C-C
Upstream Slope (Rapid Drawdown)
Topsoil Removed
Existing Sewage Lagoon Modifications
Hamlet of Whale Cove

Soil: 1	Soil: 2	Soil: 3	Soil: 4	Soil: 5
Description: Proposed Fill	Description: Existing Fill	Description: Existing Fill	Description: Sand and Gravel	Description: Permafrost (Silt and Sand)
Unit Weight: 22	Unit Weight: 20	Unit Weight: 22	Unit Weight: 22	
Cohesion: 0	Cohesion: 0	Cohesion: 0	Cohesion: 0	
Phi: 38	Phi: 32	Phi: 33	Phi: 35

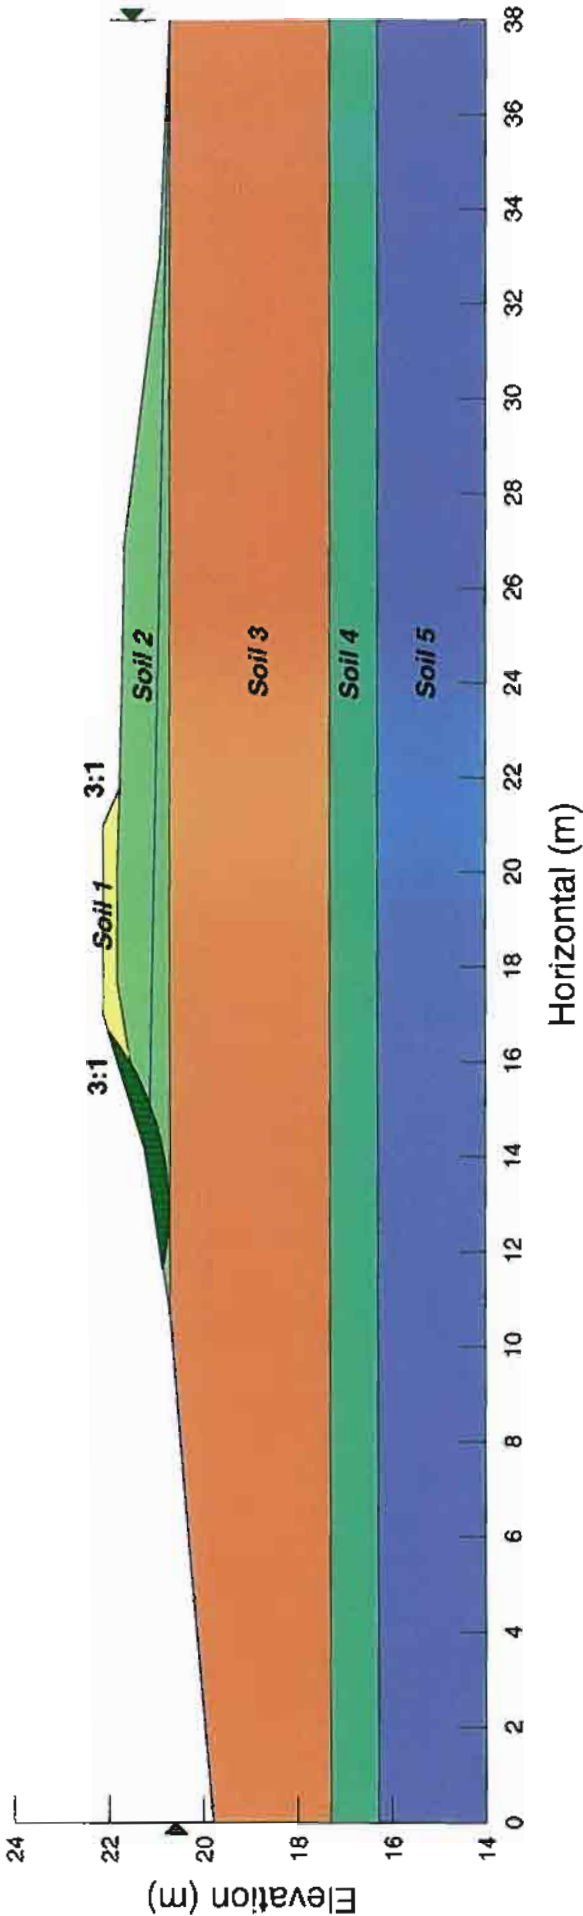
Figure 35
OTT-00201369-A0

Slope Stability Analysis - Section C-C
Upstream Slope (Rapid Drawdown + Seismic Loading)
Topsoil Removed
Proposed/Existing Sewage Lagoon
Hamlet of Whale Cove

Soil: 1	Soil: 2	Soil: 3	Soil: 4	Soil: 5
Description: Proposed Fill	Description: Existing Fill	Description: Sand and Gravel	Description: Sandy Gravel	Description: Permafrost (Silt and Sand)
Unit Weight: 22	Unit Weight: 20	Unit Weight: 22	Unit Weight: 22	
Cohesion: 0	Cohesion: 0	Cohesion: 0	Cohesion: 0	
Phi: 38	Phi: 32	Phi: 33	Phi: 35

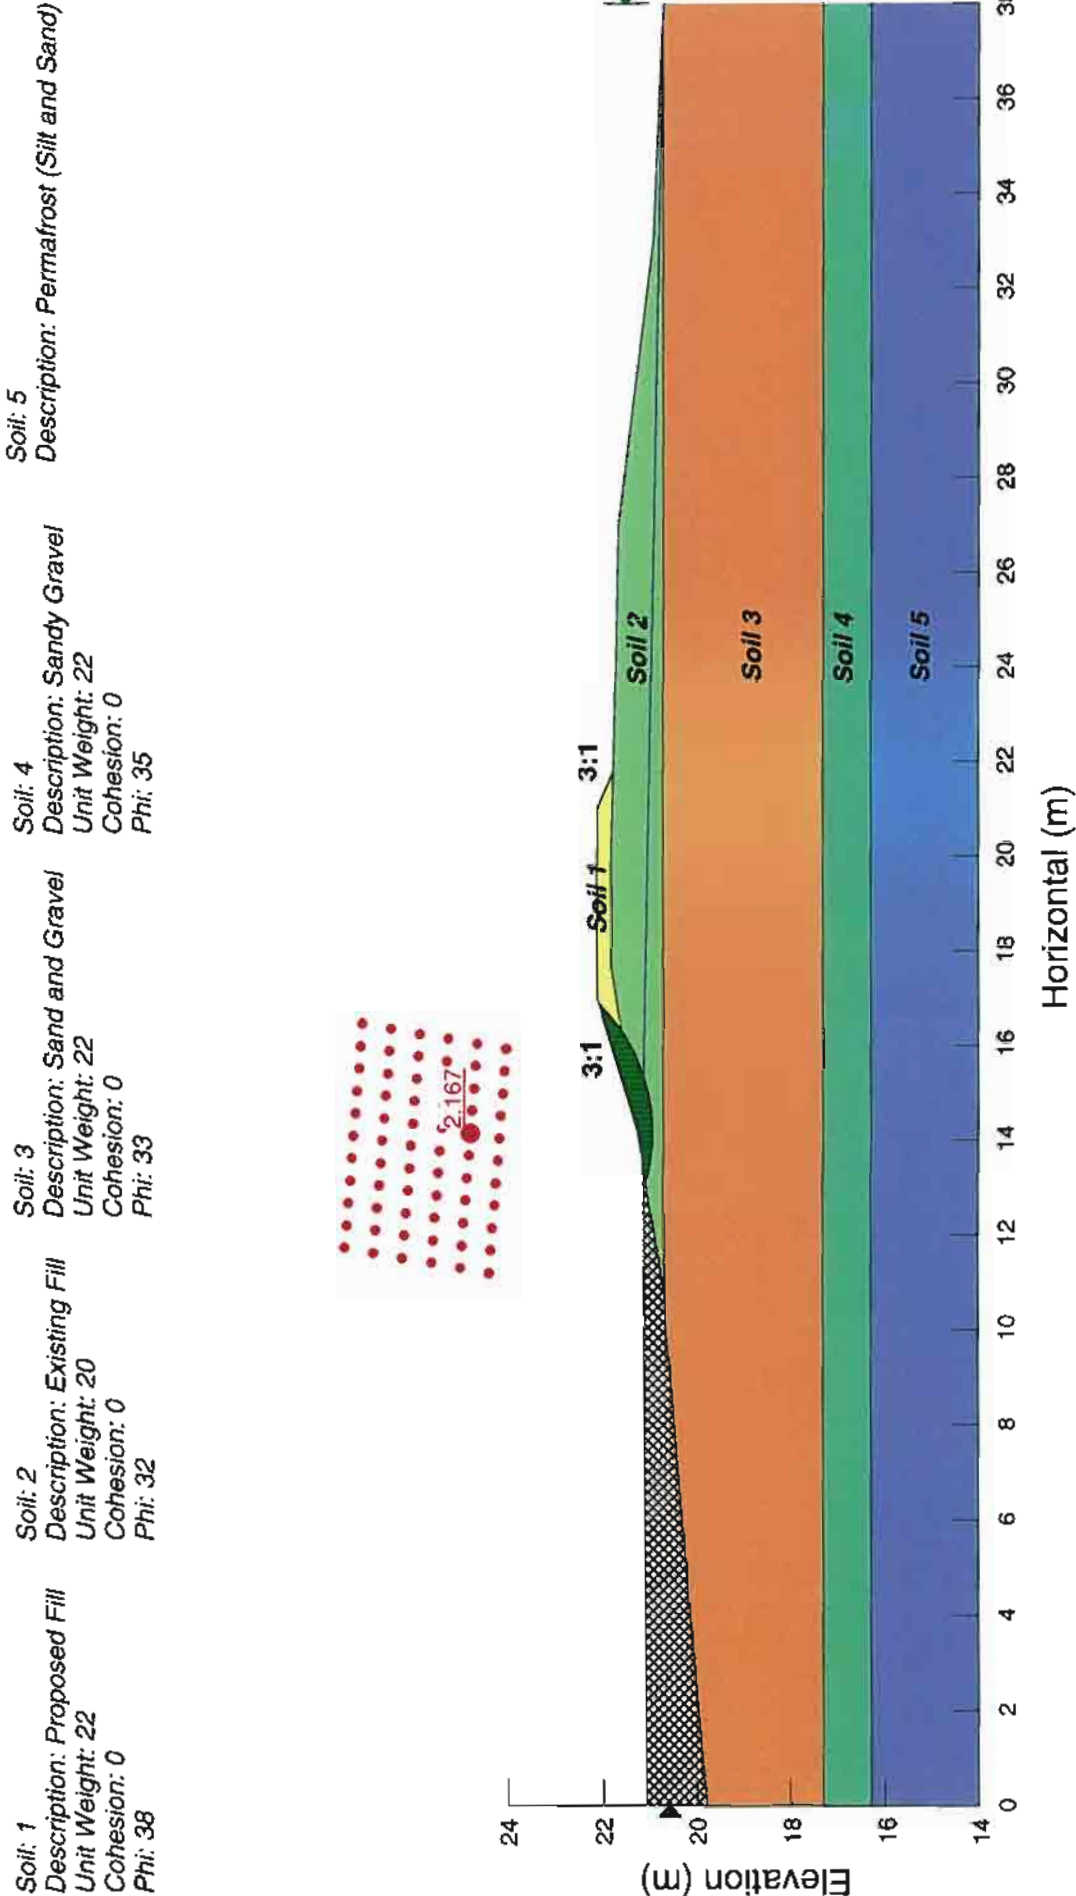
Figure 36
OTT-00201369-A0

Slope Stability Analysis - Section C-C
Upstream Slope (Submerged Slope)
Topsoil Removed
Existing Sewage Lagoon Modifications
Hamlet of Whale Cove

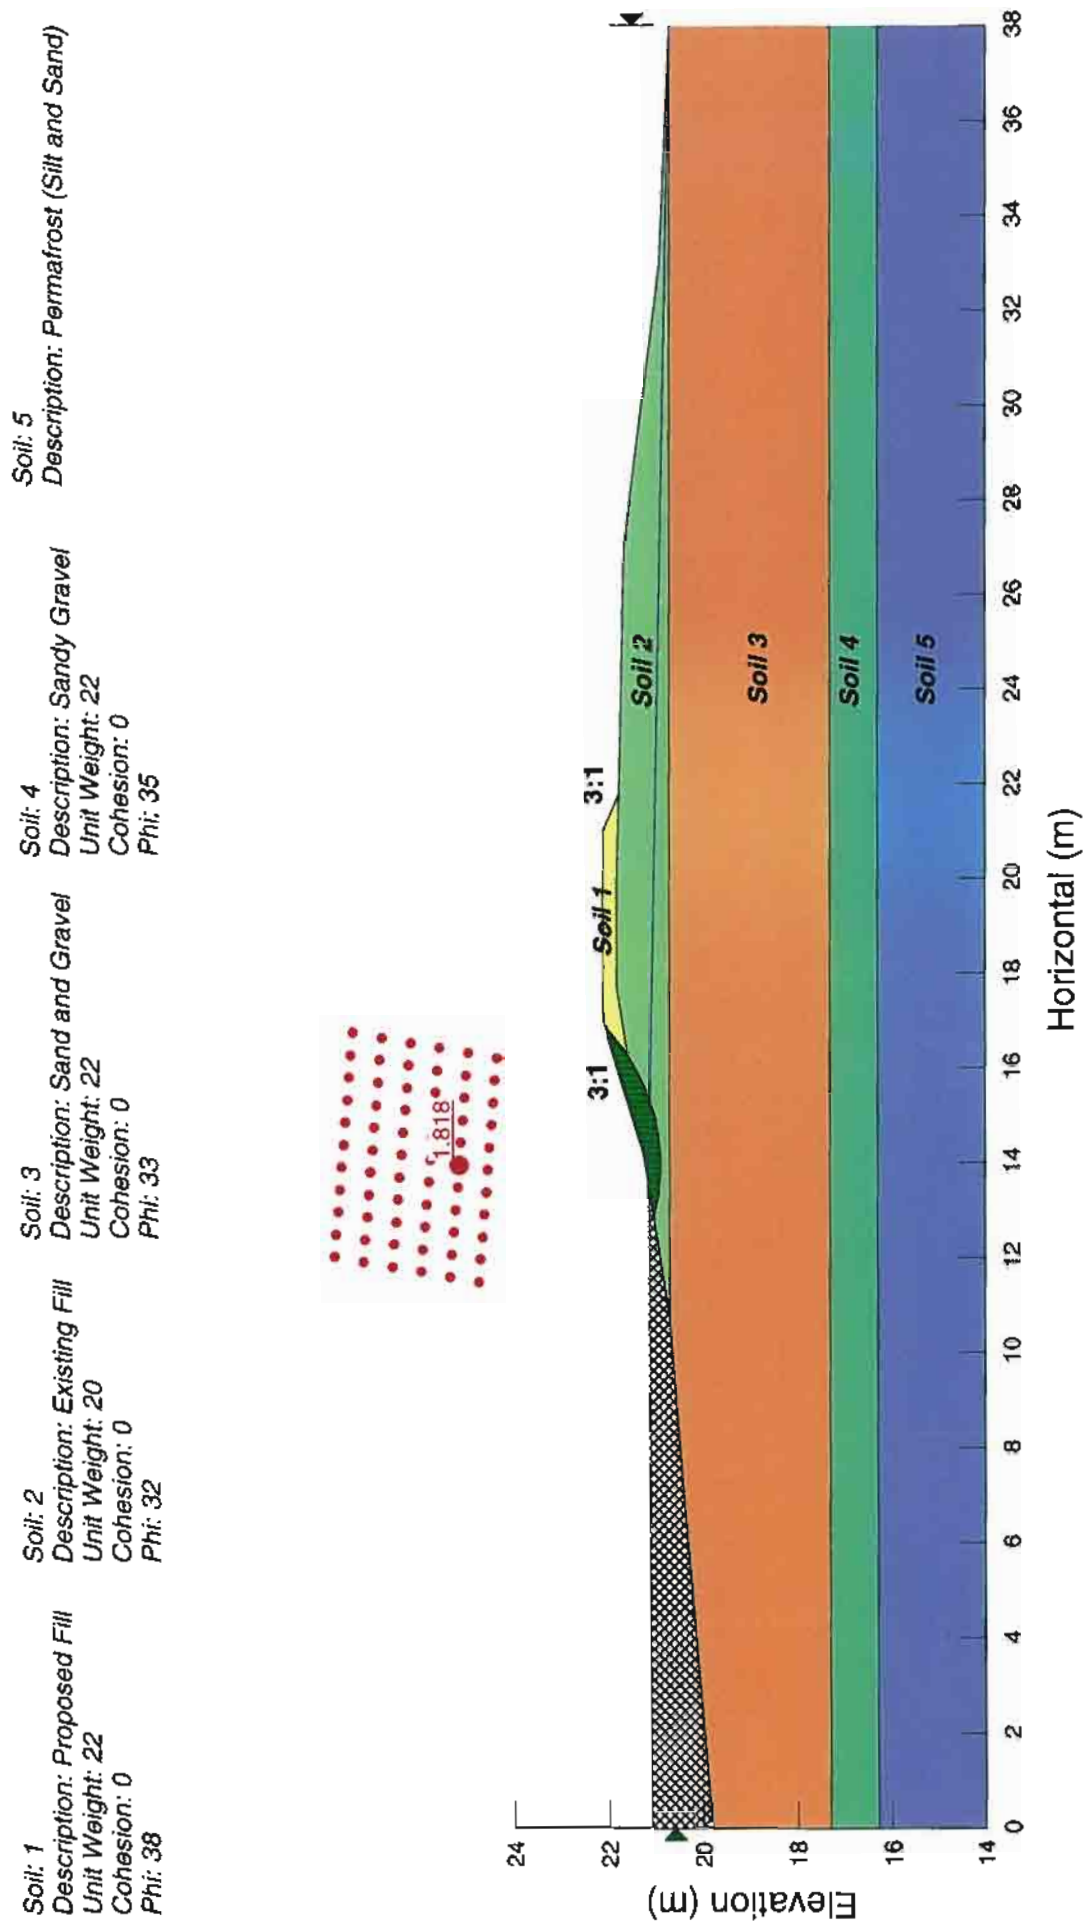
Figure 37
OTT-00201369-A0

Slope Stability Analysis - Section C-C
Upstream Slope (Submerged Slope + Seismic Loading)
Topsoil Removed
Existing Sewage Lagoon Modifications
Hamlet of Whale Cove

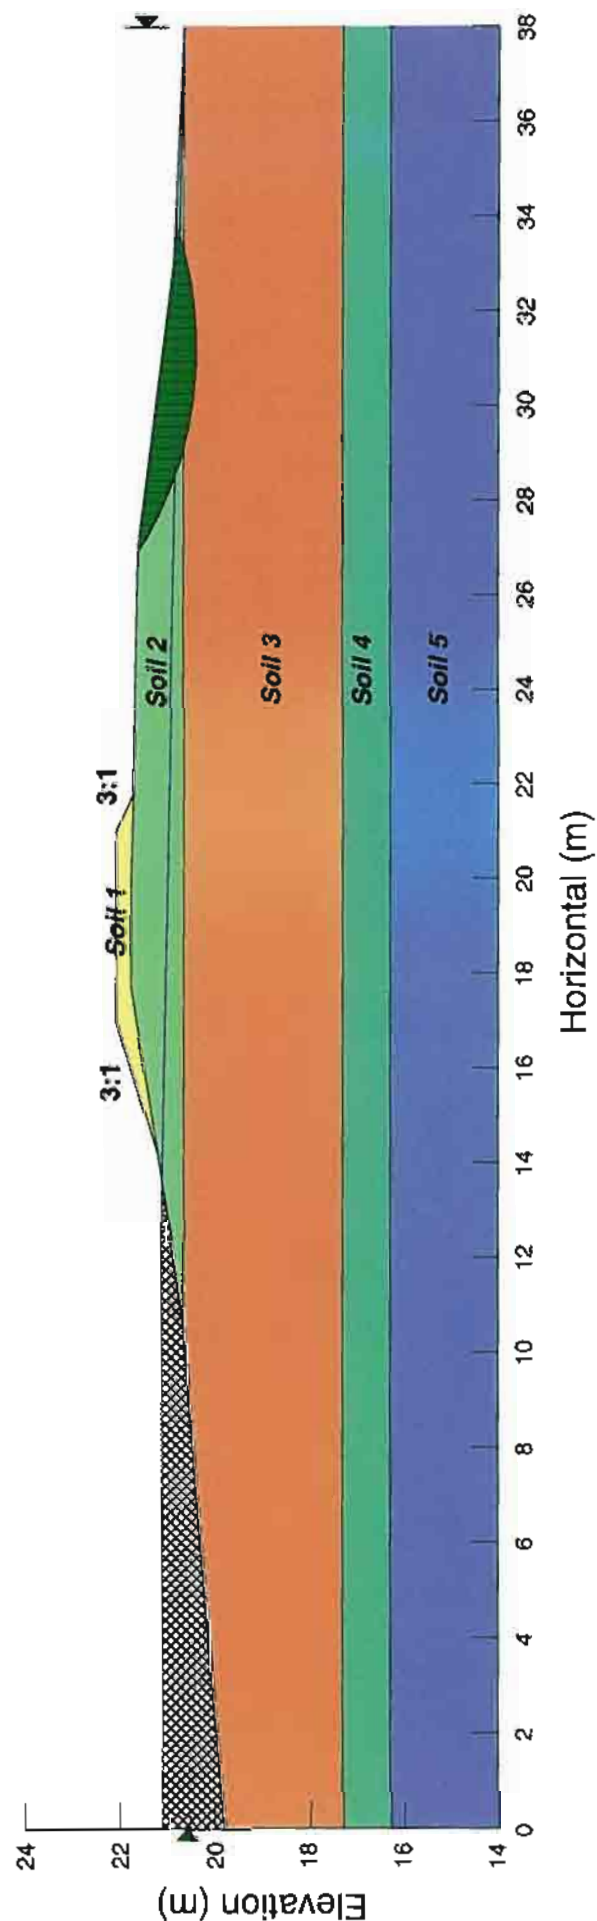
Figure 38
OTT-00201369-A0

Slope Stability Analysis - Section C-C
Downstream Slope (Steady State Seepage)
Topsoil Removed
Existing Sewage Lagoon Modifications
Hamlet of Whale Cove

Soil: 1	Soil: 2	Soil: 3	Soil: 4	Soil: 5
Description: Proposed Fill	Description: Existing Fill	Description: Sand and Gravel	Description: Sandy Gravel	Description: Permafrost (Silt and Sand)
Unit Weight: 22	Unit Weight: 20	Unit Weight: 22	Unit Weight: 22	
Cohesion: 0	Cohesion: 0	Cohesion: 0	Cohesion: 0	
Phi: 38	Phi: 32	Phi: 33	Phi: 35

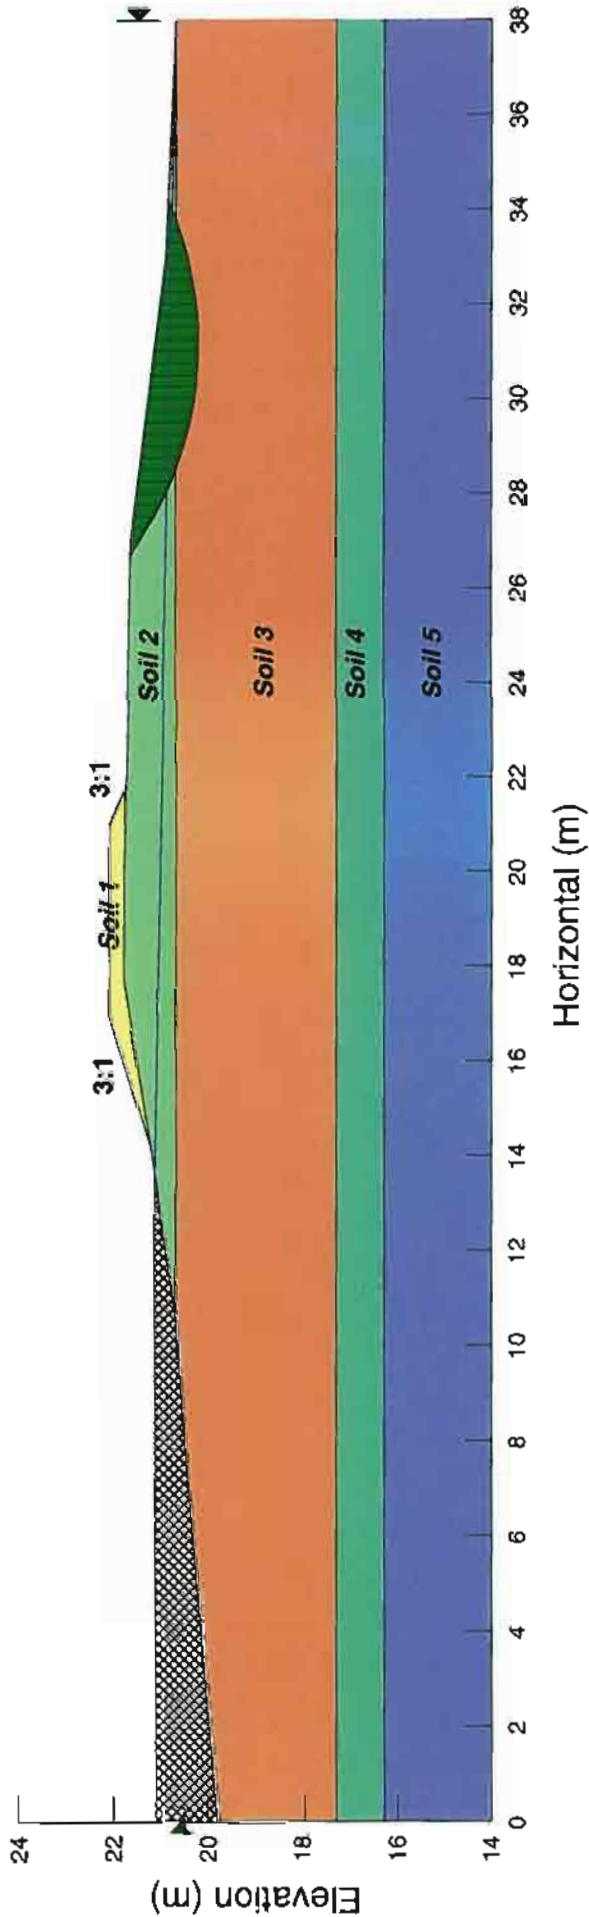
Figure 39
OTT-00201369-A0

Slope Stability Analysis - Section C-C
Downstream Slope (Steady State Seepage + Seismic Loading)
Topsoil Removed
Existing Sewage Lagoon Modifications
Hamlet of Whale Cove

Soil: 1	Soil: 2	Soil: 3	Soil: 4	Soil: 5
Description: Proposed Fill	Description: Existing Fill	Description: Sand and Gravel	Description: Sandy Gravel	Description: Permafrost (Silt and Sand)
Unit Weight: 22	Unit Weight: 20	Unit Weight: 22	Unit Weight: 22	
Cohesion: 0	Cohesion: 0	Cohesion: 0	Cohesion: 0	
Phi: 38	Phi: 32	Phi: 33	Phi: 35

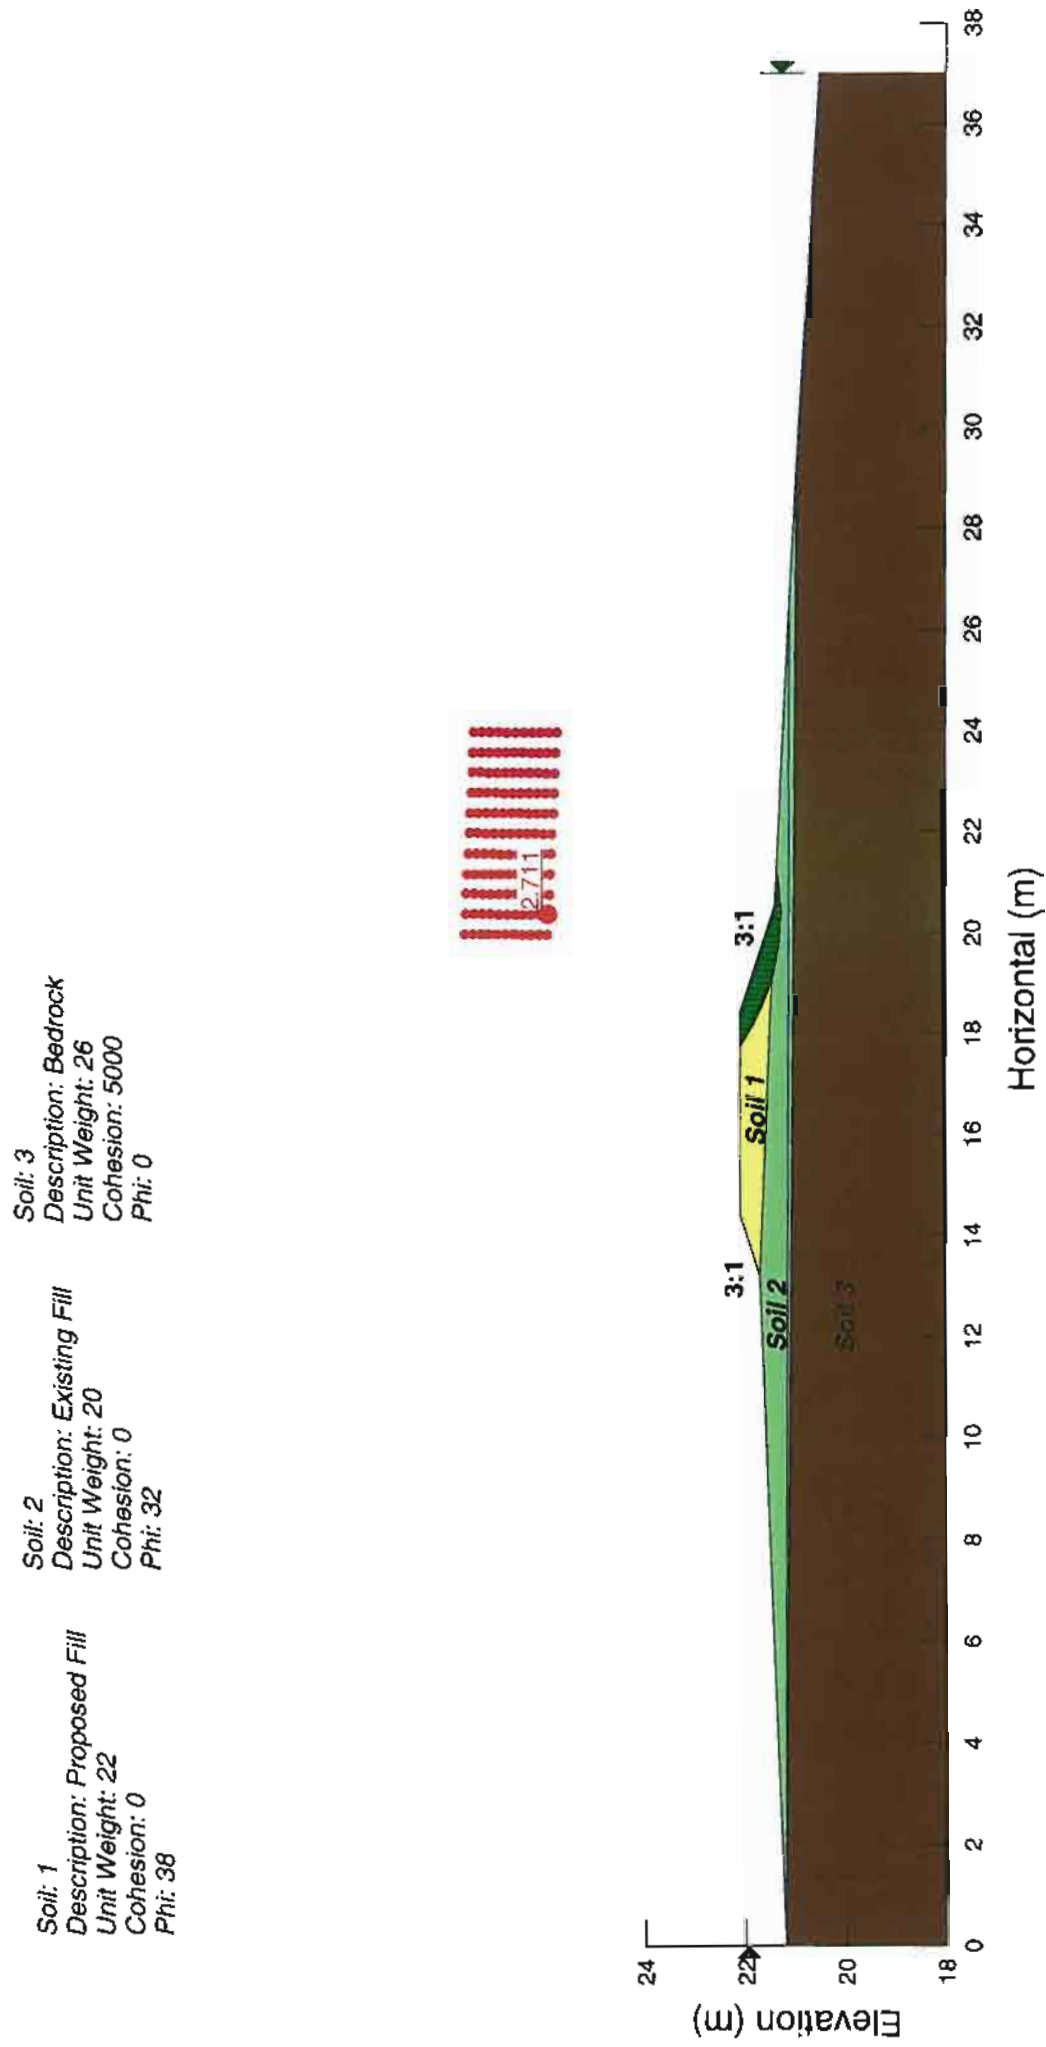
Figure 40
OTT-00201369-A0

Slope Stability Analysis - Section E-E
Upstream Slope (Rapid Drawdown)
Topsoil Removed
Existing Sewage Lagoon Modifications
Hamlet of Whale Cove
