Geotechnical Recommendations

Proposed Modifications to Sewage Lagoon
Hamlet of Whale Cove, Nunavut

OTT-00201369-A0

September, 2012

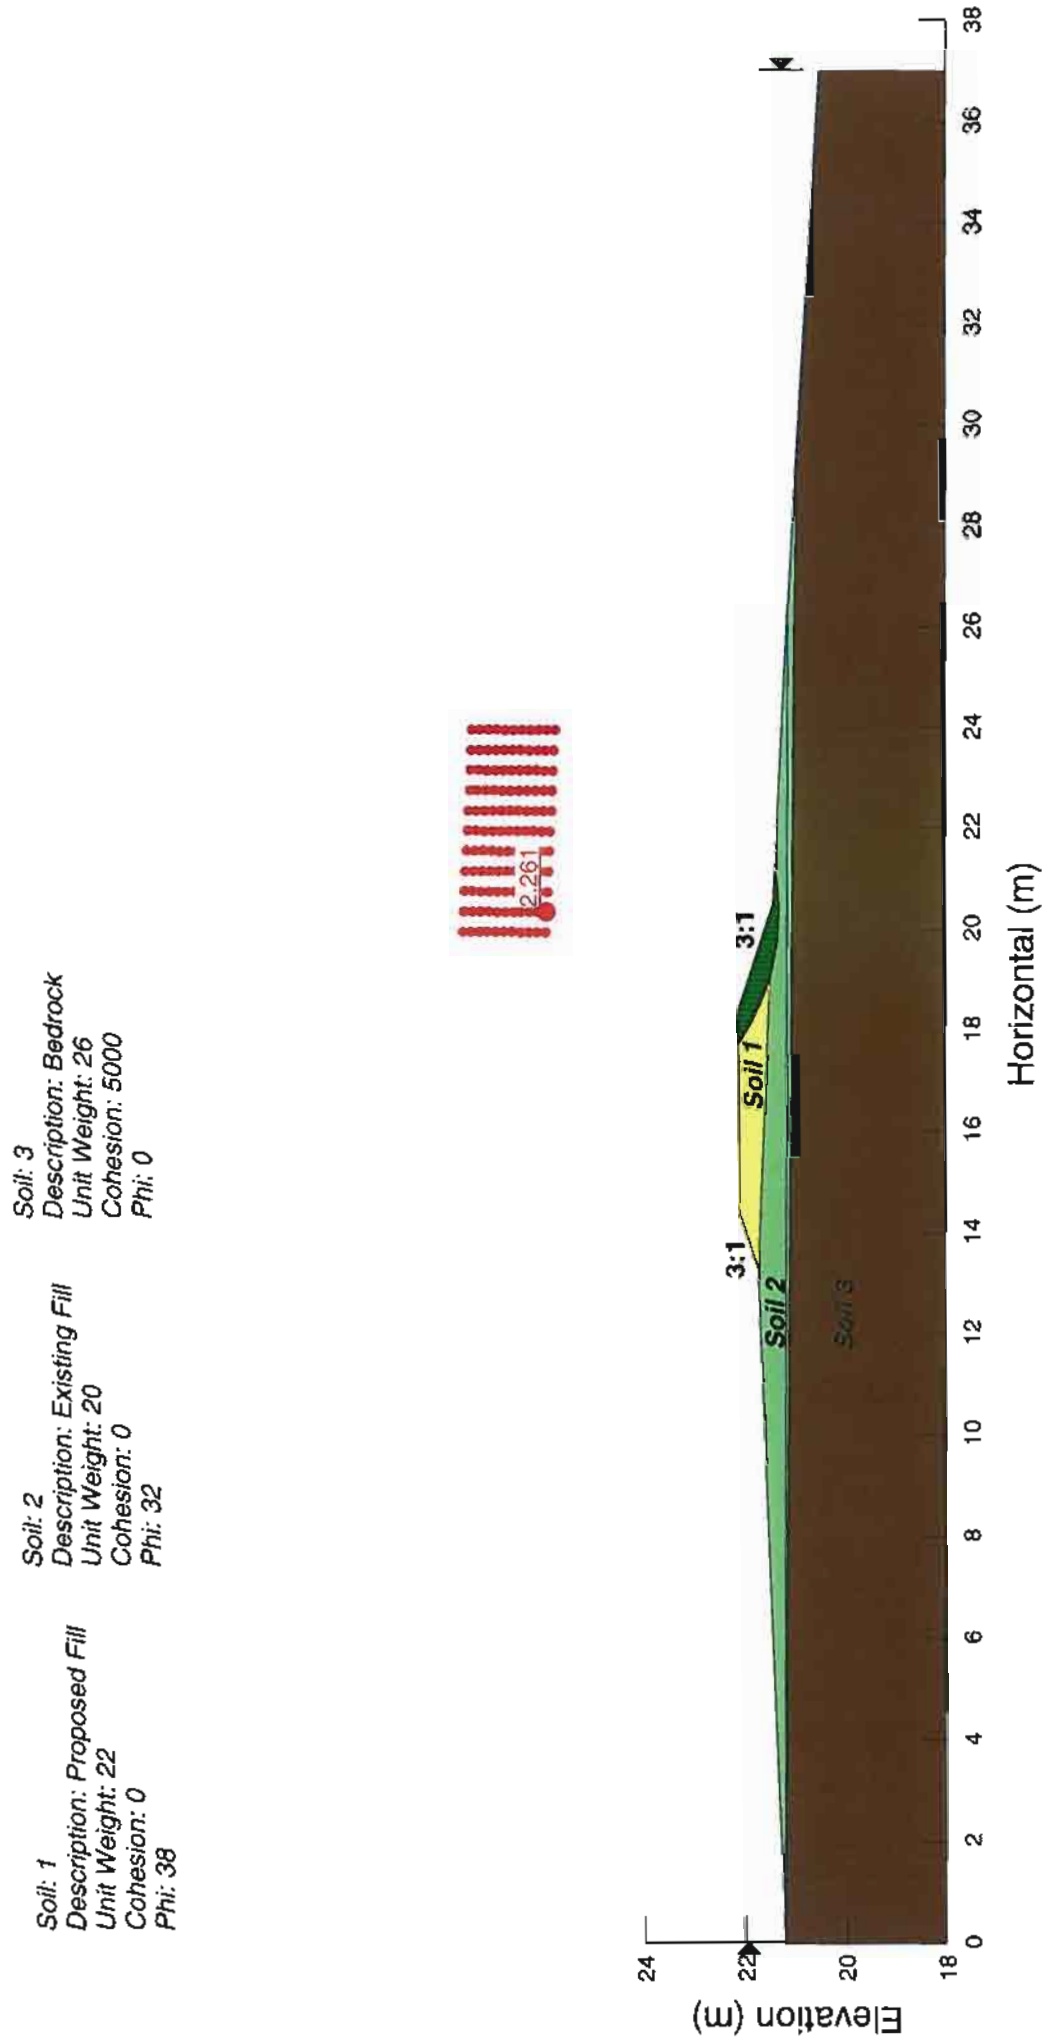
Figure 41
OTT-00201369-A0

Slope Stability Analysis - Section E-E
Upstream Slope (Rapid Drawdown + Seismic Loading)
Topsoil Removed
Existing Sewage Lagoon Modifications
Hamlet of Whale Cove

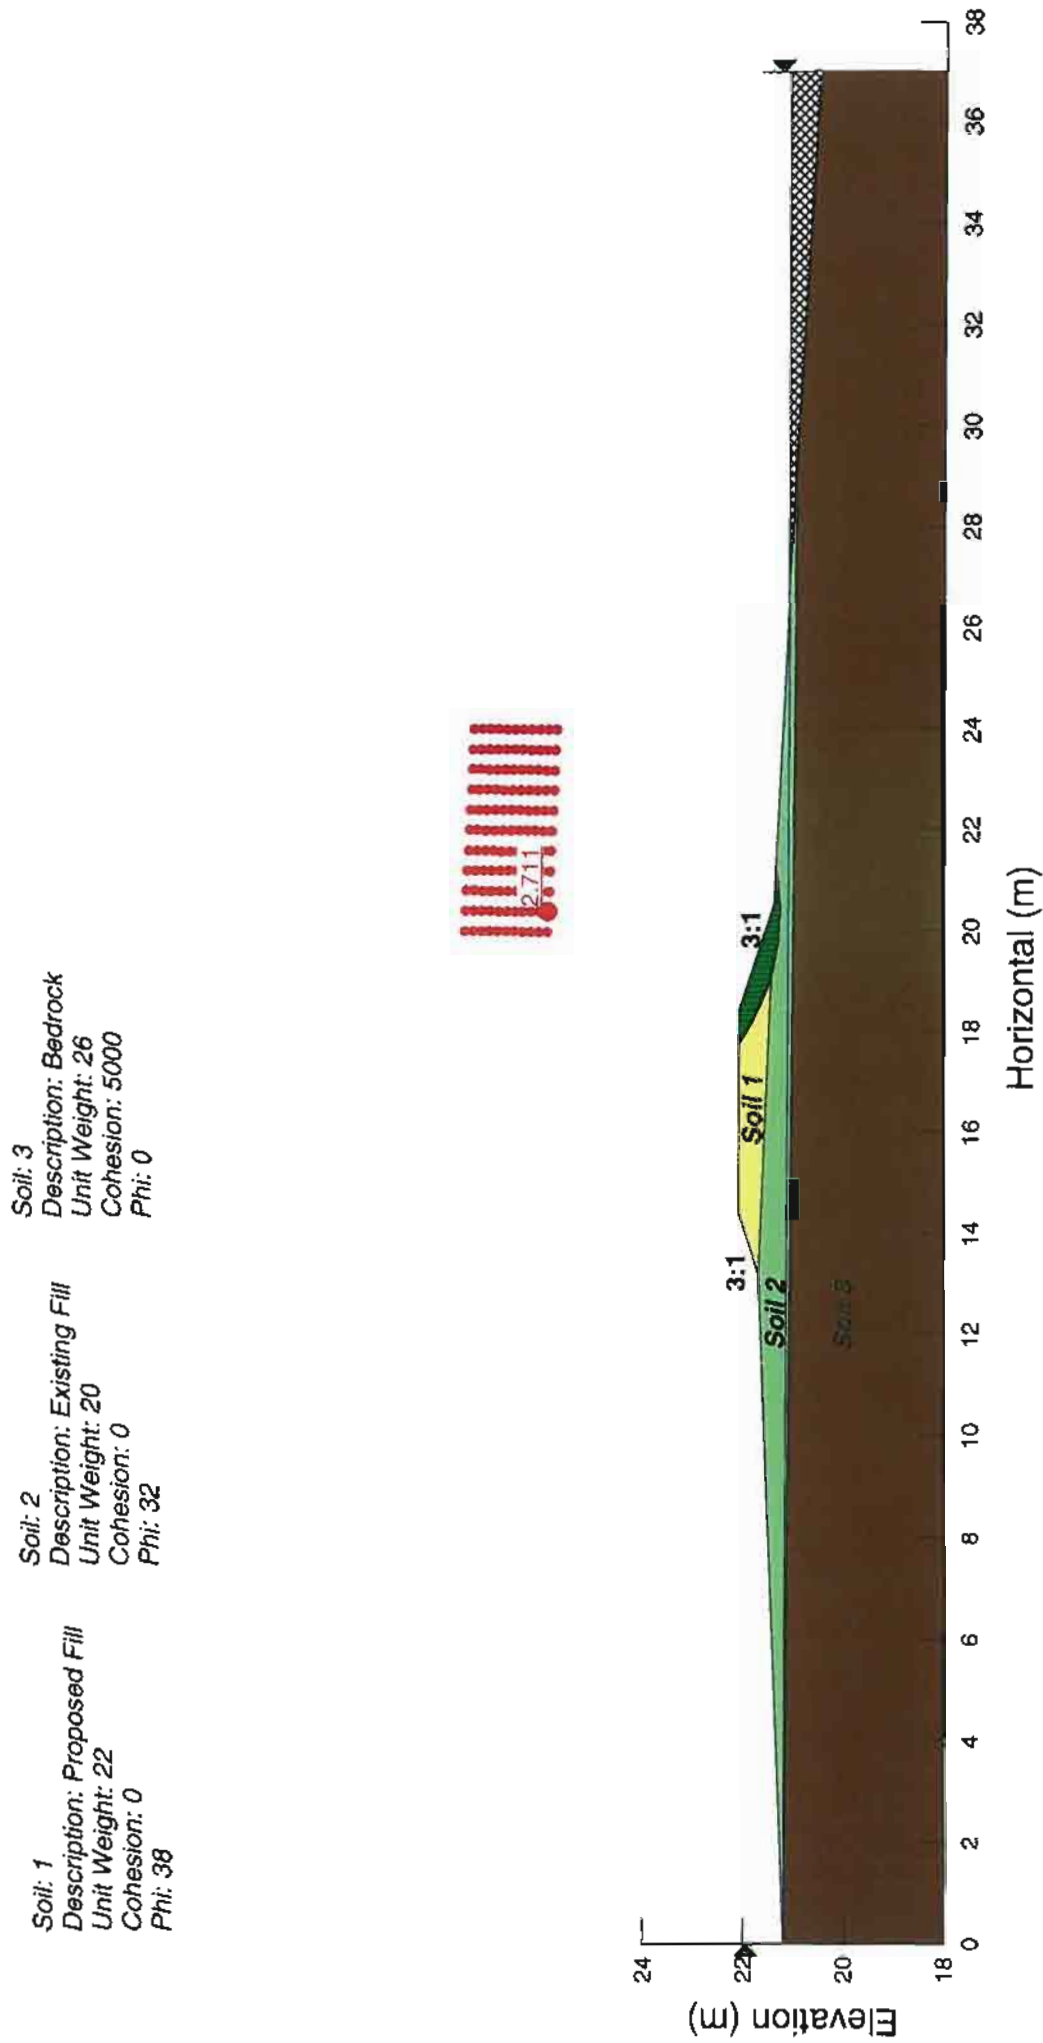
**Figure 42
OTT-00201369-A0**

**Slope Stability Analysis - Section E-E
Upstream Slope (Submerged Slope)
Topsoil Removed
Existing Sewage Lagoon Modifications
Hamlet of Whale Cove**

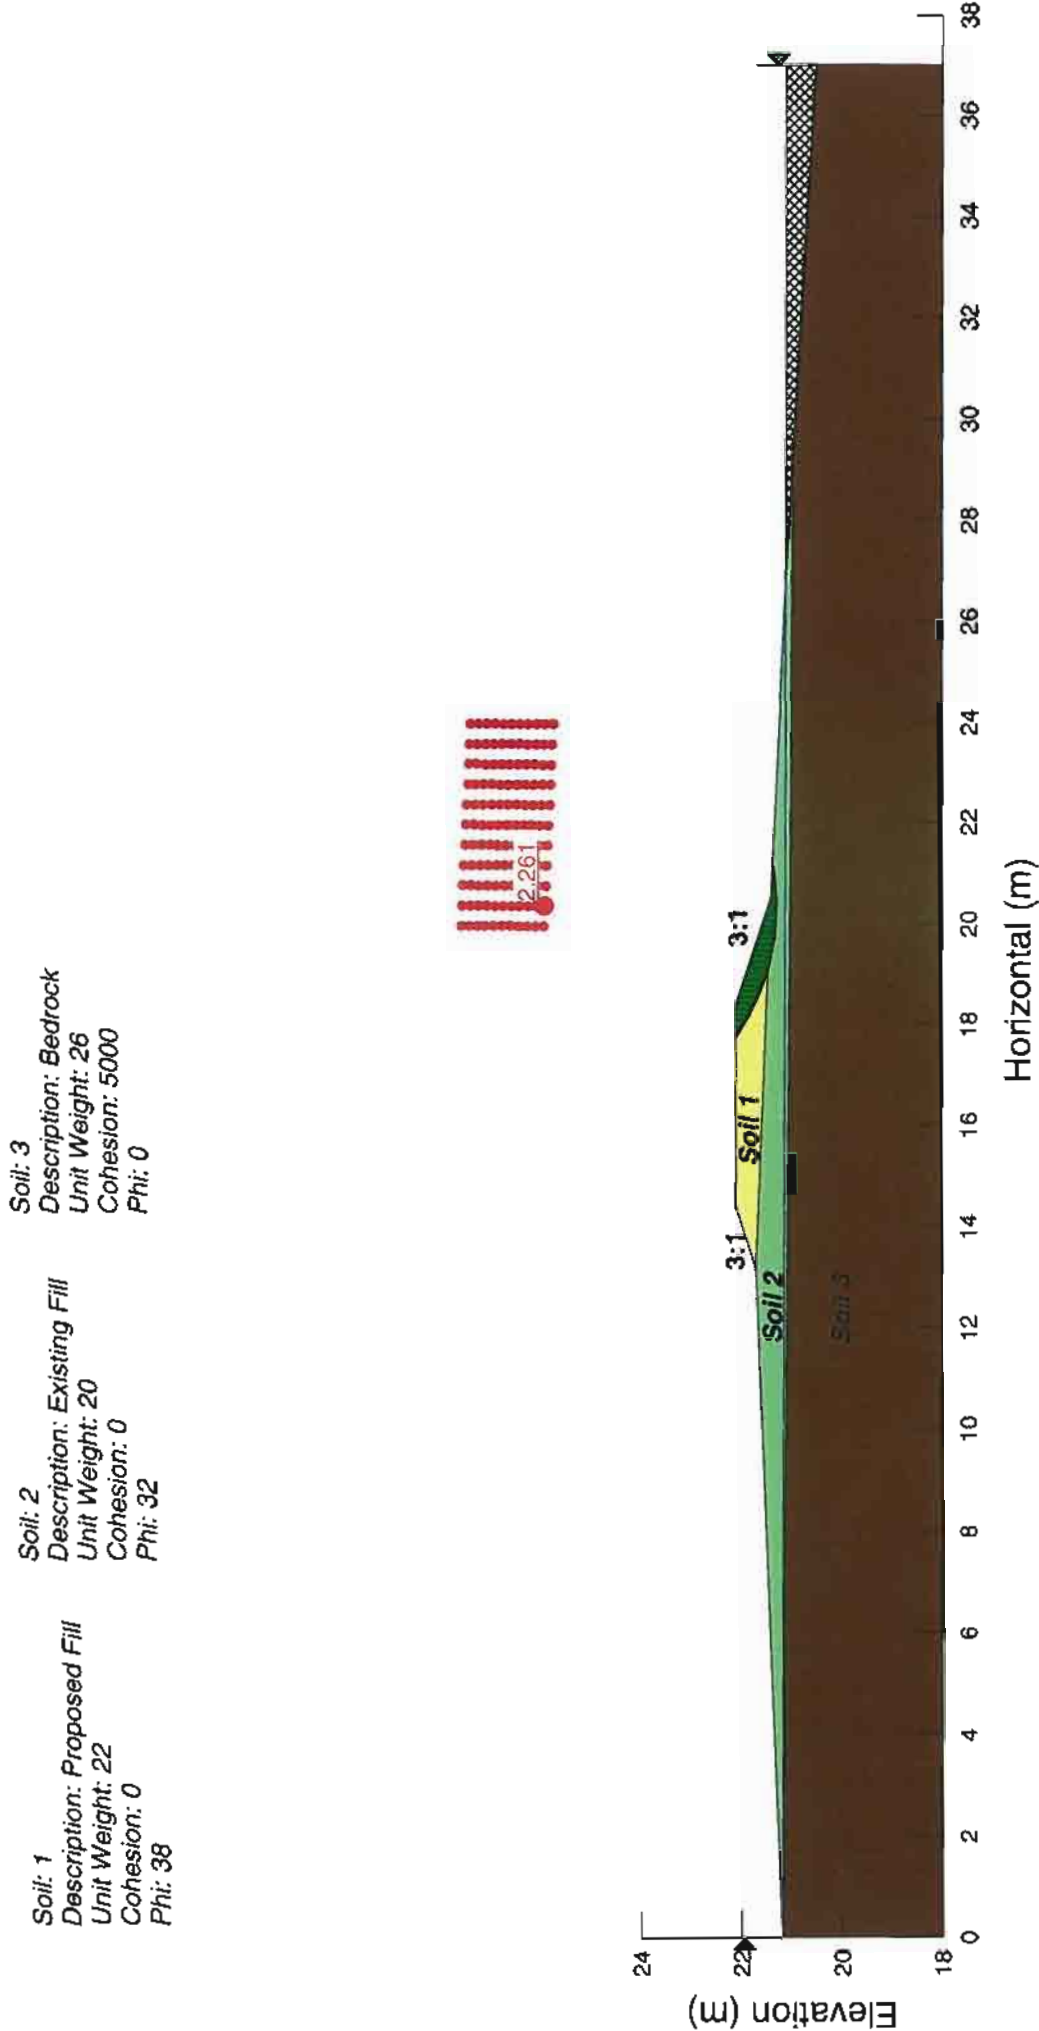
Figure 43
OTT-00201369-A0

Slope Stability Analysis - Section E-E
Upstream Slope (Submerged Slope + Seismic Loading)
Topsoil Removed
Existing Sewage Lagoon Modifications
Hamlet of Whale Cove

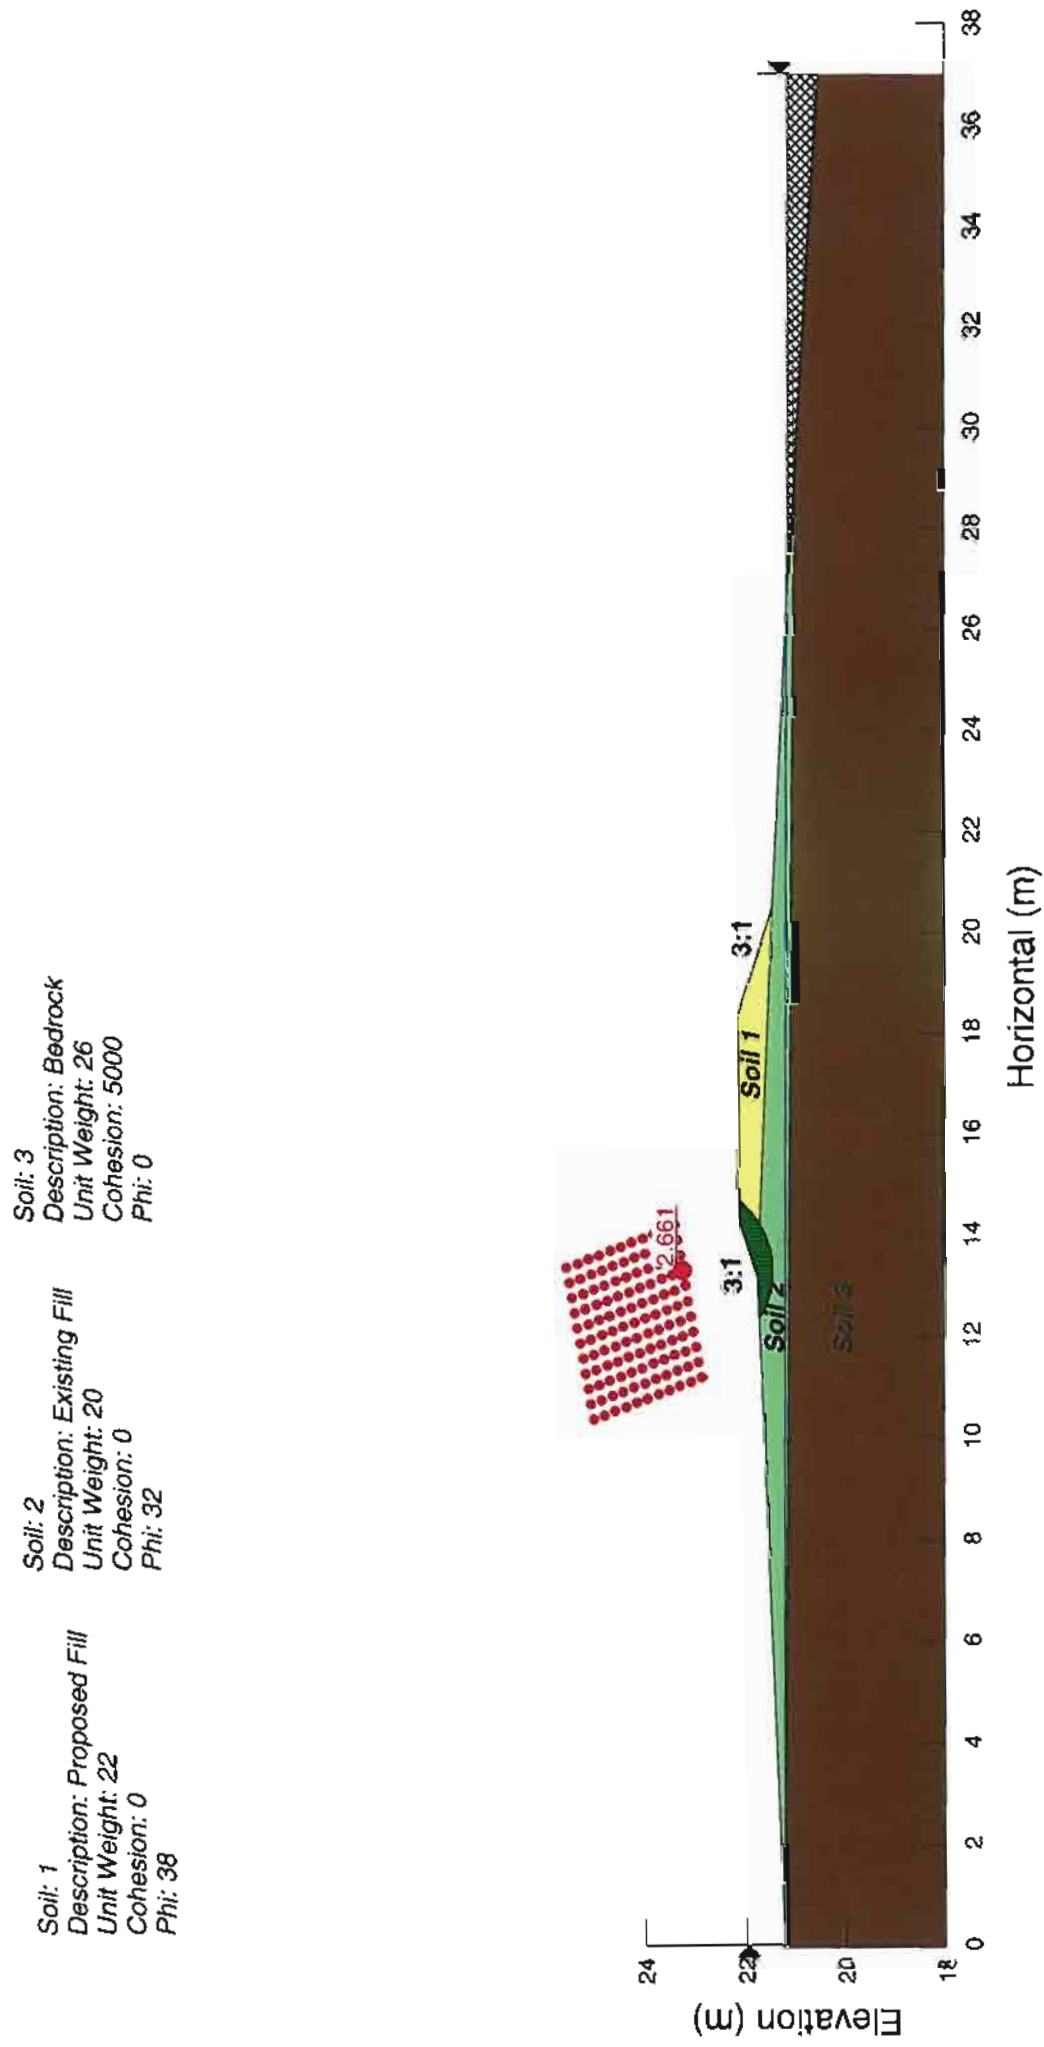
Figure 45
OTT-00201369-A0

Slope Stability Analysis - Section E-E
Downstream Slope (Steady State Seepage + Seismic Loading)
Topsoil Removed
Existing Sewage Lagoon Modifications
Hamlet of Whale Cove
