Road access to Cape Christian

Fish habitat compensation and monitoring plan

Municipality of Clyde River

April 2009

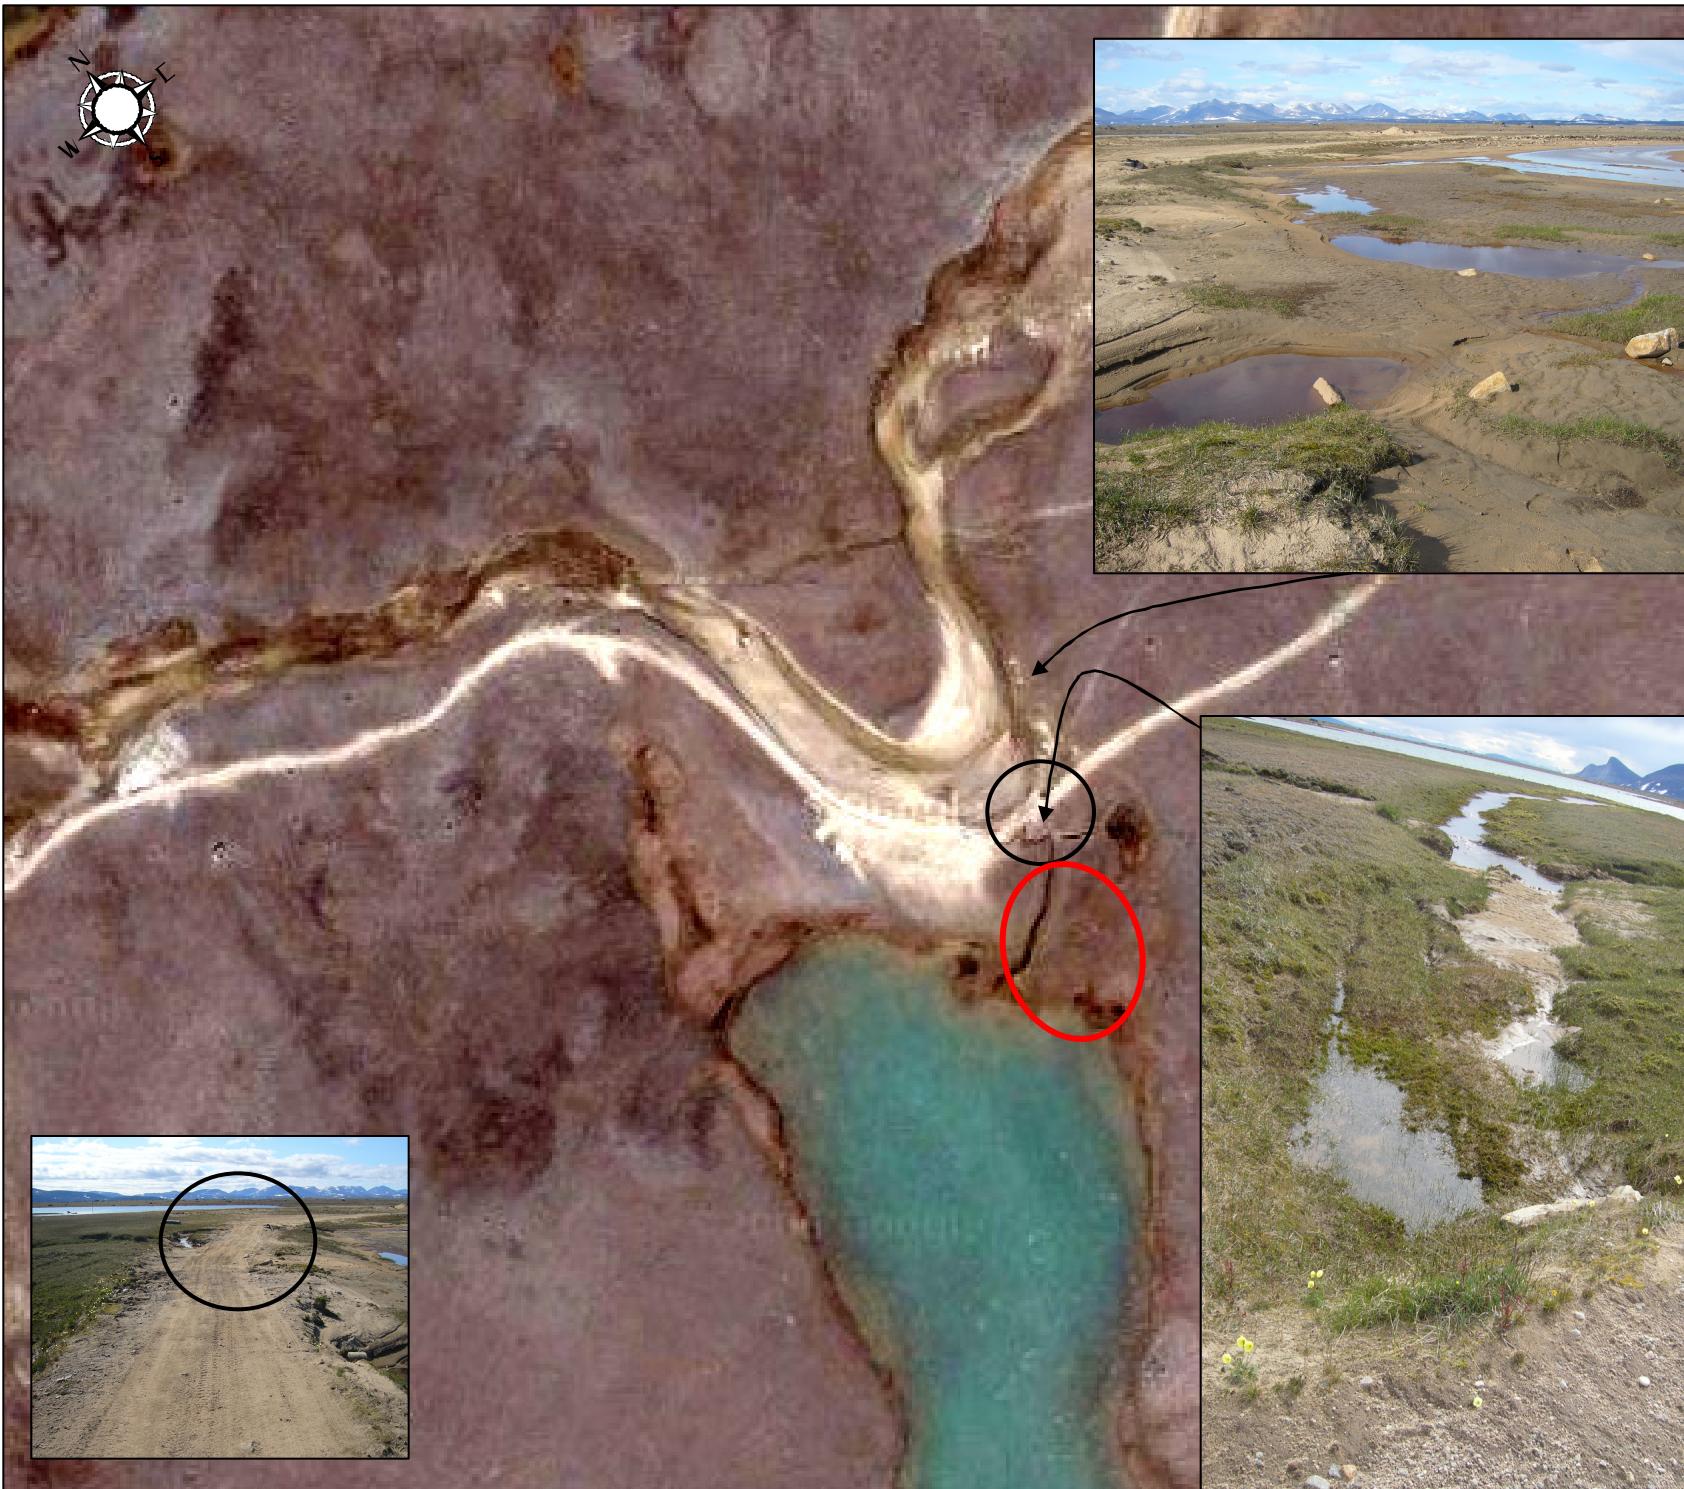
FIGURE 2.

Culvert crossing and habitat enhancement- site No. 5

Our evaluation suggests that the watercourse near crossing No. 5, to be the area offering the most valuable habitat creation and enhancement opportunities. The south portion of the crossing is the location considered for the compensation measures (Figure 2).

The lake and the channel do not offer diversified habitat structures. The channel's banks have extensive vegetation indicating stable annual hydrologic conditions but both channel and lake present very little cover for fish.

The stream channel reaches about 100 m from the mainstem to the lake and for the most part (approx. 80 m), appears free of sediment deposits, which are present on the first 15 to 20 meters. These deposits impair water flow and fish passage at low water levels, between the road and the remaining of the channel. These sediments likely originate from the lack of culvert at the crossing, which situation should be corrected by the culvert installation.
