**PROJECT SPECIFIC INFORMATION for NIRB**  
**SCREENING PART 2**

**Hamlet of Gjoa Haven, NU, Swan Lake River Bridge Construction**

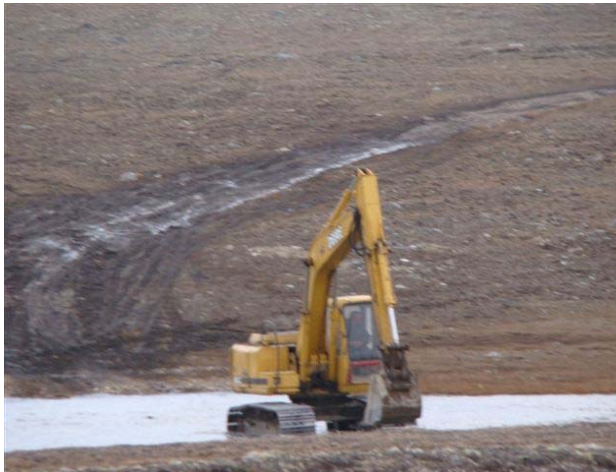
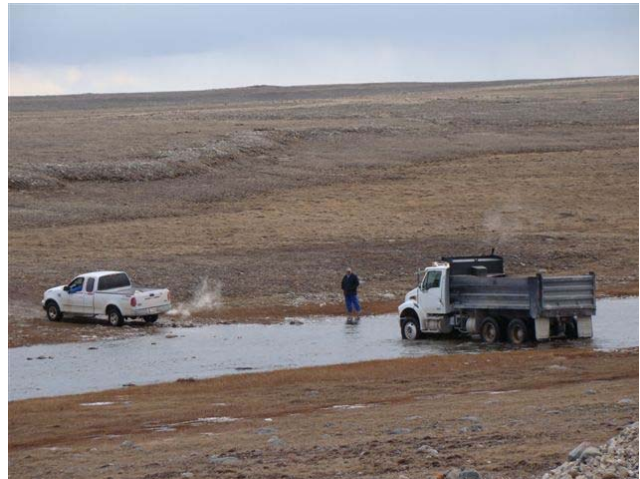
The proposed bridge is located on an existing trail leading to rich hunting grounds and places of traditional gatherings of community members. Presently, at this location, light and heavy community and construction traffic are crossing the Swan Lake River travelling directly on the river bed. In spring and early summer months, during high water discharges, vehicles have difficulties crossing the river. The bridge would offer all weather access to the lands beyond the river. It would also eliminate the continuous destruction of fish habitat in the area of the crossing.

The only location we found competent to support loading from the bridge abutments is presently used by local residents for fording the river with vehicles ranging from ATV's to heavy construction equipment. This location, shown on the pictures above and on the enclosed Google Earth maps, is proposed for construction of the bridge crossing.
