1.0 INTRODUCTION

The Nanisivik Mine is located on northern Baffin Island in the Nunavut Territory. It is an underground zinc-lead mine owned by CanZinco Ltd. and was in continuous operation from 1976 to 2002 when it ceased production permanently.

The information contained herein is submitted as the Quarterly Report covering the months of July through September 2006. The reclamation activities at Nanisivik during this period included the following:

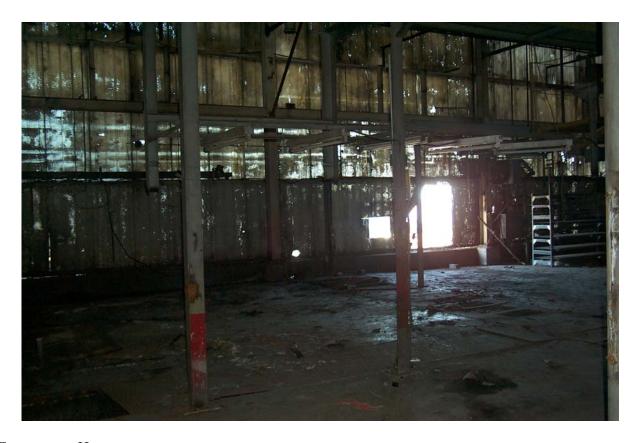
Industrial Complex:

The powerhouse section of the industrial complex was taken off line in early August. By the end of the quarter, most of the equipment and all of the generators were salvaged from the building. 700 cubic metres of demolition debris were hauled underground during the period. Crews were starting to dismantle the control room at the end of September. The dismantling of the structure is scheduled to take place during the 4th Quarter.

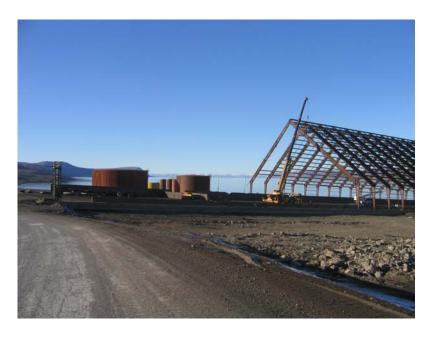
Concentrate Shed:

The exterior cladding was completely removed and hauled underground during the 3rd quarter. Frame dismantling was still in progress at the end of September with eighteen of the 38 frames removed. Approximately 200 cubic metres of demolition debris were hauled underground during the dismantling process.

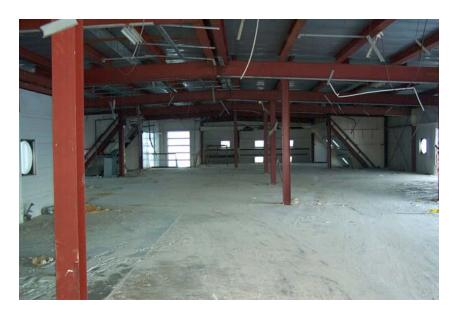
Town Complex

During the latter part of the quarter, a small crew worked on preparing the government complex for structural dismantling. The interior of the central part of the building, including the upper floor of the school, the Northern Store, Library and Post Office were completely gutted. Approximately 300 cubic metres of demolition debris was hauled underground and an additional 400 m3 have been stockpiled adjacent to the structure for haulage during the 4th quarter.

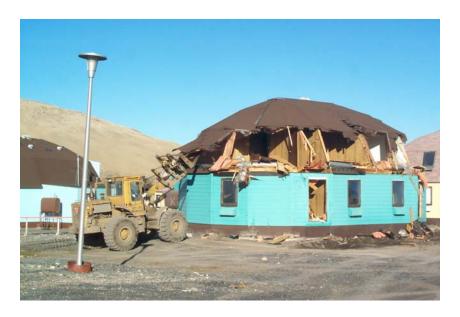
Town site houses:

One house was removed during the quarter. This house was taken apart using just a loader/forklift in order to remove whole sections of walls and salvage as much wood as possible for use as crating material.

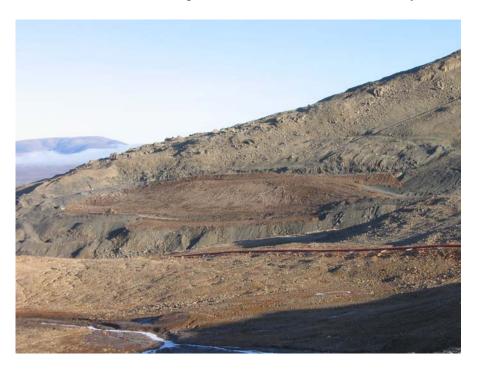
West Open Pit:

The sand and gravel armor for the West Open Pit was completed during the 3rd quarter. A total of 8000 cubic metres were hauled. The area to the South of the road in front of the pit was also covered. This area previously contained a waste rock pile that was placed into the pit in 2005. A half metre of shale was place here as well as a 0.3 metre layer of armor rock.

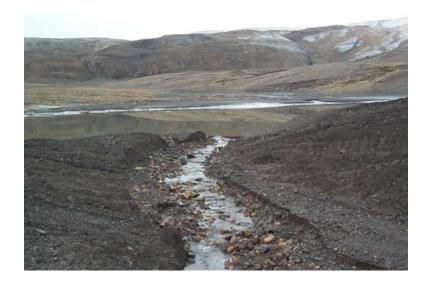
Chris Creek Crossing at K-Baseline

Natural drainage was restored in this area by utilizing the Dozer to rip and push the former roadway down to original ground. The large culvert was then removed and hauled underground. Another culvert between this crossing and the East open pit was also dug out at this time.

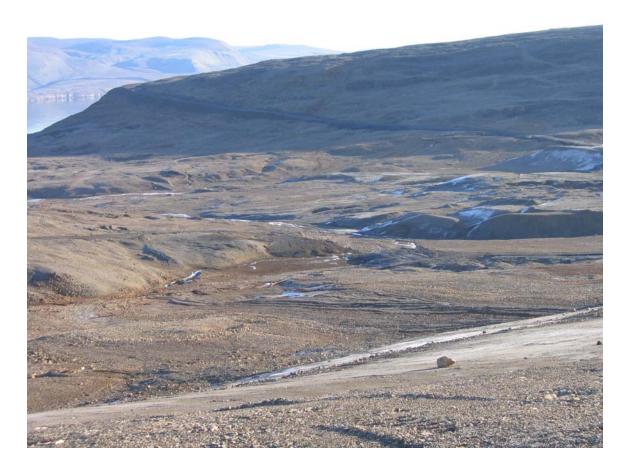
East Open Pit Area

The thermal cover at the East open Pit and associated waste piles was completed in 2005 except for the armoring of a small deflection berm at the toe of the cover. This armoring was completed in September 2006. We left the East Adit treatment facility in place throughout the summer, while we monitored the performance of the cover and the water quality in the area. The generator, pumps and piping were removed at the end of the quarter and the dykes breached and re-contoured. Sampling of the pond sediments indicate that most of this material meets the soil quality remediation objective.

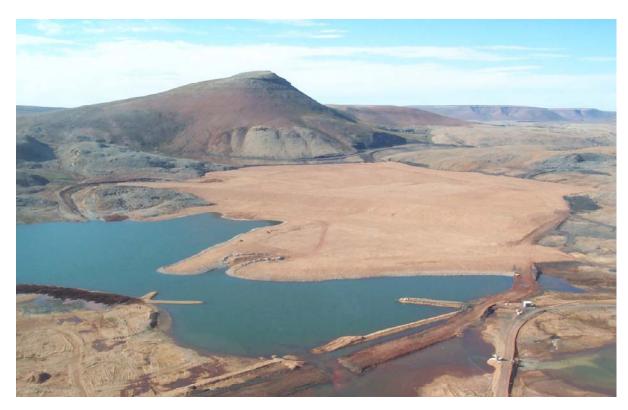
West Twin Lake Area

A minor amount of work took place here as well during the quarter. The baffle and temporary roadway across the reservoir was breached to allow flow through to the polishing pond. The sediments that were excavated from the polishing pond and hauled to the reservoir shoreline in 2005 were leveled off. It was originally thought that this material may have high metal values, but a sampling campaign of the piles proved otherwise. Riprap placement at the shoreline of the test cell outlet and the spillway was also completed during the quarter. Some of the shoreline touchups around the reservoir (additional riprap etc.) were completed, but one area near the toe of the West Twin Dyke will require a general beefing up in 2007. Tailings island removal that was in progress at the end of the 2nd quarter was completed during the 3rd quarter. A portable pump was used to hose the mounds of tailings into the surrounding water. The reservoir level was kept low by using a high volume pump to discharge water into the polishing pond for while the task was completed.

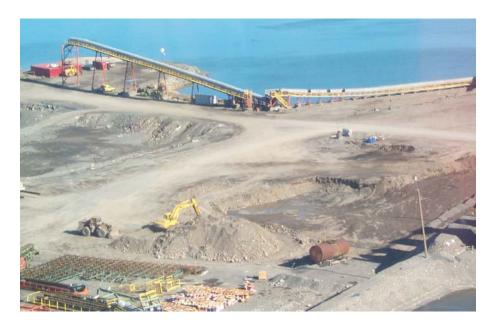
Tank Farm Pump House

The excavation of hydrocarbon-contaminated soil around the tank farm pump house continued for most of the summer with approximately 11,000 cubic metres hauled to the mine. The pump house itself was left in place for use during the winter and contaminated soil remains in place in the immediate area. A lined berm separating the contaminated area from the clean area was constructed to prevent migration of contaminants. This area will be excavated in 2007.

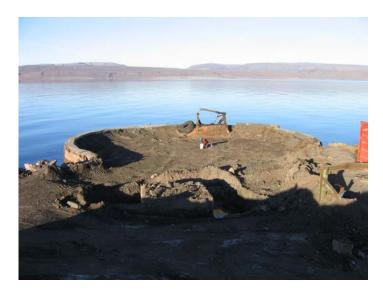
Center Dock Cell

Excavation of the center dock cell began at the end of the quarter. Preliminary results indicate that the volume of contaminated material is less than the original estimate. The plan is to complete the excavation in the 4^{th} quarter, perform confirmatory sampling and then backfill the cell to prevent structural damage by the tidal action of the ice. Approximately 800 cubic metres of soil were hauled underground from this location.
