NANISIVIK MINE, A DIVISION OF CANZINCO LTD.

PROJECT	CLOSURE PLAN			
MINE OPENINGS	CLUSURE PLAN			
TITLE OCEANVIEW PORTAL				
PHYSICAL CHARACTERISTICS				
PROJECT No.	DWG No.	REV.		
0255-009-10.03	16	0

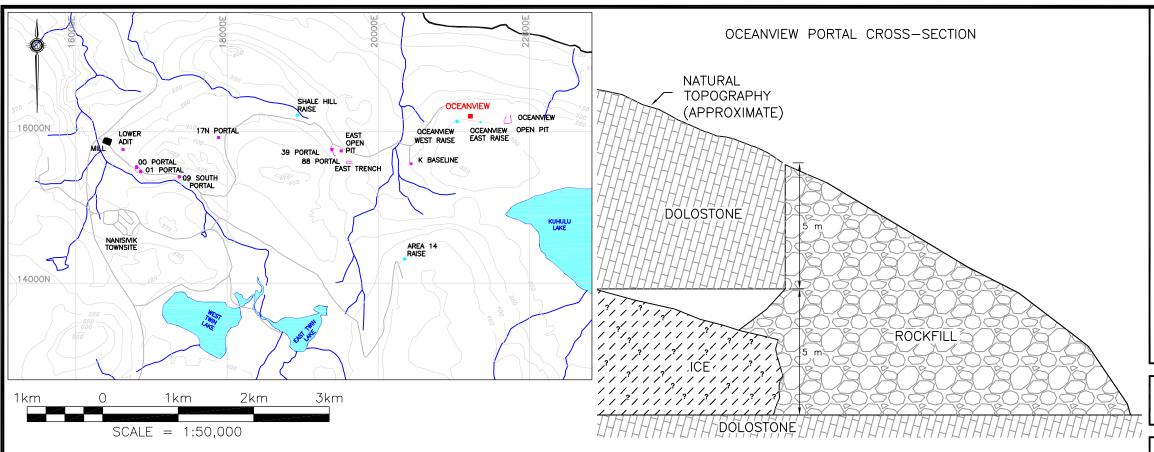
NOTE: EXTENT OF ICE IN MINE WORKINGS IS UNCERTAIN.

- CROSS SECTION DRAWING OF PORTAL IS A SCHEMATIC AND IS
   BASED ON AVAILABLE INFORMATION SUPPLIED BY THE MINE SITE.
- 2) REFERENCE TABLE 2 IN MAIN REPORT FOR RECLAMATION REQUIREMENTS FOR THIS SPECIFIC PORTAL.

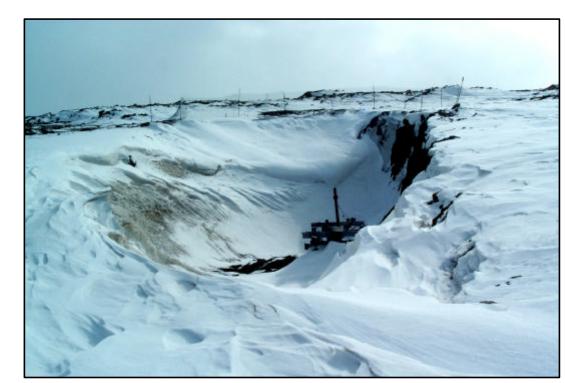
VIEW OF OCEANVIEW PORTAL PARTIALLY COVERED IN SNOW (PRE SEPT. 2002).

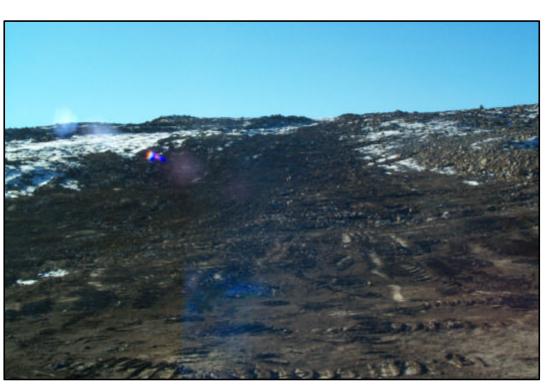
VIEW OF OCEANVIEW PORTAL (SEPTEMBER 2002).
