## POLARIS MINE - DECOMMISSIONING & RECLAMATION SCHEDULE

**POLARIS MINE DECOMMISSIONING, RECLAMATION AND MONITORING COST ESTIMATE**  
**3rd QUARTER 2003 UPDATE**

***Polaris Mine Closure***  
**CASCADE PROJECT 2071**

# **GARROW LAKE LEVEL CONTROL STRUCTURE COST ESTIMATE**

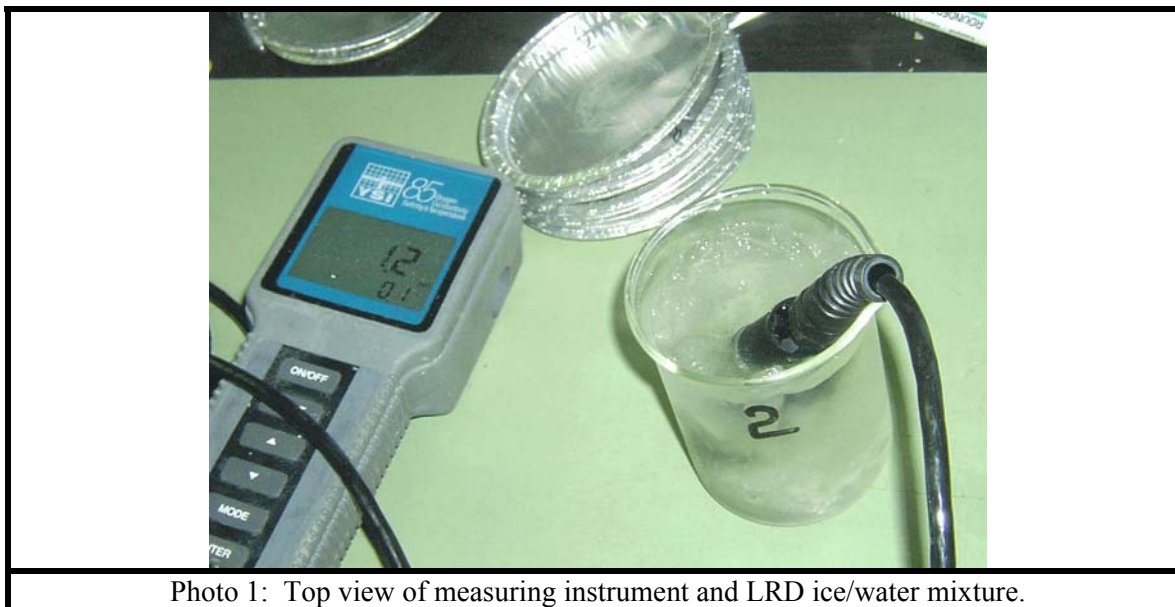
The samples were stored in 300mL beakers in the freezer until the samples were approximately 40% frozen. At this point the ice in the beaker was broken up and the instrument inserted in the ice/water mixture. The mixture was then stirred in order to maintain a constant temperature. When the readings became stable, temperature and salinity parameters were taken. The results from the experiment are as follows:

Parameter	LRD Water	Distilled Water (control)
Temperature	0.1°C	0.3°C
Salinity	1.1ppt	0.0ppt

Photo 1: Top view of measuring instrument and LRD ice/water mixture.
