Re: Polaris Mine Decommissioning and Reclamation- Review of 3rd and 4th Quarter Reports

As requested under Standing Offer Agreement 01-03-6011, BGC Engineering Inc. (BGC) has reviewed the Third and Fourth Quarter reports prepared by Teck Cominco (TC) for the Polaris Mine Decommissioning and Reclamation Project. The quarterly reporting of progress, including the updating of costs and the reclamation schedule is a requirement under the Water Licence. The Third Quarter report is dated January 19, 2004 and the Fourth Quarter report is dated March 9, 2004.

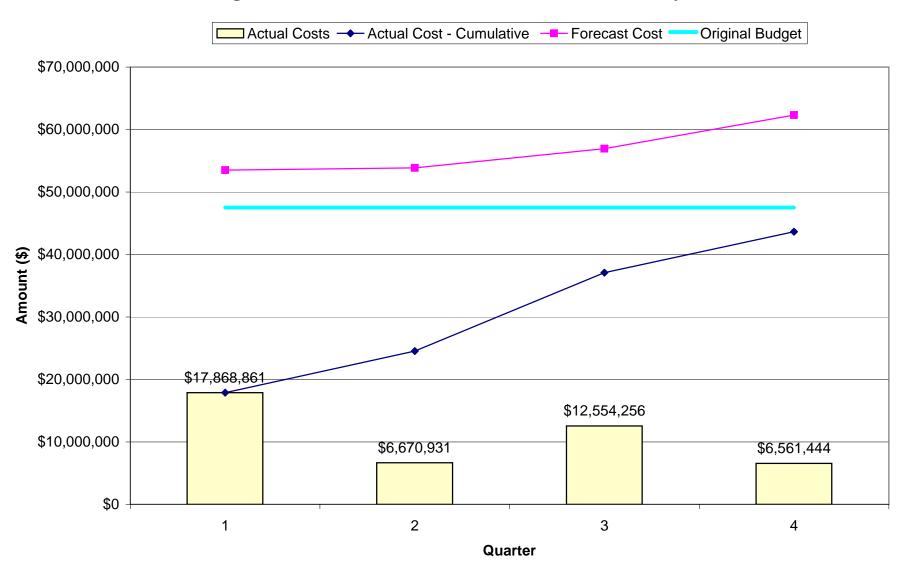
Figure 1 - Polaris Mine 2003 Closure Costs Summary

Mine closure costs during the period amounted to a total of \$12,554,256. The forecasted costs to complete decommissioning, reclamation and monitoring through to 2011 have increased from the second quarter estimate of \$53,860,906. This represents an overall cost increase of about 20% over the original cost estimate of \$47,500,000. The costs incurred to the end of the third quarter therefore represent about 65% of the forecasted costs to complete. The work remaining as of September 30, 2003 represents and estimated outstanding liability of \$19,831,060. This compares with an outstanding liability of \$28,969,034 at the end of the second quarter.
