## **Abandonment and Restoration Plan for Chesterfield Inlet Landfarm**

*Version 1.2*

Stantec Project # 144901145

GN Project # 10-3018

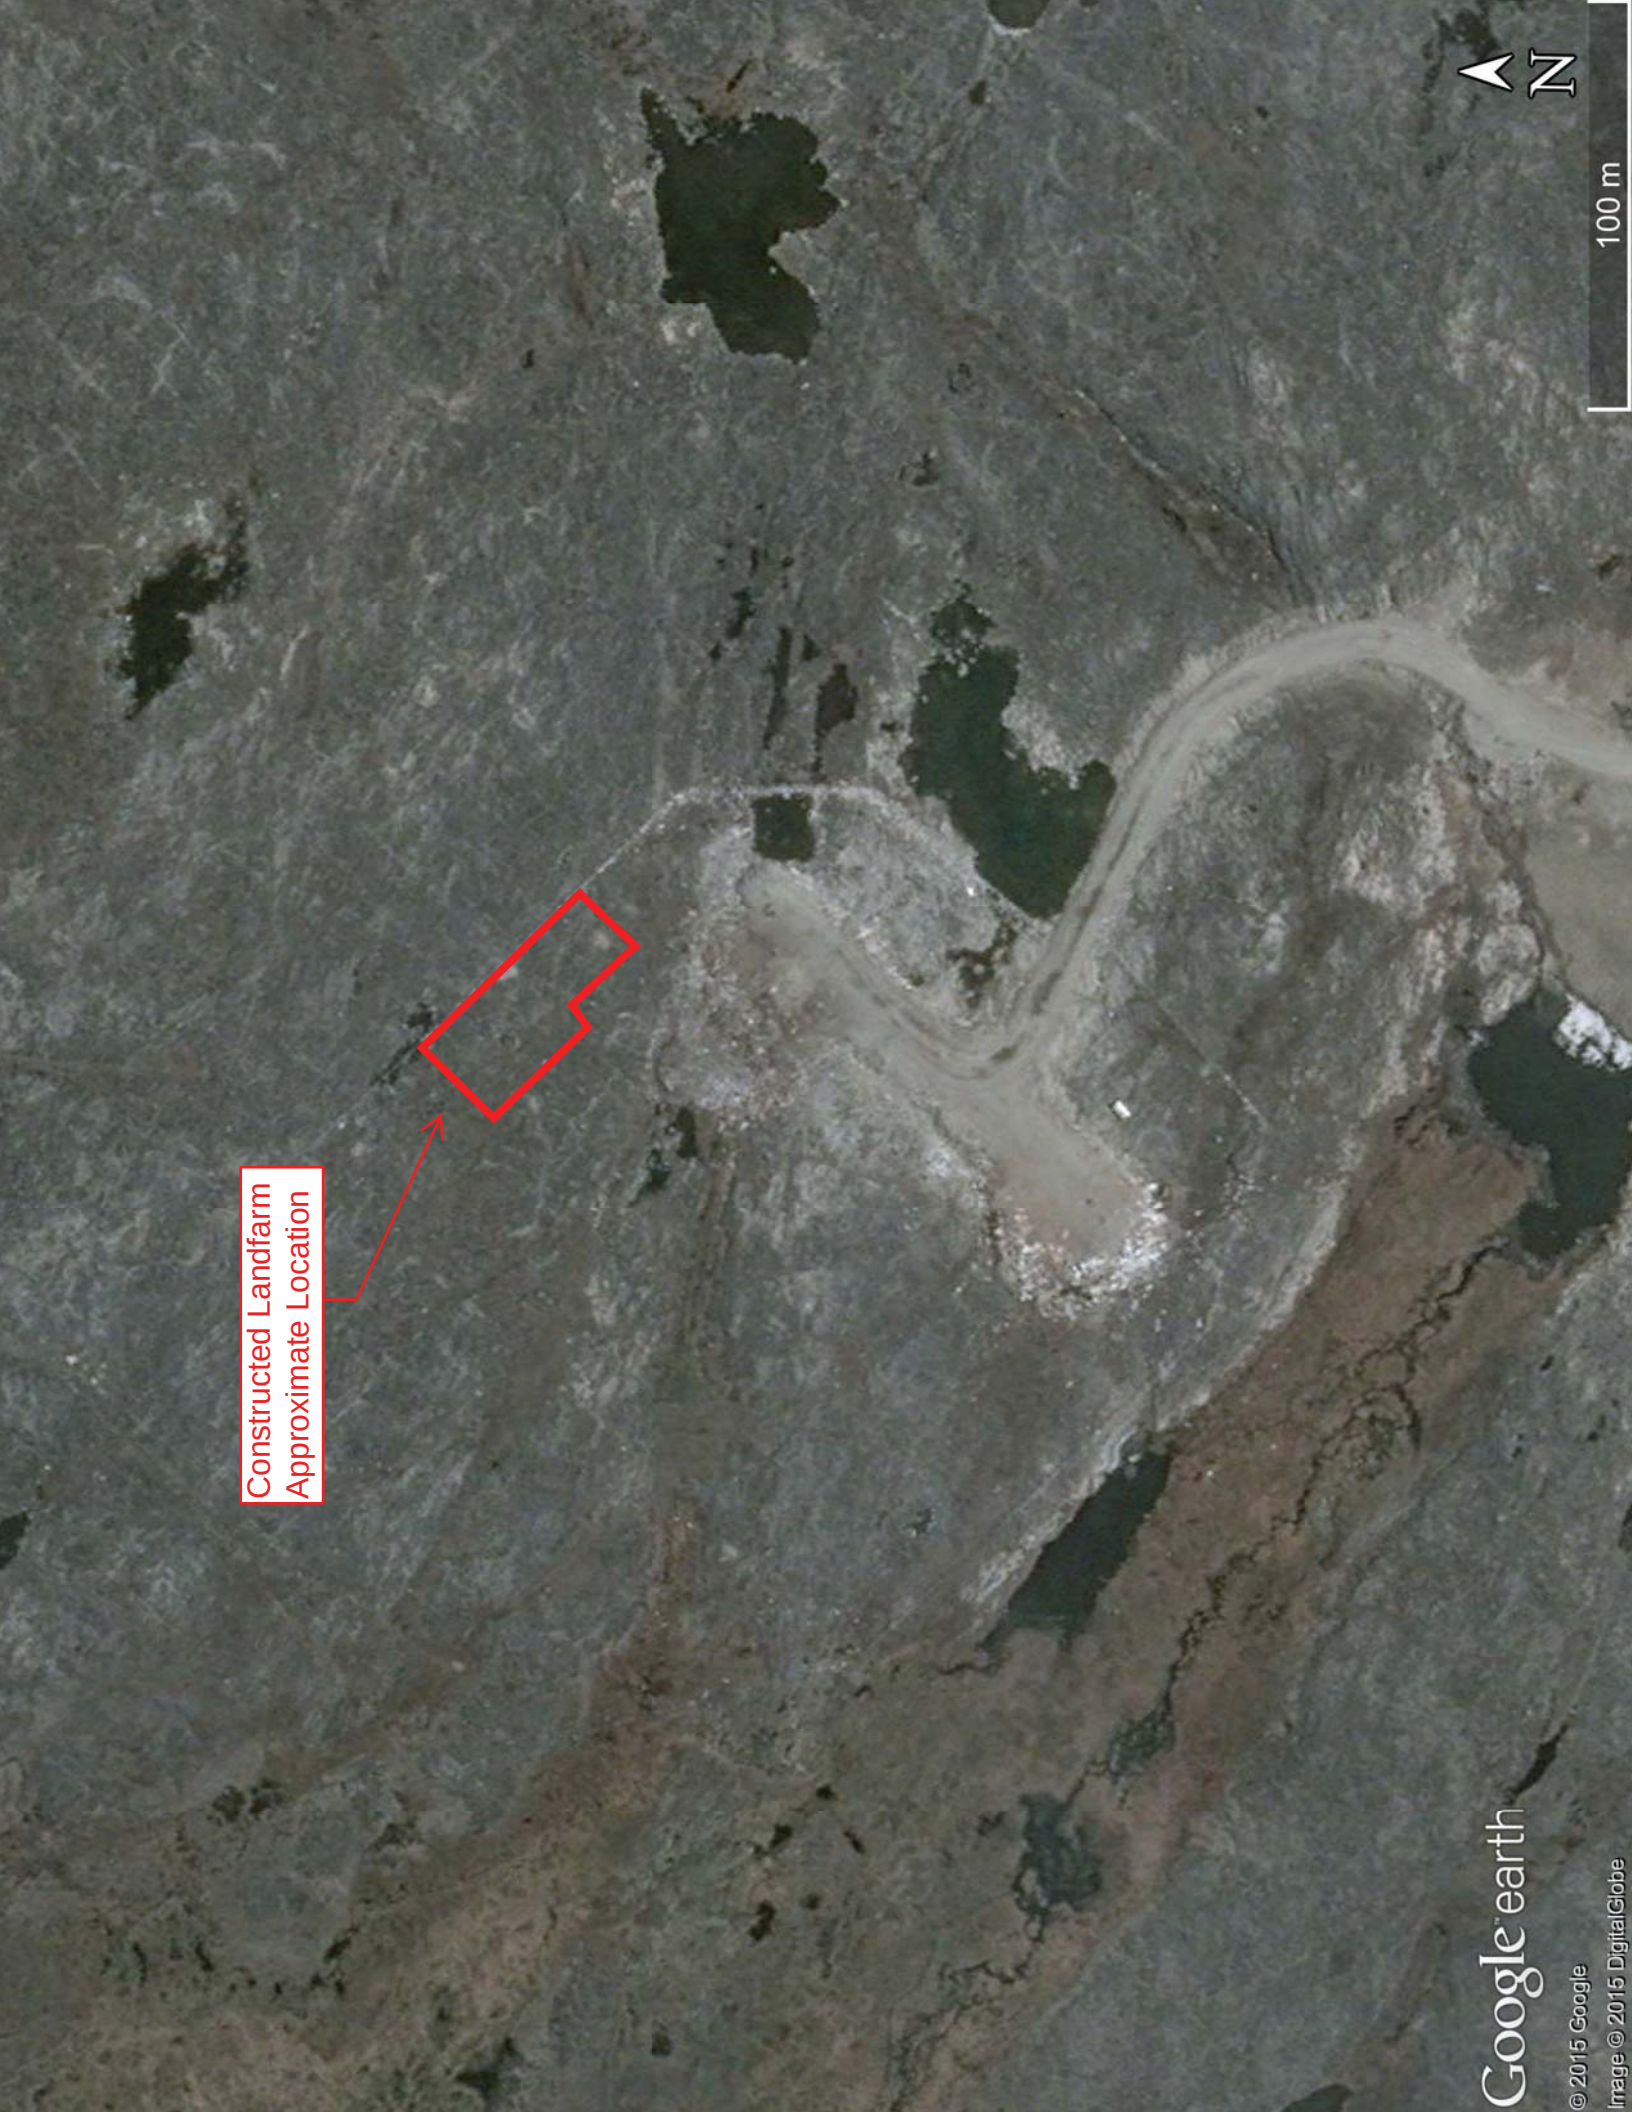
## Appendix A: Map

Constructed Landfarm  
Approximate Location

See Appendix A for drawings and site maps.
