**Environmental Protection Plan:  
Removal of Fuel Drums Within Watershed  
and  
Culvert Installation  
Ekalugad Fjord  
Fox C Dew Line Site**

## **ENVIRONMENTAL PROTECTION PLAN**

### **REMOVAL OF FUEL DRUMS WITHIN WATERSHED AND CULVERT INSTALLATION**

#### **EKALUGAD FJORD FOX C DEWLINE SITE**

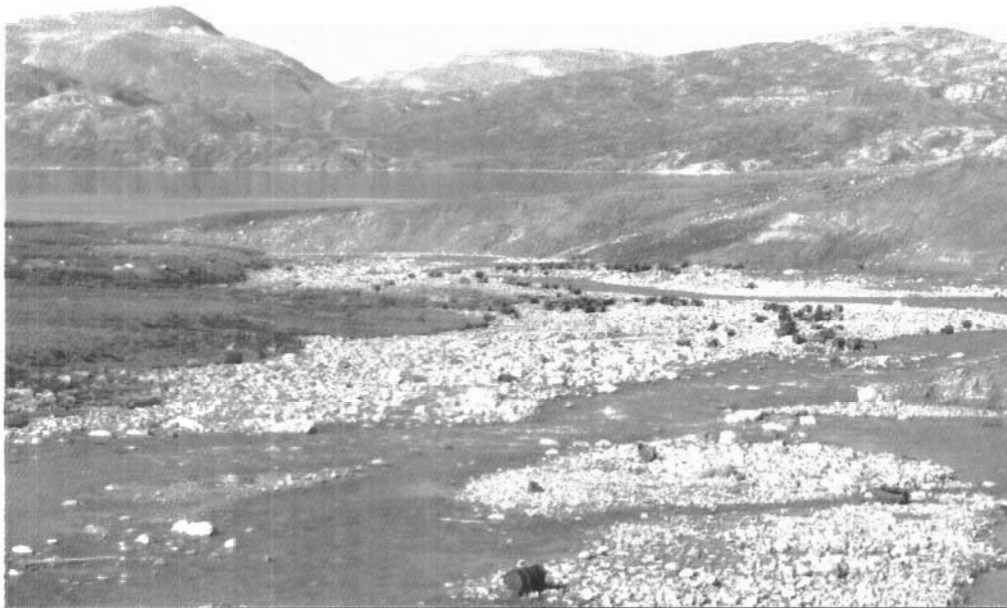
Photo 1: Barrels along the river and floodplain.

The river area between the lake and Ekalugad Fiord has banks scattered with drums and domestic garbage. This area includes the riverbed and banks and two separate dump areas. The riverbed and banks contain approximately 200 rusted empty drums with no visible labels. Approximately 400m downstream of the lake there is an area containing tin cans, glass, wood, old newspapers and empty drums. Further down the river on the east slope there is another fuel drum dump with 175 drums scattered over the east bank above the high water mark.<sup>9</sup>

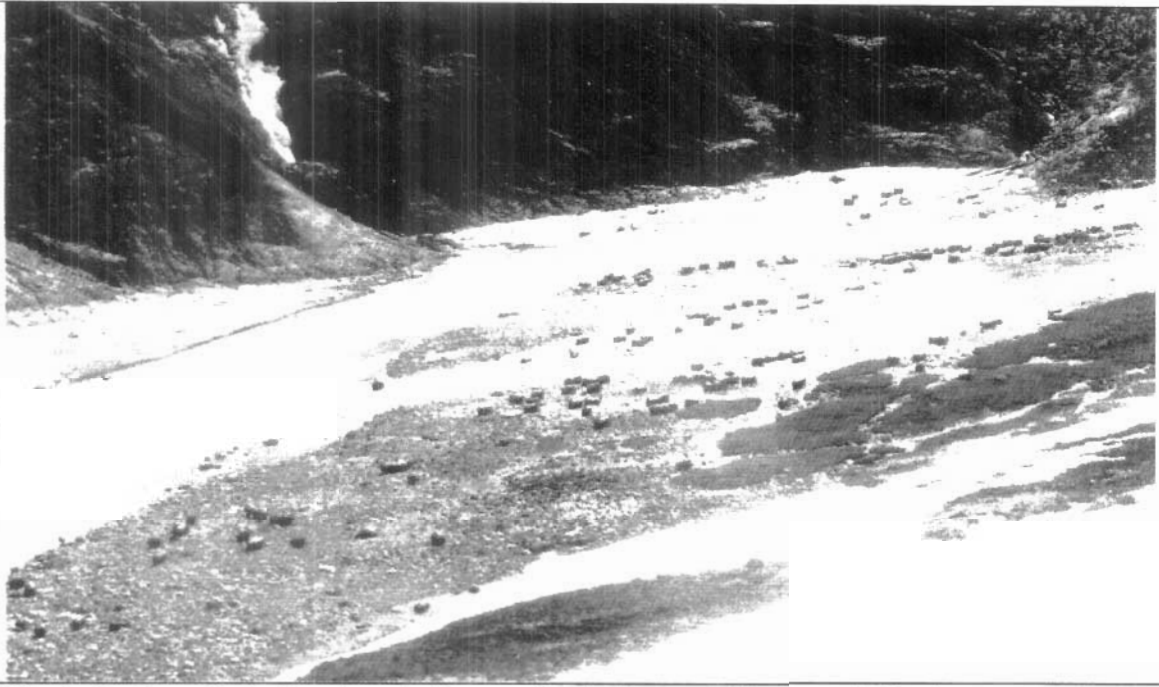
Photo 3: Barrels in the river between the Lake and Ekalugad Fjord.

During removal of the fuel drums, it will be necessary to place booms across the river for containment in the event that a spill occurs. These booms will have attached silt fencing and will be placed around the drums as well as downstream, in the event of failure to capture product within the first boom. Absorbent materials will be stationed at the work area to absorb product should a ruptured drum be encountered. All drums will be inspected prior to any removal process and at this time it will be determined if there are contents within the drum. Most of the drums that are within the river itself have likely corroded and ruptured due to continued submergence in the water.
