**ENVIRONMENTAL PROTECTION PLAN**

**REMOVAL OF FUEL DRUMS  
WITHIN WATERSHED  
AND  
CULVERT INSTALLATION**

**EKALUGAD FJORD  
FOX C DEWLINE SITE**

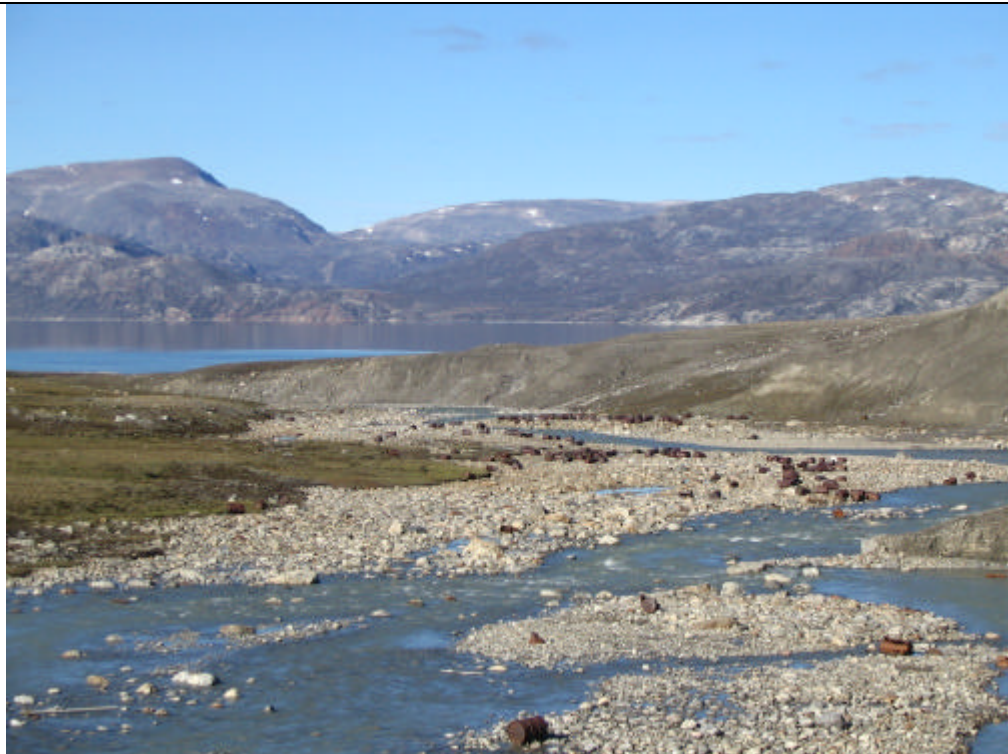
Photo 1: Barrels along the river and floodplain.

The river area between the lake and Ekalugad Fiord has banks scattered with drums and domestic garbage. This area includes the riverbed and banks and two separate dump areas. The riverbed and banks contain approximately 200 rusted empty drums with no visible labels. Approximately 400m downstream of the lake there is an area containing tin cans, glass, wood, old newspapers and empty drums. Further down the river on the east slope there is another fuel drum dump with 175 drums scattered over the east bank above the high water mark.<sup>8</sup>

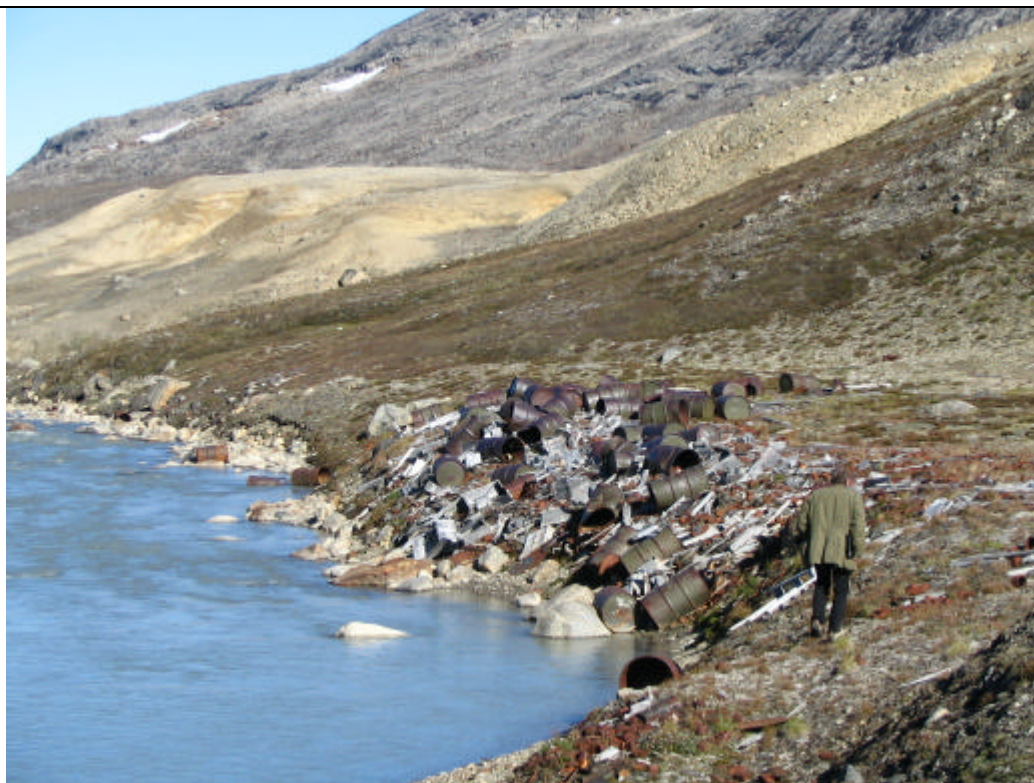
Photo 2: Barrels along the riverbank.

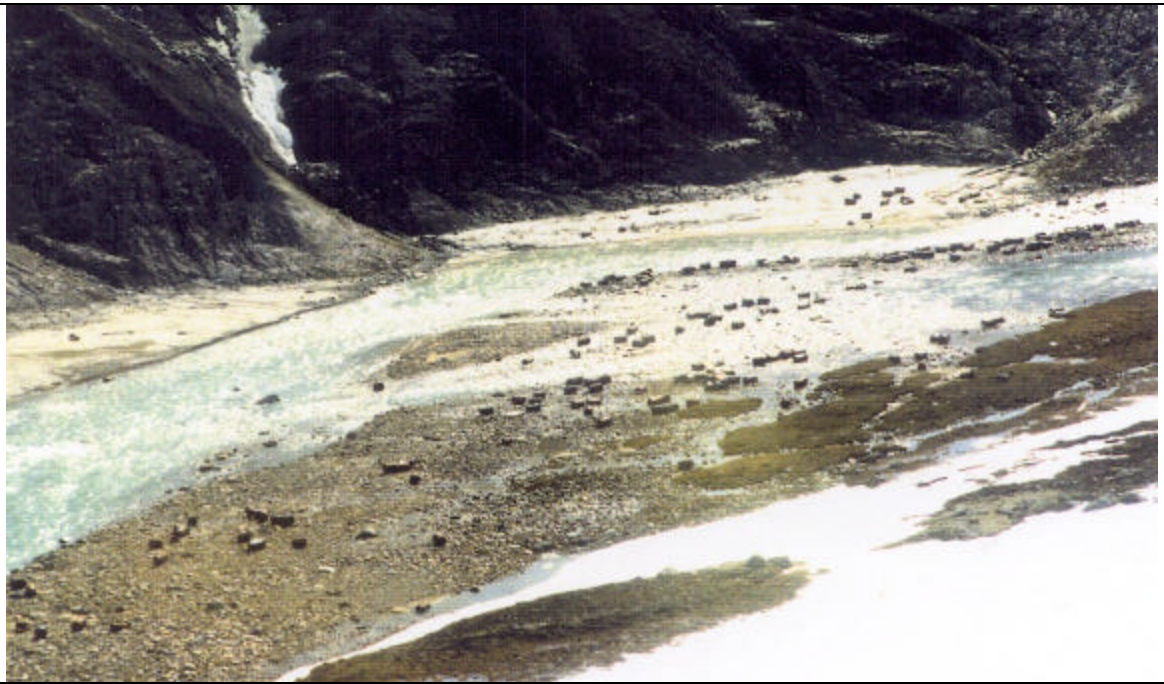
Photo 3: Barrels in the river between the Lake and Ekalugad Fjord.
