# **Revised Spill Contingency Plan**

**Cambridge Bay  
Apron and Fire Training Area Land Treatment Units**

**Prepared by  
Transport Canada**

**July 2018**

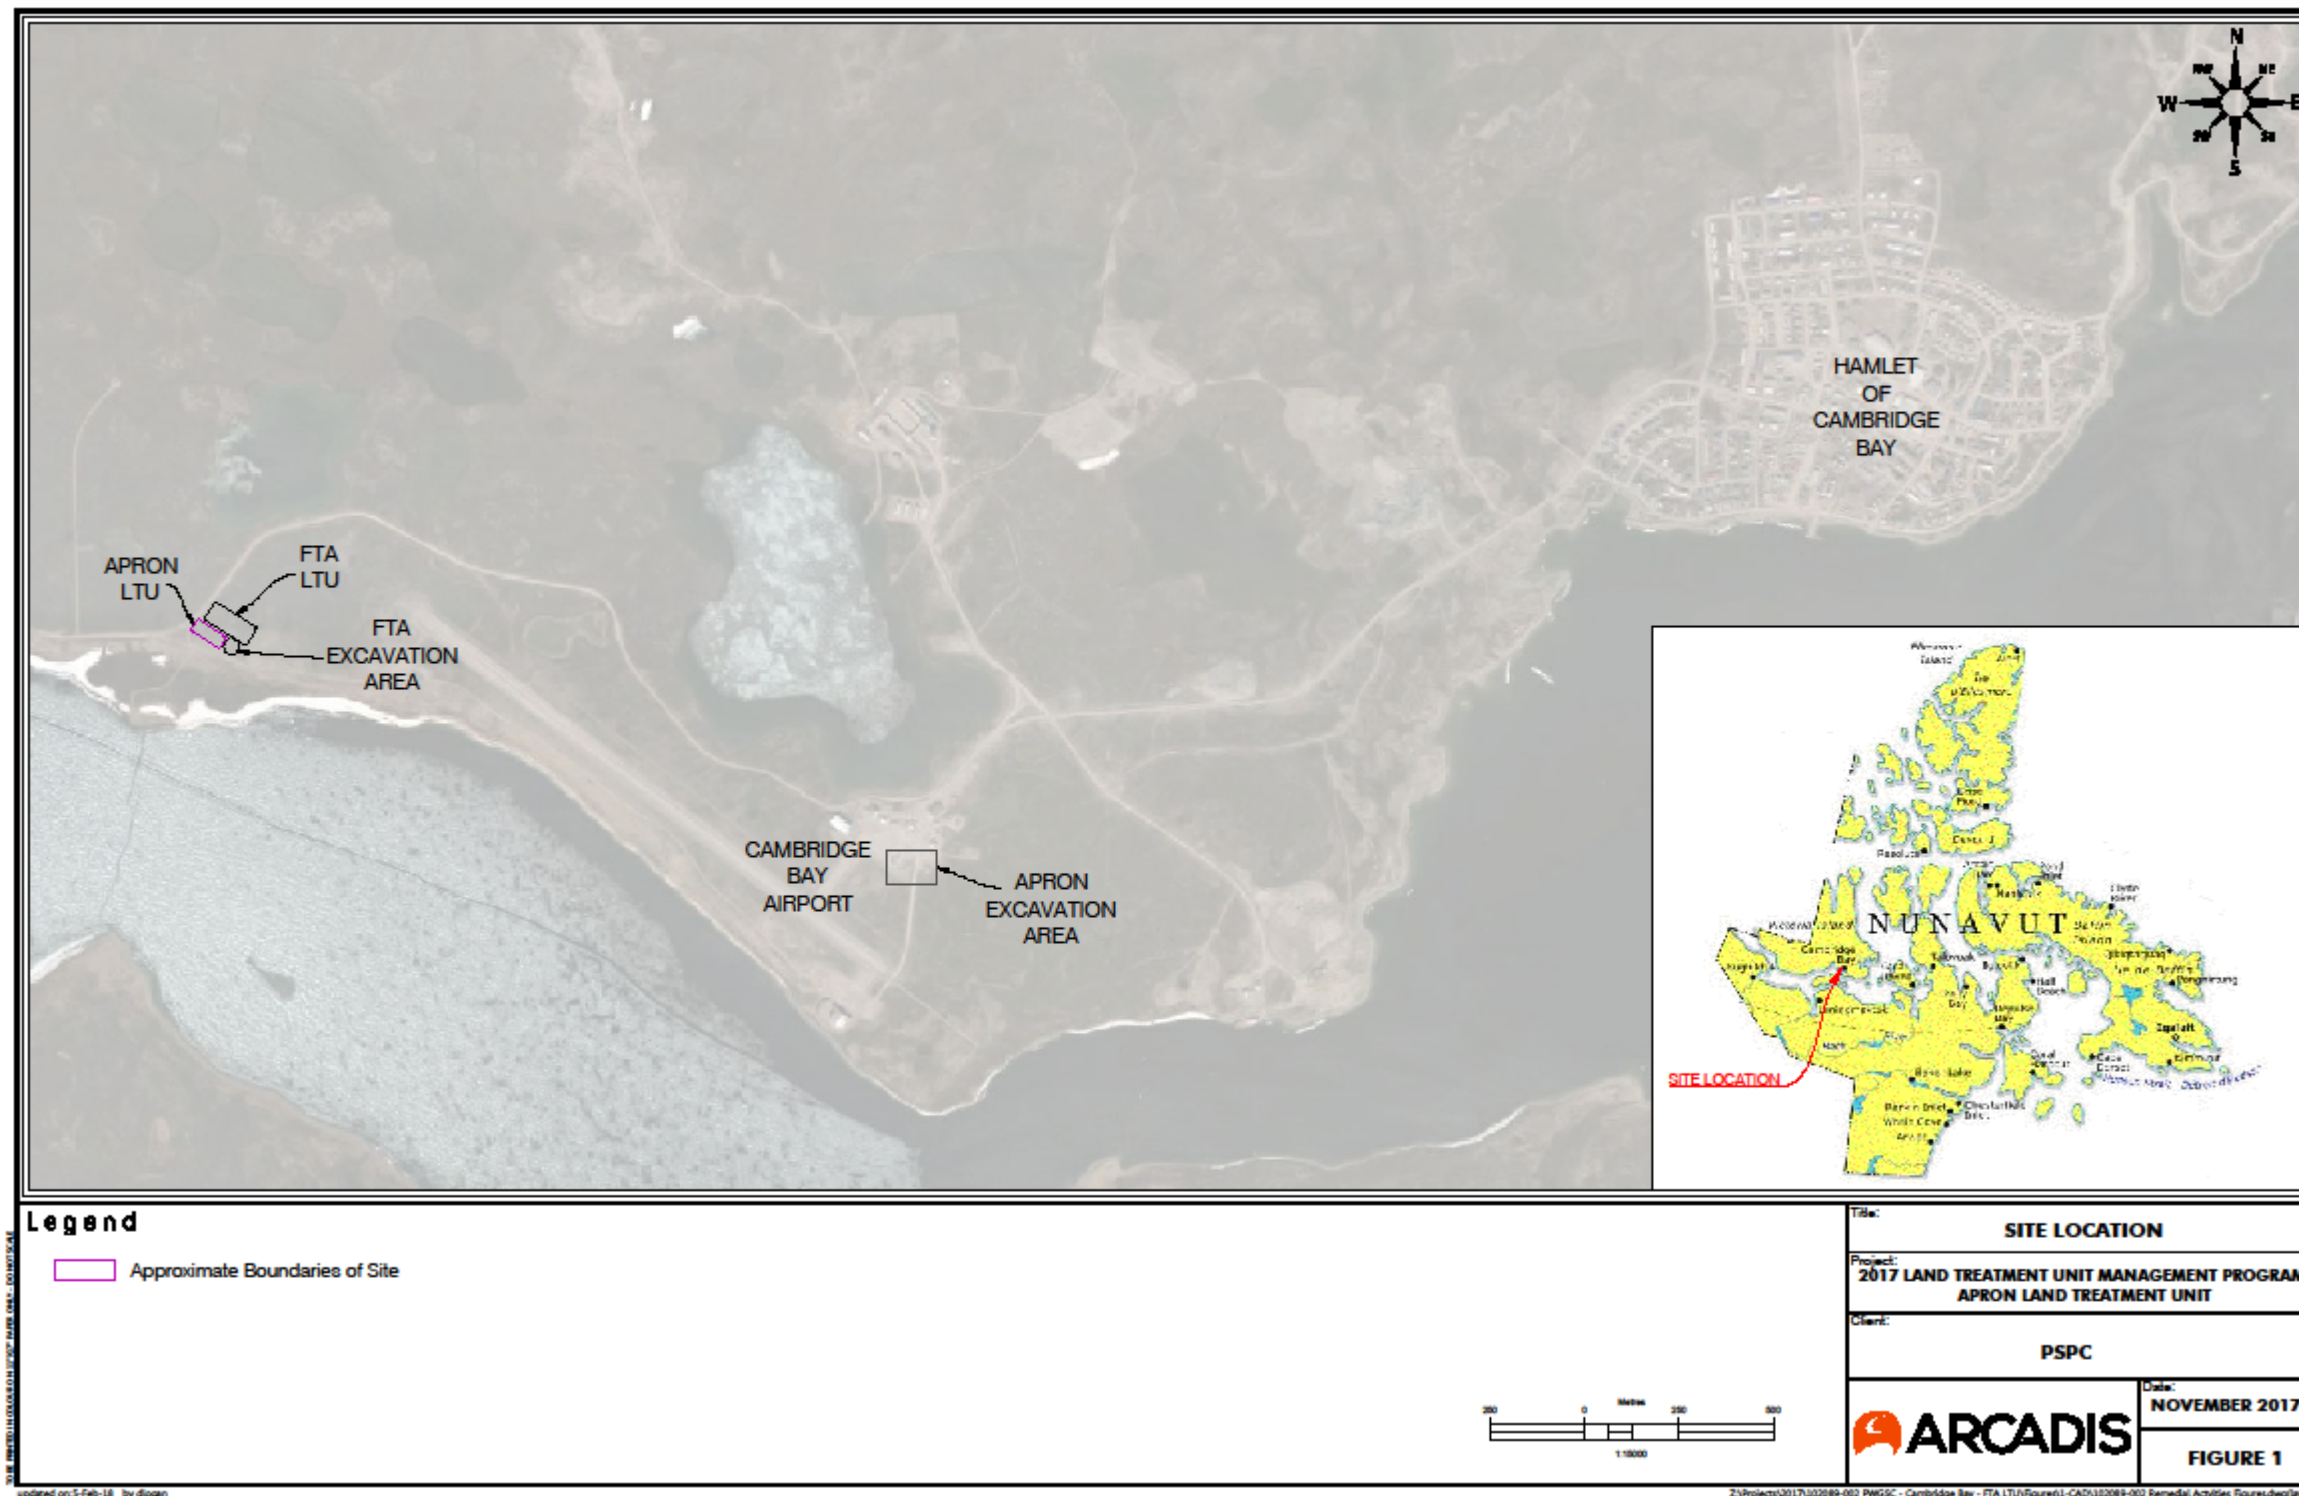
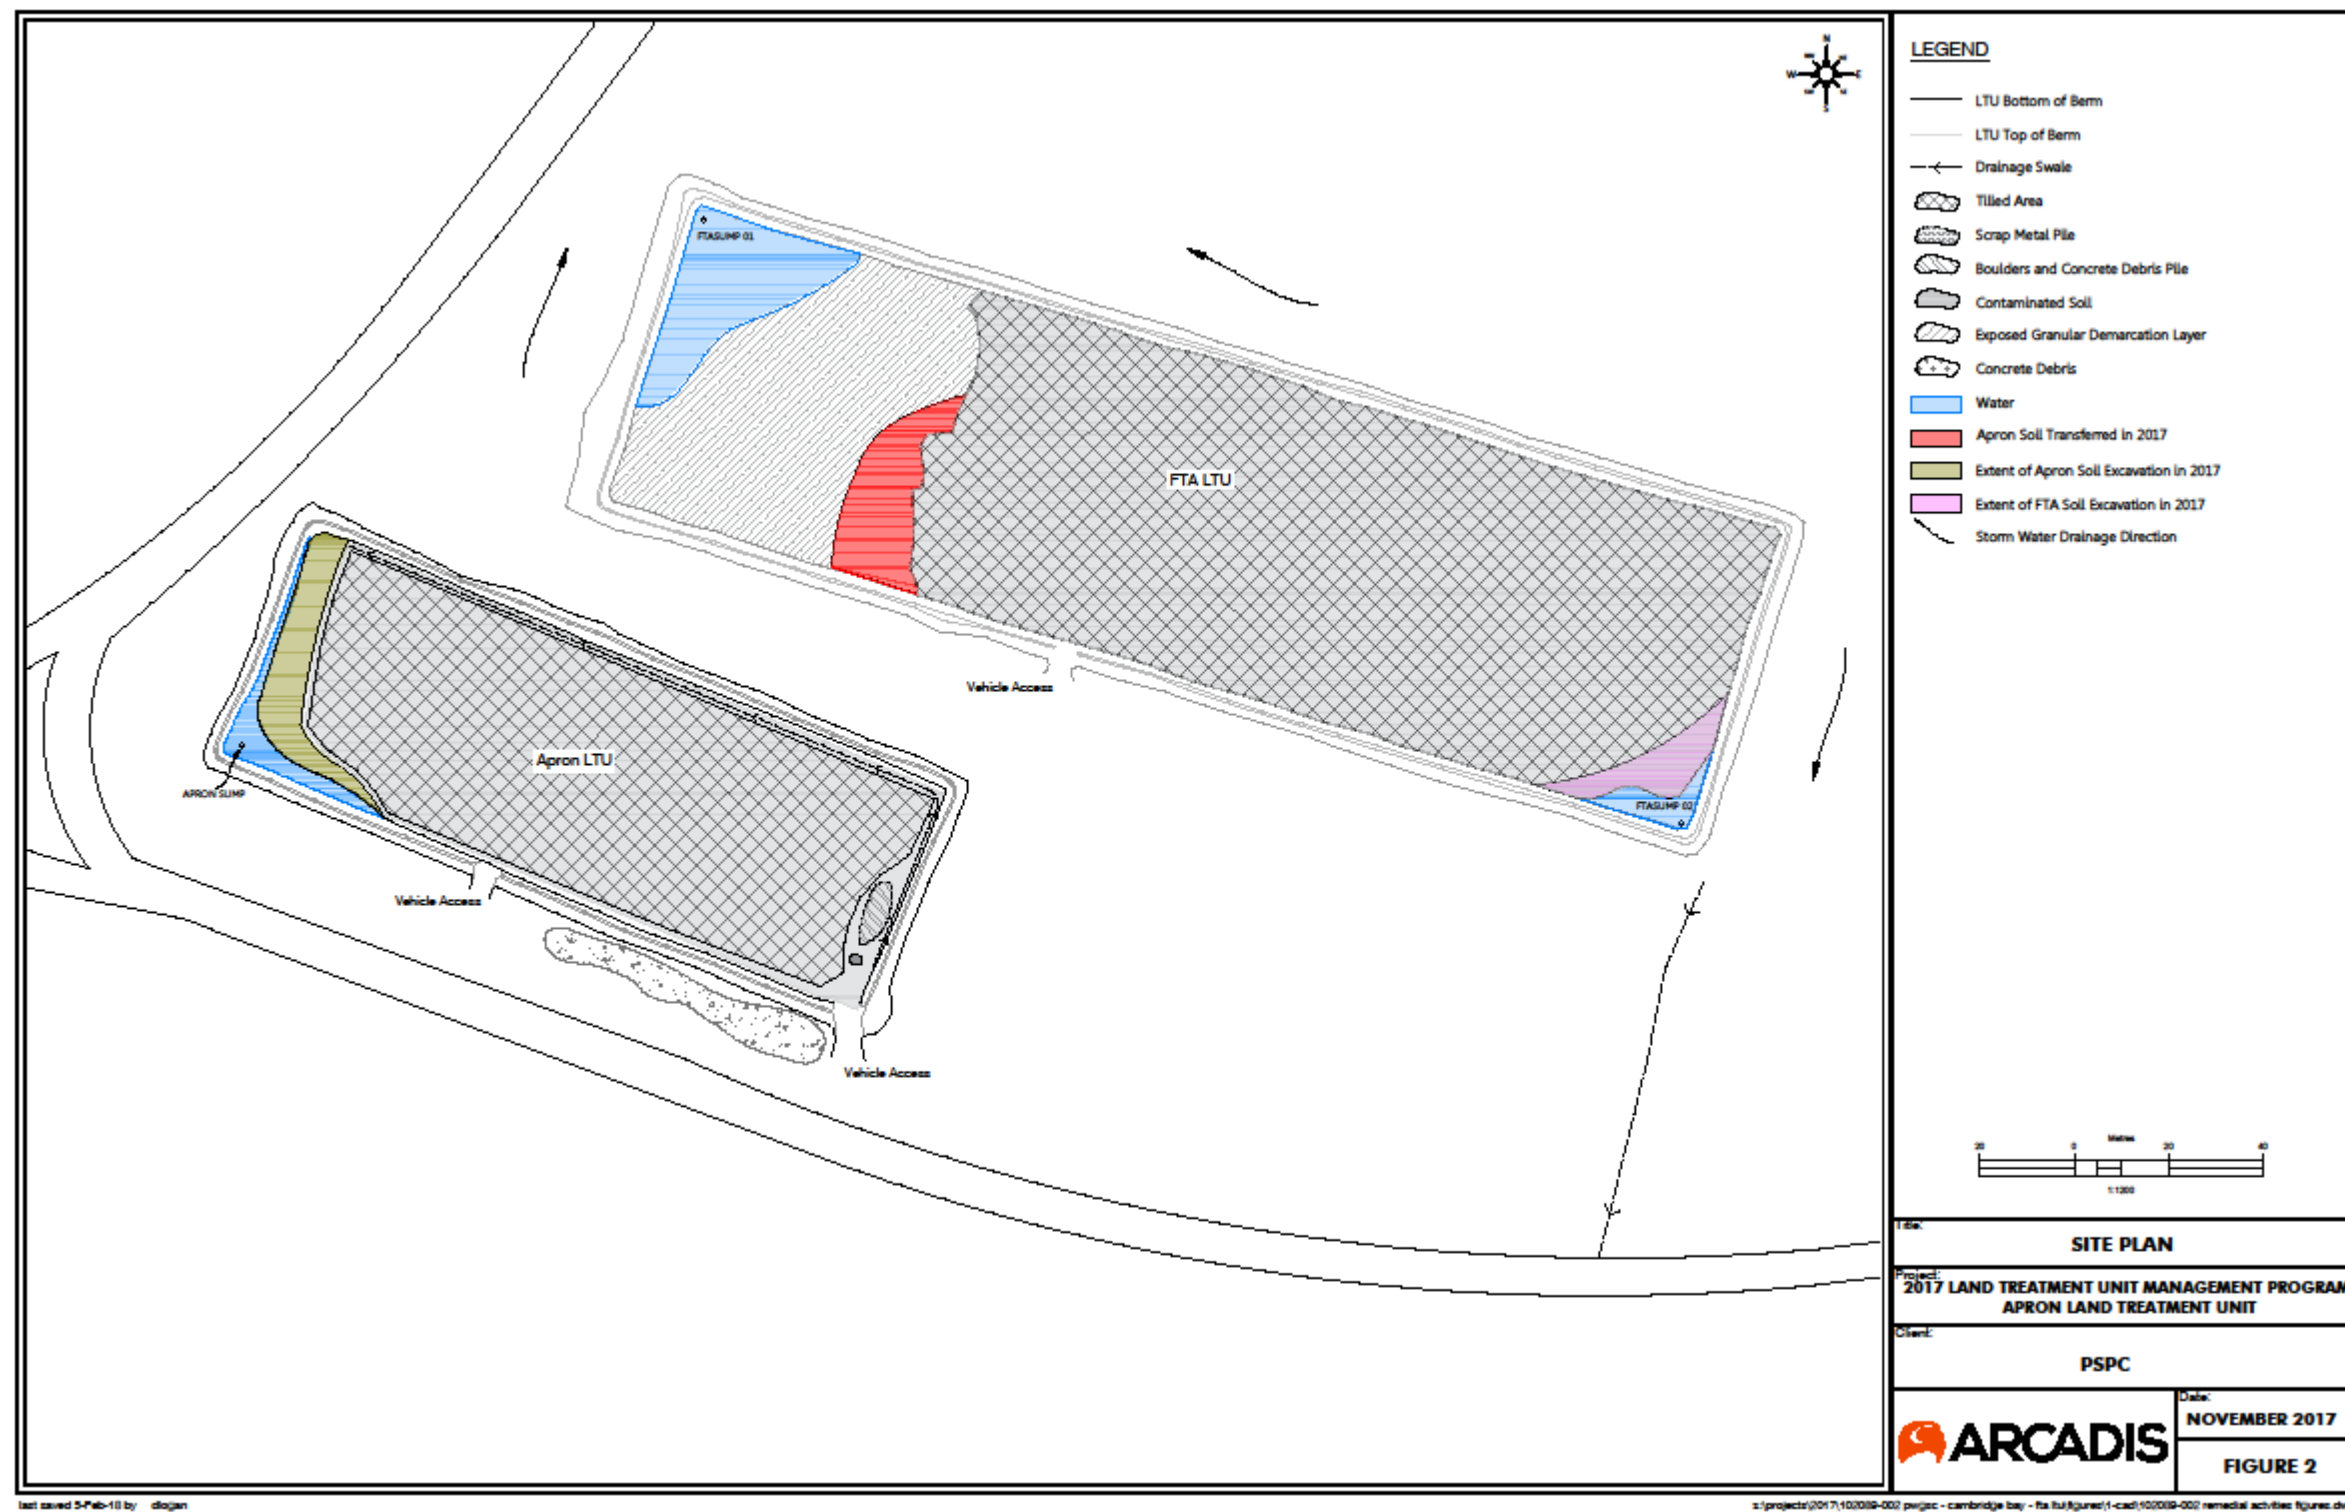
## **SITE DRAWINGS**

In 2013, hydrocarbon impacted soil was excavated from the Apron area at the Cambridge Bay Airport and placed in an engineered Land Treatment Unit (LTU) on-site. In 2014, hydrocarbon impacted soil was excavated from the former Fire Training Area (FTA) at the Cambridge Bay Airport and placed in an additional engineered Land Treatment Unit (LTU) on-site. Additionally in 2014, during construction of the FTA LTU, a buried drum cache near the former FTA area was discovered. Soils from this drum cache were excavated and placed into the Apron LTU. The Apron LTU contains approximately 4,000 m<sup>3</sup> of soil and the FTA LTU contains approximately 4,500 m<sup>3</sup> of soil.

The LTUs are located at the Cambridge Bay Airport, southwest of the northwest end of the runway. The LTUs are located in a developed area at the Cambridge Bay Airport. Therefore, they do not impact communities, traditional use areas (hunting and trapping camps), sensitive areas, parks, game preserves, and resource harvesting areas, fish spawning areas, waterfowl habitat, animal migration routes, beaches, archaeological and historic sites, public or private water supplies. The area surrounding the airport is flat lying close to the roadside, with topography then beginning to drop off quite steeply (+/- 10 m drop) towards the shoreline and West Arm of Cambridge Bay. Please see Annex I for location/contour maps.
