Project Number: CAM-4 (3.6)

Re: 2005 Annual Report: Water Use License #NWB5PEL0510

Encl. Overall Site Plan

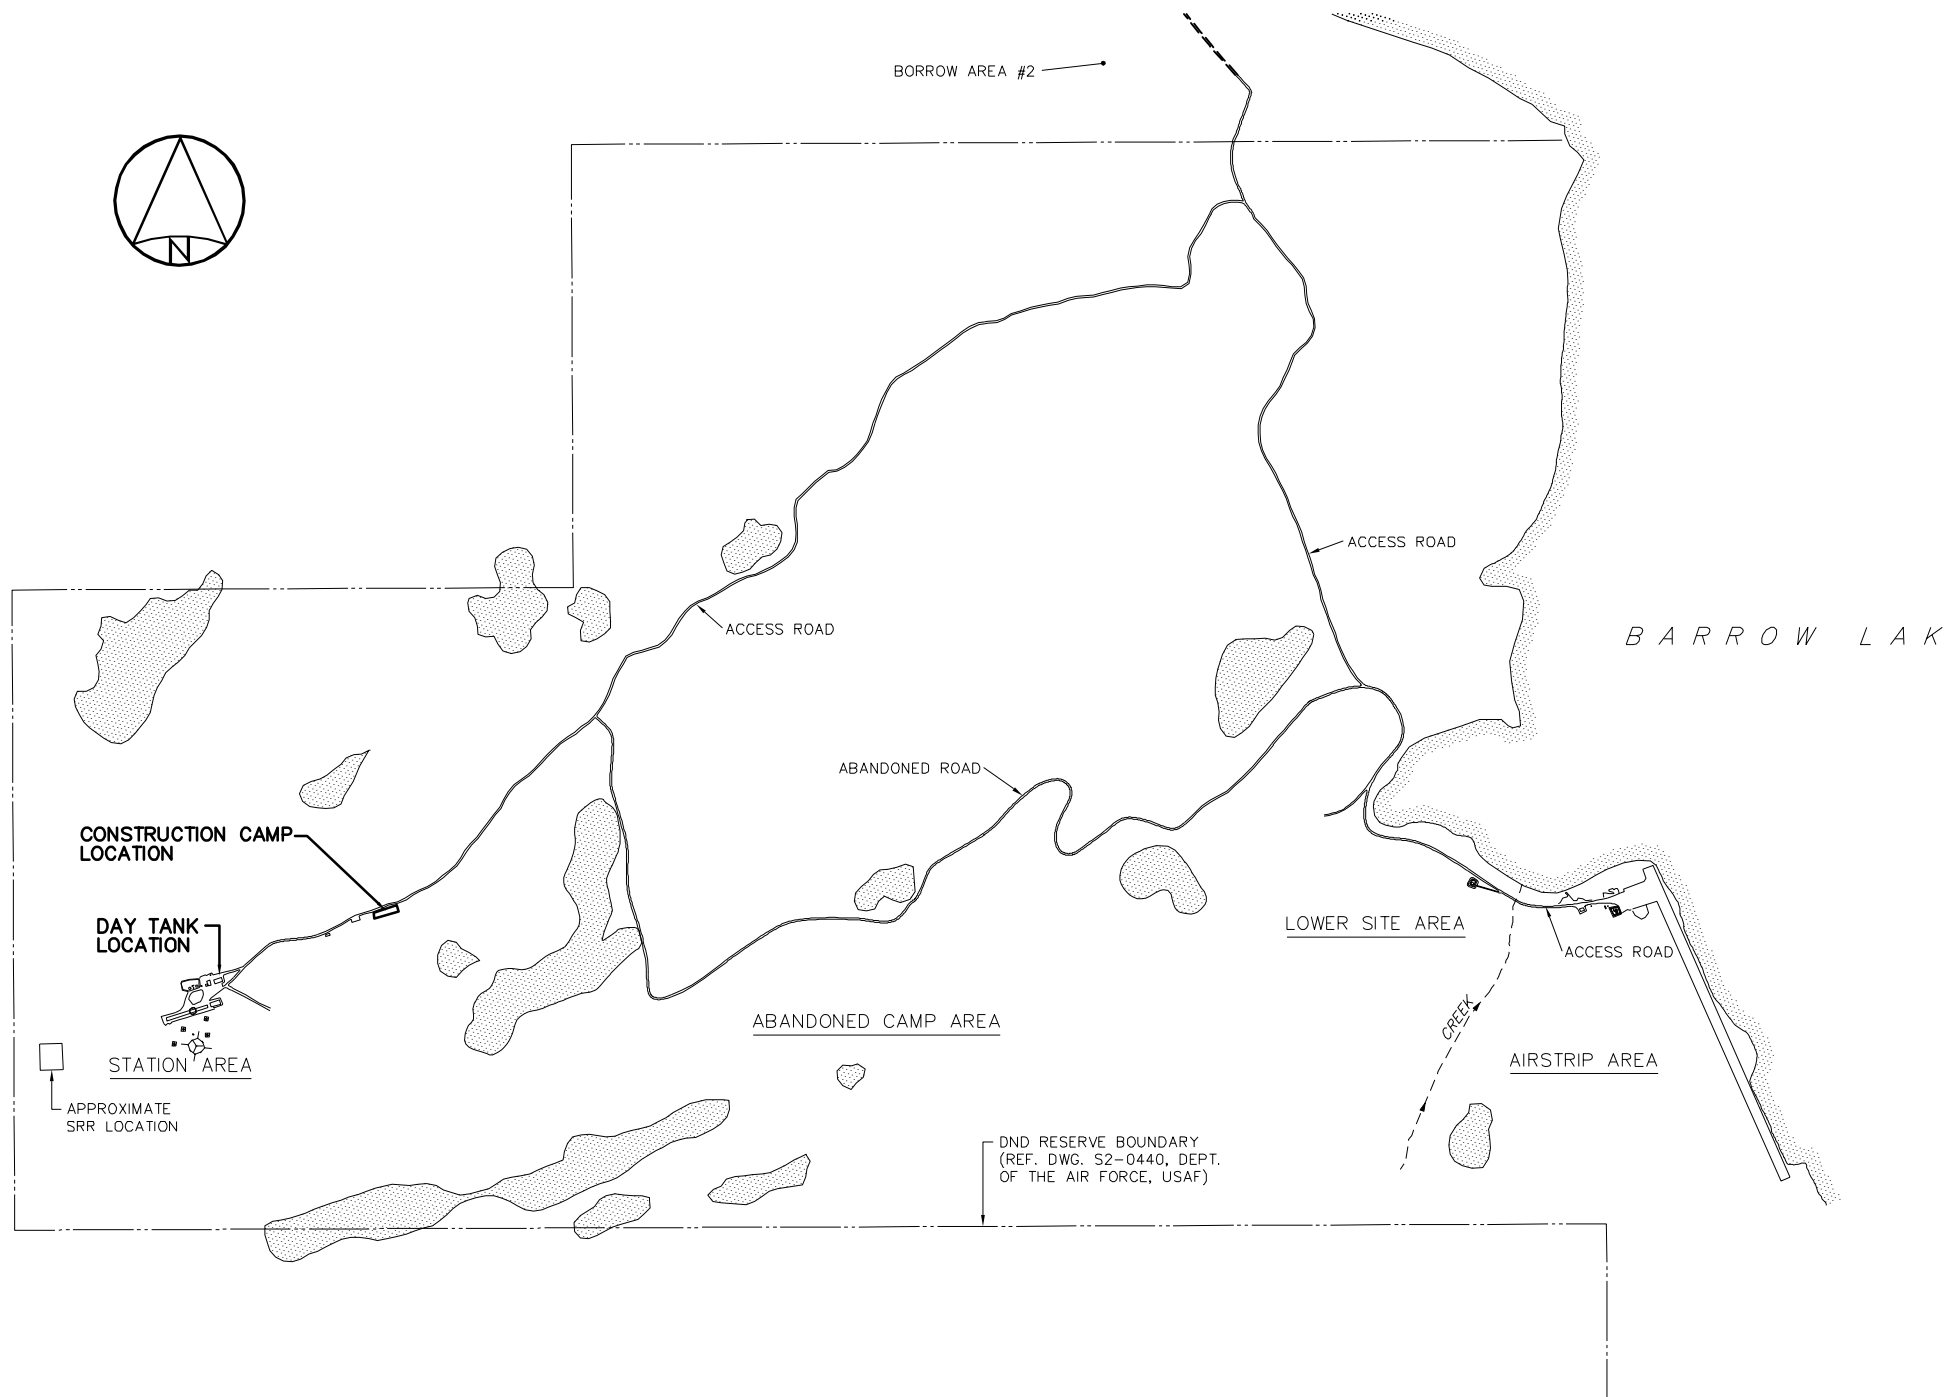
An overall site plan showing the location of the construction camp is attached.

CONSTRUCTION CAMP
LOCATION
