# **Post-Closure Monitoring Plan for the Resolute Bay Airport Landfill, Resolute Bay, Nunavut**

**PSPC Project R.112072.001**

**Final Report**

September 2020

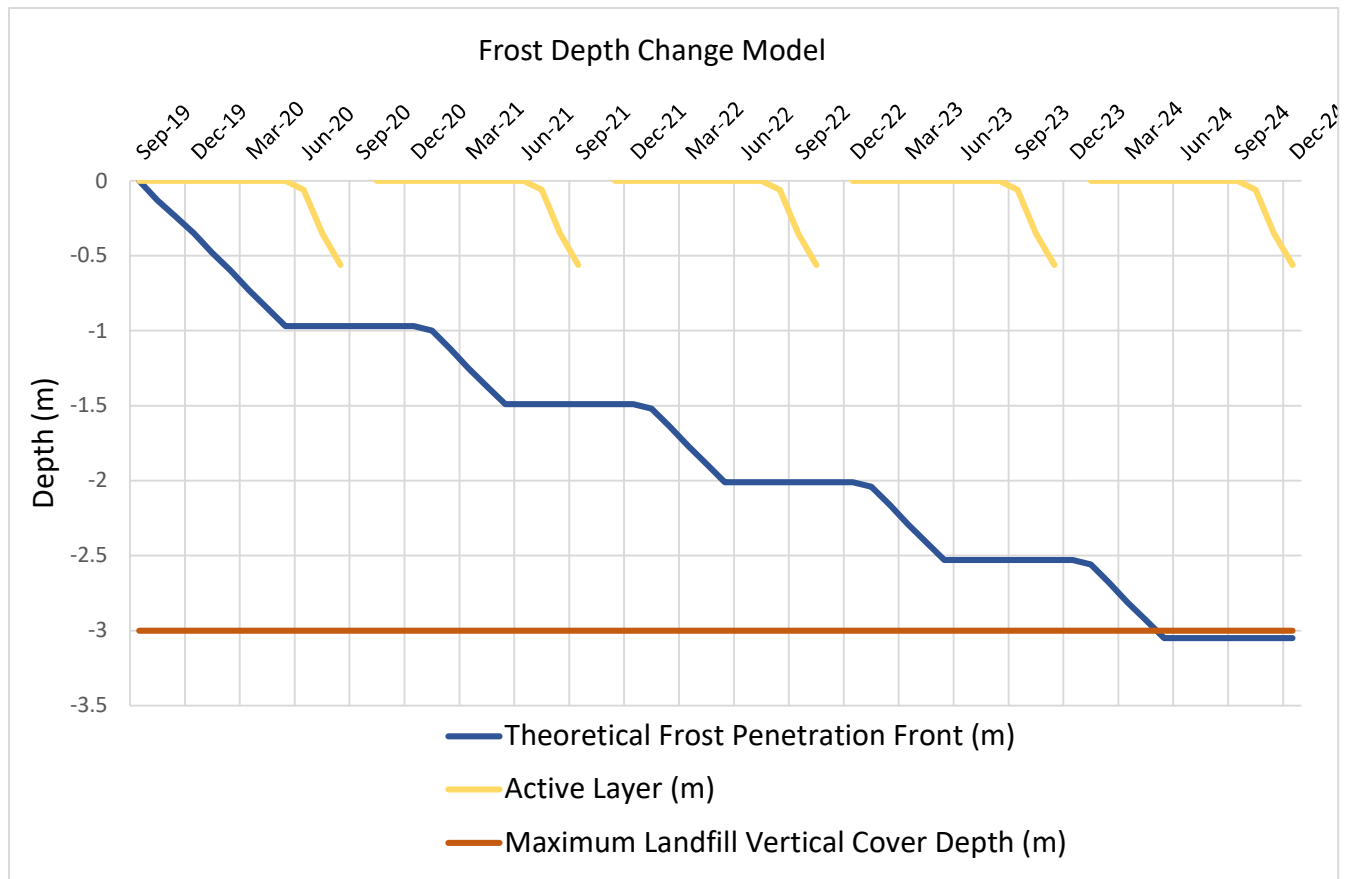
**FIGURE 1: FROST DEPTH CHANGE MODEL**

- Thermal conductivity of  $0.25 \left( \frac{W}{m K} \right)$  was used, based on typical values for a gravel material.
- Ice density of  $997 \left( \frac{kg}{m^3} \right)$
- Volumetric fraction of ice in frozen soil of 0.1 based on conservative calculations from sieve analyses and field reports of rain records.
- Latent heat of fusion of  $334,000 \left( \frac{W \times s}{kg} \right)$
- Average temperature during freezing cycles of  $-1^\circ C$  based on a conservative estimate of the insulating factors of snow.
- Ground temperature to air temperature factor of 1.35, based on correlations between the model and average test pitting active layer depths.

This model provides an average distribution of what each thermistor shown in *Appendix A: Figure 1* should represent over time.

For thermal monitoring, it is predicted that steady state permafrost aggradation will be reached after year 5 based on the maximum landfill vertical cover depth (See Appendix D). After this timeframe, the theoretical frost penetration front is expected to reach either the existing permafrost or the capped landfill waste.

It is predicted that steady state permafrost aggradation will be reached after year 5 based on the maximum landfill vertical cover depth (see Appendix D). After, this timeframe the theoretical frost penetration front is expected to reach either the existing permafrost or the capped landfill waste.

Previous on-site test pitting outlined in the *Phase 3 Environmental Site Assessment* identified 5 test pits in AEC 1 with an average active layer of 0.56m in depth before permafrost was encountered. The maximum active layer depth for *Figure 1* above was established based on this data. The active layer depth was also used to correlate the relationship between air temperature and ground temperature (factor n). It should be noted, however, the installation of thermistors will allow for actual average ground temperatures to be used into the *Frost Depth Change Model*, which will increase its overall precision.

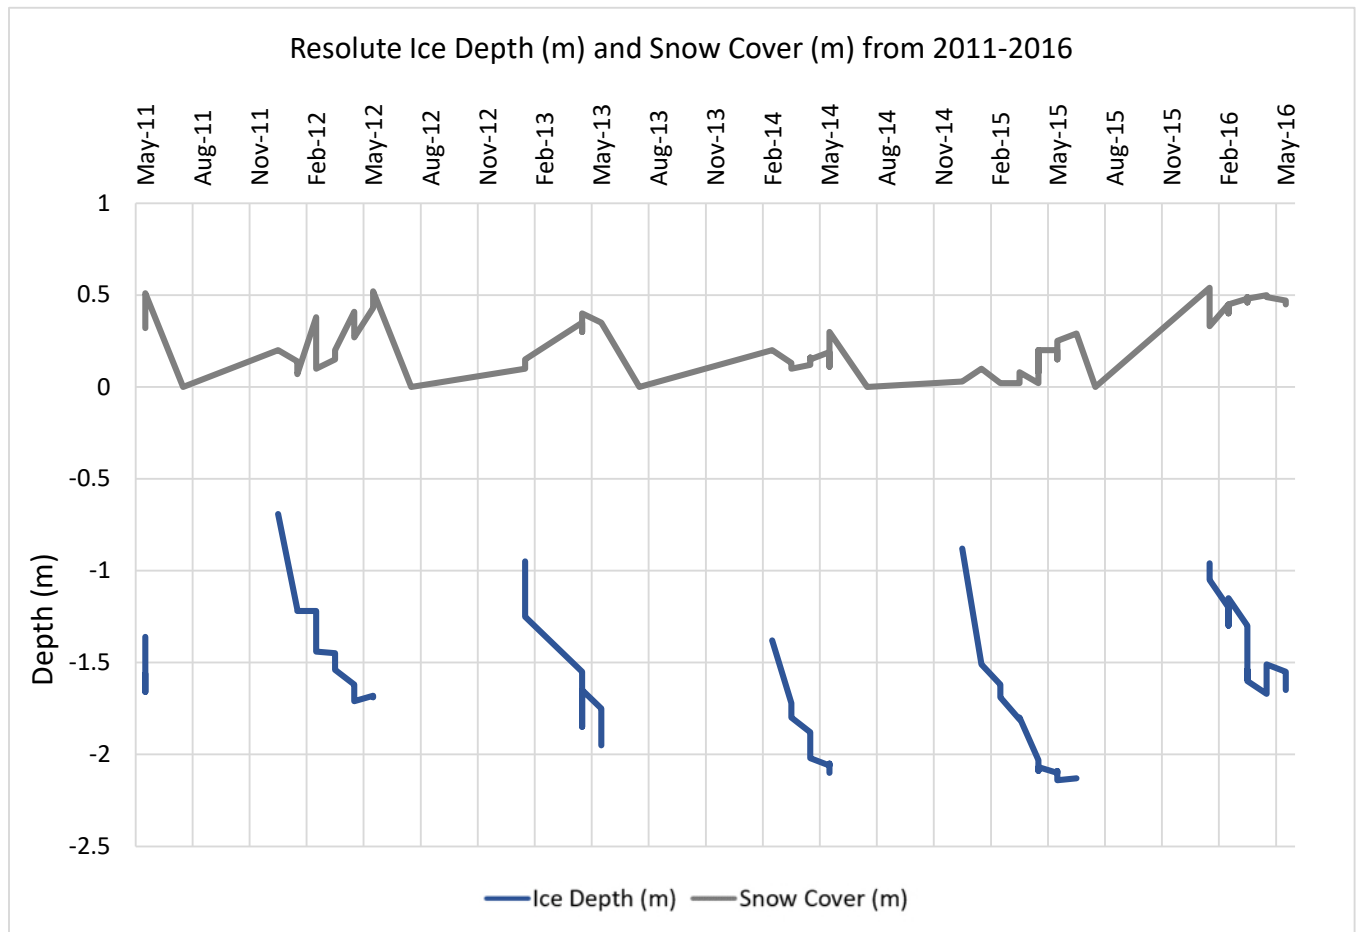
**FIGURE 2: RESOLUTE ICE DEPTH (M) AND SNOW COVER (M) FROM 2011-2016**

In order to confirm the validity of the *Frost Depth Change Model*, historic Ice thickness and snow cover depths were analyzed. Results from May 2011 to May 2016 are shown below:

Monthly ice depth was confirmed using Environment and Climate Change Canada historic weather station data of Resolute. The depth of accumulated ice in this model further confirms that the *Frost Depth Change Model* can reach steady state in a 5-year span.

Based on the data from the two previous figures, it is proposed that a thermistor depth of 3.0 m be used moving forward, or to the bottom of the capping material. This will ensure there is useable data for the remainder of the Monitoring Plan, while also allowing for this data to be correlated to Environment and Climate Canada data as required. It should be noted that thermistor depths of 3.0 m may not be
