File Name: CAM-3 (3.6)

**Re: 2006 Annual Report: Water Use License #1BR-SHE0510**

UMA Engineering Ltd. is pleased to submit this annual report as per the requirements of Part B.1 of water use license 1BR-SHE0510. The report was prepared on behalf of Defence Construction Canada and the Department of National Defence.

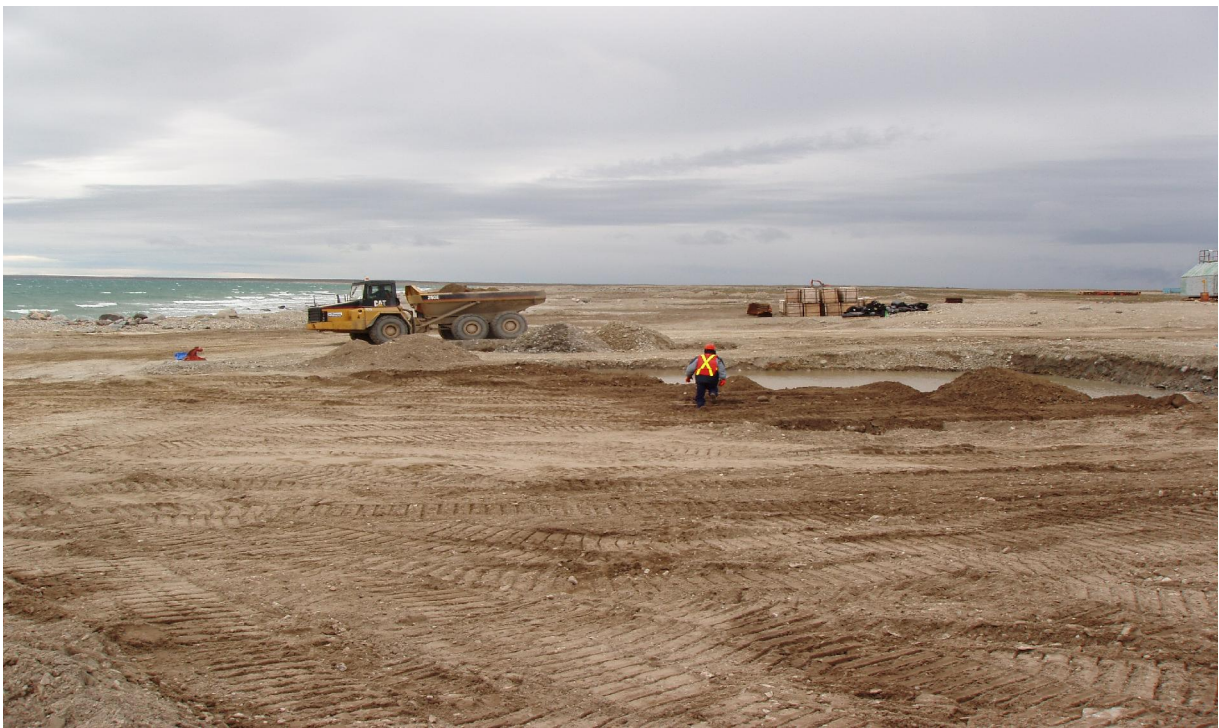
Photo 1: Backfilling Beach POL excavation.

**Contaminated Soil Removal:** All Type B hydrocarbon soil areas have been excavated and backfilled with clean granular material. The excavation and backfilling of Type A hydrocarbon soils is in progress. Tier I and II soil removal is scheduled for 2007. One Tier II soil site was excavated as it interfered with a Type B soil excavation. The soil has been temporarily stockpiled and will be placed in the Tier II facility in 2007. The removal of hazardous soils is in progress.

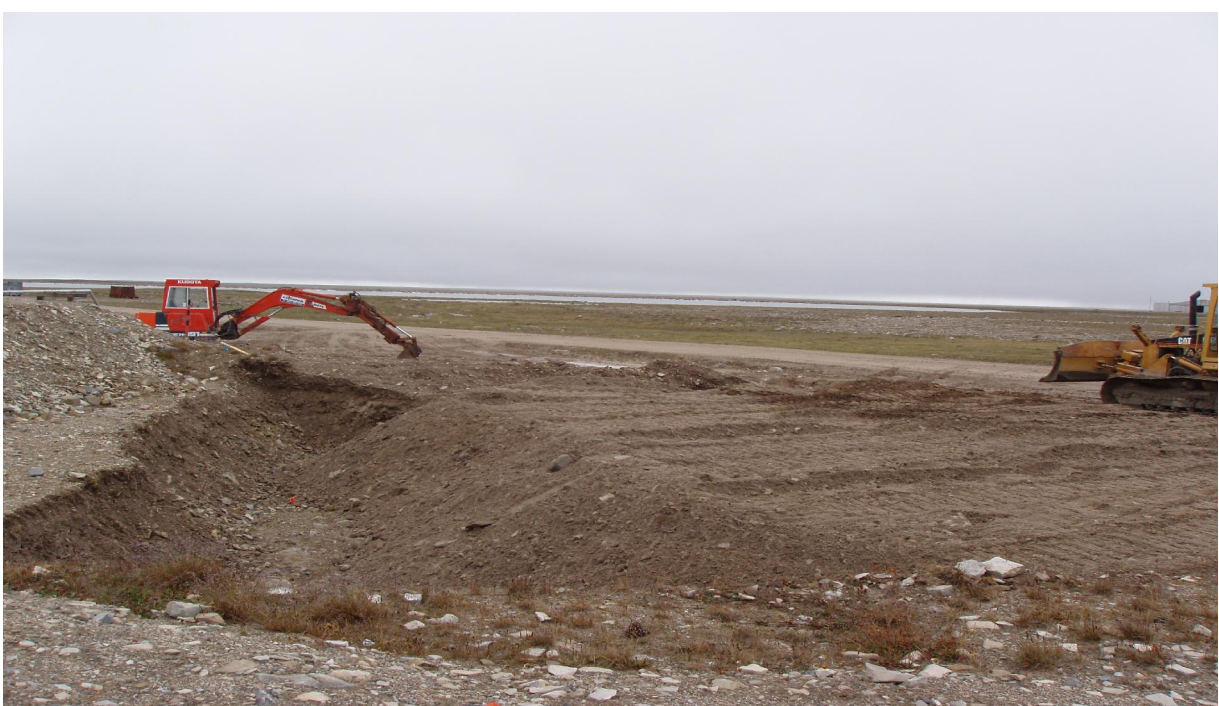
Photo 2: Backfilling contaminated soil area #9.

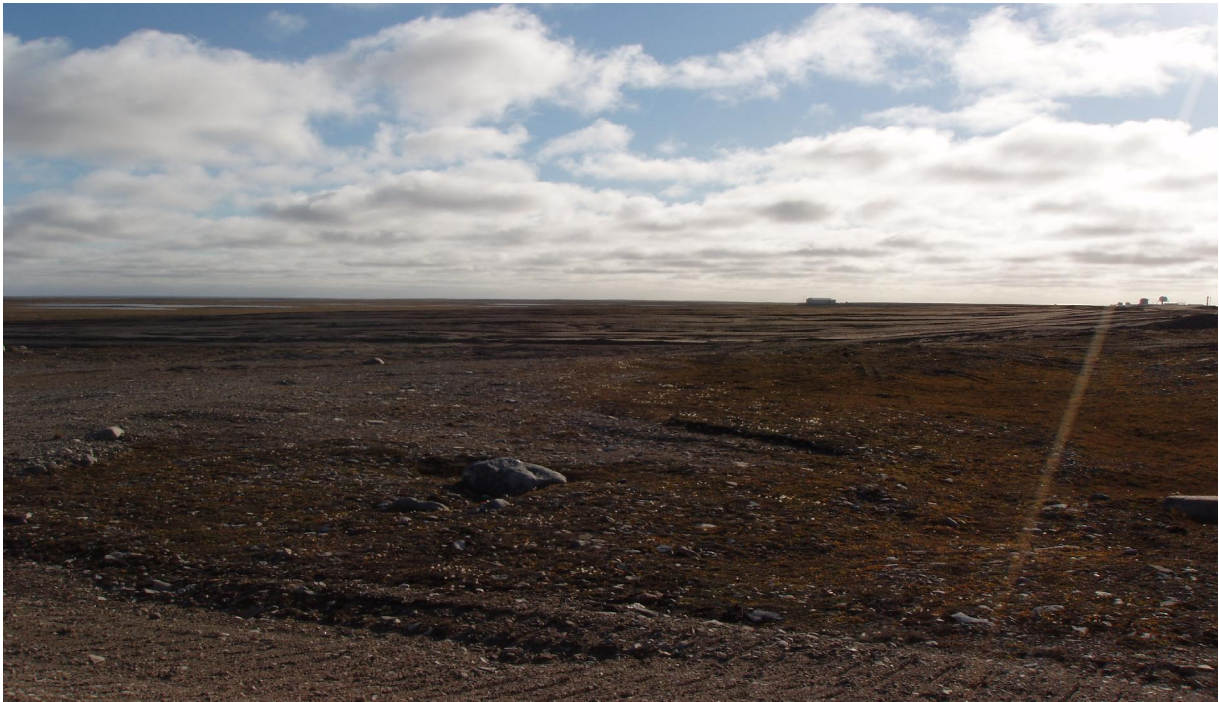
Photo 3: USAF Landfill

**Landfill Remediation:** The USAF landfill has had the surface regraded and the first sand lift was placed. Leveling, placement and compaction and closure are scheduled in 2007.

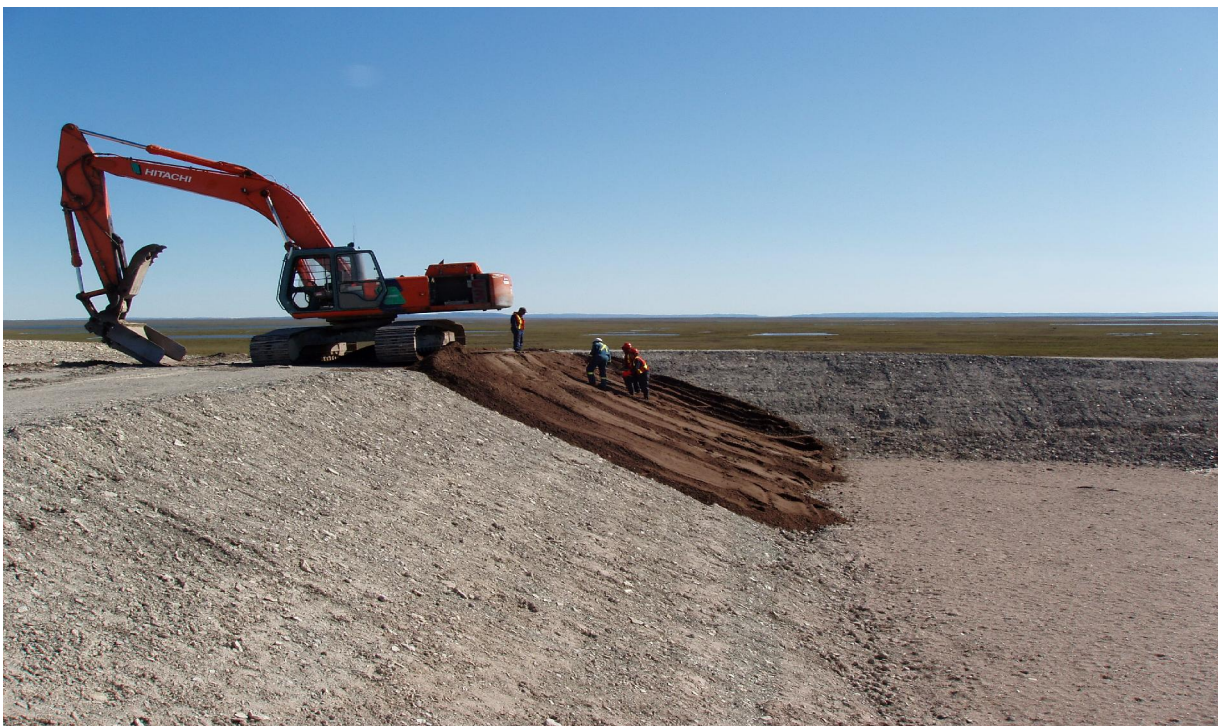
Photo 4: Placement of sand layer on Tier II Soil Disposal Facility berms

**Tier II Soil Disposal Facility:** The outer berms of the Tier II Soil Disposal Facility are complete and the facility is ready for liner installation in 2007.

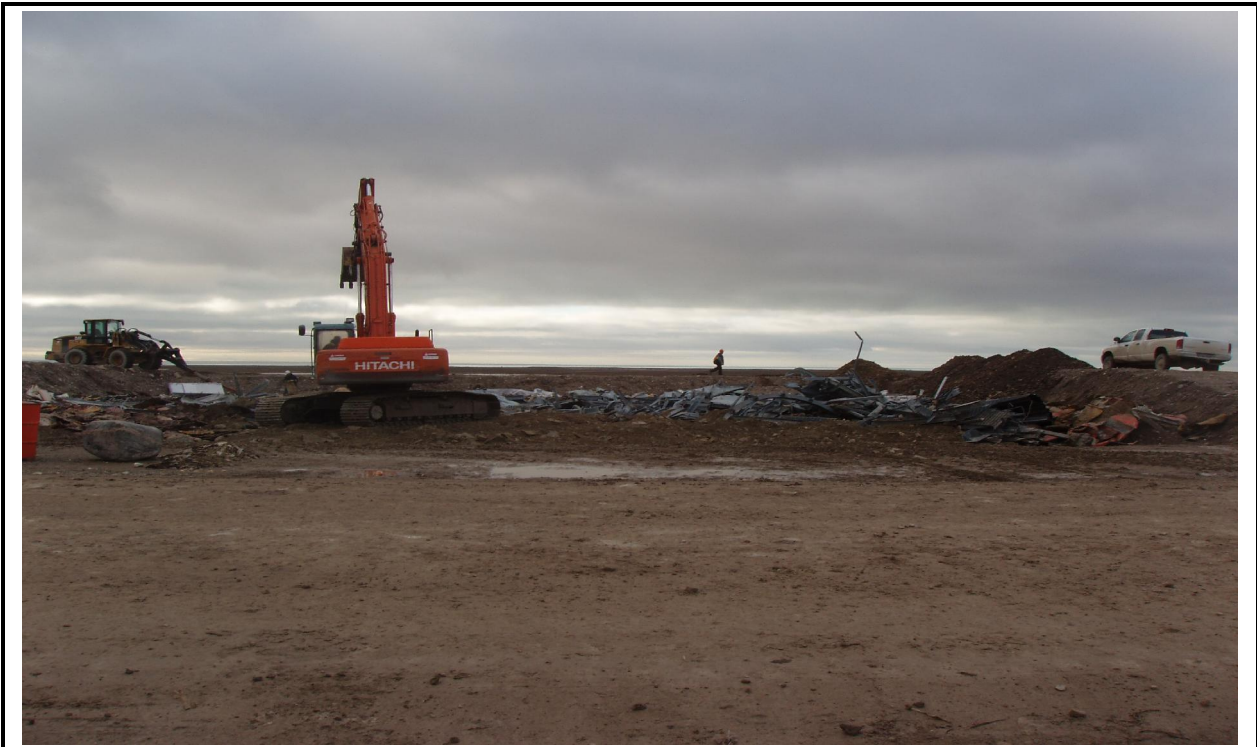
Photo 5: Placement of cover layer on Non-Hazardous Waste Landfill

**Non-Hazardous Waste Landfill:** The Non-Hazardous Waste Landfill area was surveyed and berm construction was completed. The facility started receiving waste the week ending July 22, 2006. The contractor built smaller than the tender specifications; therefore, in order to correct this problem the inside of the berms were trimmed back. The outer material of the berms still requires compaction, which should be completed in 2007.

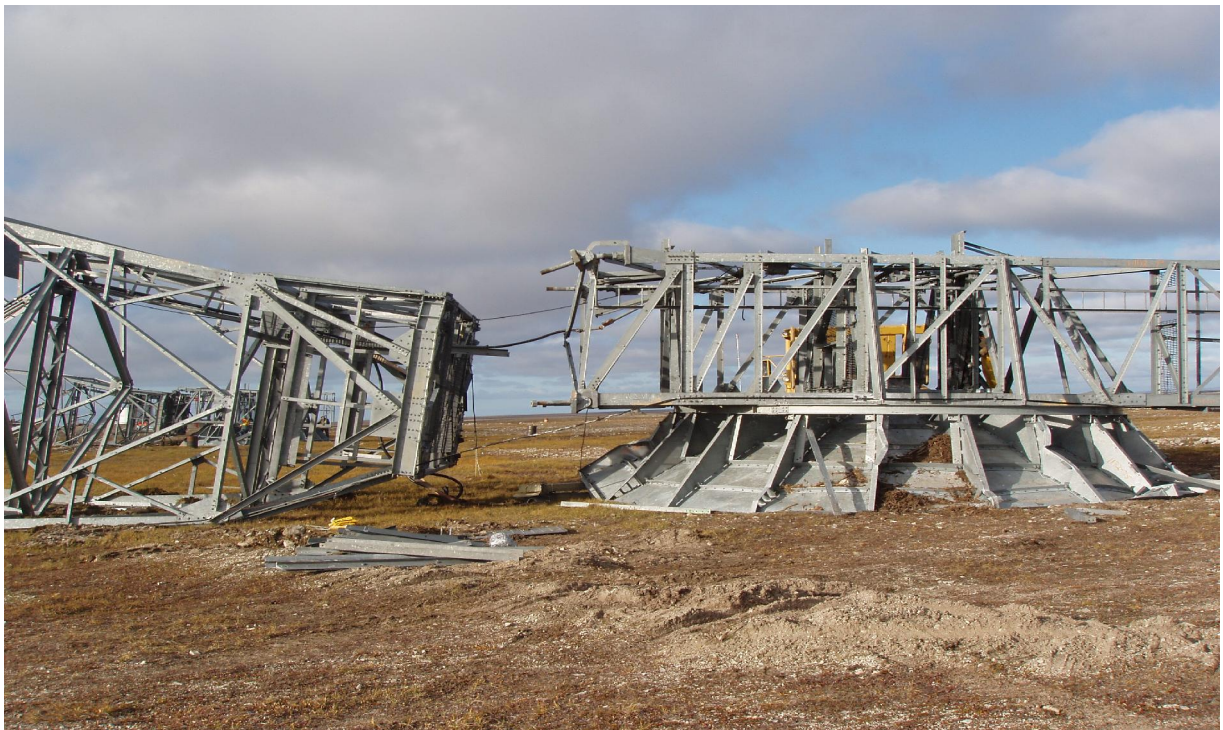
Photo 6: Demolition of communication dish

**Demolition:** Five out of the eight demolition sites have been totally completed. The cold storage shed, POL lines, diesel fuel tank and concrete ring, antenna poles and culverts from the old airstrip have been demolished and appropriately disposed of. The communication dishes, the billboard and POL storage tank still need to be hauled to the Non-Hazardous Waste Landfill. Asbestos found during demolition of the cold storage shed was containerized in double bags.

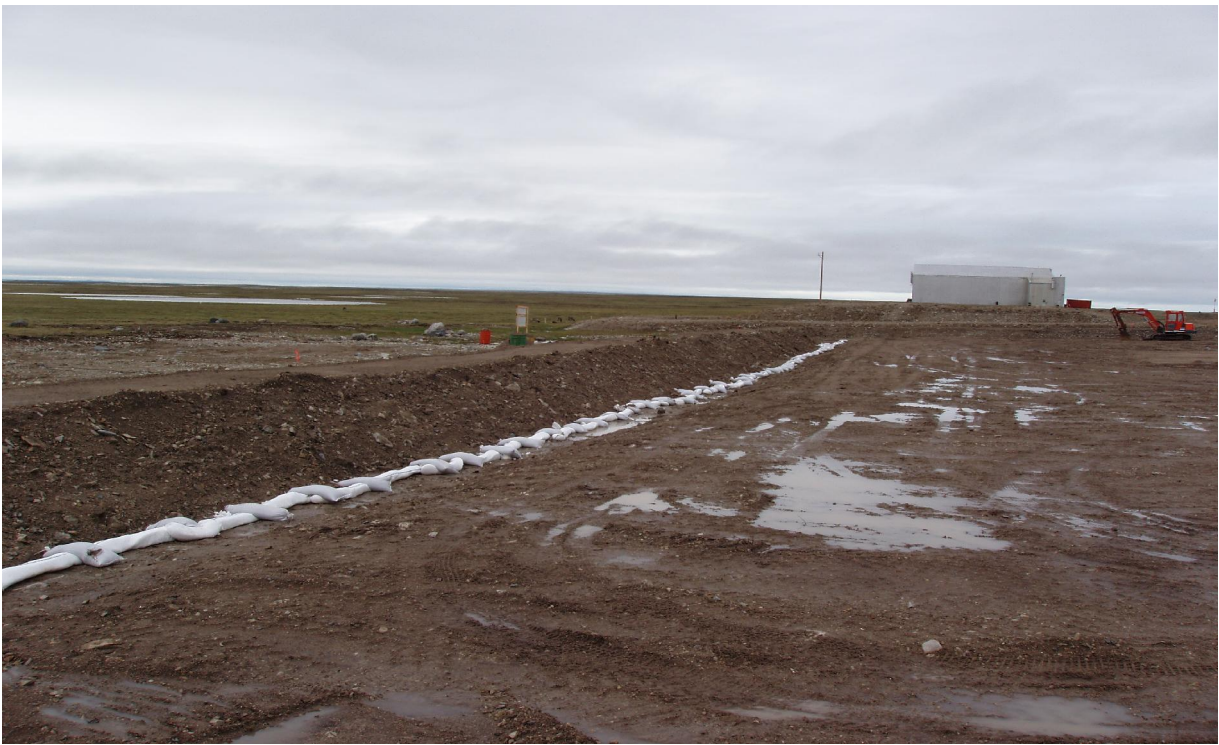
Photo 7: Oil sorbent booms at the landfarm

**Landfarm:** The landfarm area was surveyed, stripped, reshaped, and regraded. Berm construction and the key trench were completed and then the geomembrane and non-woven geotextile filter fabric were installed. The landfarm started receiving hydrocarbon impacted soil on July 19, 2006. Primary tilling began on August 18, 2006. Approximately 3600 m<sup>3</sup> of hydrocarbon contaminated soil has been removed and placed in the landfarm.

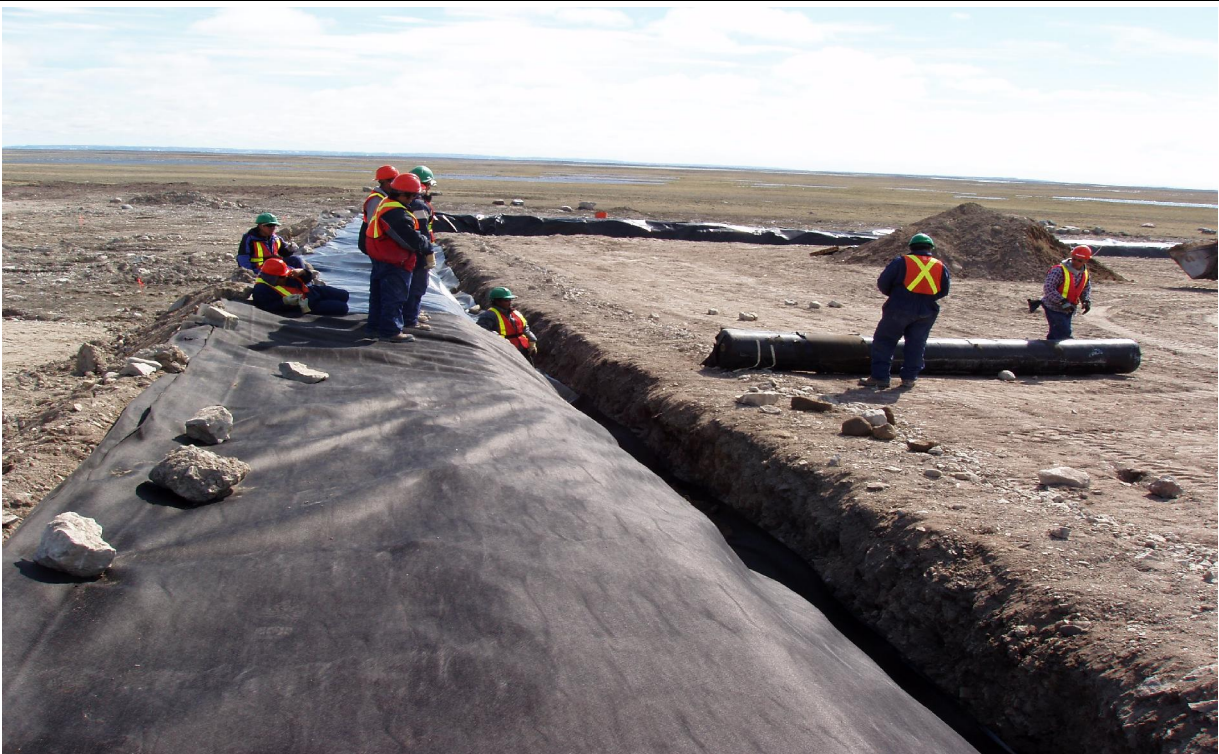
Photo 8: Placement of geotextiles at landfarm
