Public Works and Government Services Canada  
Northern Contaminated Sites Program

# **Remedial Action Plan**

## **CAM-A Sturt Point, NU**

### **Intermediate DEW Line Site**

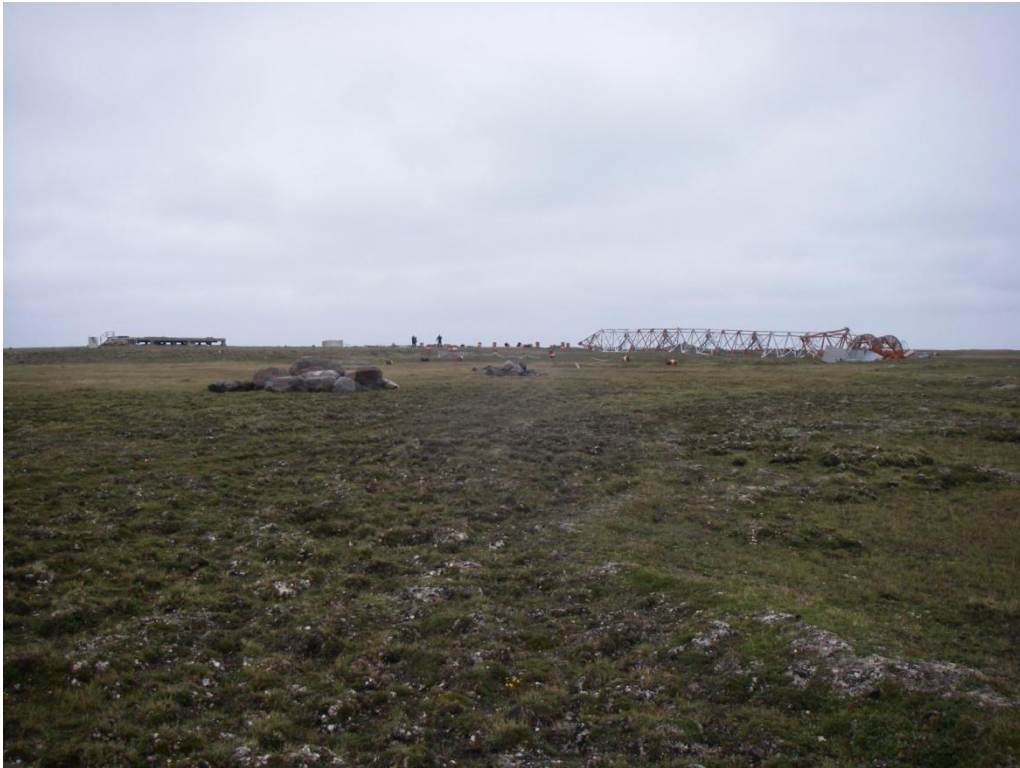
**Plate 1 View south of antenna and main facility location CAM-A DEW Line site.**

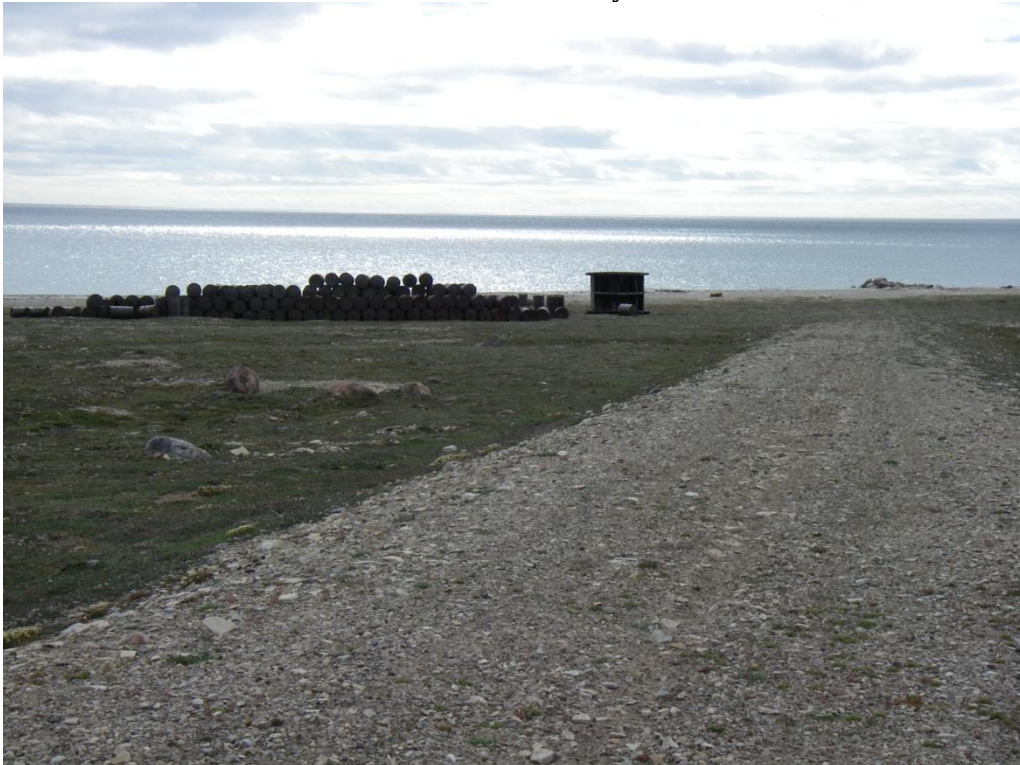
**Plate 2 Barrels on the beach near the barge landing at CAM-A.**
