DORIS NORTH PROJECT “NO NET LOSS” PLAN

**- REVISION 6 -
September 2007**

Prepared For:

Miramar Hope Bay Ltd.

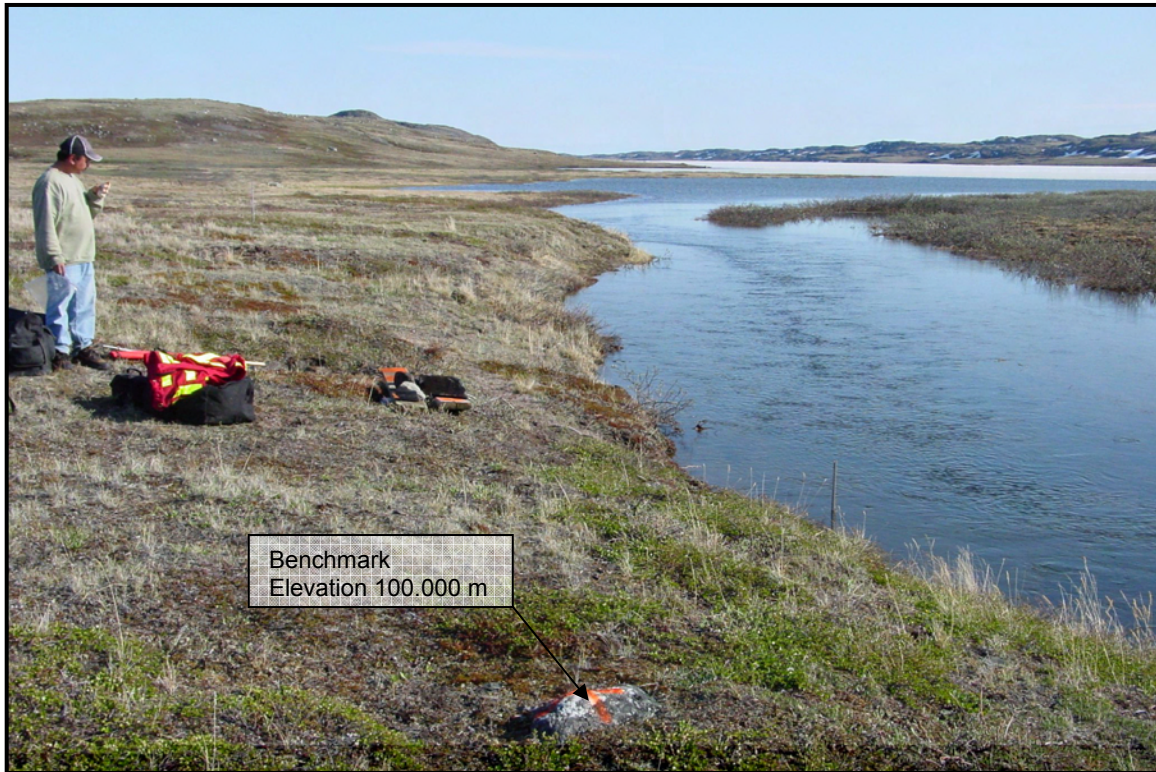
Figure 1 Doris Lake outlet gauging station, looking south (upstream) from right downstream bank.

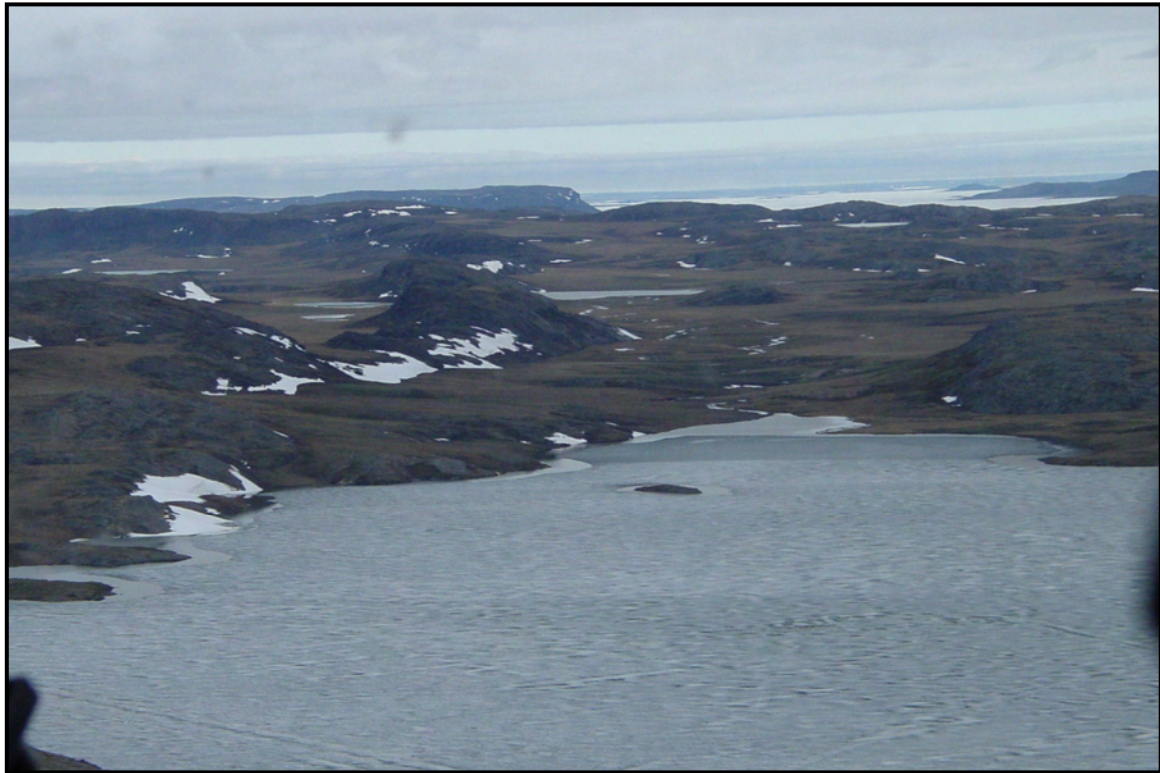
Figure 3 Aerial view of Doris Lake outlet gauging station, looking north (downstream).

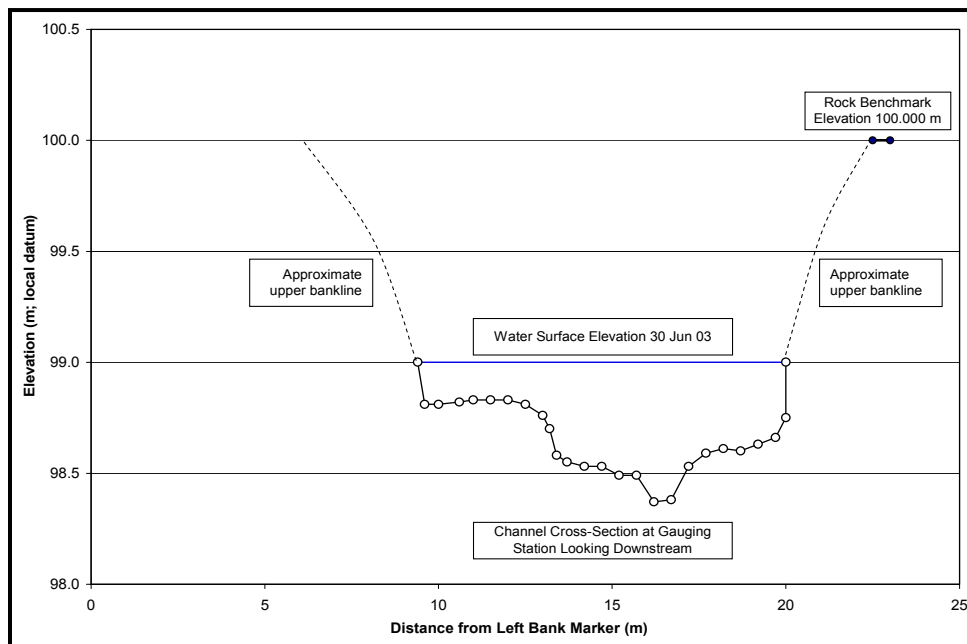
Figure 4 Cross-section and water surface elevation at Doris Lake outlet gauging station, looking downstream. Upper banklines are approximate; lower cross-section and benchmark elevation were measured.

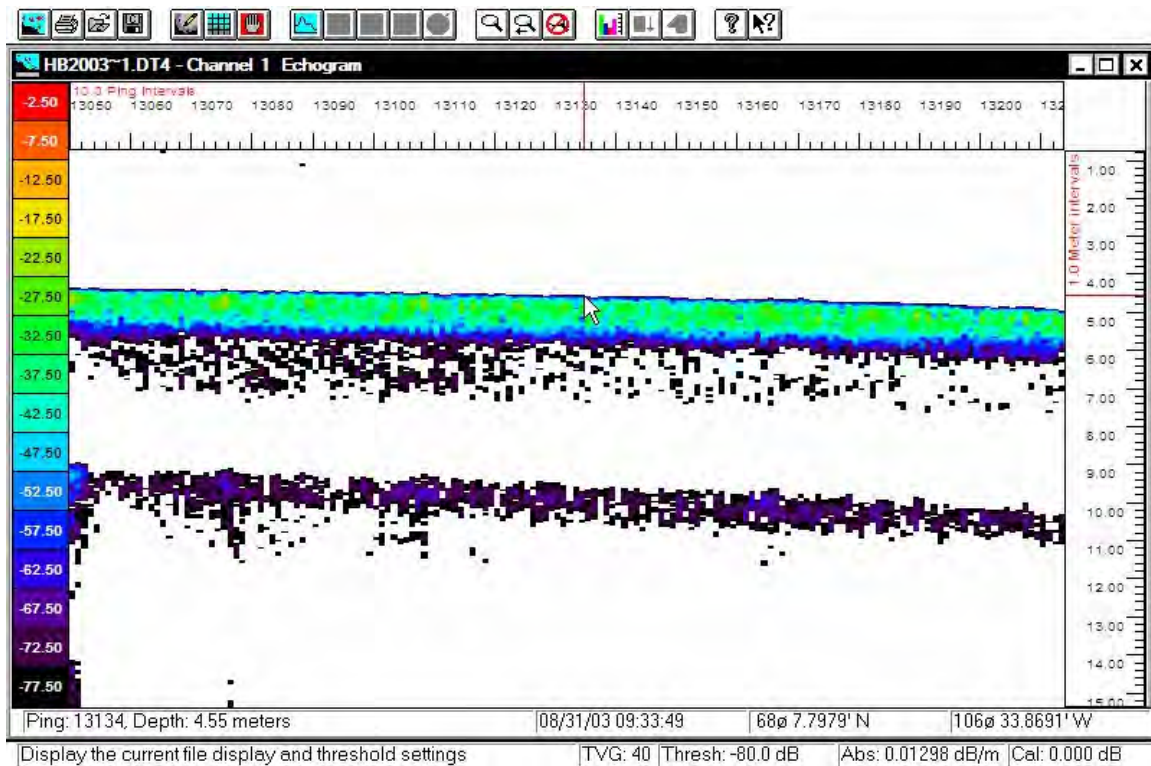
Figure 7 Example of silt substrate using a scientific hydroacoustic system.

To further support the nearshore water depth assumptions given above, Figures 7 to 10 illustrate the depth at which the substrate in Tail Lake transitions from large substrate (preferred fish habitat) to fine substrate (poor quality fish habitat). These data were collected during bathymetric surveys in Tail Lake during August 2003. The surveys were carried out using a BioSonics (Model DT-X) scientific hydroacoustic system. The system uses a digital split beam transducer and geo-references data points to provide real-time depth displays. The Global Positioning System (GPS) has decimeter accuracy. All data are stored directly to the computer hard disk. During the bathymetric survey of Tail Lake, 40 transects were run along the east-west axis and two transects were run across the entire length of Tail Lake along the north-south axis. An additional four transects were surveyed along the north-south axis in the deepest basin at the north end of the lake.

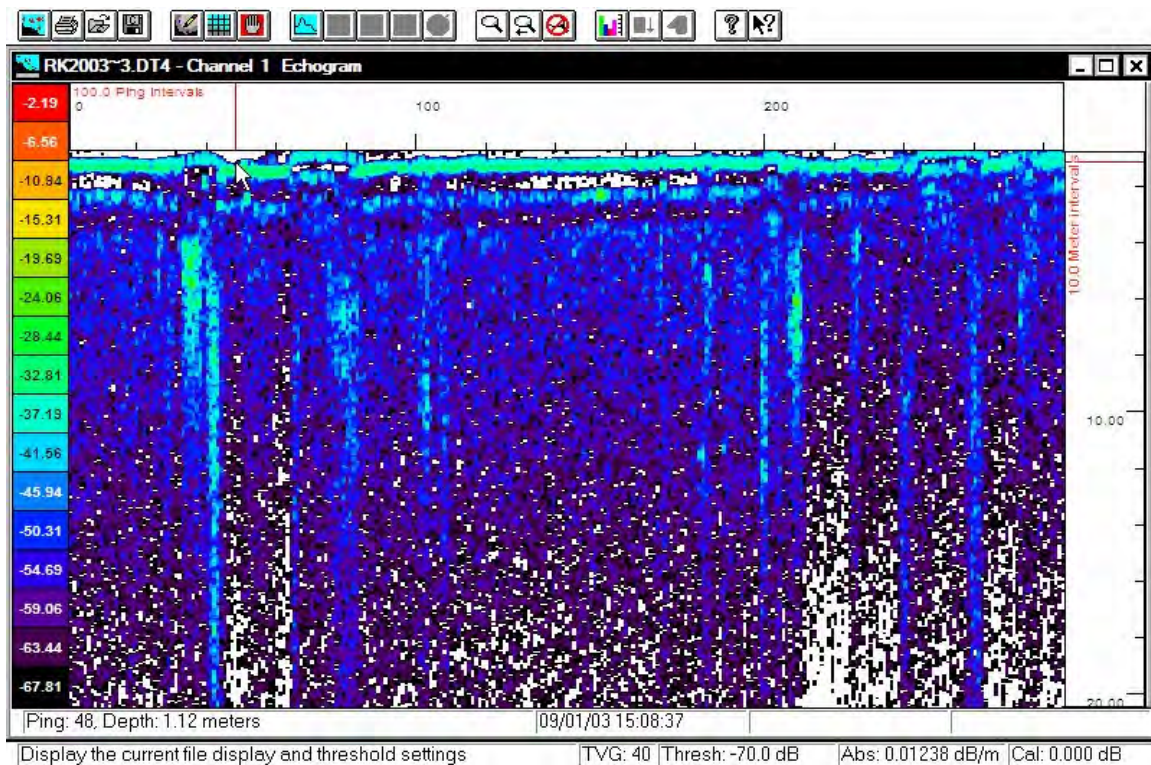
Figure 8 Example of rock substrate using a scientific hydroacoustic system.

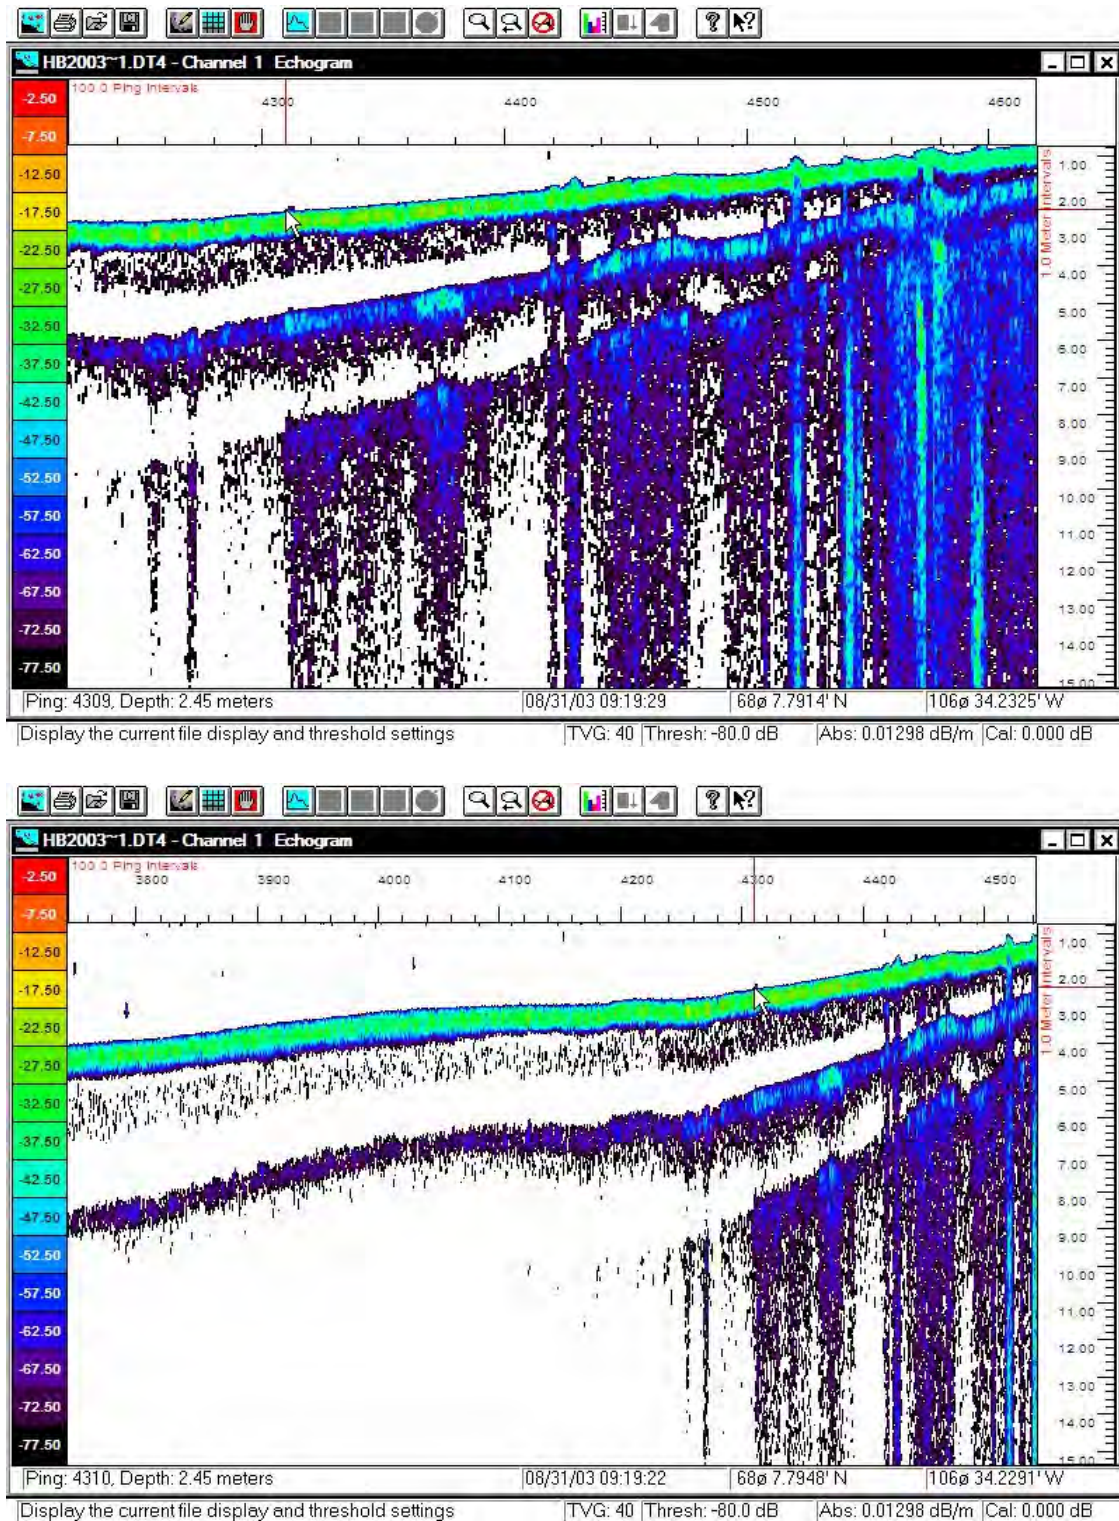
Figure 10 Lake bed images of the shoreline in the main basin of Tail Lake illustrating that the transition zone of large and fine substrate is at 2.5 m depth. Note: both frames are from the same location but the top frame is magnified closest to shore. The cursor references the same location in both frames.

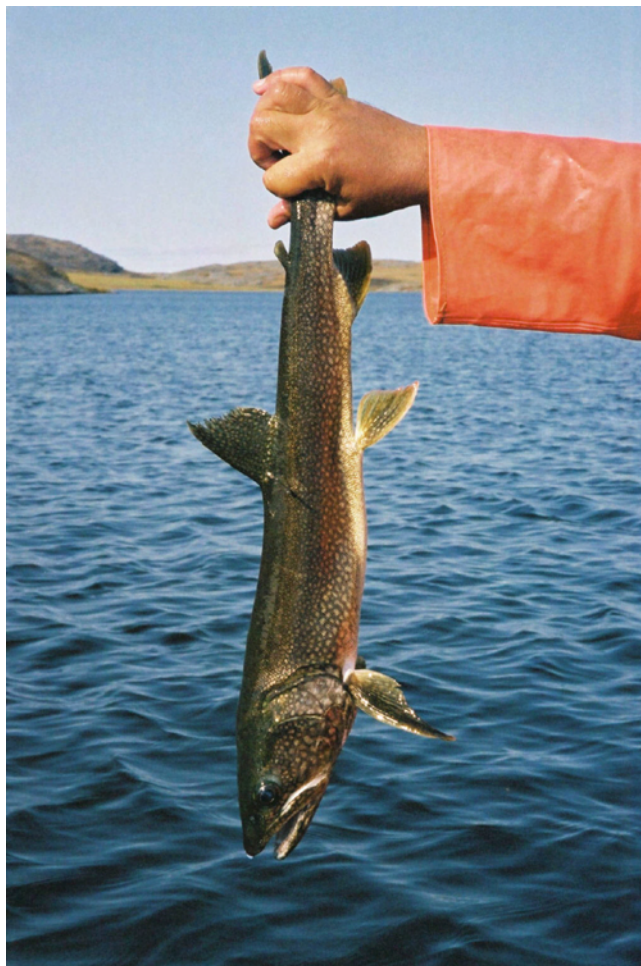
Figure 11 Lake trout captured in Tail Lake during 2003 illustrating the poor condition of fish in this lake.

estimate was derived based on the results of the Petersen index (2365 fish) and the mean weight of lake trout captured (1685 g/fish). The total biomass of lake trout in Tail Lake was estimated as 3986 kg. The lake trout in this lake did not grow to a large size (maximum length of 650 mm and weight of 2500 g) due to the poor forage base in the lake. No small lake trout were captured during the 2002 survey (the smallest fish was 436 mm fork length) indicating that recruitment of juveniles into the population is likely limited by predation of the young by the older lake trout. Most fish (79%) ranged in fork length between 520 and 650 mm. The lake trout of Tail Lake were in poor condition (Figure 11), based on Fulton's condition factor, with the mean condition factor for lake trout in Tail Lake being 0.95, and a range of 0.59 to 1.32. In comparison, the lake trout in Snap Lake region, in lakes with a diverse forage base for lake trout, had mean condition factors ranging from 1.01 to 1.52 (De Beers 2002).

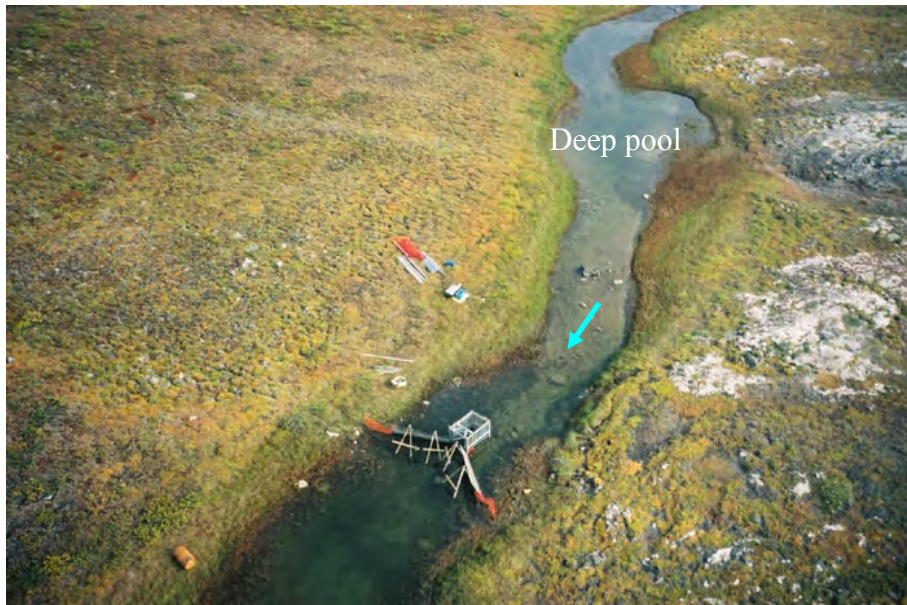
Plate 1 Roberts Outflow, 16 August 2002. Aerial view of fish trap. The deep pool provided a holding area for migrating Arctic char.

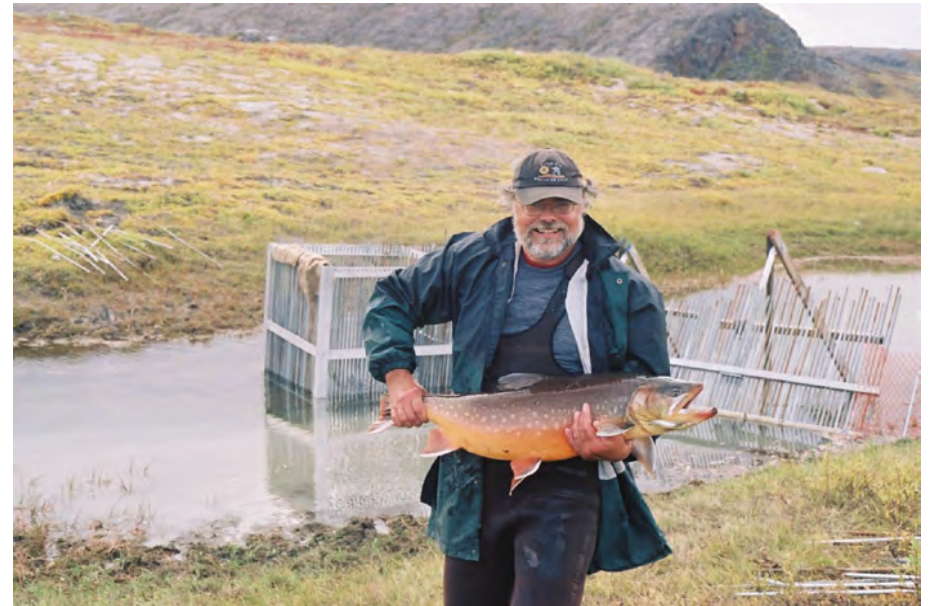
Plate 2 Roberts Outflow, 27 August 2002. Large male Arctic char (sample #457) in spawning colors captured at fence and released upstream.

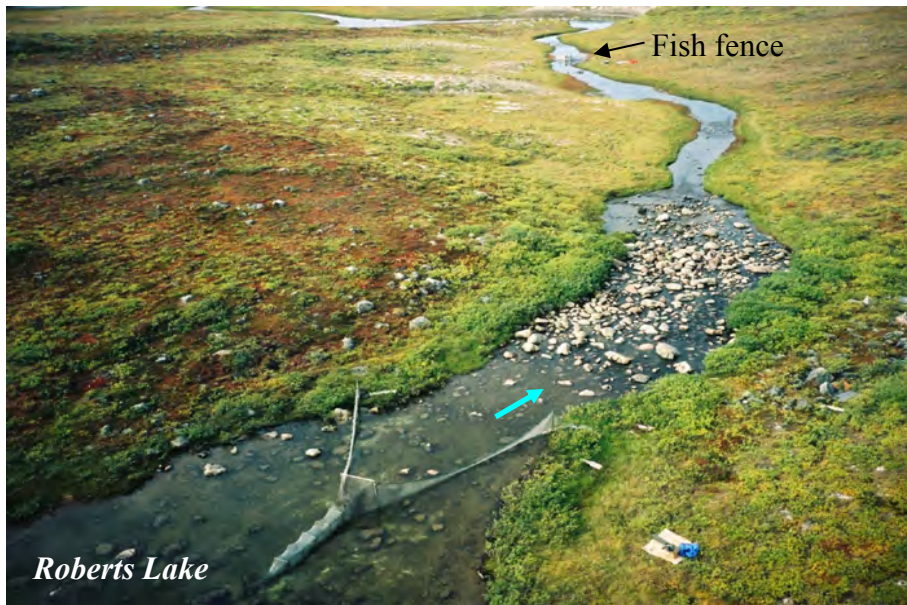
Plate 3 Aerial view of fyke net (FN1) set at upstream end of **Roberts Outflow** (Roberts Lake outlet). Note: Boulder garden, fish fence and trap downstream.

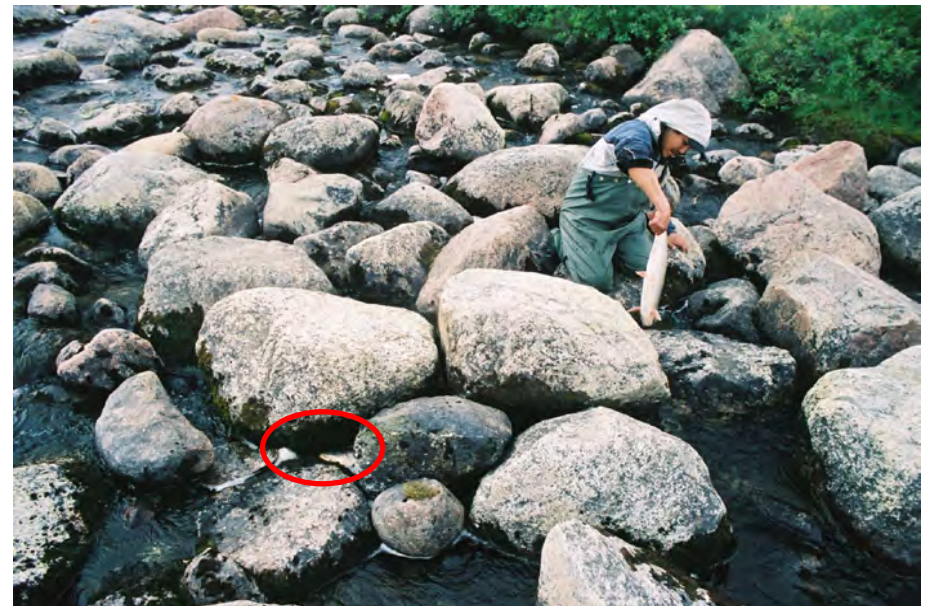
Plate 4 Roberts Outflow, 16 August 2002. Salvage operation of migrating Arctic char trapped between boulders immediately downstream of Roberts Lake.

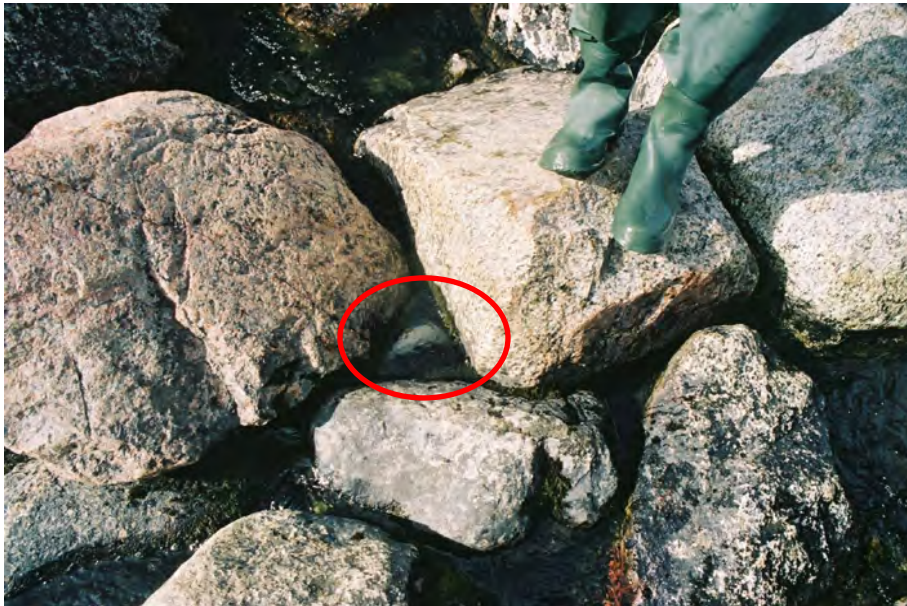
Plate 5 **Roberts Outflow, 16 August 2002.** Arctic char trapped in deep pocket between boulders immediately downstream of Roberts Lake.

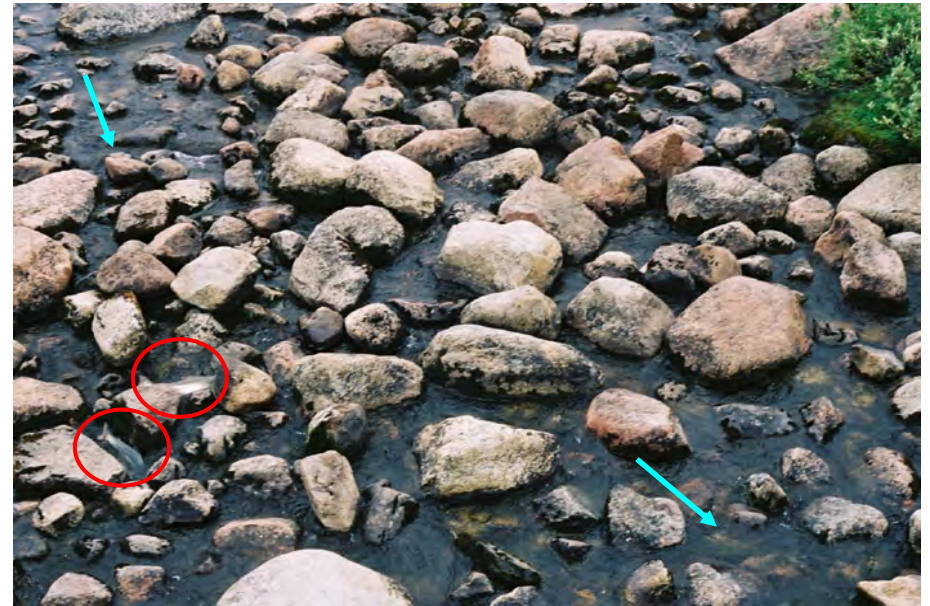
Plate 6 **Roberts Outflow, 16 August 2002.** Low level aerial view of Arctic char trapped in boulder garden stranding zone.

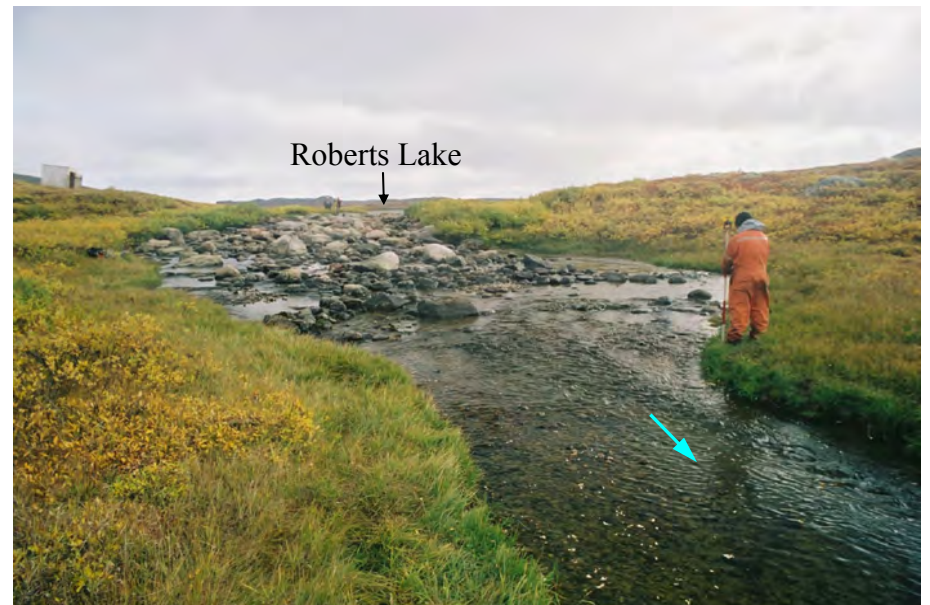
Plate 8 **Roberts Outflow, 1 September 2002.** Survey measurement of boulder garden to determine stream gradient.

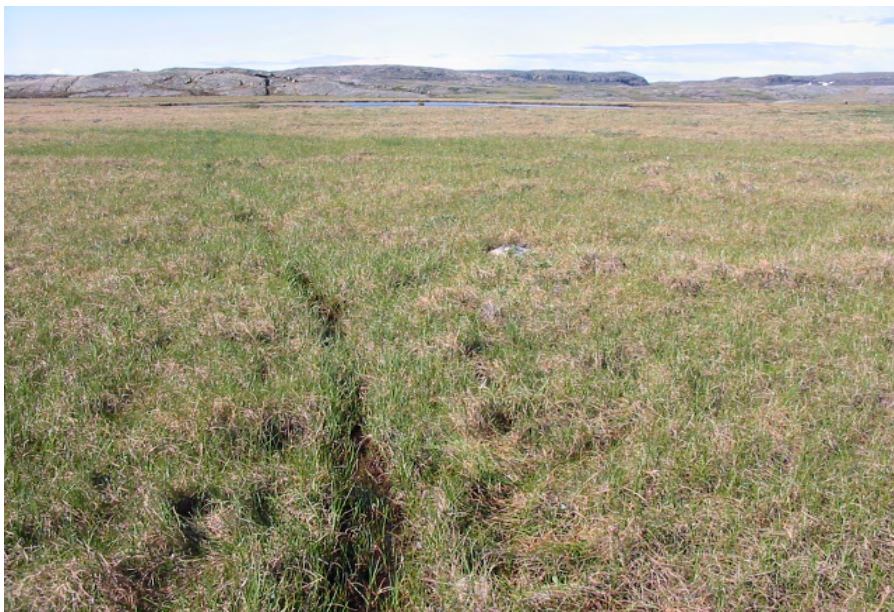
Plate B1. *21 July 2004.* Downstream view of Stream Crossing #1. Channel was 20-30 cm wide and dry.

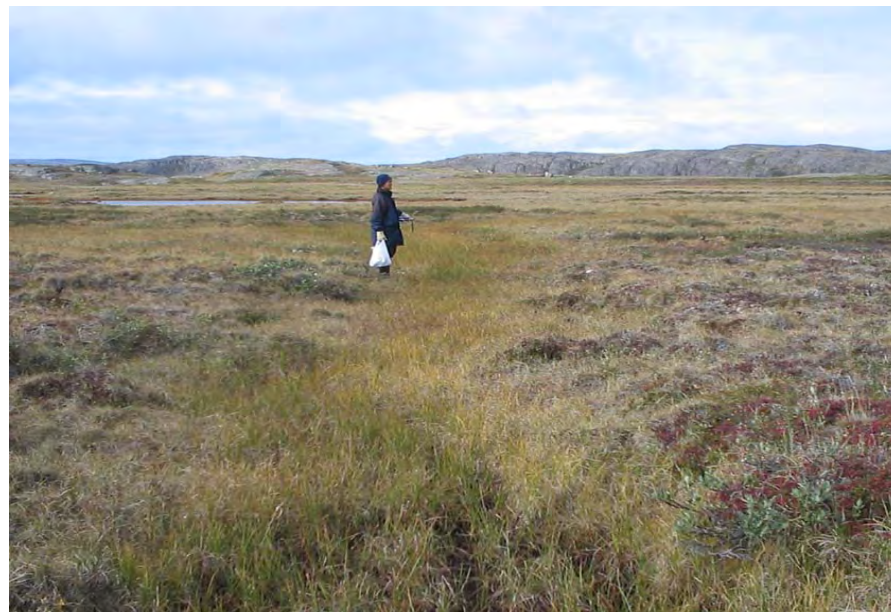
Plate B2. *24 August 2004.* Downstream view of Stream Crossing #1 from east side of proposed road. Stream channel was dry.

In total, there are nine watercourse locations identified along the Main Road and the Tailings Service Road that will require rock drains (Figure 5). Representative photos of each of the crossings were taken during the 2004 field season (Appendix B). All streams with proposed crossings have narrow channels and are shallow; they are approximately 20 to 30 cm wide and approximately 5 to 10 cm deep (when water was present). Most of the streams did not have flowing water in July or August. Similarly, the three runoff drainages crossed by the ventilation service raise road are also ephemeral drainages (see photos B19 to B21 in Appendix B).

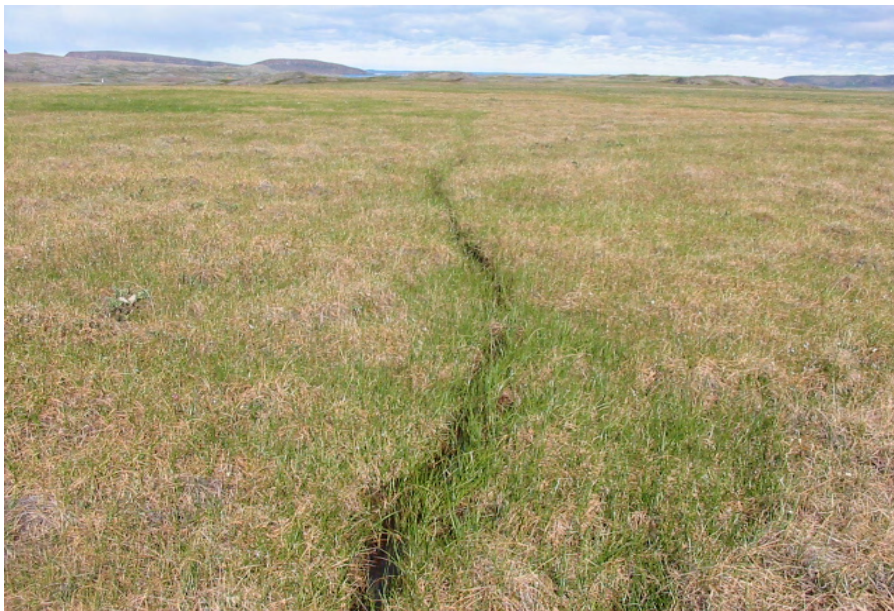
Plate B3. *21 July 2004.* Downstream view of Stream Crossing #2. Channel was approximately 20 cm wide and 10 cm deep, with flowing water present.

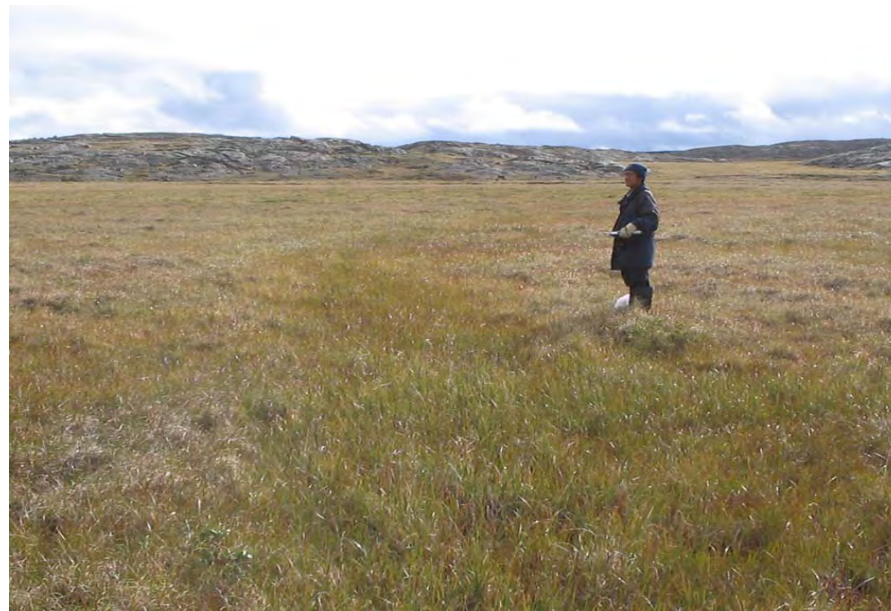
Plate B4. *24 August 2004.* Upstream view of Stream Crossing #2 from west side of proposed road. Channel was dry.

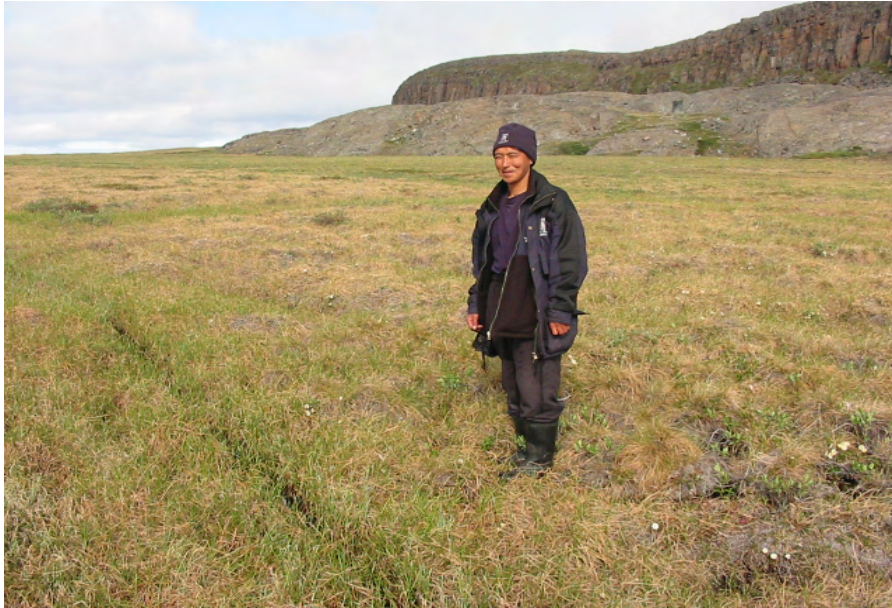
Plate B5. 20 July 2004. Upstream view of Stream Crossing #3. Channel was approximately 20 cm wide and 5 cm deep.

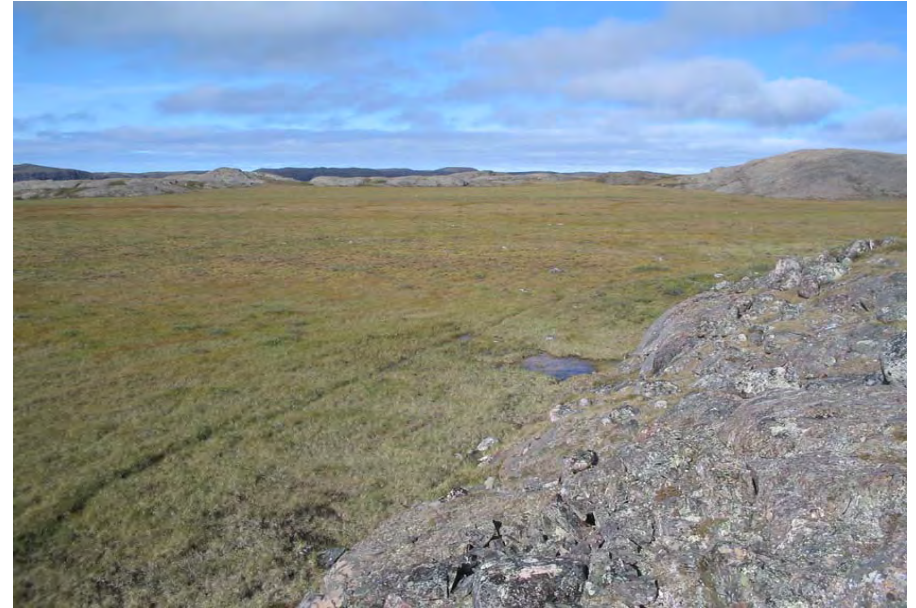
Plate B6. 24 August 2004. Downstream view of Stream Crossing #3.

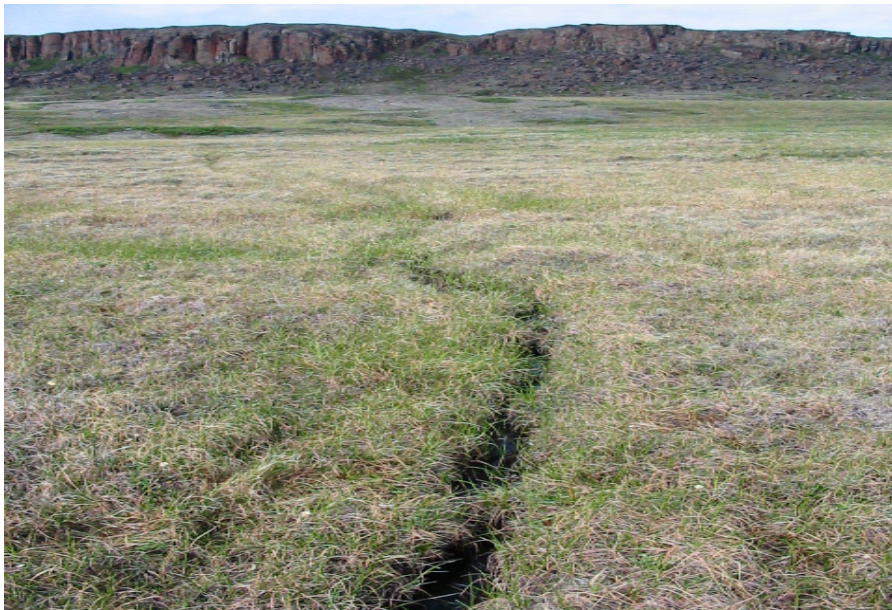
Plate B7. 20 July 2004. Upstream view of Stream Crossing #4. Channel was approximately 20 cm wide and 10 cm deep and had stagnant water.

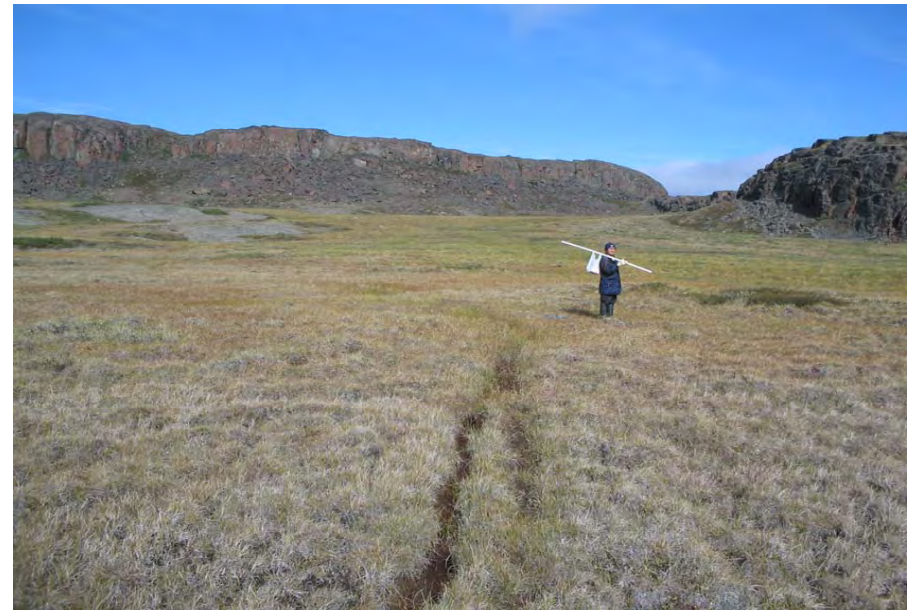
Plate B8. 24 August 2004. Upstream view of Stream Crossing #4.

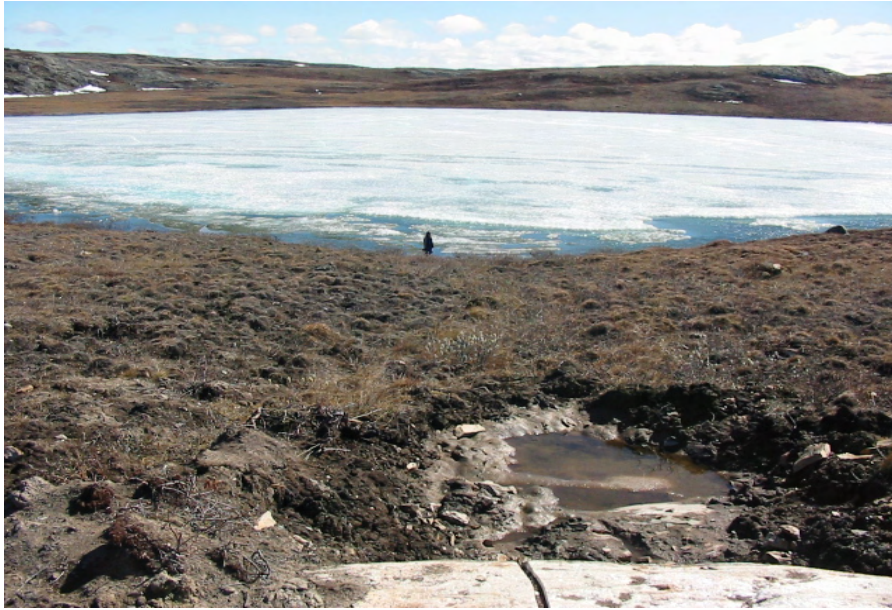
Plate B9. 21 June 2004. Downstream view of Stream Crossing #5. The majority of the channel was dry in both June and July.

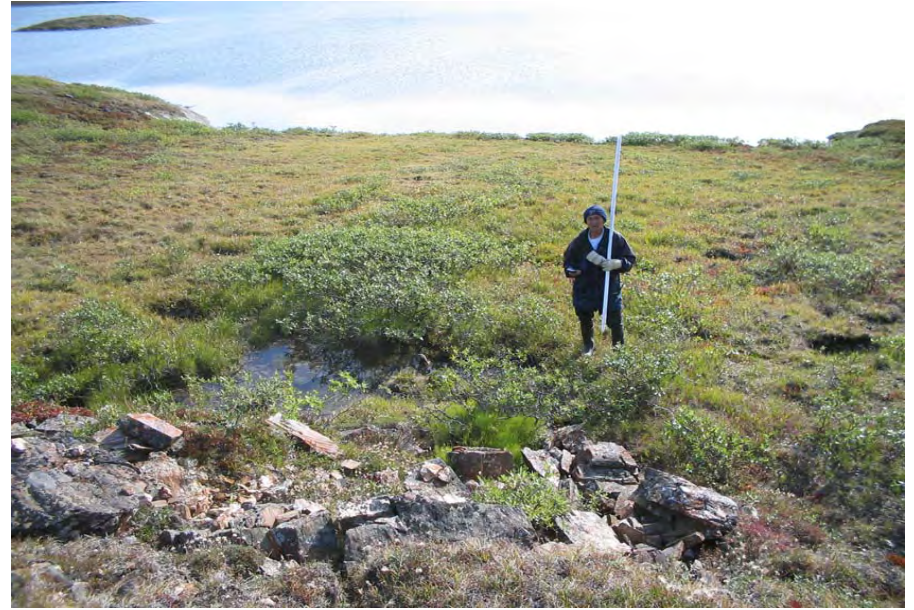
Plate B10. 24 August 2004. Downstream view of Stream Crossing #5. The majority of the channel was dry.

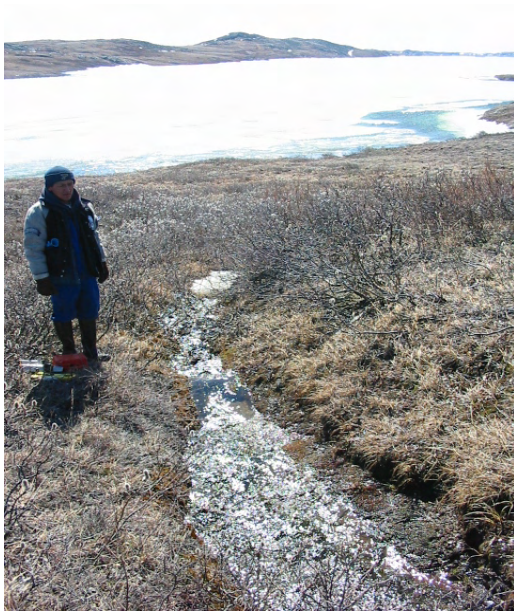
Plate B11. 21 June 2004. Downstream view of Stream Crossing #6. The channel had flowing water in June, but was dry in July and August.

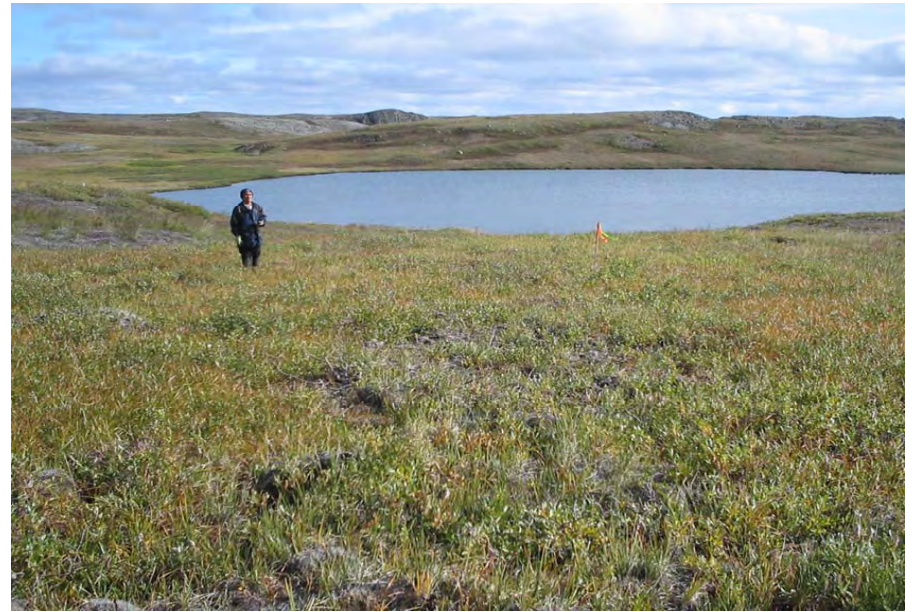
Plate B12. 24 August 2004. Downstream view of Stream Crossing #6. Channel was dry.

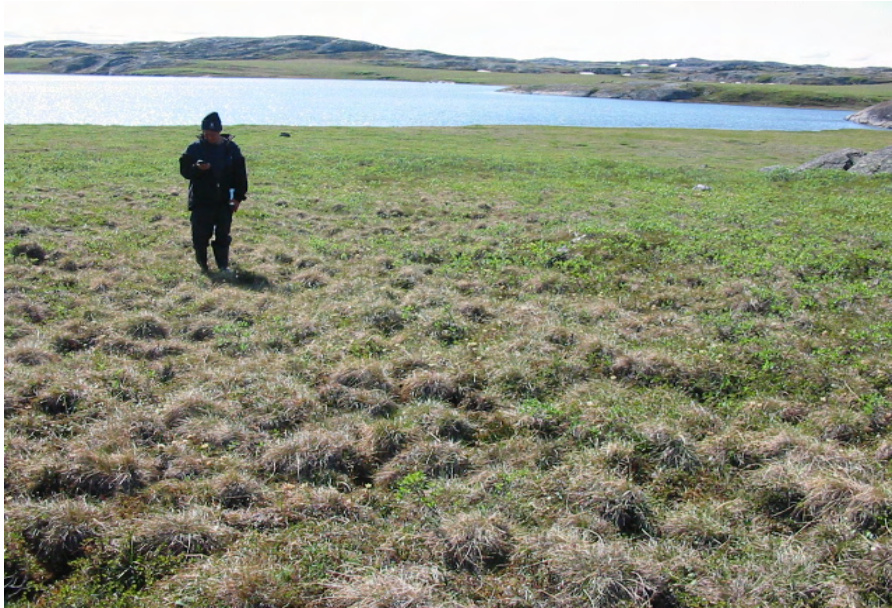
Plate B13. *21 July 2004.* Downstream view of Stream Crossing #7. There was no defined channel and no flowing water in either June or July.

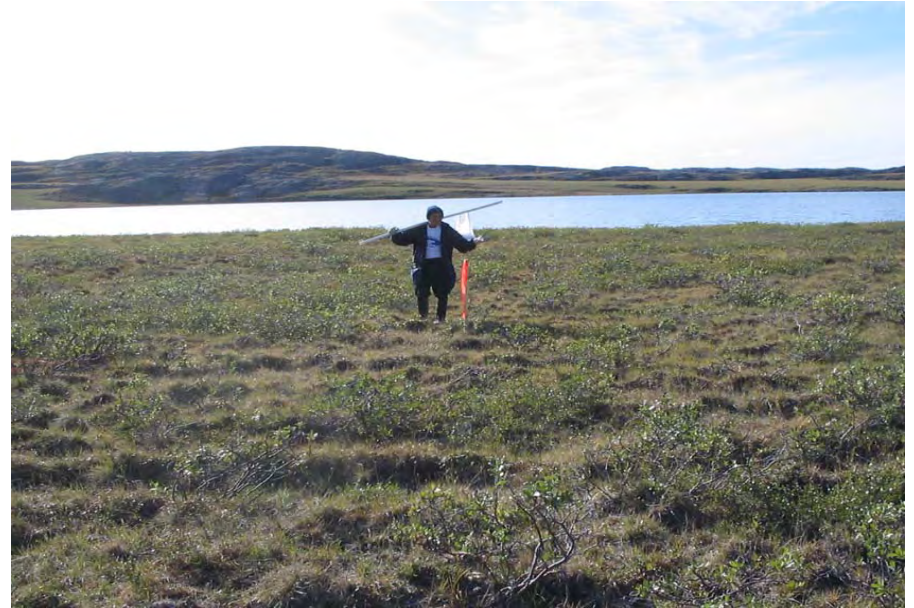
Plate B14. *24 August 2004.* Downstream view of Stream Crossing #7. There was no defined channel and no flowing water.

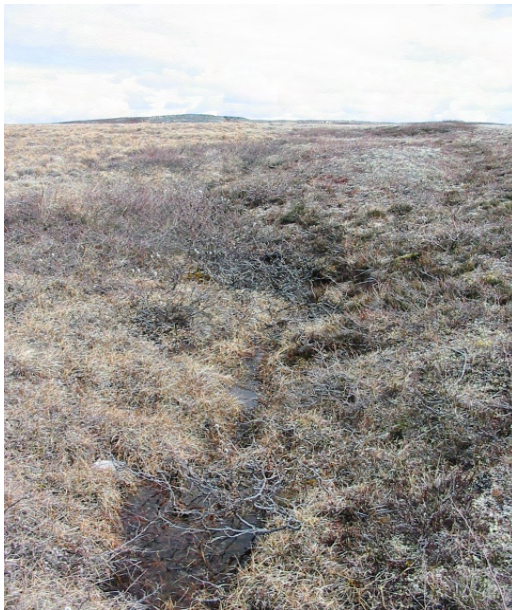
Plate B15. *21 June 2004.* Upstream view of Stream Crossing #8. Flowing water was present in the channel during June, but dry in July and August.

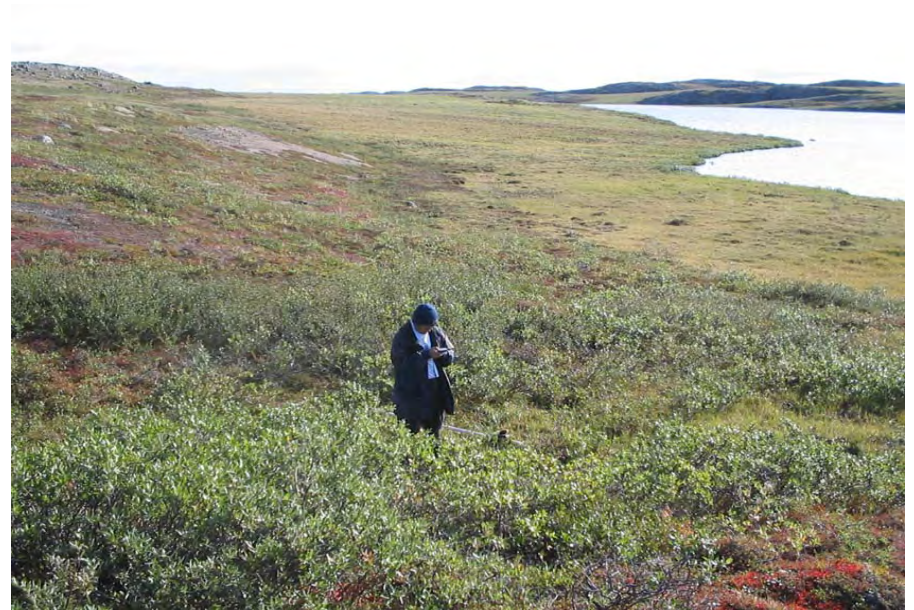
Plate B16. *24 August 2004.* Downstream view of Stream Crossing #8. The stream channel was dry.

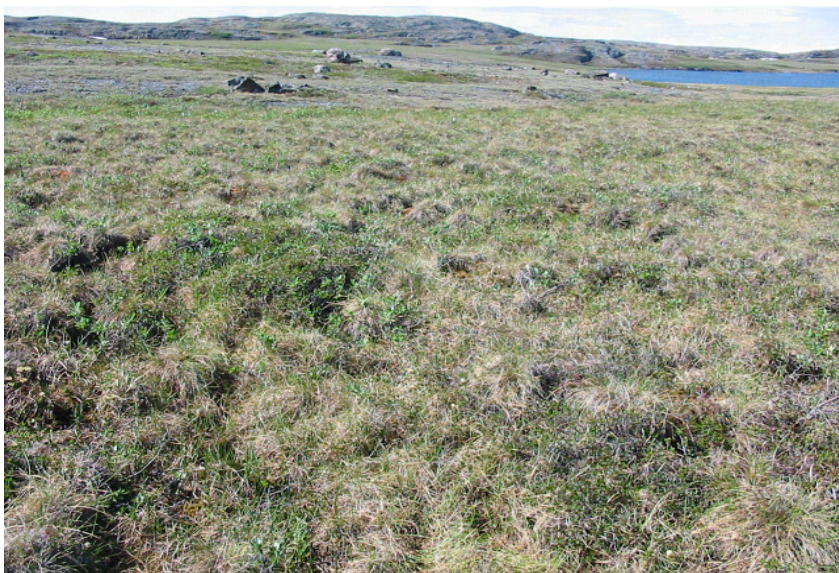
Plate B17. *21 July 2004.* Downstream view of Stream Crossing #9. Stream channel was undefined and dry.

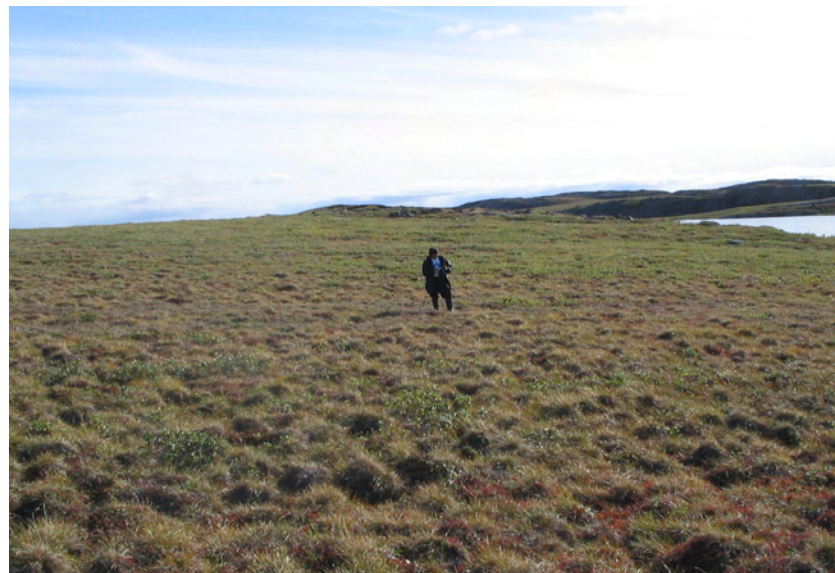
Plate B18. *24 August 2004.* South view over Stream Crossing #9. Channel was dry.

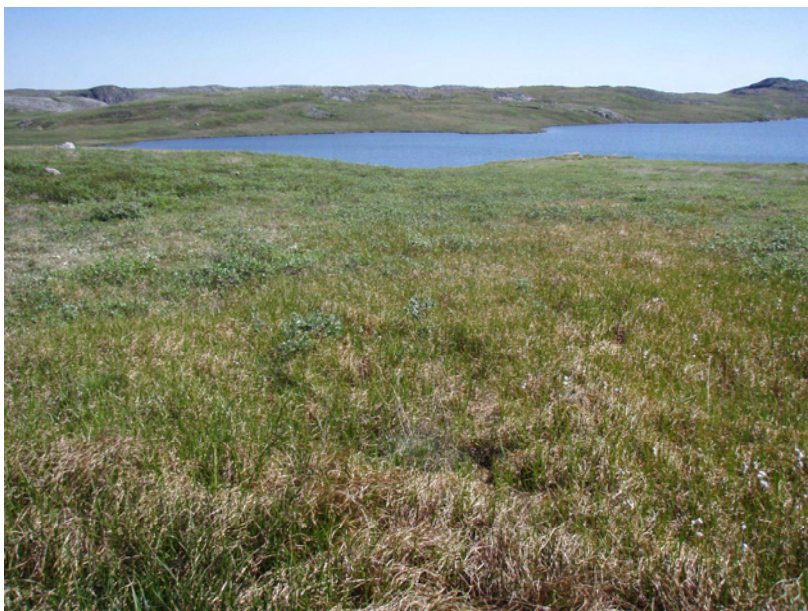
Plate B19. *13 July 2007.* Downstream view of vent raise access road watercourse crossing #1 at UTM 433703 m E, 7559310 m N. The watercourse was a vegetated swale with no flowing water.

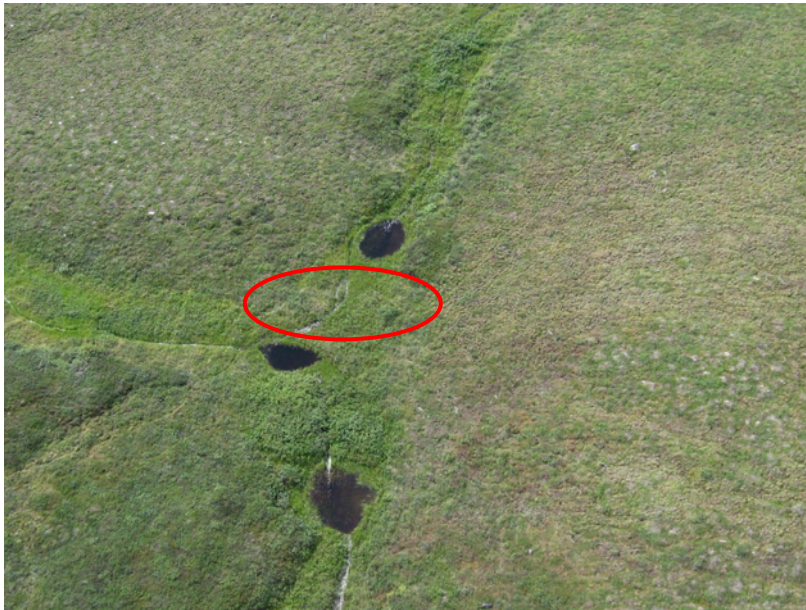
Plate 1 Stream E09, August 2007. Upstream view of confluence of Stream E09 and Stream E10. Compensation area is highlighted.

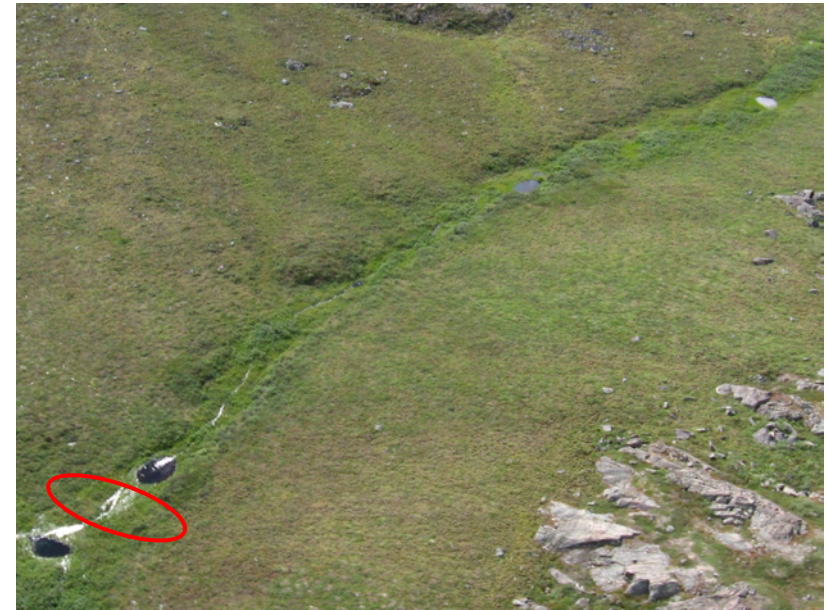
Plate 2 Stream E09, August 2007. Upstream view of the Stream E09.
