DORIS NORTH PROJECT “NO NET LOSS” PLAN

**- REVISION 6 -
September 2007**

Prepared For:

Miramar Hope Bay Ltd.

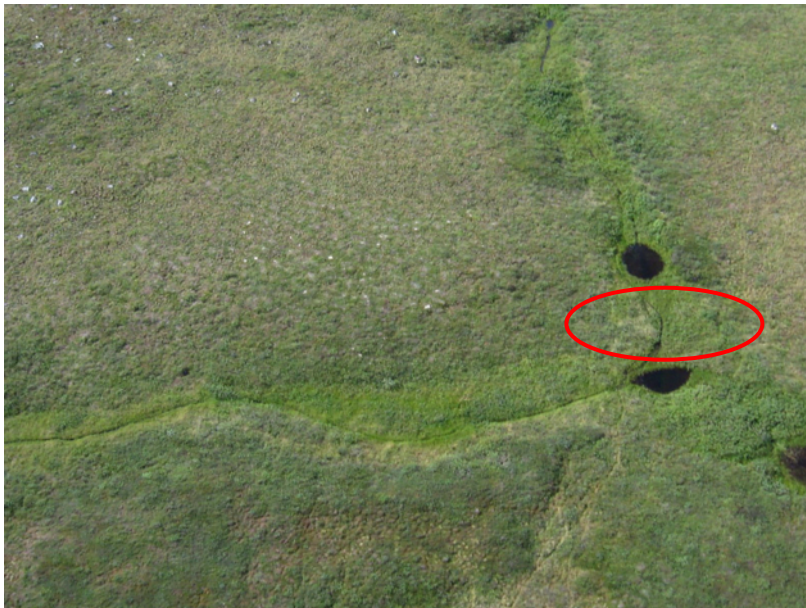
Plate 3 Stream E09, August 2007. Stream E10 southeast of confluence.

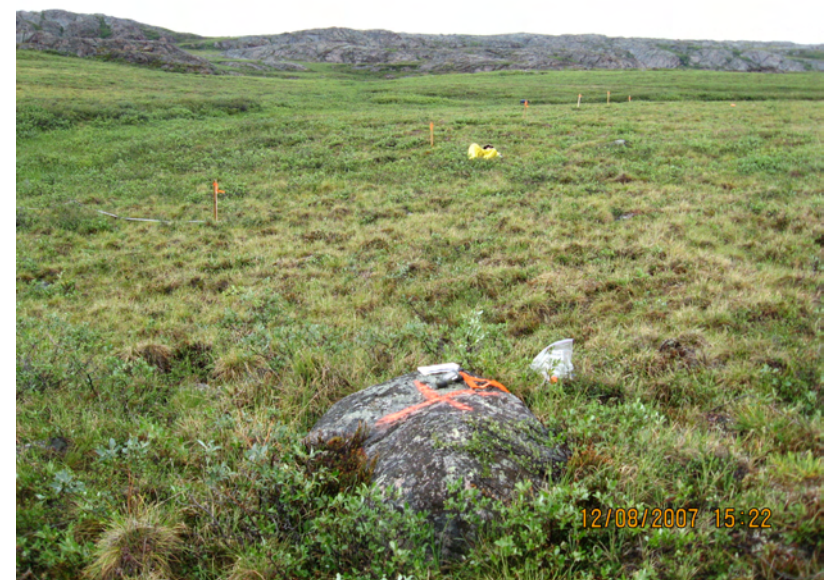
Plate 4 Stream E09, August 2007. Ground view from southwest towards confluence of streams

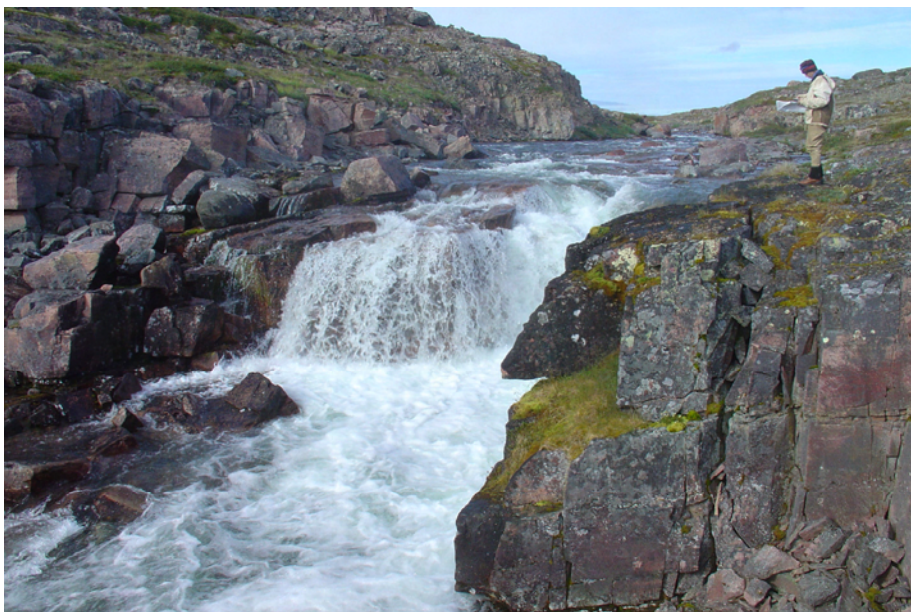
Plate 1 Site 1, *August 2004*. UTM 13 W 0406635E 7551813N. Upstream view of the waterfall.

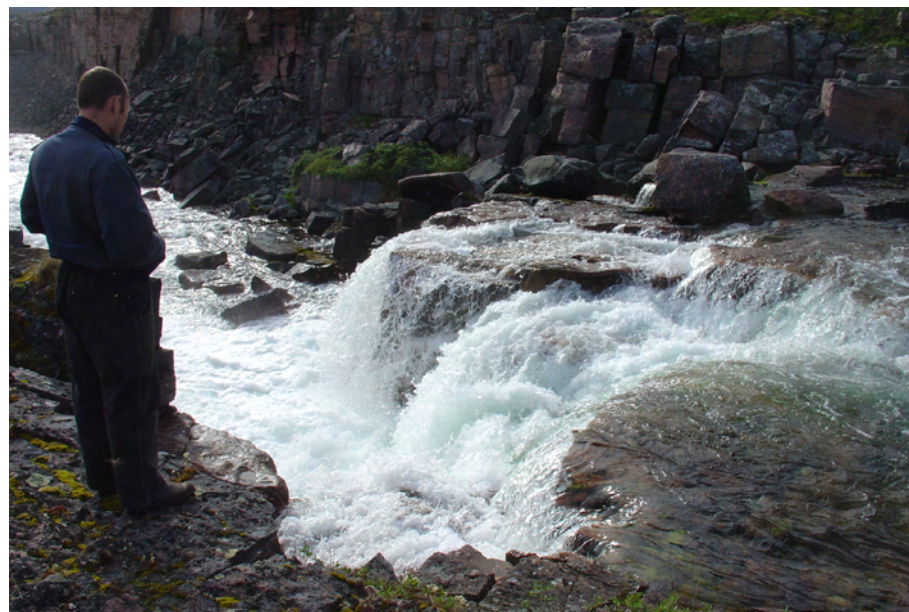
Plate 2 Site 1, *August 2004*. Downstream view of the waterfall.

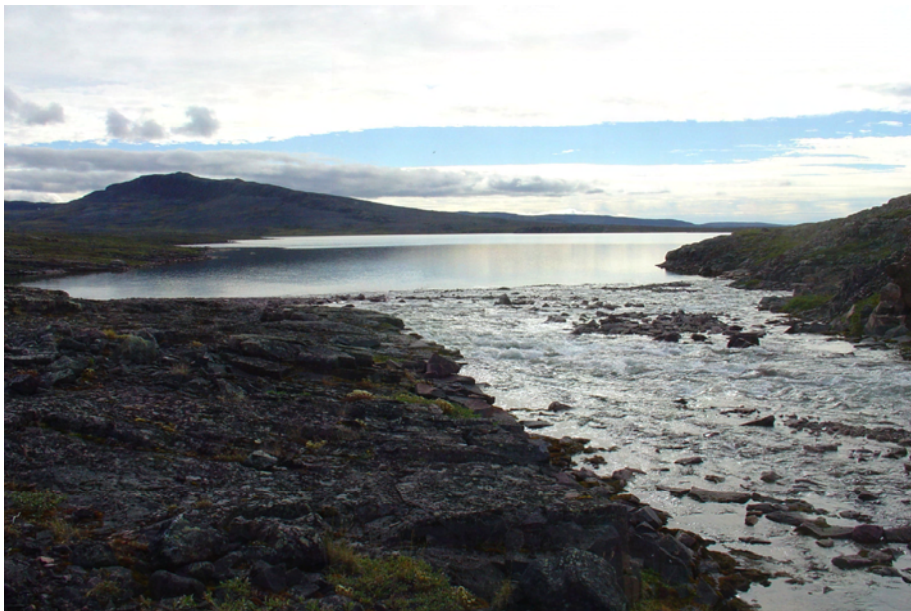
Plate 3 Site 1, *August 2004*. Upstream view above the waterfall.

Site 1 has a waterfall that is approximately 2 to 2.2 m in height (Appendix F, Plates 1 to 3). This waterfall is located between two lakes; the distance between the lakes is

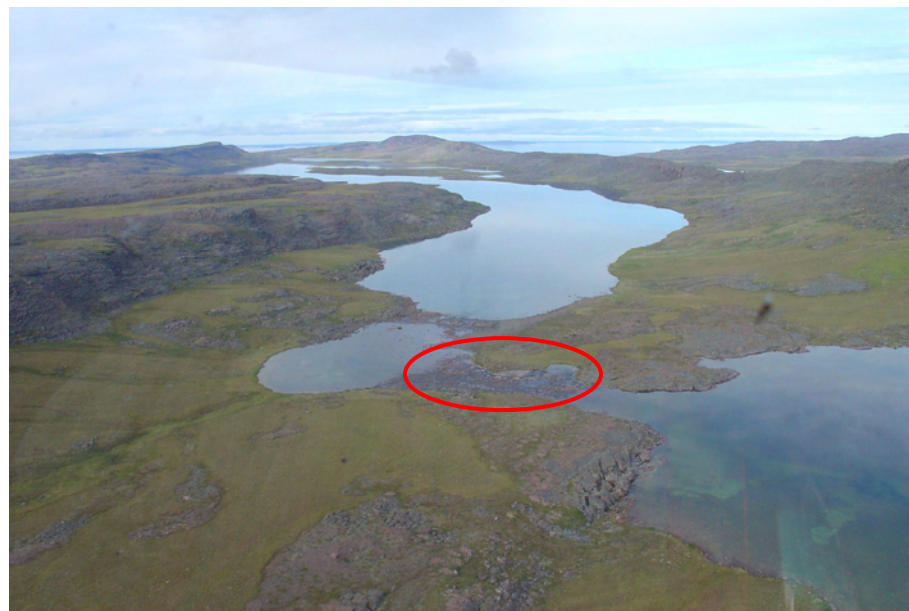
Plate 4 Site 1b, *August 2004*. Boulder garden area flowing into the lake upstream of the Site 1.

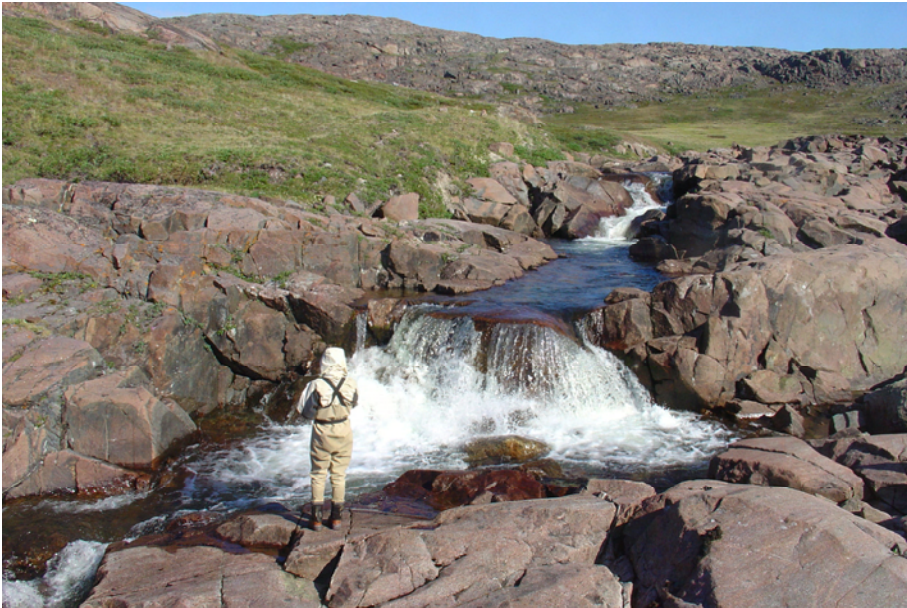
Plate 5 Site 2, August 2004. UTM 13 W 0420258E 7554046N. Upstream view of waterfall. This waterfall is a barrier to fish passage. The cascade in the background is not a fish barrier.

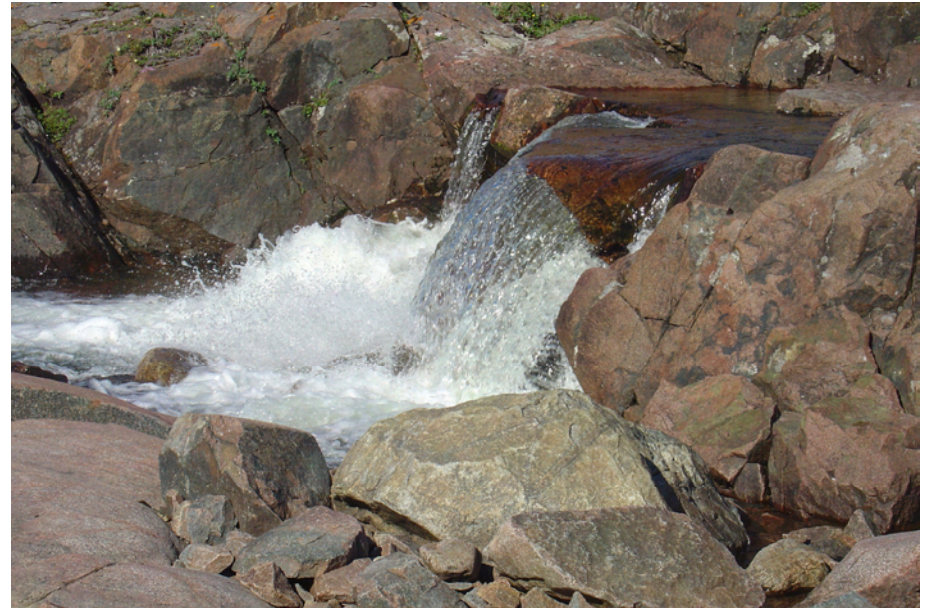
Plate 6 Site 2, August 2004. Side view of waterfall.

A waterfall and a cascade are present at Site 2 (Appendix F, Plates 5 to 8). The waterfall is approximately 1.5 m in height and is a barrier to fish passage. The cascade is not a fish barrier. During the field survey, wildlife were sighted feeding on fish at a pool below the waterfall (Appendix F, Plate 8 indicates the location of the pool).

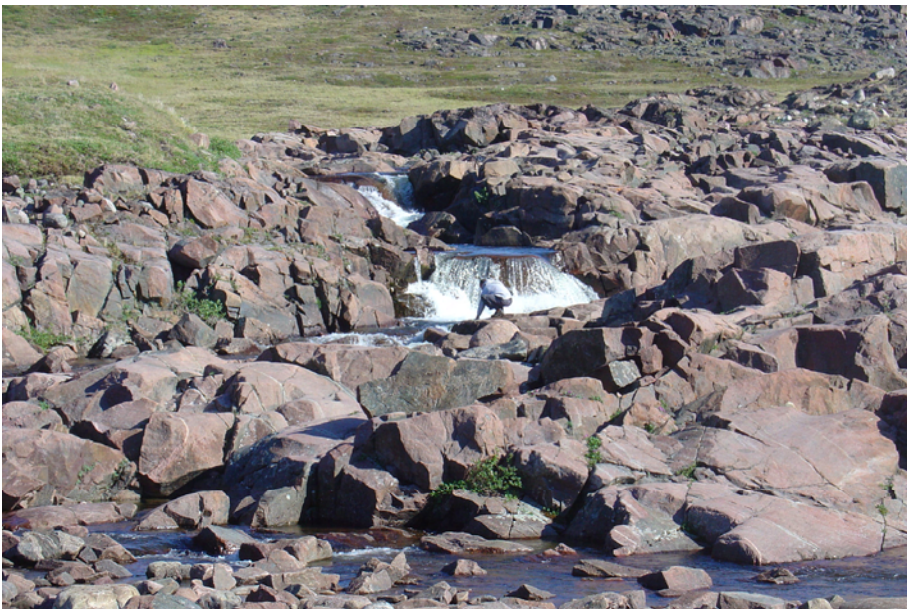
Plate 7 Site 2, August 2004. Upstream view of waterfall, which is a barrier to fish passage. Note the cascade in the background.
