Re: TMAC Response to INAC Inspection Report October 10-11, 2017

TMAC Resources Inc. (TMAC) is providing this letter in response to action items identified in the Inspection Report provided by Indigenous and Northern Affairs Canada (INAC) on October 10-11, 2017. Action items and TMAC response are detailed below:

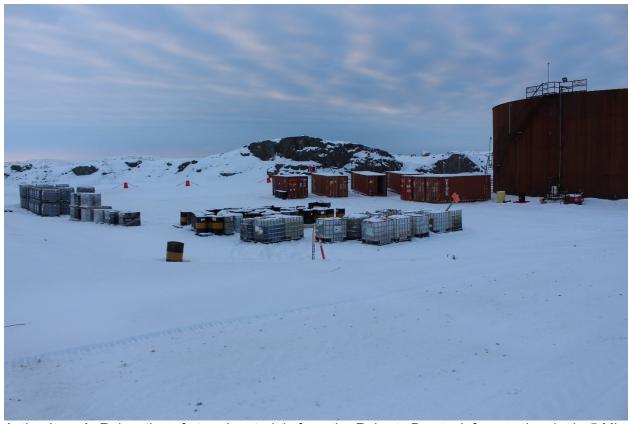
Action Item A: Relocation of stored materials from the Roberts Bay tank farm to the single-5 ML tank farm has begun.

TMAC Response: Products that had been stored in the Roberts Bay tank farm will be relocated to the single-5 million L tank farm berm for temporary storage. Before the 5 million L tank is placed back into fuel storage service a separate lined berm area will be constructed for the purpose of storing totes and drums of new hydrocarbon products to be used at site and waste products destined for backhaul. Images provided below for more detail.

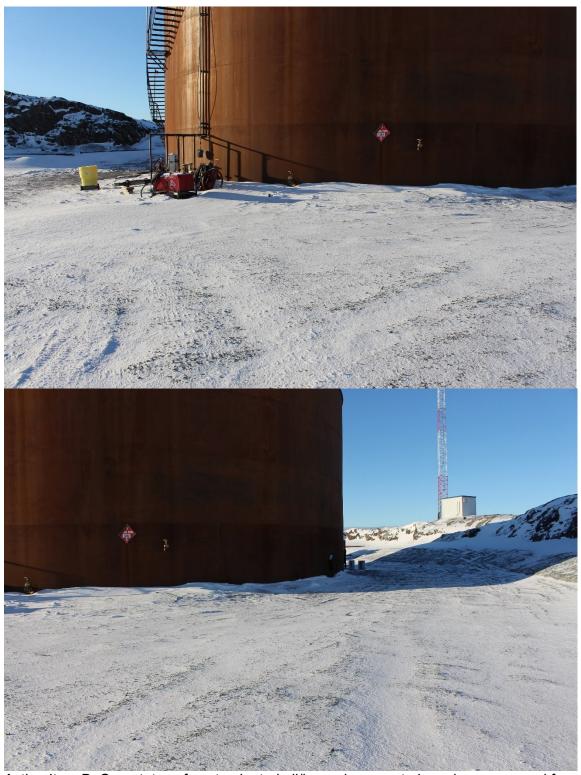
Action Item B: Open totes of contaminated oil/hazardous waste have been removed from single-5 ML tank farm berm.

TMAC Response: The contents of the open totes of contaminated oil/hazardous waste will be transferred to containers that will be sealed as per TMAC's Hazardous Waste Management Plan (HWMP). The open totes have been relocated to a lined Quonset building in Roberts Bay to allow Waste Management personnel to transfer this material to appropriate containers which will be securely closed.

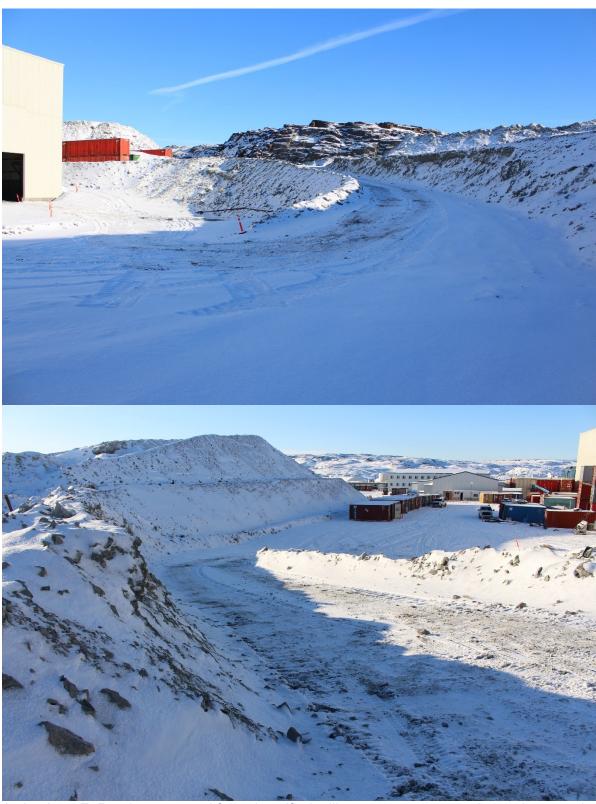
Action Item E: Road constructed from detoxified tailings management pad to underground portal.

TMAC Response: A road has been constructed from the mill pad directly to the portal for the purpose of transporting detoxified tailings to the underground workings. Underground haul trucks carrying detoxified tailings will use this road to travel from the detoxified tailings collection pad on the south side of the mill to the portal. This route will ensure that this material does not leave the pollution control management area. Images of the completed roadway are provided below.
