# **DORIS NORTH PROJECT “NO NET LOSS” PLAN**

**- REVISION 6 -  
December 2007**

**FINAL REPORT**

**Miramar Hope Bay Ltd.**

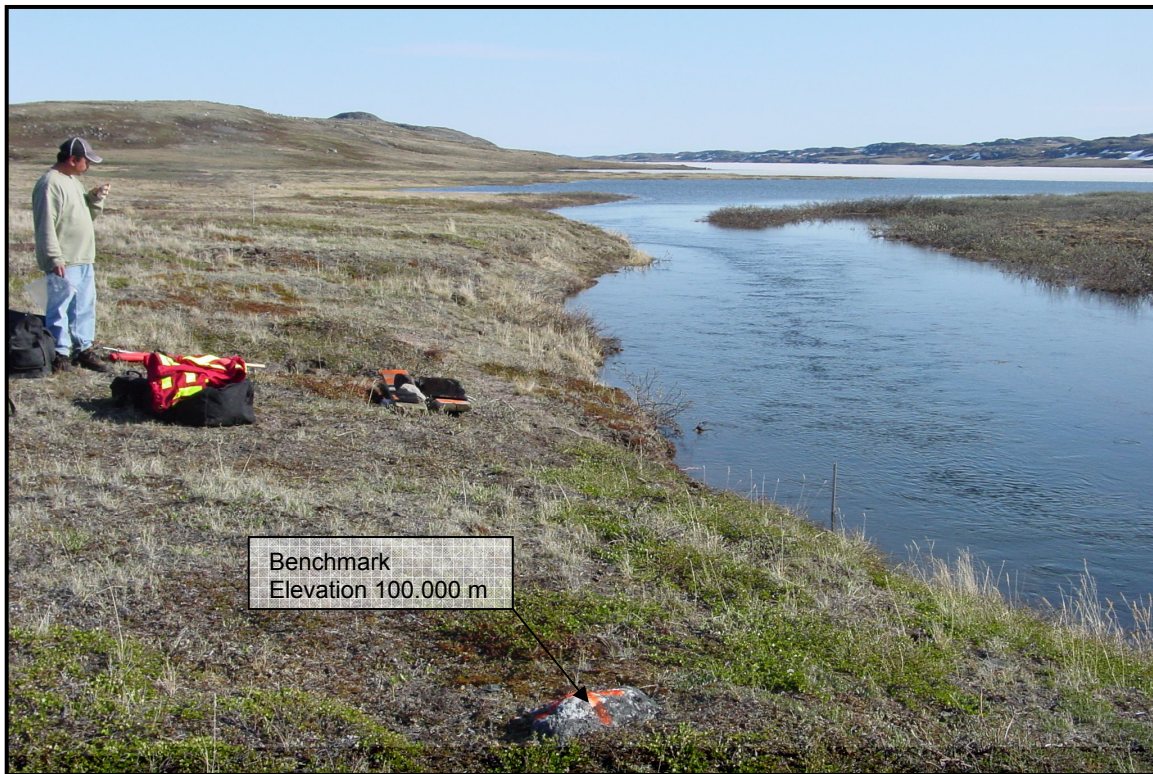
**Figure 1** Doris Lake outlet gauging station, looking south (upstream) from right downstream bank.

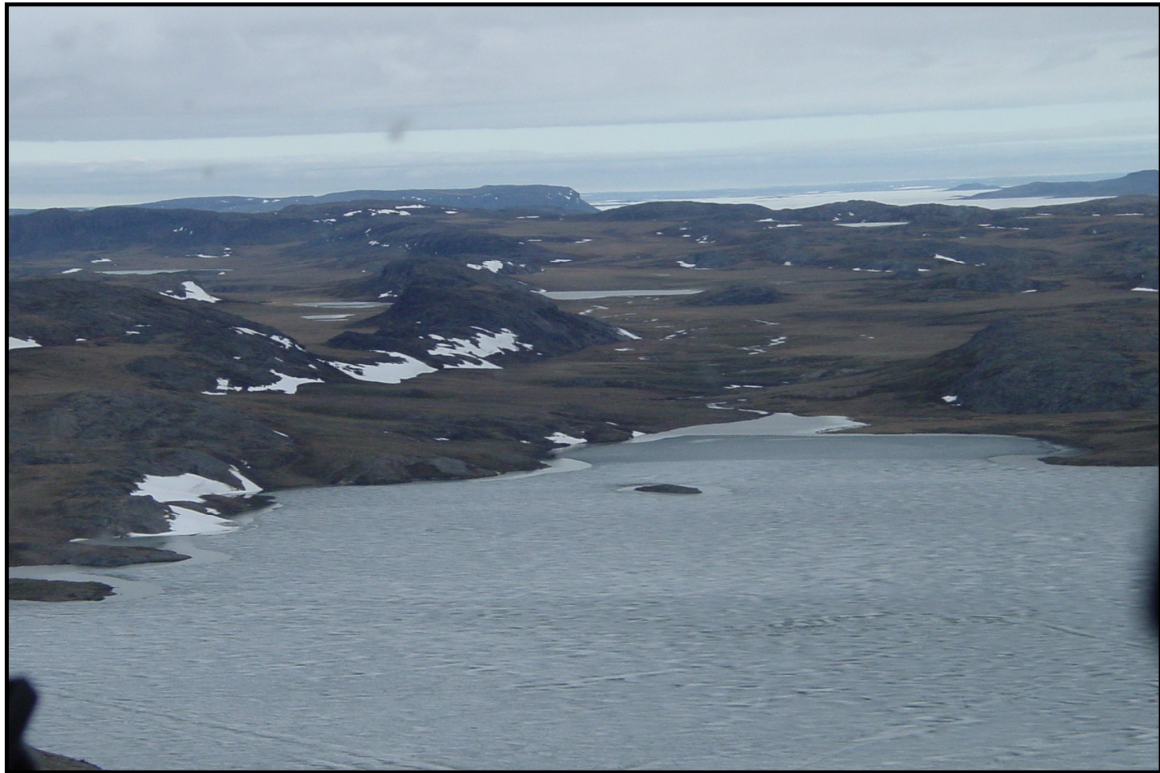
**Figure 3** Aerial view of Doris Lake outlet gauging station, looking north (downstream).

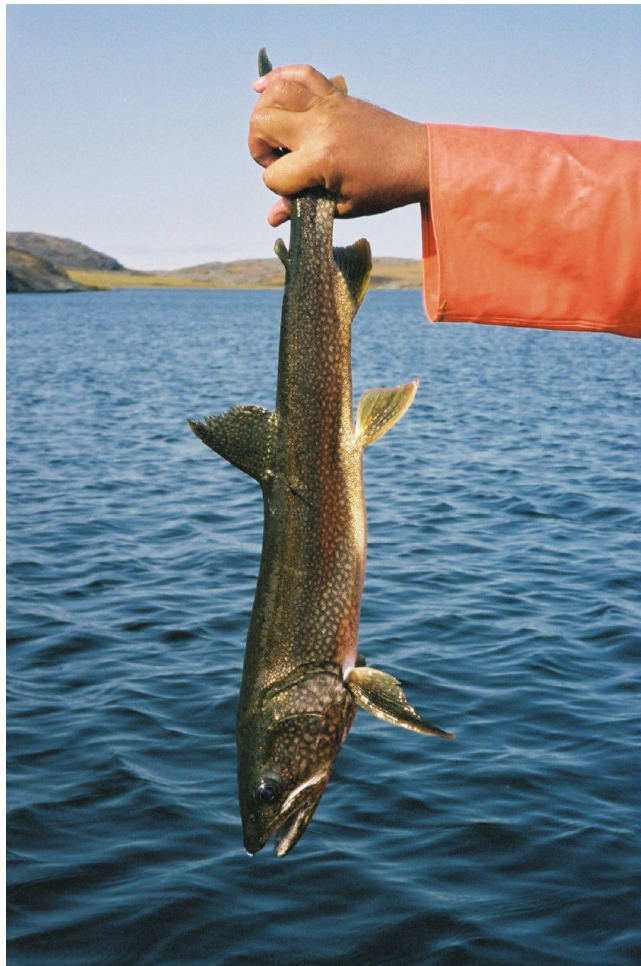
**Figure 11** Lake trout captured in Tail Lake during 2003 illustrating the poor condition of fish in this lake.

estimate was derived based on the results of the Petersen index (2365 fish) and the mean weight of lake trout captured (1685 g/fish). The total biomass of lake trout in Tail Lake was estimated as 3986 kg. The lake trout in this lake did not grow to a large size (maximum length of 650 mm and weight of 2500 g) due to the poor forage base in the lake. No small lake trout were captured during the 2002 survey (the smallest fish was 436 mm fork length) indicating that recruitment of juveniles into the population is likely limited by predation of the young by the older lake trout. Most fish (79%) ranged in fork length between 520 and 650 mm. The lake trout of Tail Lake were in poor condition (Figure 11), based on Fulton's condition factor, with the mean condition factor for lake trout in Tail Lake being 0.95, and a range of 0.59 to 1.32. In comparison, the lake trout in Snap Lake region, in lakes with a diverse forage base for lake trout, had mean condition factors ranging from 1.01 to 1.52 (De Beers 2002).

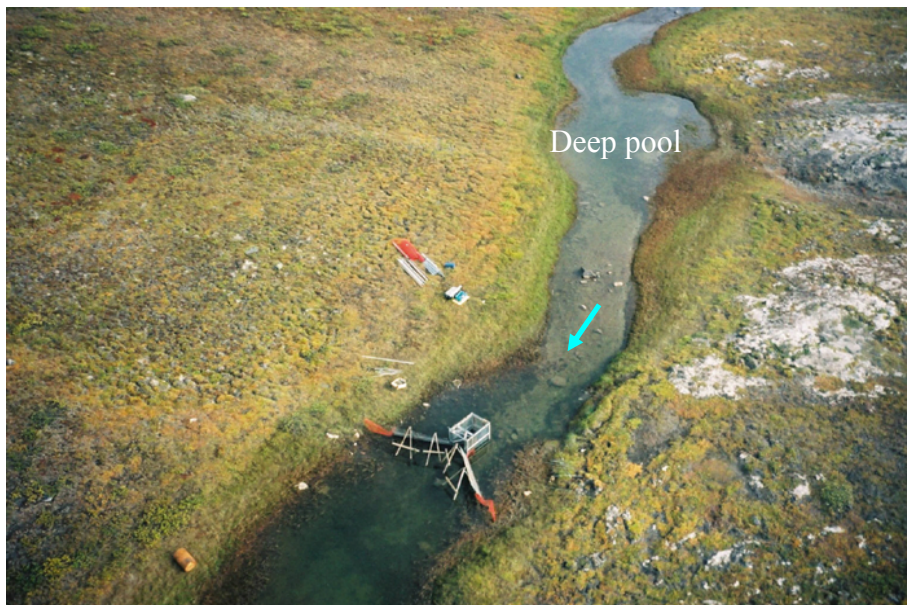
**Plate 1 Roberts Outflow, 16 August 2002.** Aerial view of fish trap. The deep pool provided a holding area for migrating Arctic char.

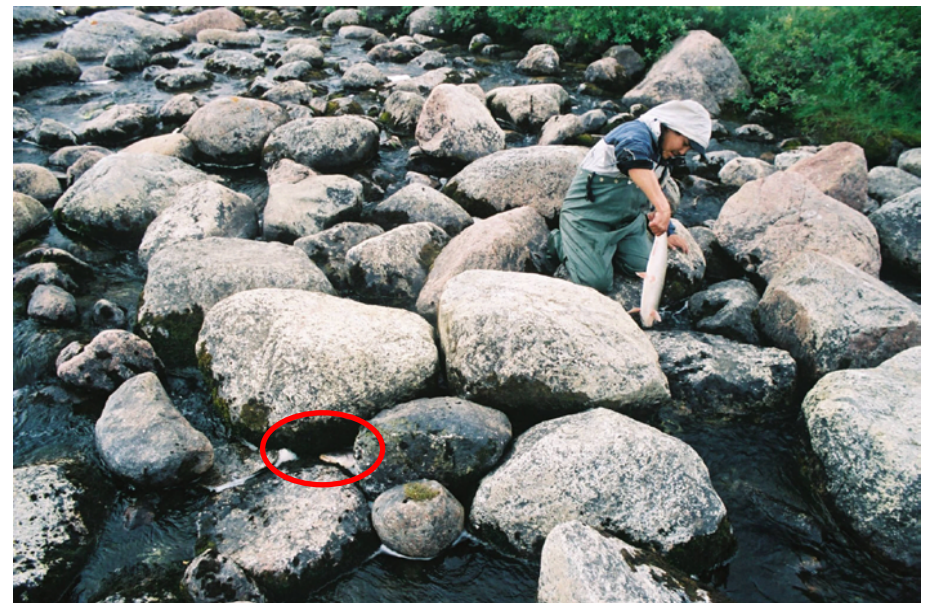
**Plate 4 Roberts Outflow, 16 August 2002.** Salvage operation of migrating Arctic char trapped between boulders immediately downstream of Roberts Lake.

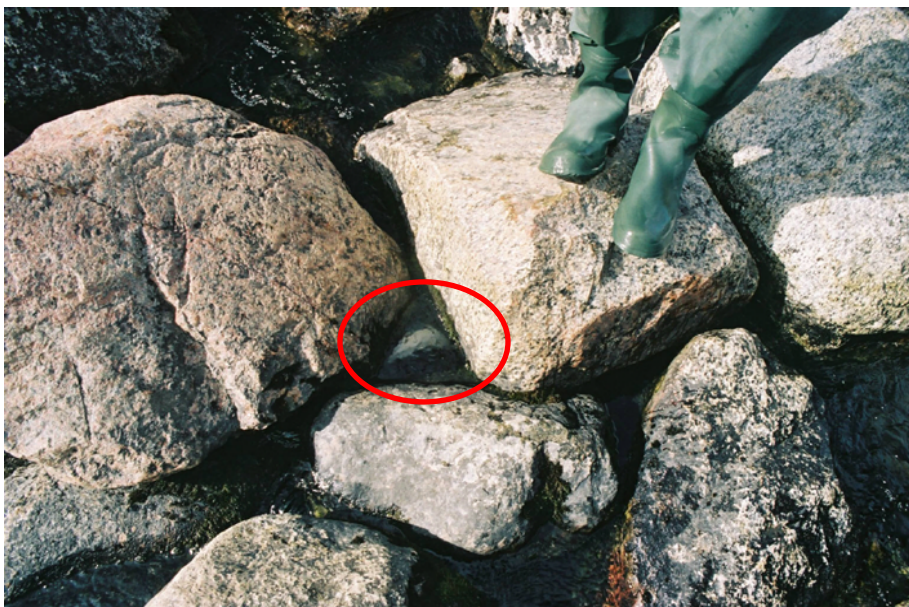
**Plate 5** **Roberts Outflow, 16 August 2002.** Arctic char trapped in deep pocket between boulders immediately downstream of Roberts Lake.

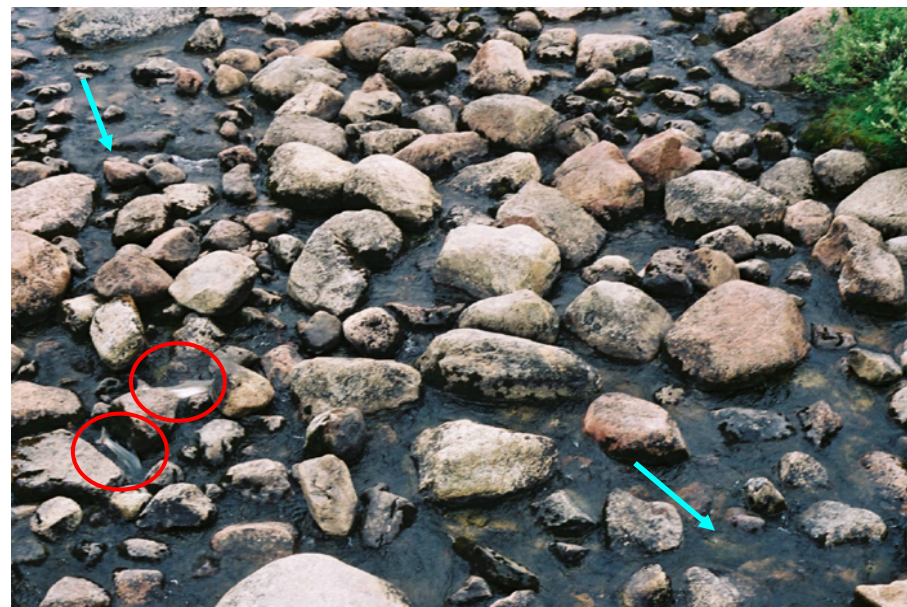
**Plate 6** **Roberts Outflow, 16 August 2002.** Low level aerial view of Arctic char trapped in boulder garden stranding zone.

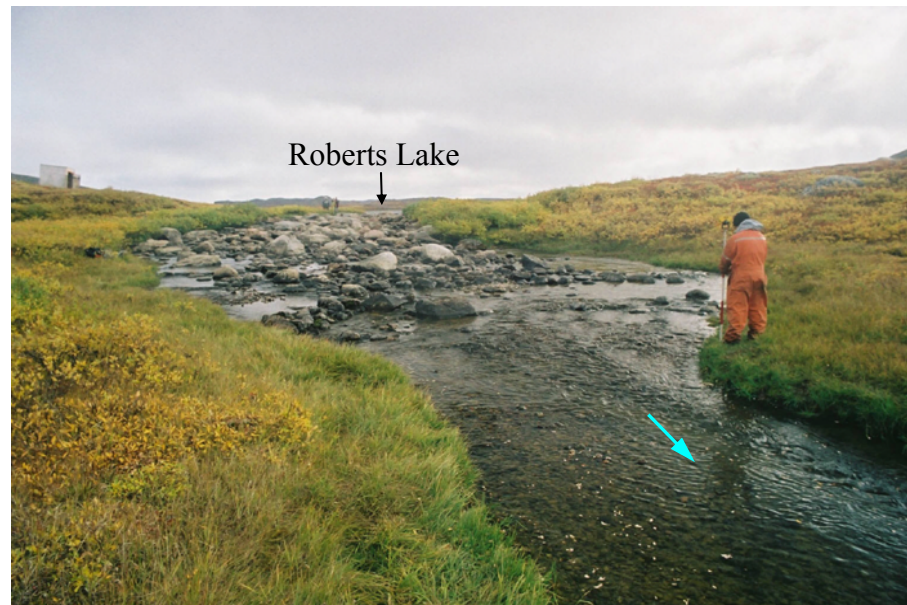
**Plate 8** **Roberts Outflow, 1 September 2002.** Survey measurement of boulder garden to determine stream gradient.

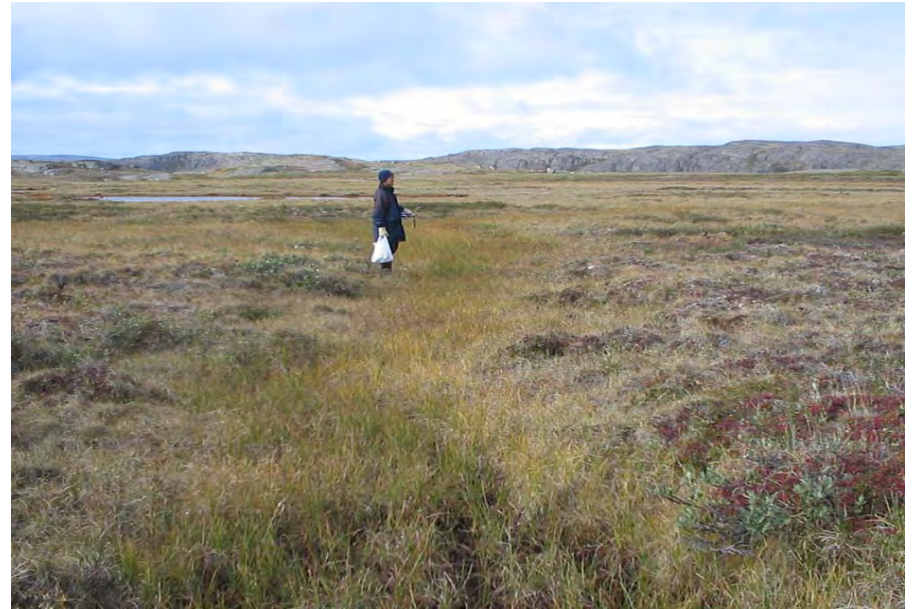
**Plate B2.** 24 August 2004. Downstream view of Stream Crossing #1 from east side of proposed road. Stream channel was dry.

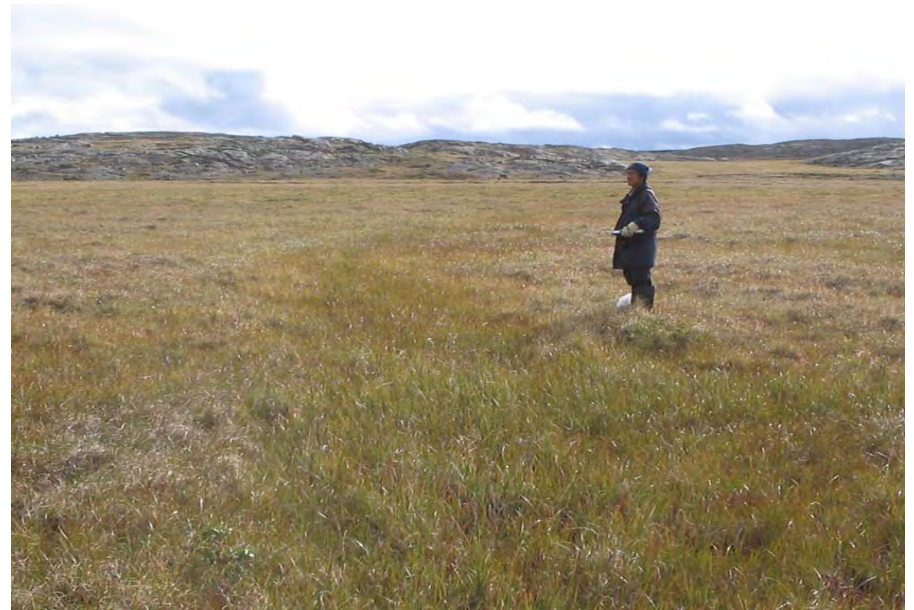
**Plate B4.** 24 August 2004. Upstream view of Stream Crossing #2 from west side of proposed road. Channel was dry.

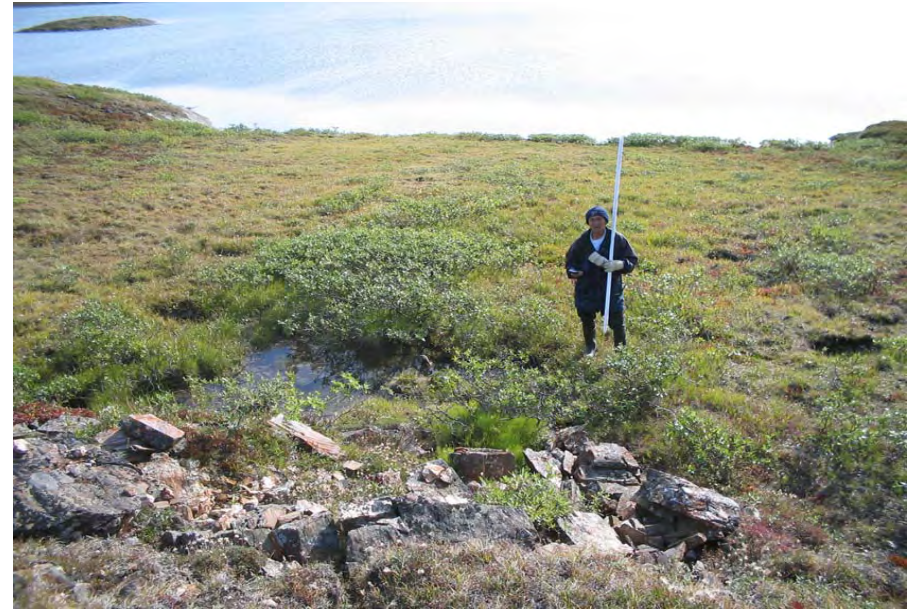
**Plate B10.** 24 August 2004. Downstream view of Stream Crossing #5. The majority of the channel was dry.

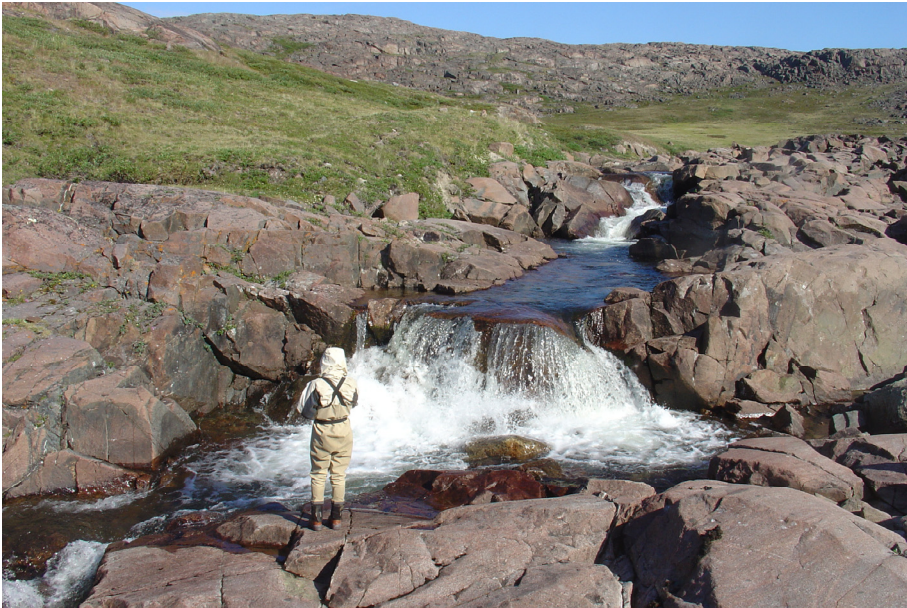
**Plate 5** Site 2, *August 2004*. UTM 13 W 0420258E 7554046N. Upstream view of waterfall. This waterfall is a barrier to fish passage. The cascade in the background is not a fish barrier.

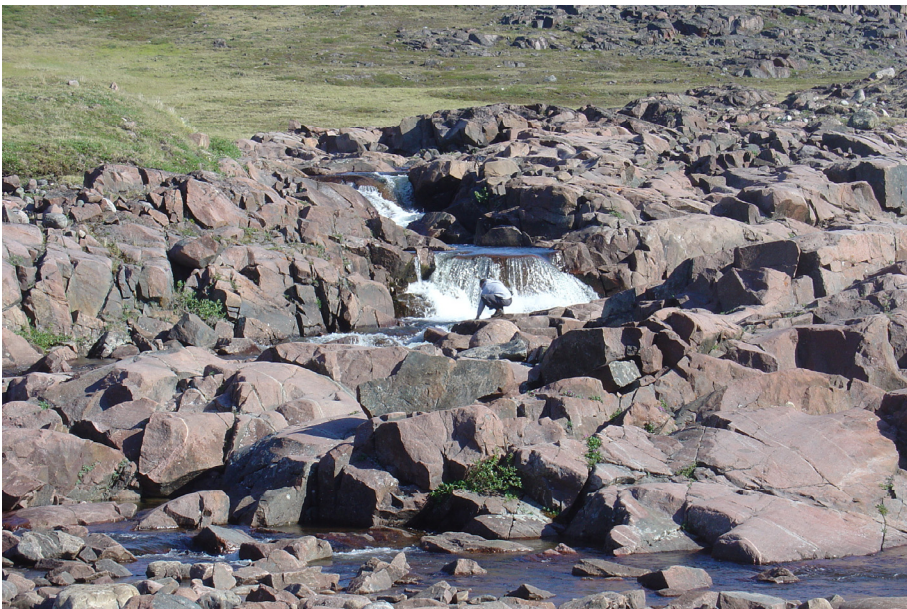
**Plate 7** Site 2, *August 2004*. Upstream view of waterfall, which is a barrier to fish passage. Note the cascade in the background.
