From: [Mark Valerioté](#)
To: [Miskolczi, Iozsef](#)
Subject: Panda Diversion Dam
Date: Tuesday, February 22, 2011 10:29:58 AM
Attachments: [As-builtConstRpt.pdf](#)

Here's the section and photos from the Panda Diversion Dam that I showed you this morning.

4.2 PLACEMENT OF ZONE B MATERIAL (CORE)

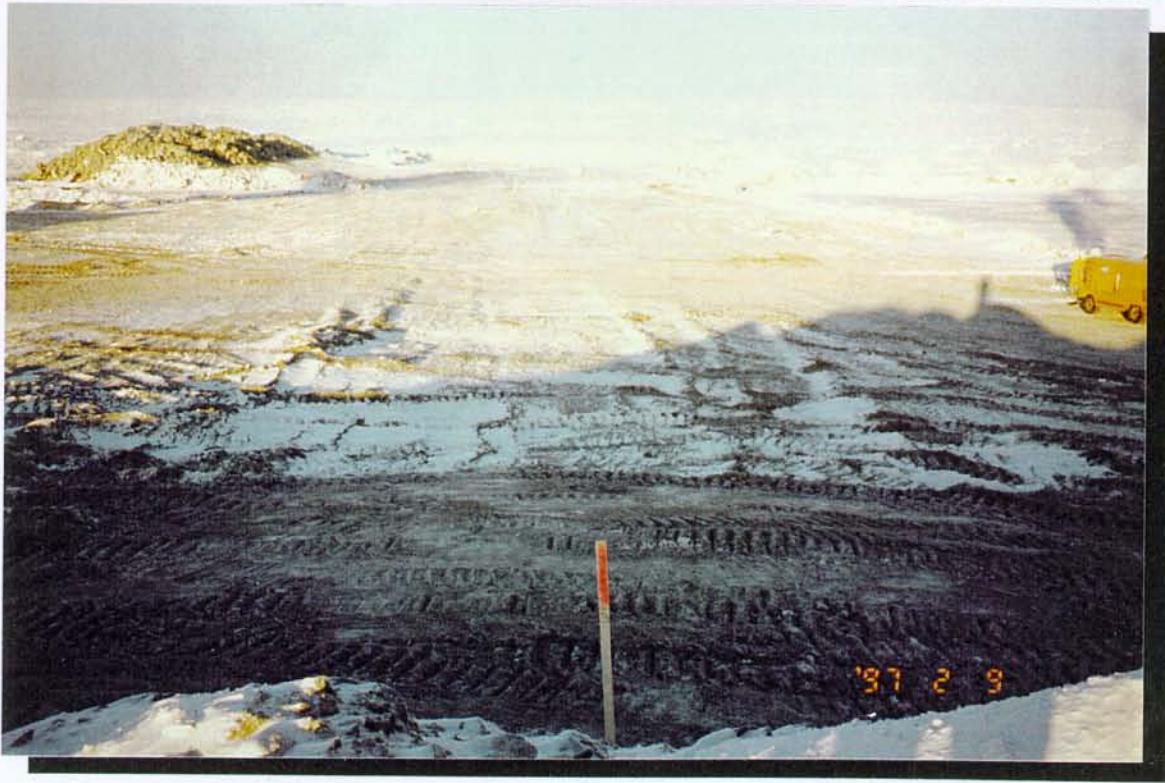
Photo 3
"Zone A" Material Placed to Lake Level - Looking East
along Dam Centreline (97/02/09)

gauge and areas where low densities were measured received additional compaction. The surface profile elevation of Zone A was approximately 460.4 to 460.6 m in the lakebed section, progressively increasing to 462.0 at the west end of the west key trench ([Photograph 3, Appendix E](#)). This operation was the initial placement phase of Zone A material since the final design elevation of this zone is 461.1 m. The second stage of Zone A placement was carried out following completion of core construction.

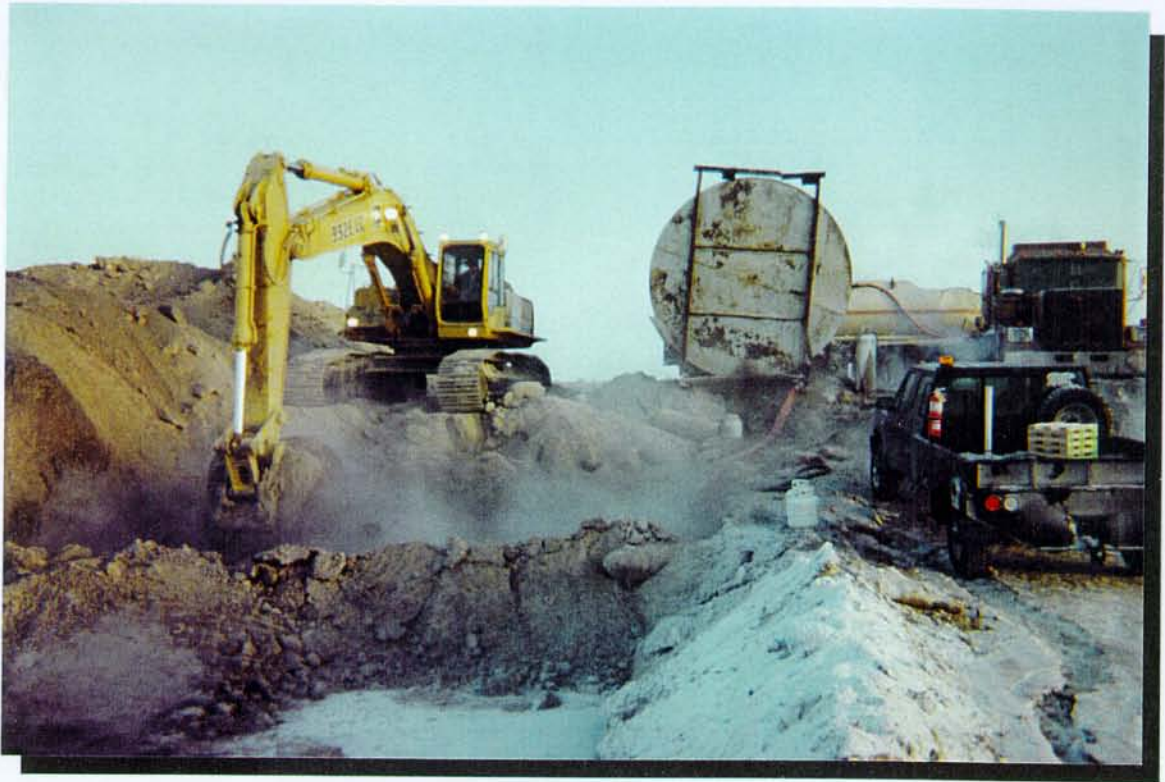
Photo 4
Mixing Pit for "Zone B" Material (97/02/18)

Preparation of Zone B material was done by mixing 20 mm minus sand and gravel with hot water in a small mixing pit located downstream of the dam core adjacent to the east abutment ([Photograph 4, Appendix E](#)). The hot water was produced using a heater unit contracted from Ceda Reactors of Grande Prairie, Alberta. This unit was able to warm the water to a temperature of 80°C at a rate of 8,000 l/hour. A 64,000 litre storage tank was placed at the construction site to maintain continuous water supply without delays due to water truck availability.

The material was mixed in the pit using a John Deere 992E excavator. The excavator then loaded the slurry into the bucket of a Cat 992 loader which would then tram the material to the dam site. The material was then spread and back-bladed using either a Cat 966 or 950 loader ([Photograph 5, Appendix E](#)).

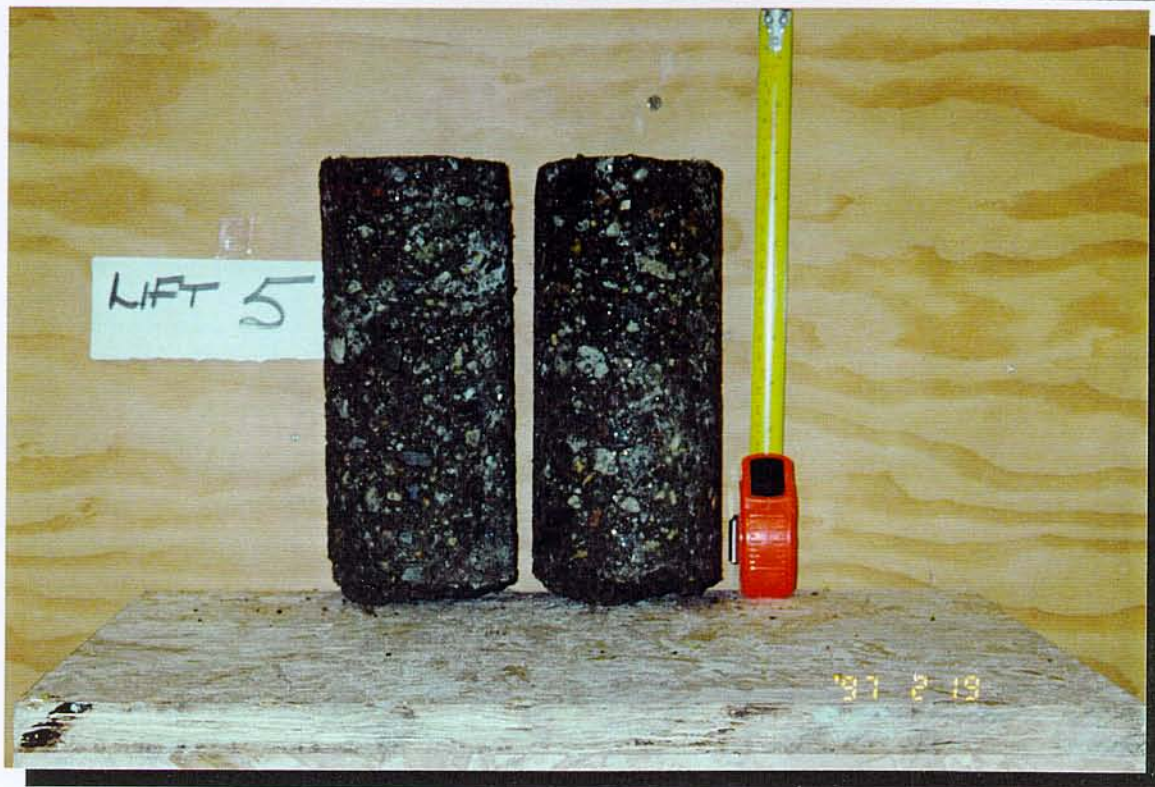
Photo 7
Typical Core Sample "Zone B" (97/02/19)

Frozen core samples of Zone B material were recovered using a concrete core barrel. The core samples were used to determine bulk density and moisture content allowing calculation of the degree of ice saturation. Two core samples were recovered from all lifts except lift #1 and all samples were photographed. [Photographs 7 and 8 \(Appendix E\)](#) present typical examples of a core sample. The results of density, moisture content and degree of saturation are given in [Table 1](#). Two samples of mixed material delivered to dam area were obtained from each lift to determine mixture bulk density and moisture content to ensure that the mixing technique was adequate. Mixture density of Zone B material was determined using a concrete yield mold in accordance with CSA CAN 3-AZ3.2-M90 procedure. [Table 2](#) presents the results of these tests.

The frozen core samples were split horizontally and examined for apparent voids. One portion of the sample was used for moisture content determination, and the other was used for bulk density determination. All samples appeared well saturated with small micro-air bubbles similar to entrained air in concrete.

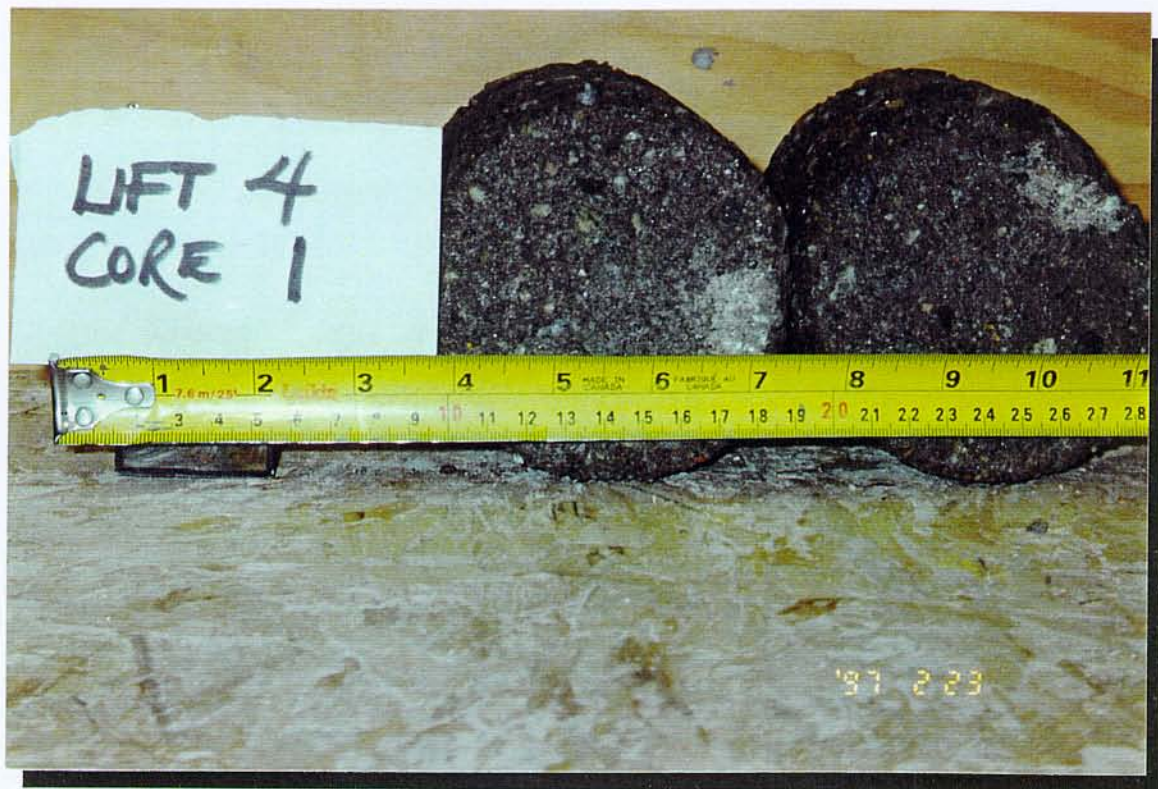
Photo 8
Typical Core Sample "Zone B" (97/02/23)
