DAILY REPORT #109– DORIS NORTH INFRASTRUCTURE/ NORTH DAM

Prepared by:	Lawrence Borowski	Date:	2012.04.23
Reviewed by:		Project #:	1CH008.058.0320
Role	Company	Personnel – Position	On Site
Client	Hope Bay Mining Limited (HBML)	Angela Holzapfel – ESR Compliance Manager David Vokey – ESR Coordinator Dean Wold - Safety Jill Turk – ESR Coordinator Katsky Venter – ESR Manger Michelle Tanquay – ESR Site Manager Stirling Kelly – HSLP Advisor	Yes Yes No No Yes No Yes
	JDS	Doug Fielding – Construction Manager Ishan Fechter – Construction Coordinator Jerry Graham – Construction Manager Mark Valeriote – Construction Manager Calvin Goldschmidt – Construction Coordinator	Yes No No No Yes
Engineering Design Consultants	SRK Consulting (Canada) Inc.	Megan Miller – Site Engineer Lawrence Borowski – Site Engineer Iozsef Miskolczi – Site Engineer	No Yes No
Earthworks Contractor	Nuna Logistics	Doug Haverland - Area Superintendent Gary Sodhi – Field Engineer Georges Cornelissen – Survey Manager Jeff Roberts - Surveyor Jim Cardinal – Foreman Jordan Gunter – Foreman (Day Shift) Margaret Caley – Surveyor Mike MacMaster – Surveyor Mike Price – Field Engineer Rick Peter – Foreman (Night Shift) Trevor Sorken

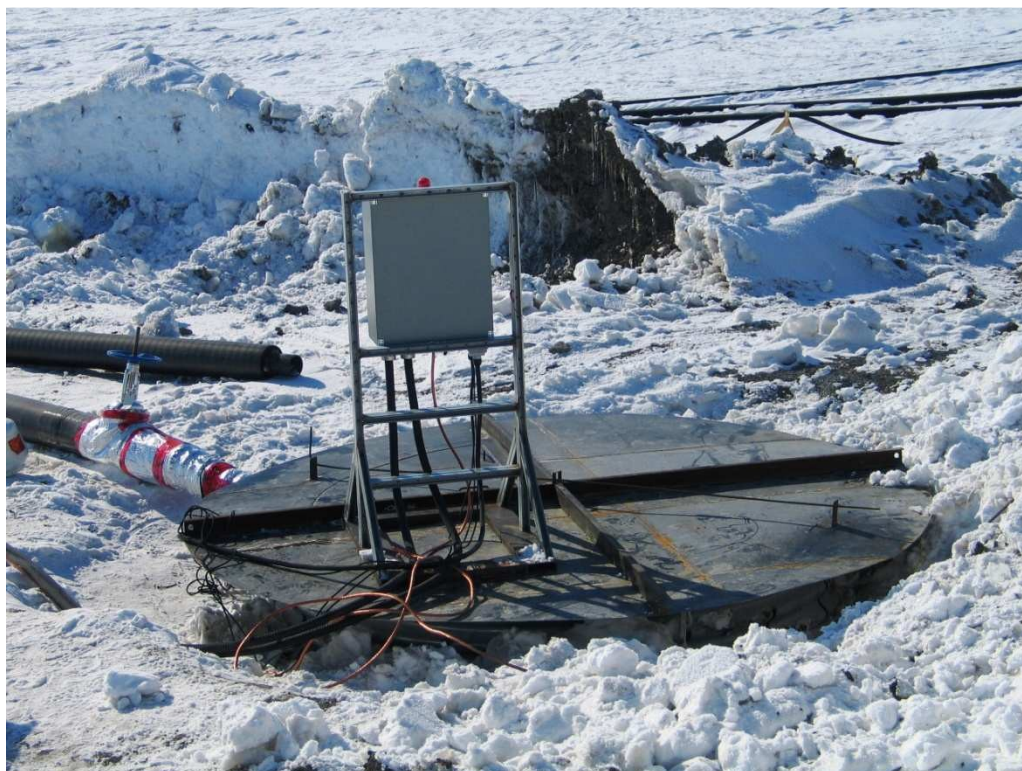
Photo 1: Electrical panel in place, sump 1.

- Electrical panels were mounted on both sumps.
- This will be the final report on sumps.

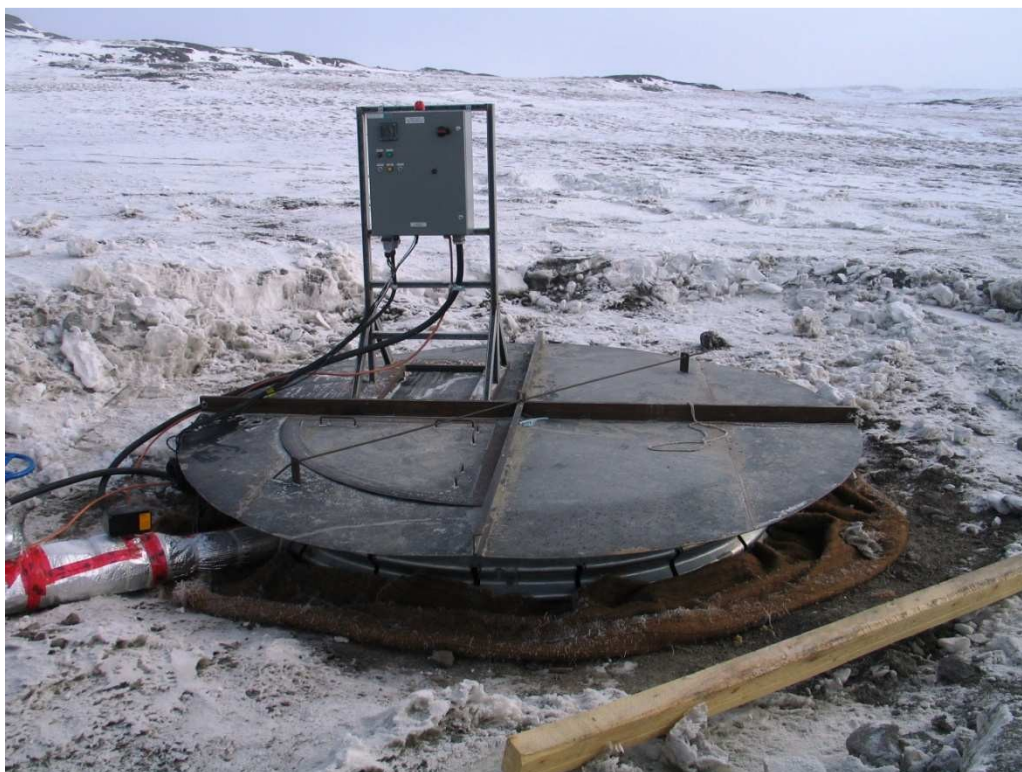
Photo 2: Electrical panel in place sump 2..

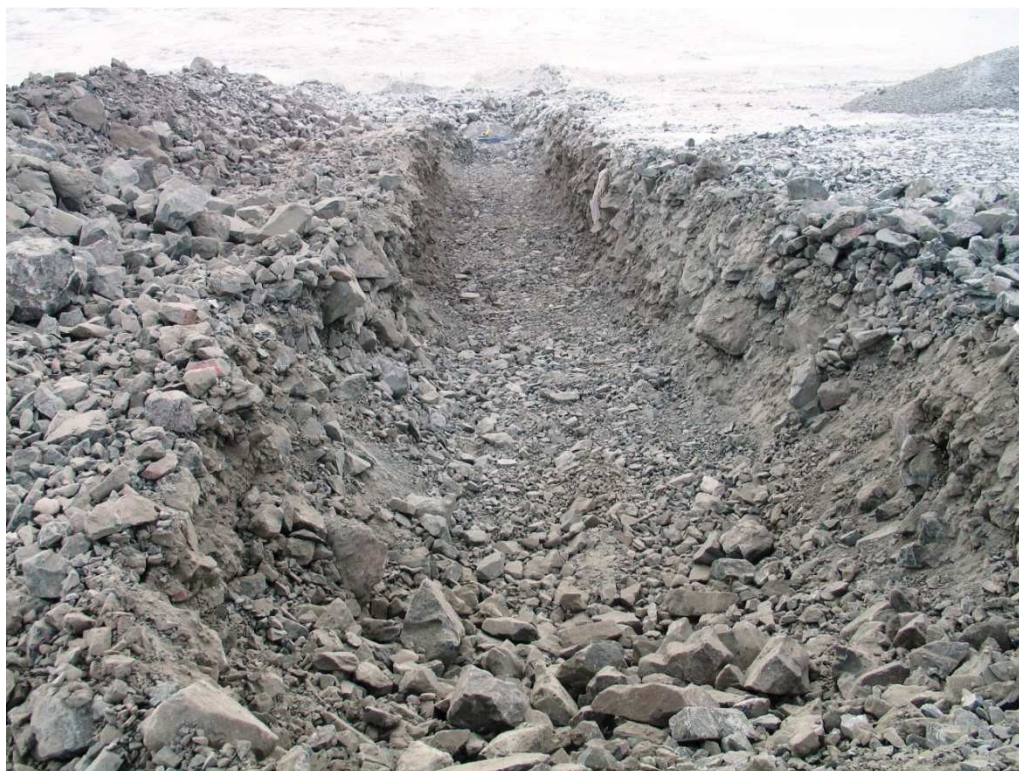
Photo 3: Excavation at Sta 1+30 us before being surveyed

- Work at Sta 1+30 was started yesterday afternoon with the most difficult part at the bottom completed. Trench was excavated to the termination point on the west side of the dam, cable installed and backfilled by 1:00 pm.

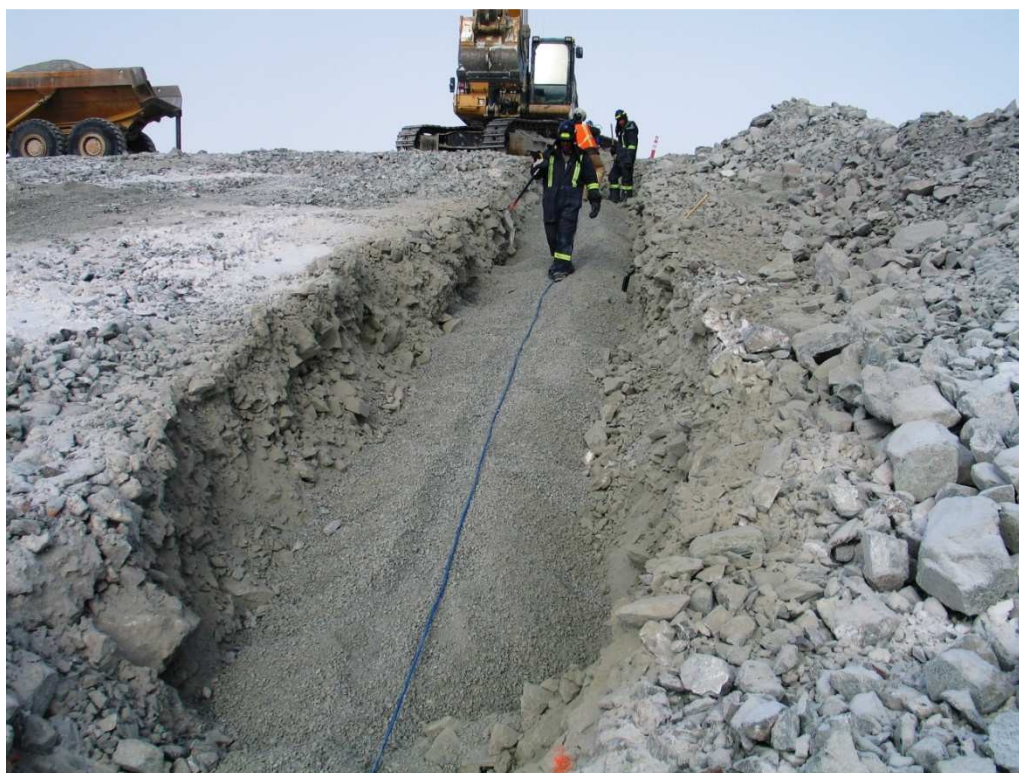
Photo 4: Placing cable Sta 1+30 us.

- Cable was long enough and did not need to be extended. It was read on completion.
- The cable at Sta 0+85 was the next cable to be extended. An inspection of this cable revealed that the 1st 40 feet were in 2-20 foot lengths of pipe. Approximately ½ of the first pipe was in ice.

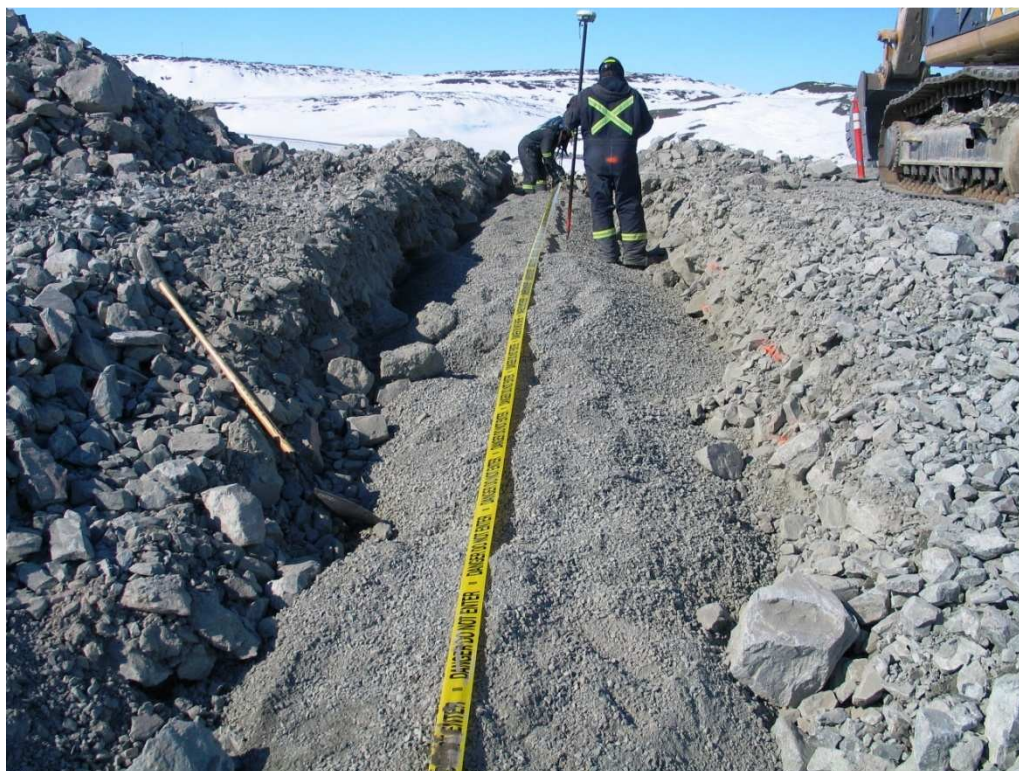
Photo 5: Final crush across the top of the dam Sta 1+30 us

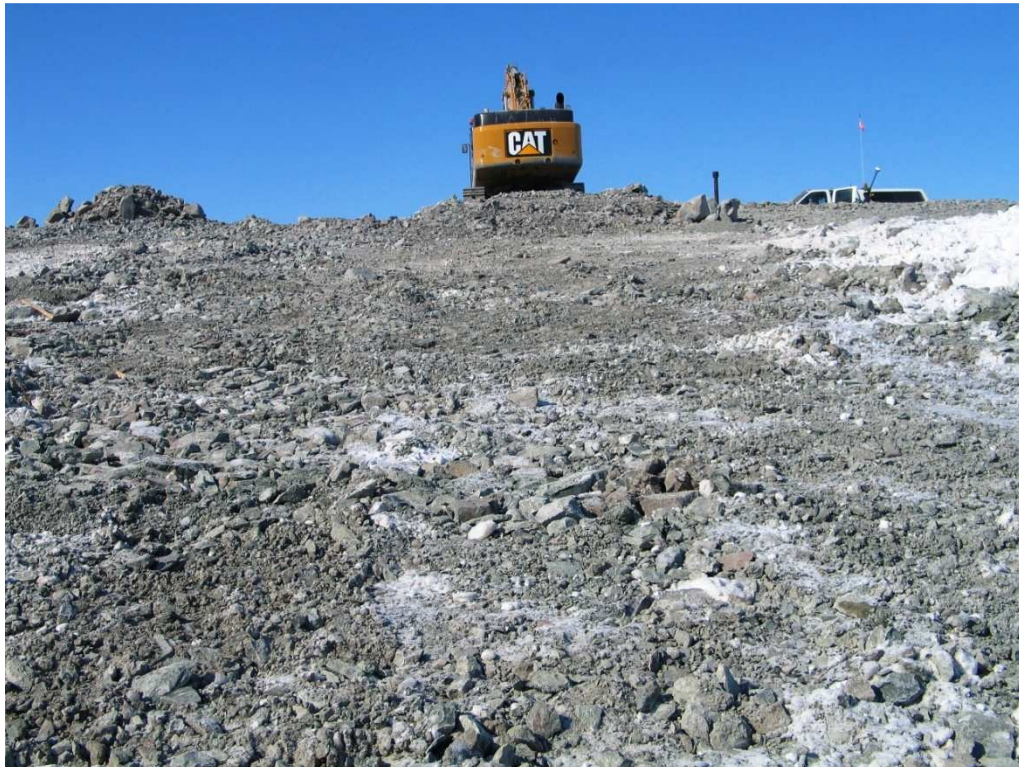
Photo 6: Final product Sta 1+30 us

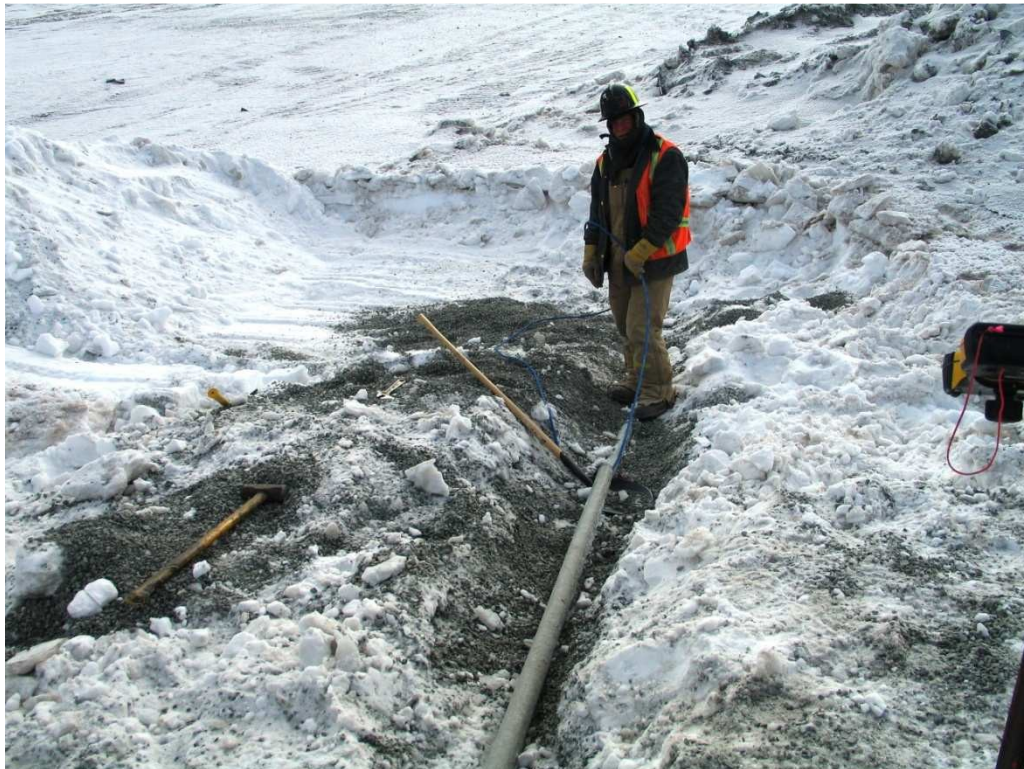
Photo 7: Two pipes separated. Cable is being pulled through the top pipe Sta 0+85 us.

- Nuna were successful in uncoupling the pipes and completely removing the end section.
- The location of the cable at ground level was marked, and a 1 m deep trench was excavated from the end of the pipe along side it.

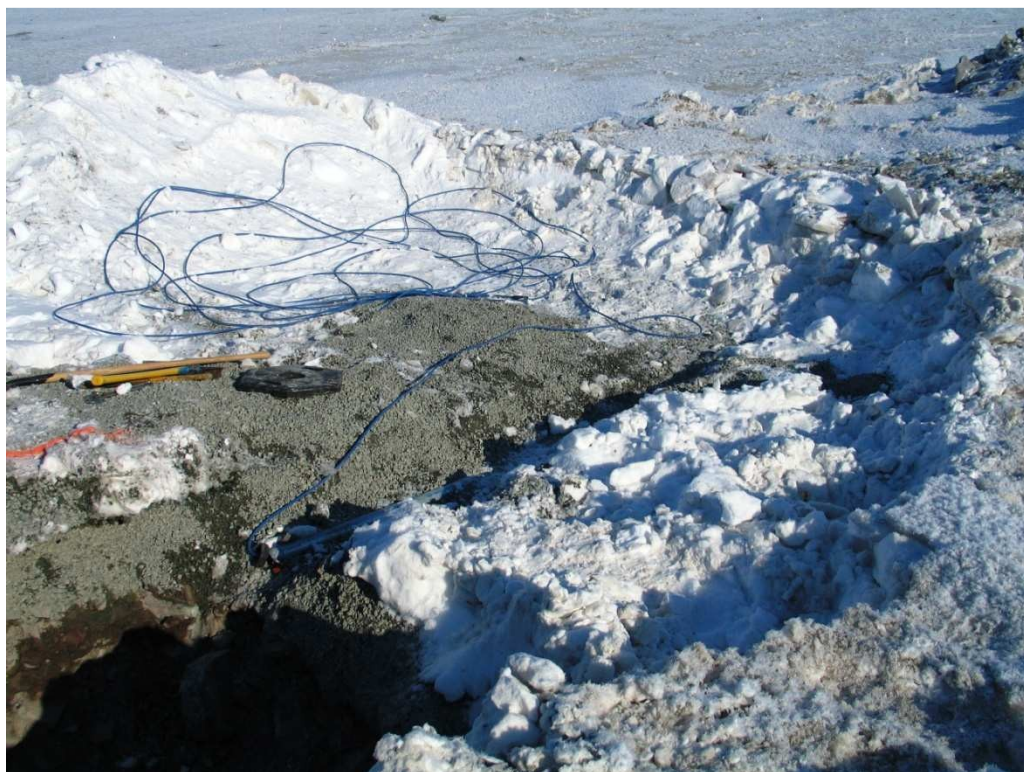
Photo 8: Sta 0+85 us. Section that will require a buttress. Note that pipe ends about 3 m into the snowbank .

- A buttress will be constructed over the 1st pipe and a minimum of 1 m beyond. Currently this is under a lot of snow and ice and will be constructed at the end.

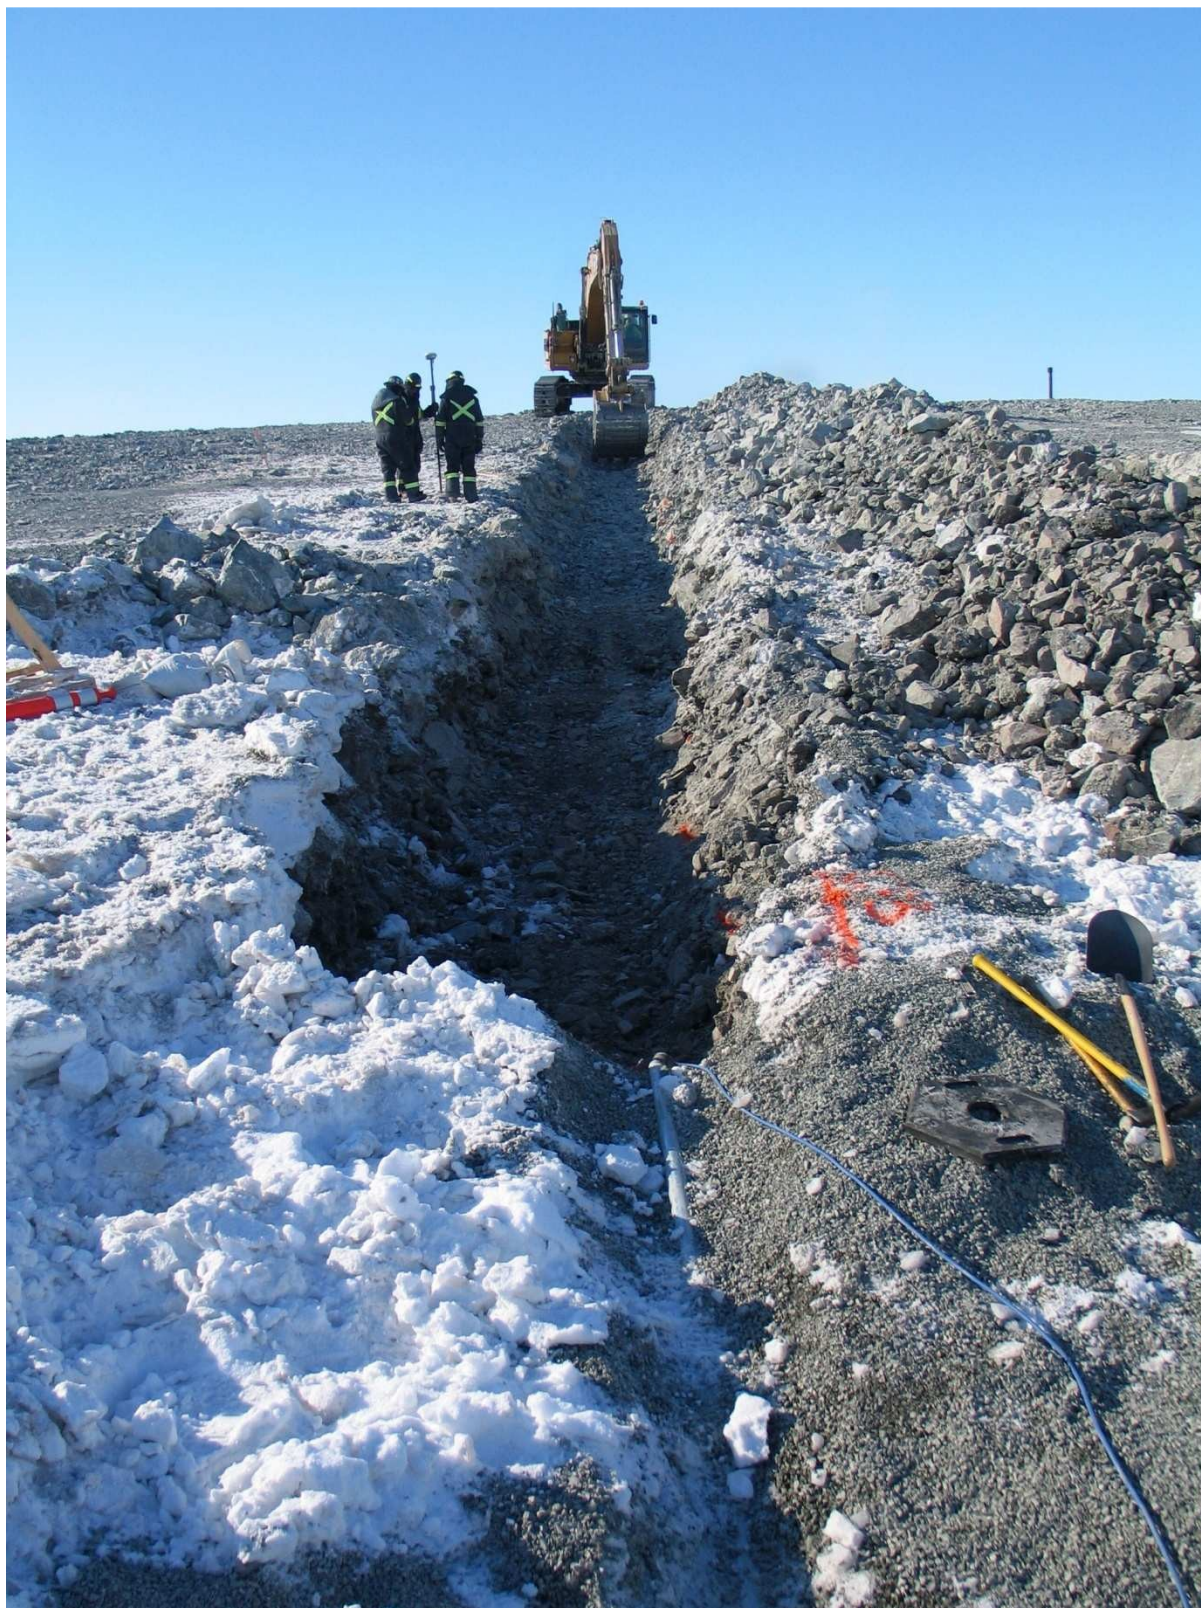
Photo 9: Excavation at Sta 0+85 us. The red paint line indicates where the underground line is located. At the pipe it was ~ 1m down

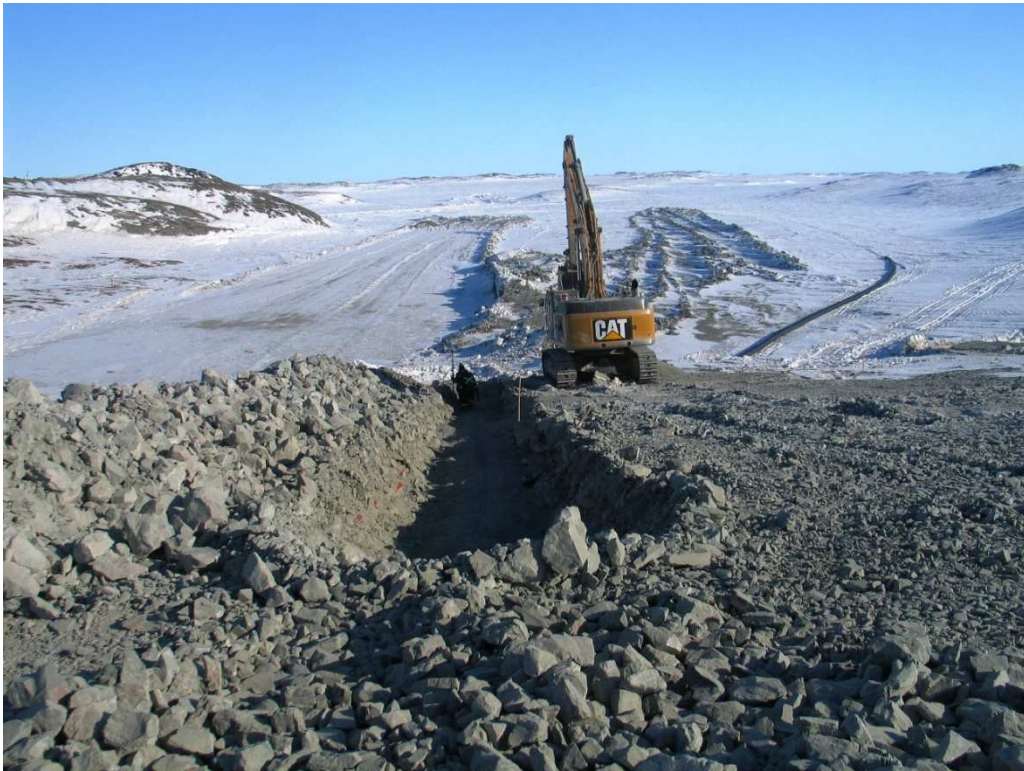
Photo 10: Extent of excavating today

- Trench was excavated and cable placed and covered to within 5 m of the top of the dam.

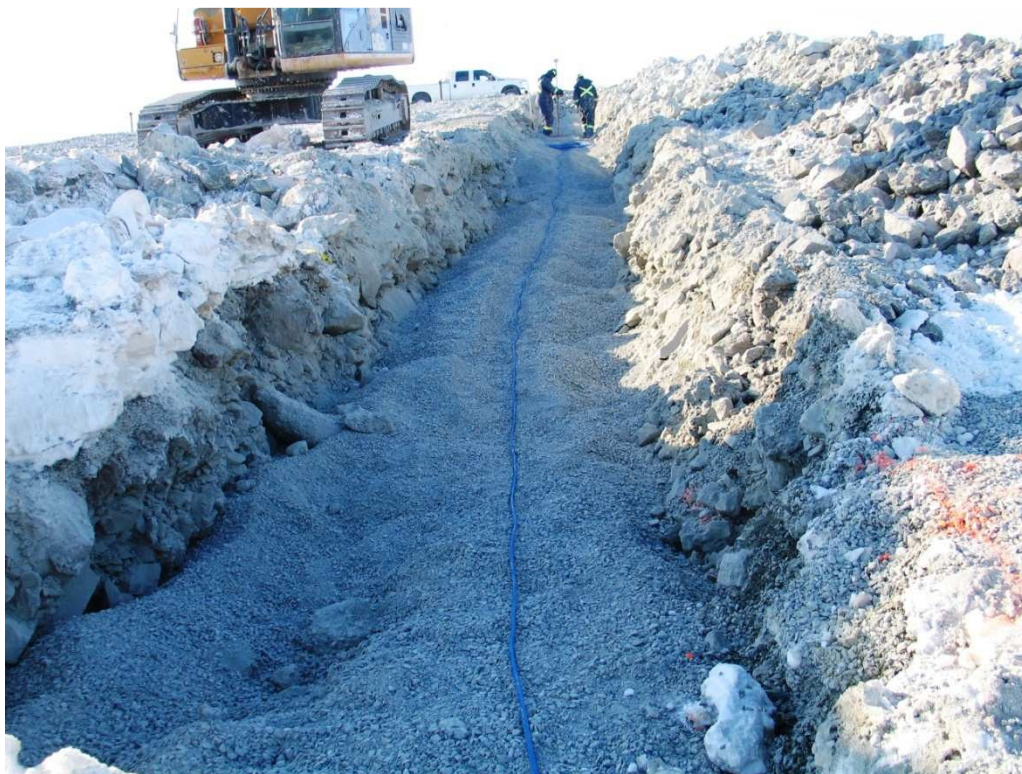
Photo 11: Cable placement Sta 0+85
