Re: February 2018 – Monthly Monitoring Report for Water Licence 2AM-DOH1323

This report is comprised of monitoring requirements as set out in Part J and Schedule J of water licence 2AM-DOH1323 Amendment 1, and additional requirements from INAC.

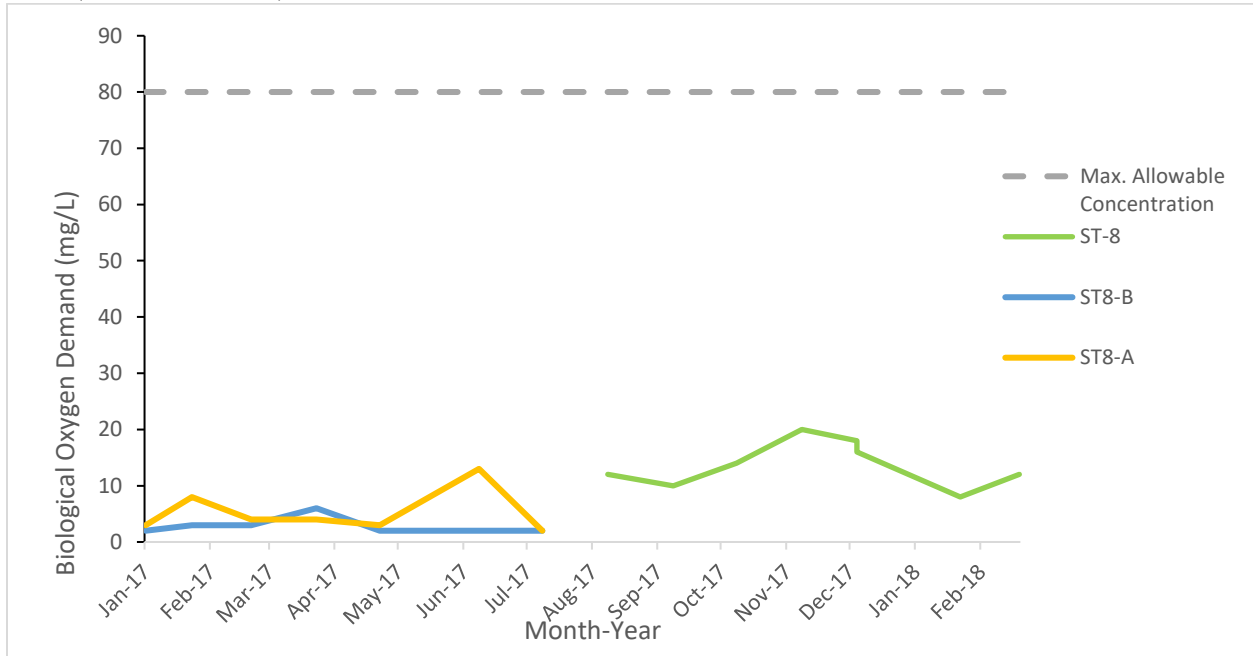
Figure 1. Biological Oxygen Demand Results Consistently Below Discharge Criteria for Wastewater Treatment Plant (ST8, ST8A, ST8B)

Note: Maximum Average Concentration as per Part G Item 4(b).

Figure 1 and 2 illustrates effluent quality characteristics for parameters of interest at select monitoring stations.

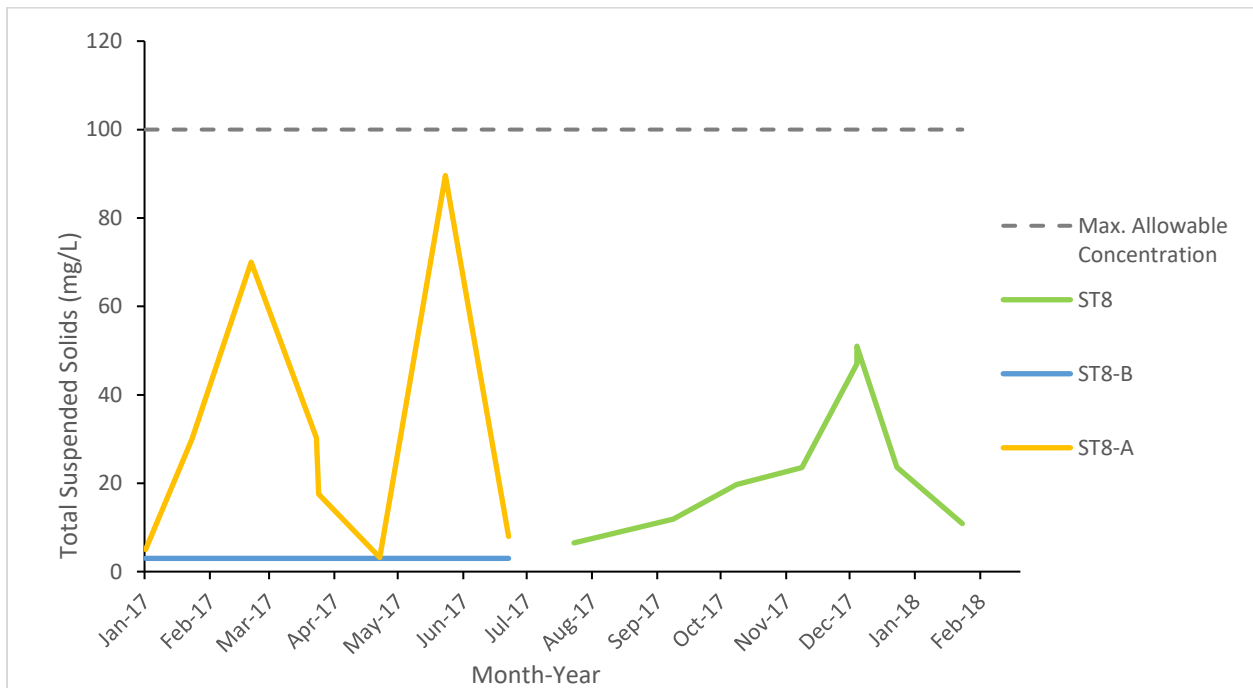
Figure 2. Total Suspended Solids Results Consistently Below Discharge Criteria for Wastewater Treatment Plant (ST8, ST8A, ST8B)

Note: Maximum Average Concentration as per Part G Item 4(b).

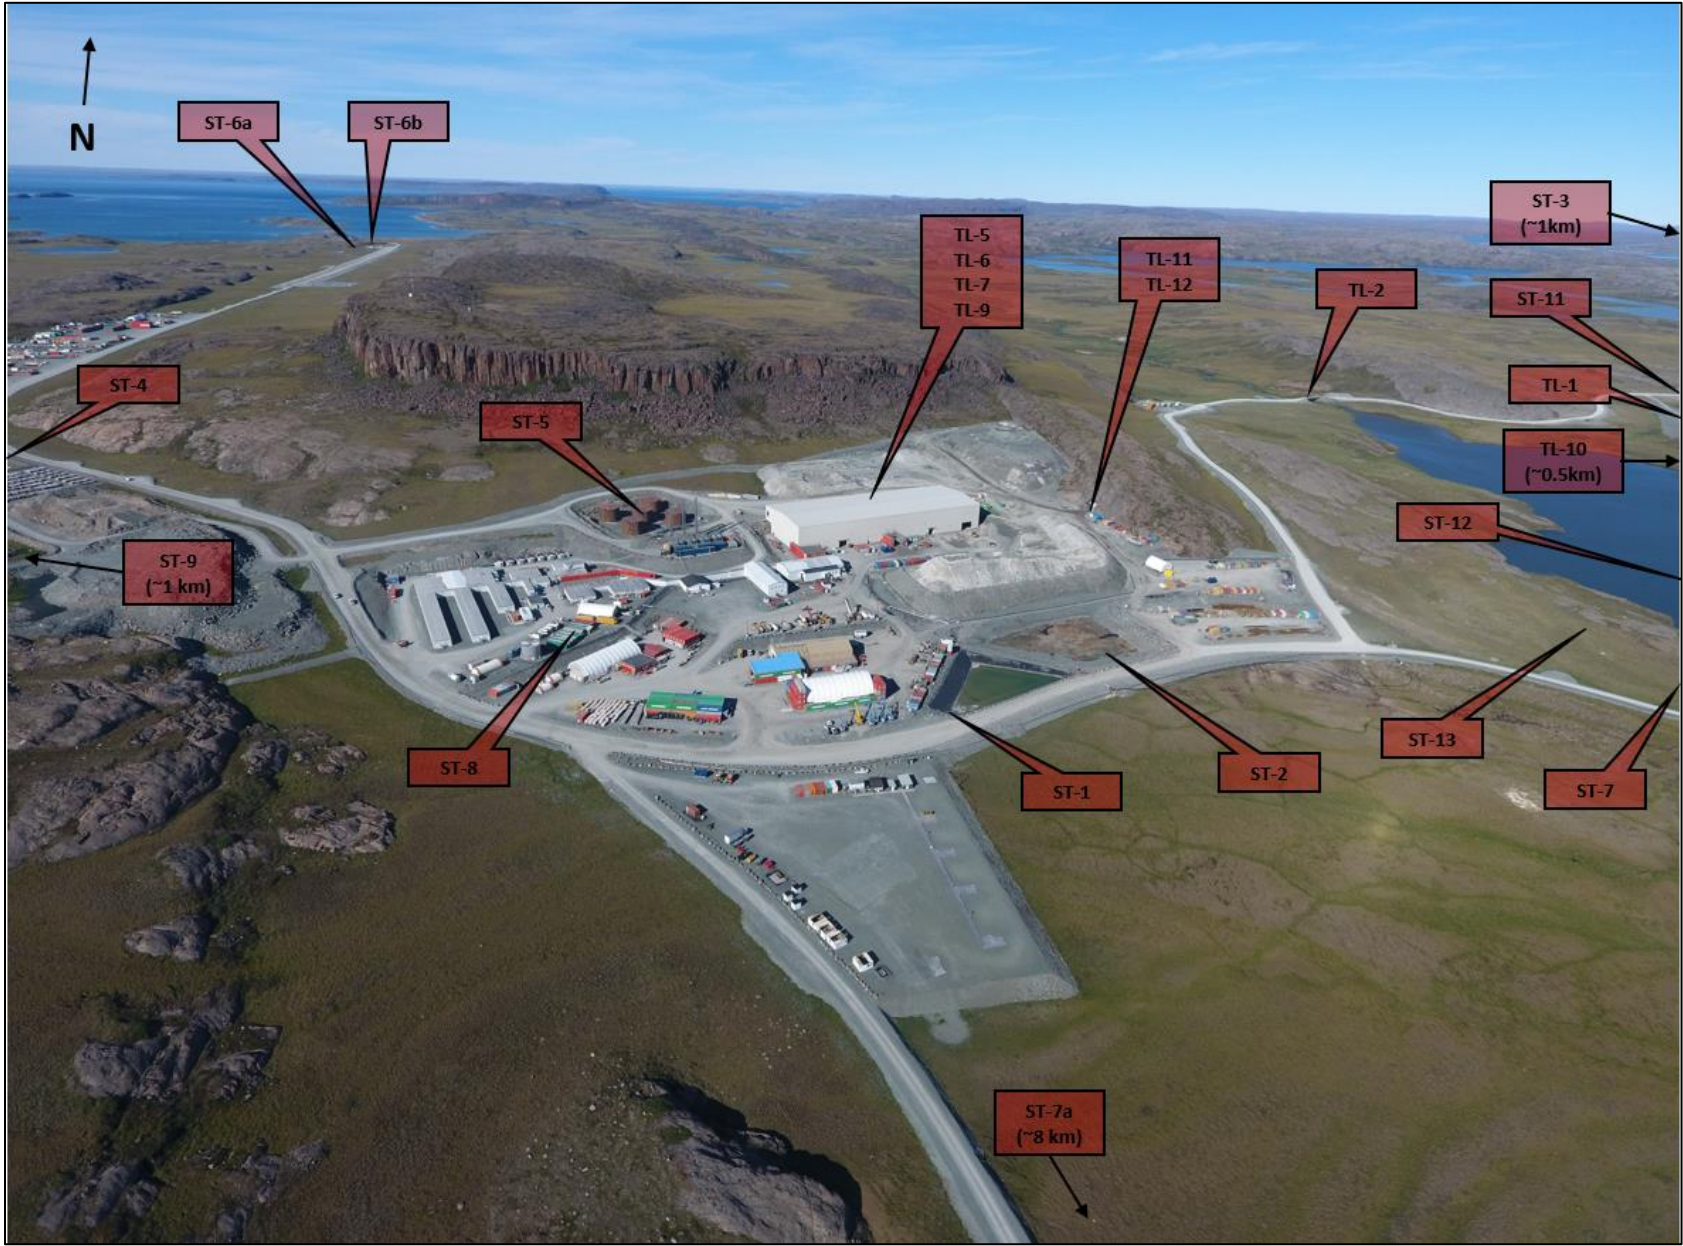
Figure 3. 2AM-DOH-1323 SNP Monitoring Locations

During the subject period of this report the focus of activities at Doris North was underground mining, construction, ore processing, water management and environmental compliance. Sampling locations monitored under this licence (seasonally or when facilities are operational) are provided in Figure 3 at the end of this report.
