Re: September 2022 – Monthly Monitoring Report for Water License 2AM-DOH1335

This report is comprised of the monitoring requirements set out in Part I and Schedule I of water licence 2AM-DOH1335 Amendment 2 (the license), and additional requirements from CIRNAC.

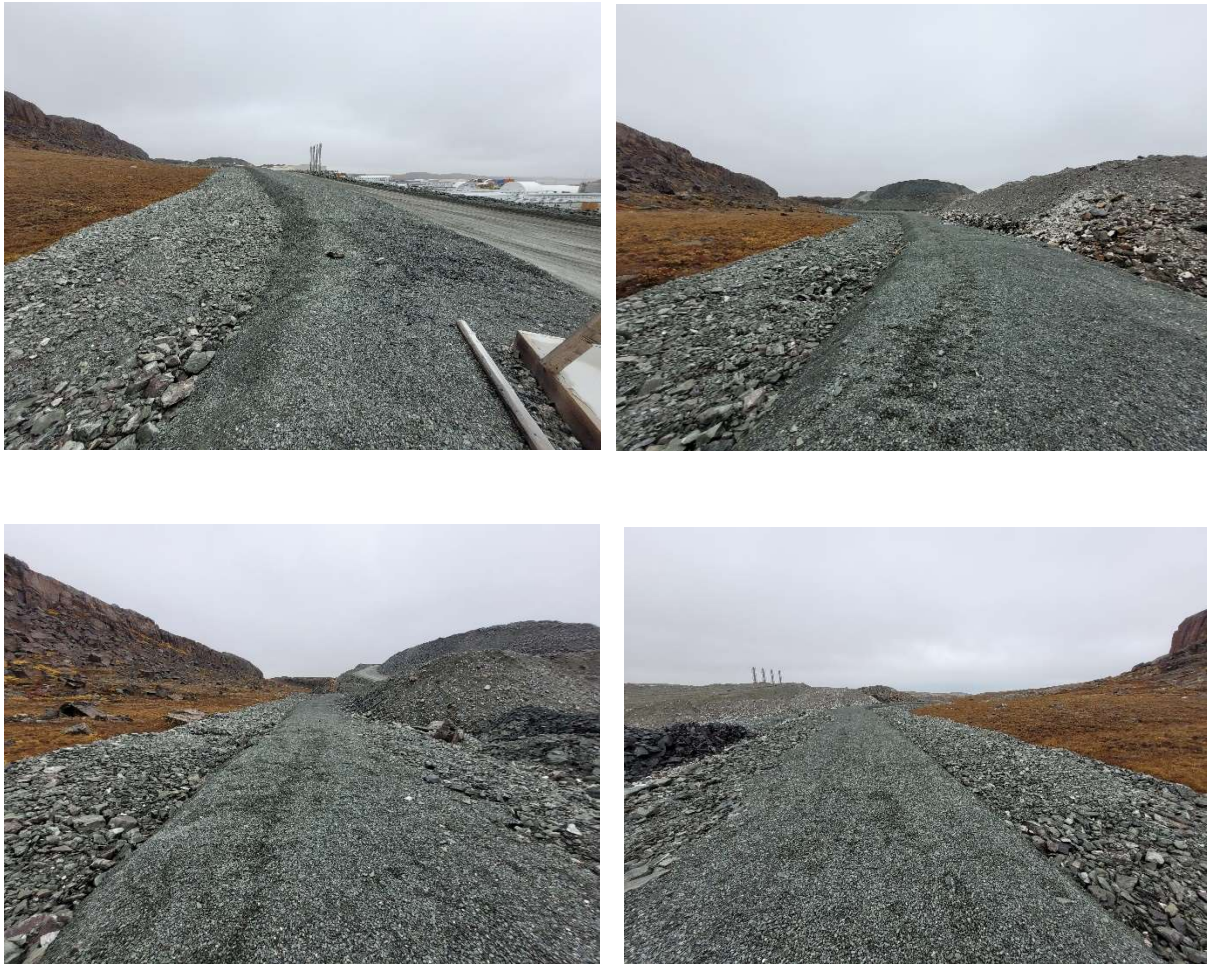
Visual monitoring was conducted at the Diversion Berm this month. No issues were identified at the Diversion Berm and associated check dam in September. Photos of this infrastructure are provided in Figure 3 below.

Figure 3. Diversion berm during August 2022

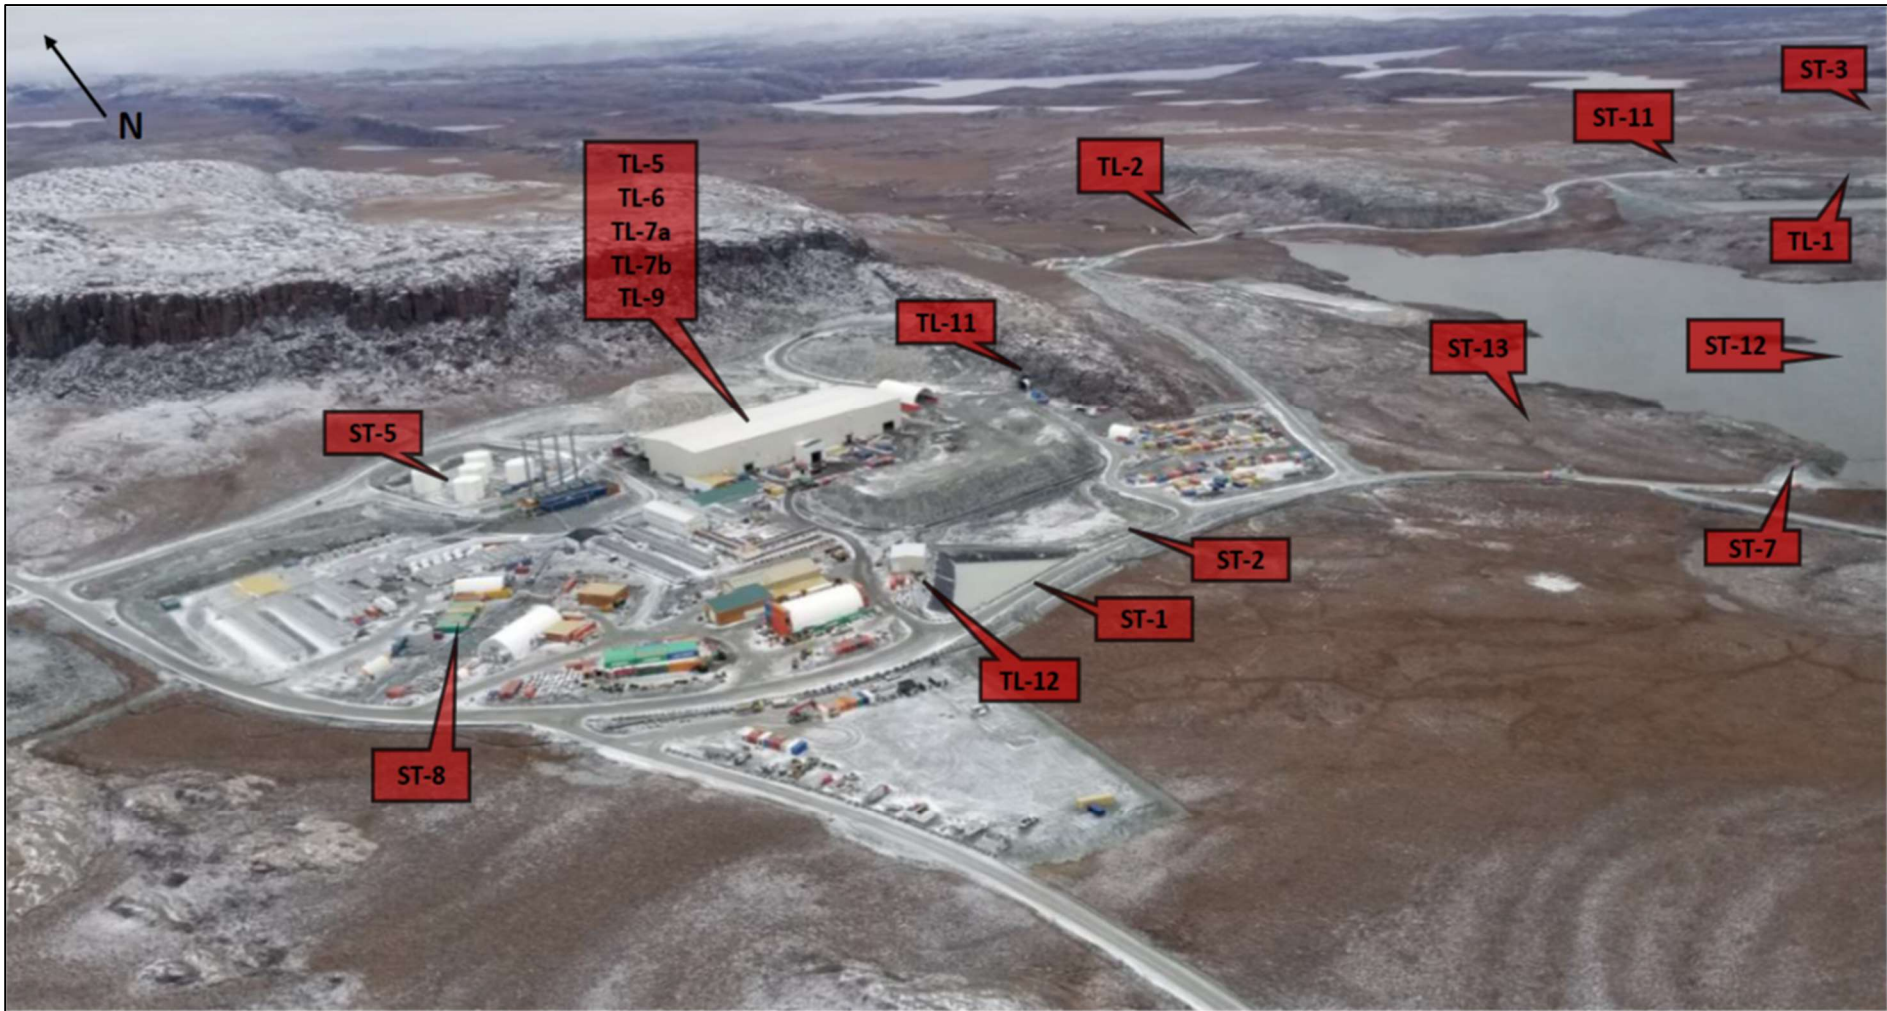
Figure 6. 2AM-DOH1335 SNP Monitoring Locations

Sampling locations monitored under this licence (seasonally or when facilities are operational) are provided in Figure 6 through Figure 8 at the end of this report.
