Re: October 2022 – Monthly Monitoring Report for Water License 2AM-DOH1335

This report is comprised of the monitoring requirements set out in Part I and Schedule I of water licence 2AM-DOH1335 Amendment 2 (the license), and additional requirements from CIRNAC.

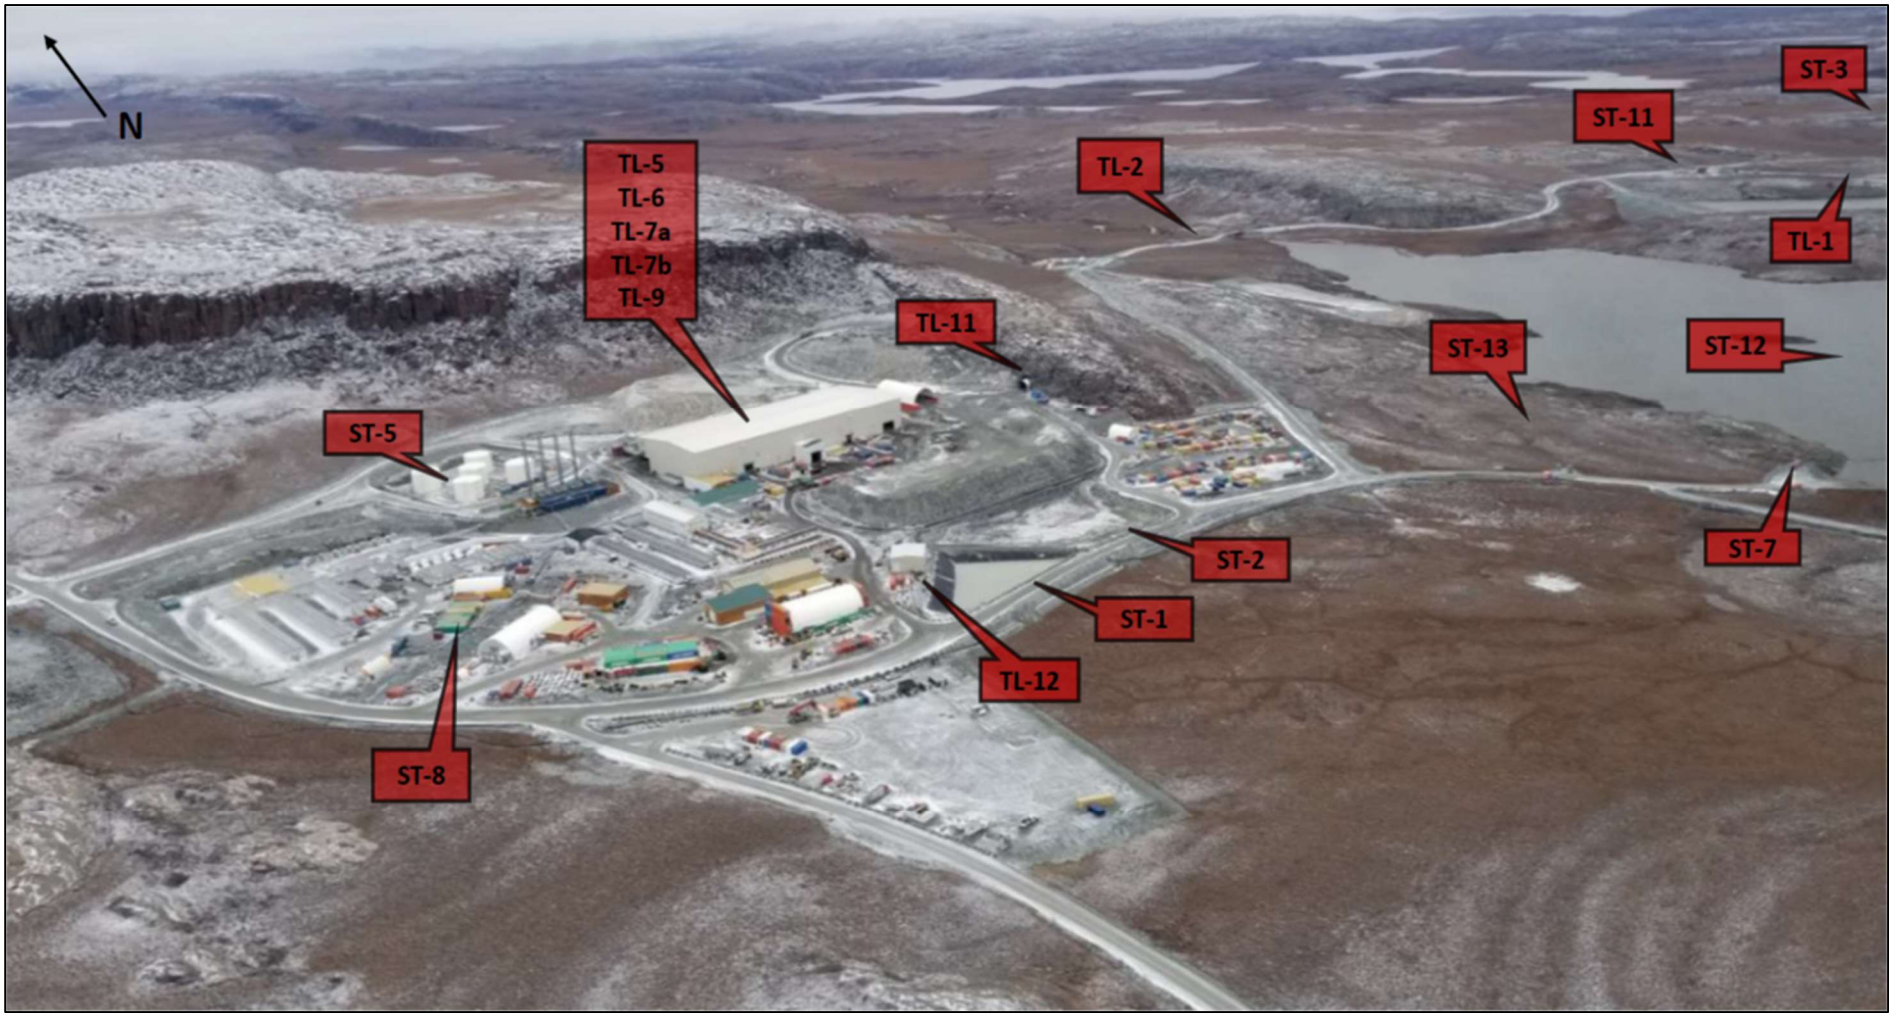
Figure 6. 2AM-DOH1335 SNP Monitoring Locations

Sampling locations monitored under this licence (seasonally or when facilities are operational) are provided in Figure 6 through Figure 8 at the end of this report.

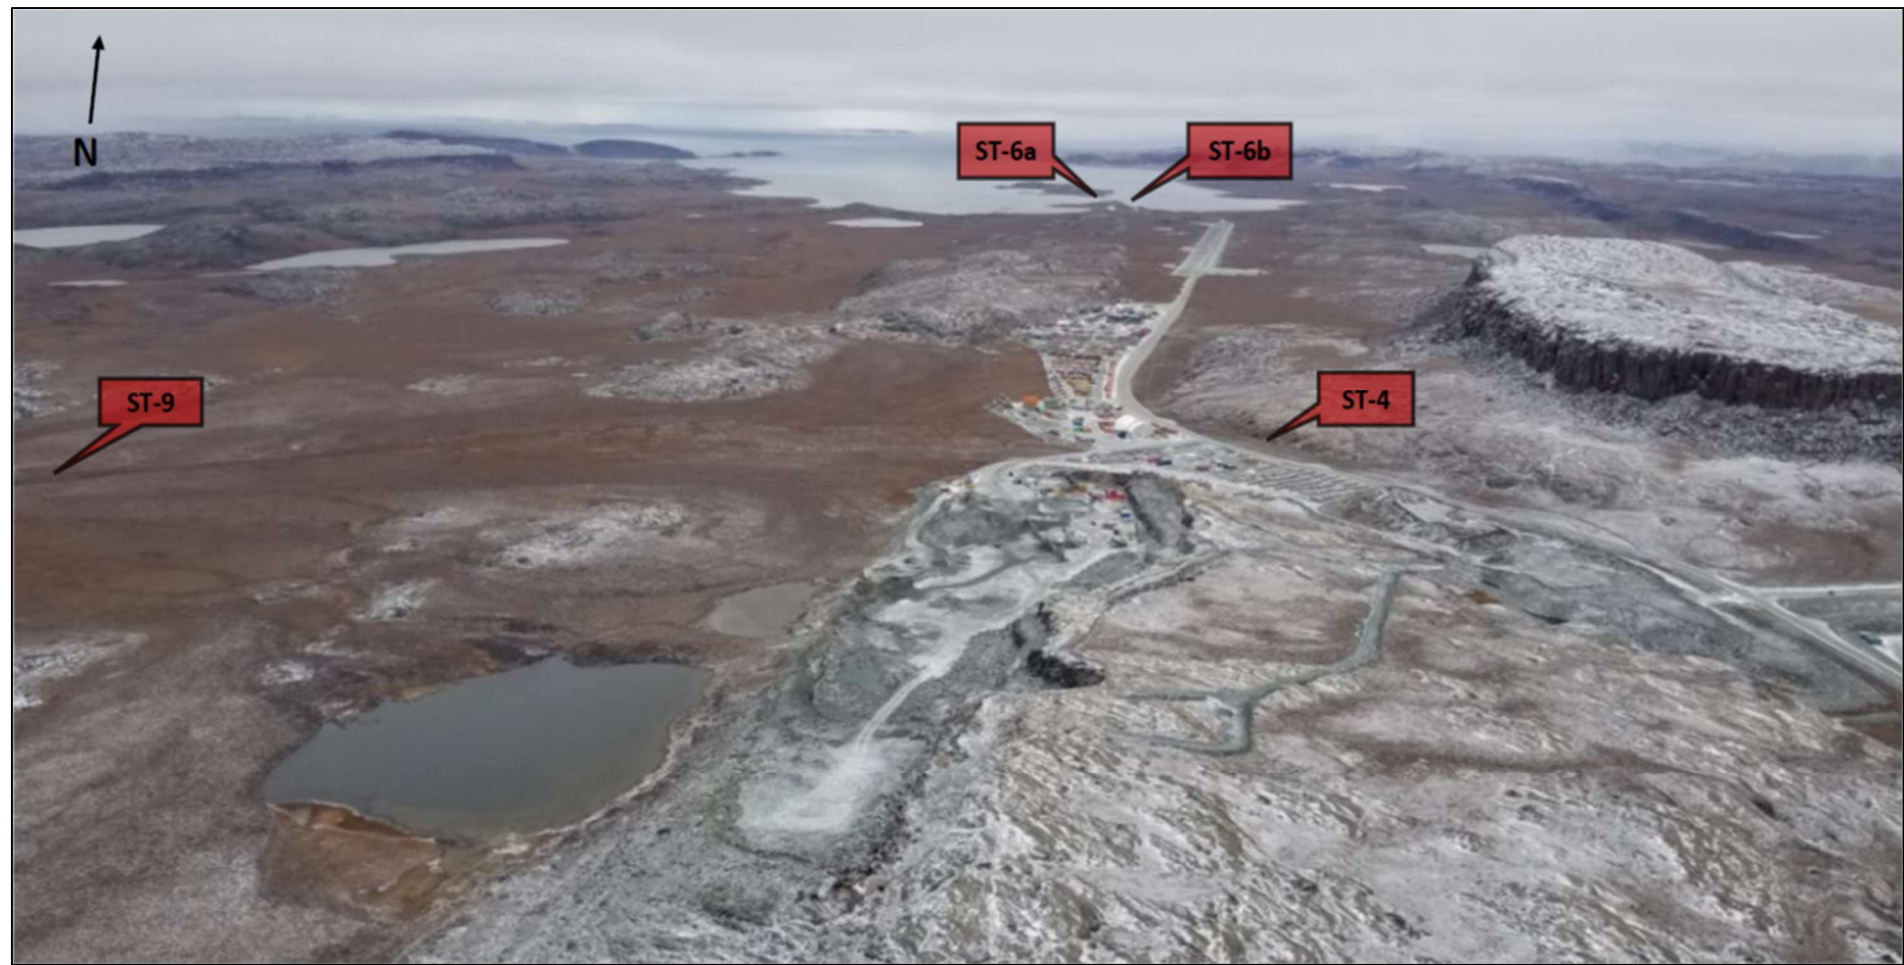
Figure 7. 2AM-DOH1335 SNP Monitoring Locations

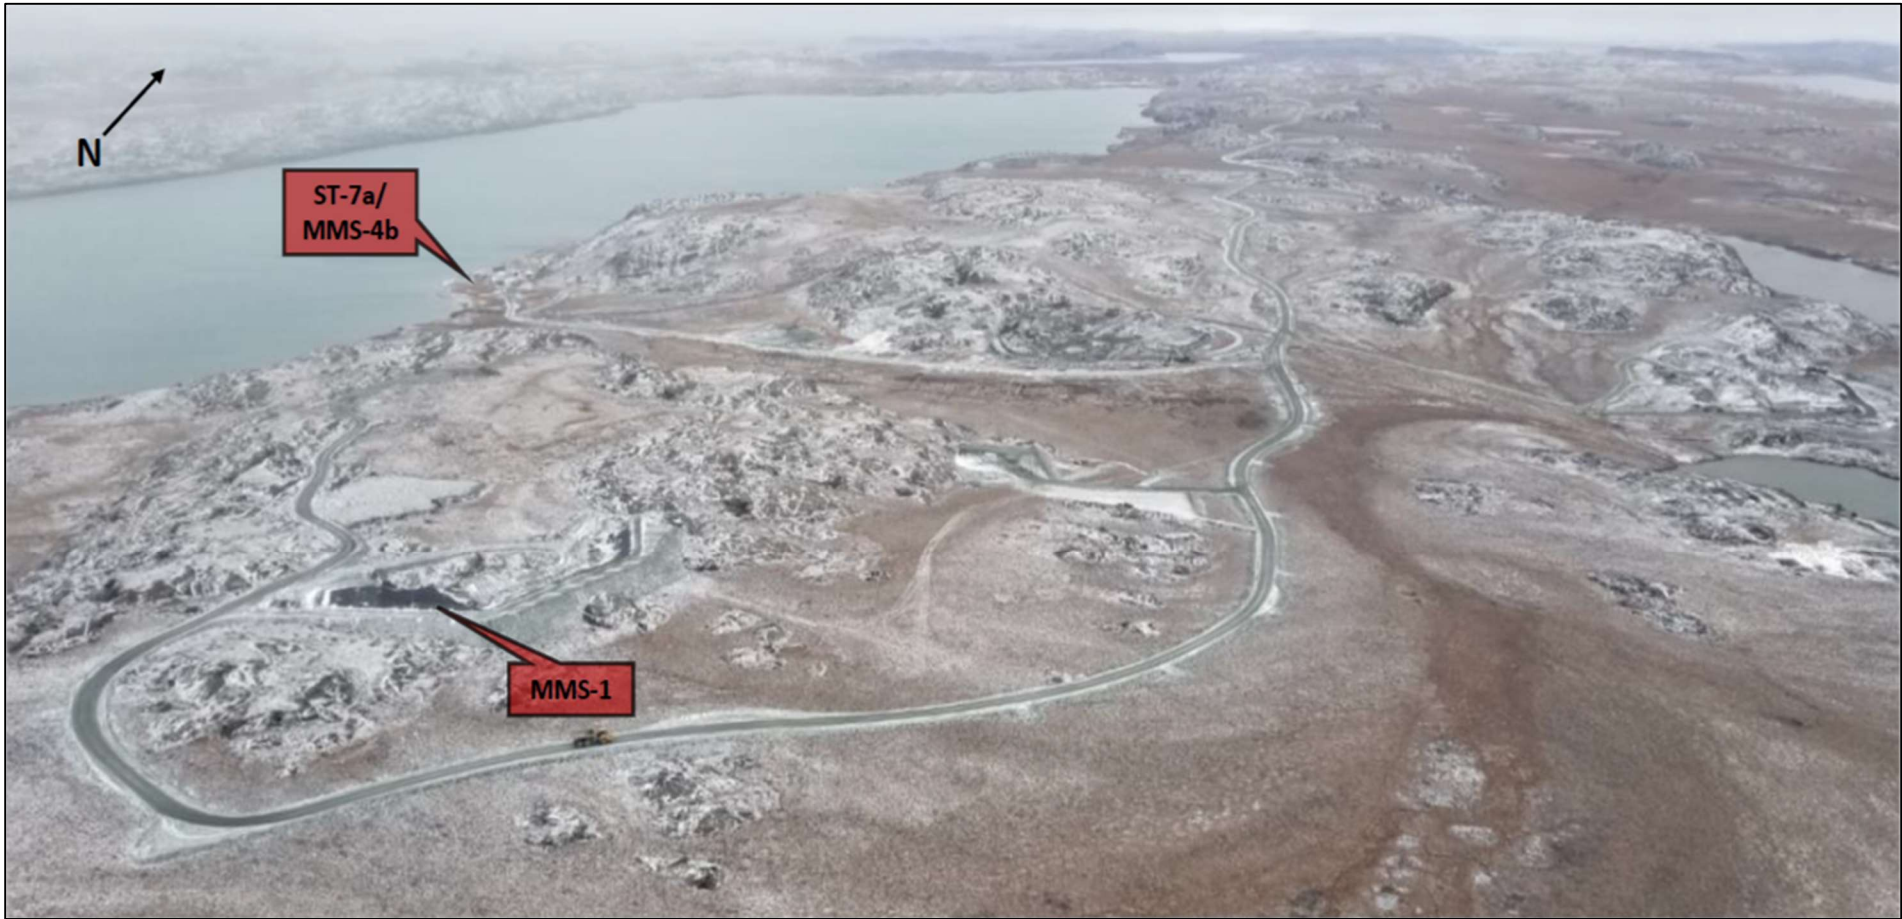
Figure 8. 2AM-DOH1335 SNP Monitoring Locations
